MINERALS PROGRAM INSPECTION REPORT
PHONE: (303) 866-3567

MINE NAME: Castillo Pit	MINE/PROSPECTING ID#: M-2000-053	MINERAL: Gravel	COUNTY: Las Animas
INSPECTION TYPE: Monitoring	INSPECTOR(S): Daniel Cunningham	INSP. DATE: September 24, 2020	INSP. TIME: 11:30
OPERATOR: Las Animas County	OPERATOR REPRESENTATIVE: Skeeter Mincic	TYPE OF OPERATION: 112c - Construction Regular Operation	
REASON FOR INSPECTION: Normal I&E Program	BOND CALCULATION TYPE: None	BOND AMOUNT: \$0.00	
DATE OF COMPLAINT: NA	POST INSP. CONTACTS: None	JOINT INSP. AGENCY: None	
WEATHER: Clear	INSPECTOR'S SIGNATURE:

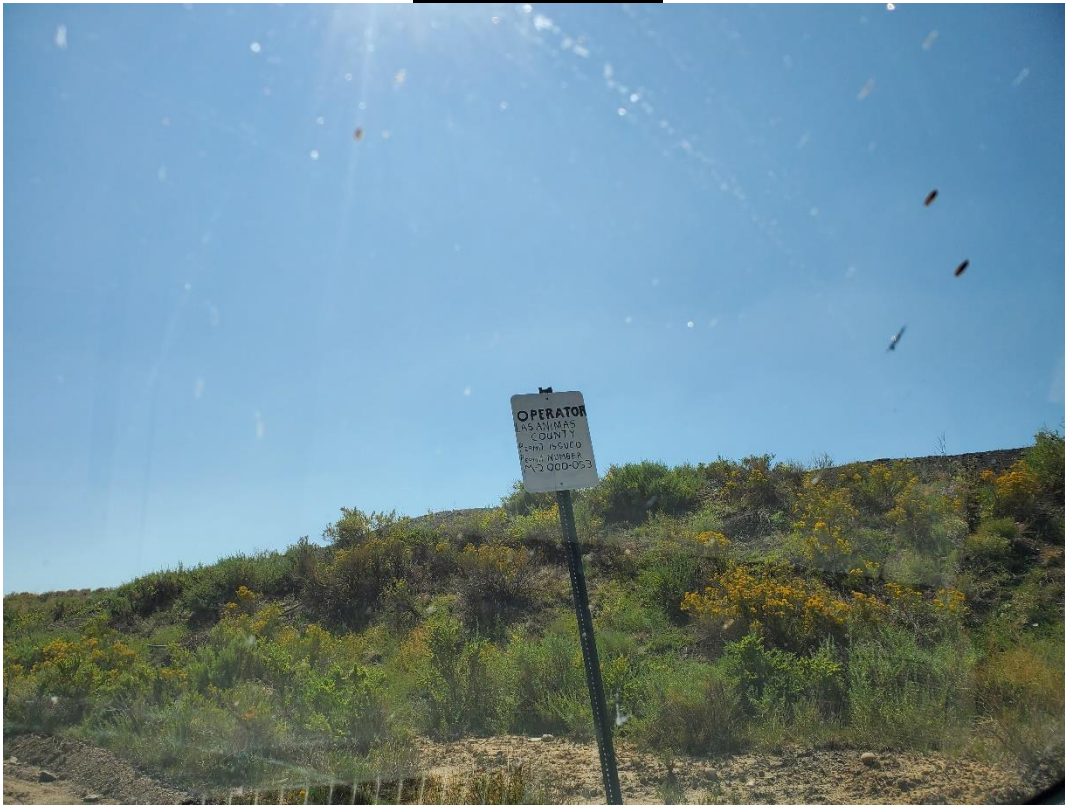
The site identification sign was posted at the mine entrance and the boundary was marked. Several small stockpile of material were located throughout the mine site. Vegetation throughout the site appeared to be a mix of natural vegetation. No major erosional issues were noted throughout the site.

Entrance Sign

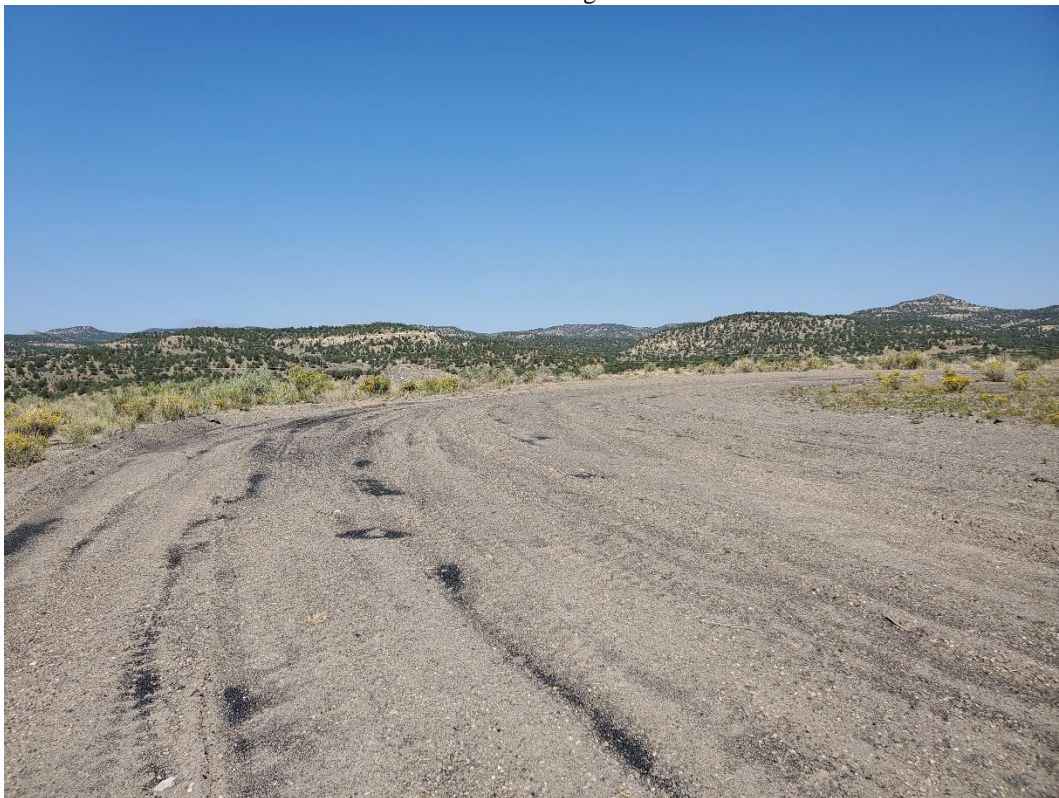
Disturbed Area

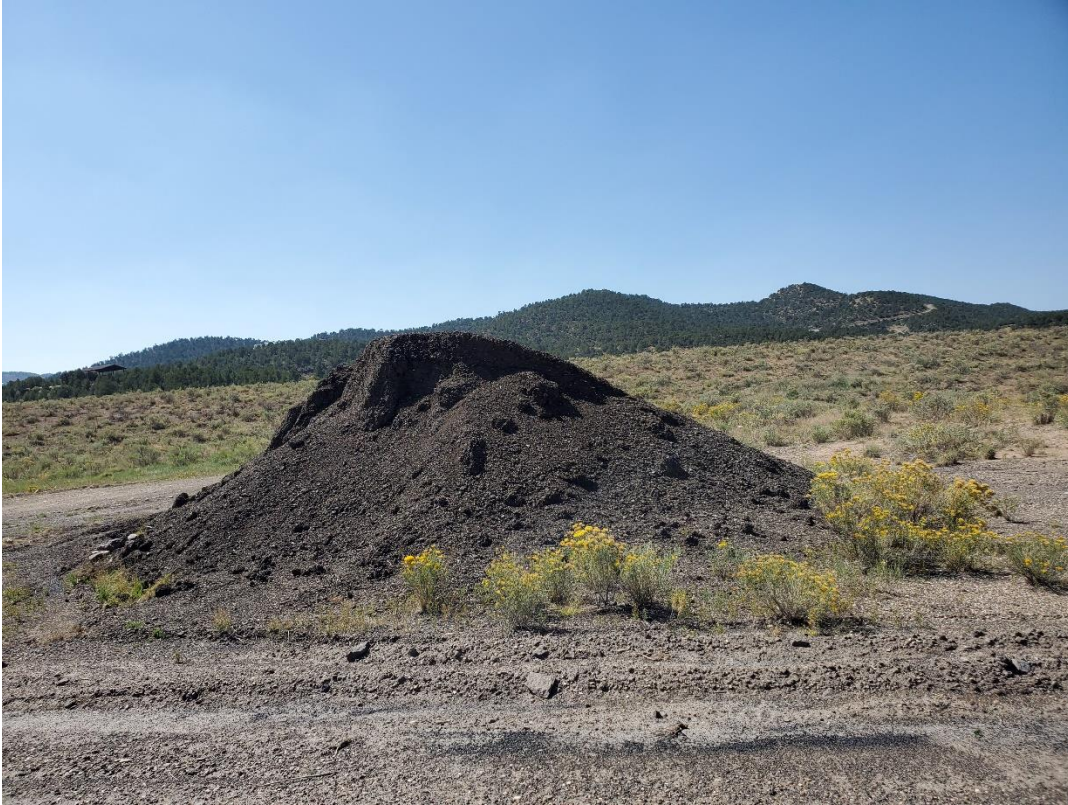
There does not appear to have been any recent mining activity done at the site. However, the material stockpile that is located near the entrance appears to have been used when comparing photos with previous inspections. The Division would remind Las Animas County that per Rule 3.1.3, reclamation is required to be completed within 5 years of the end of mining activity.

Stockpile

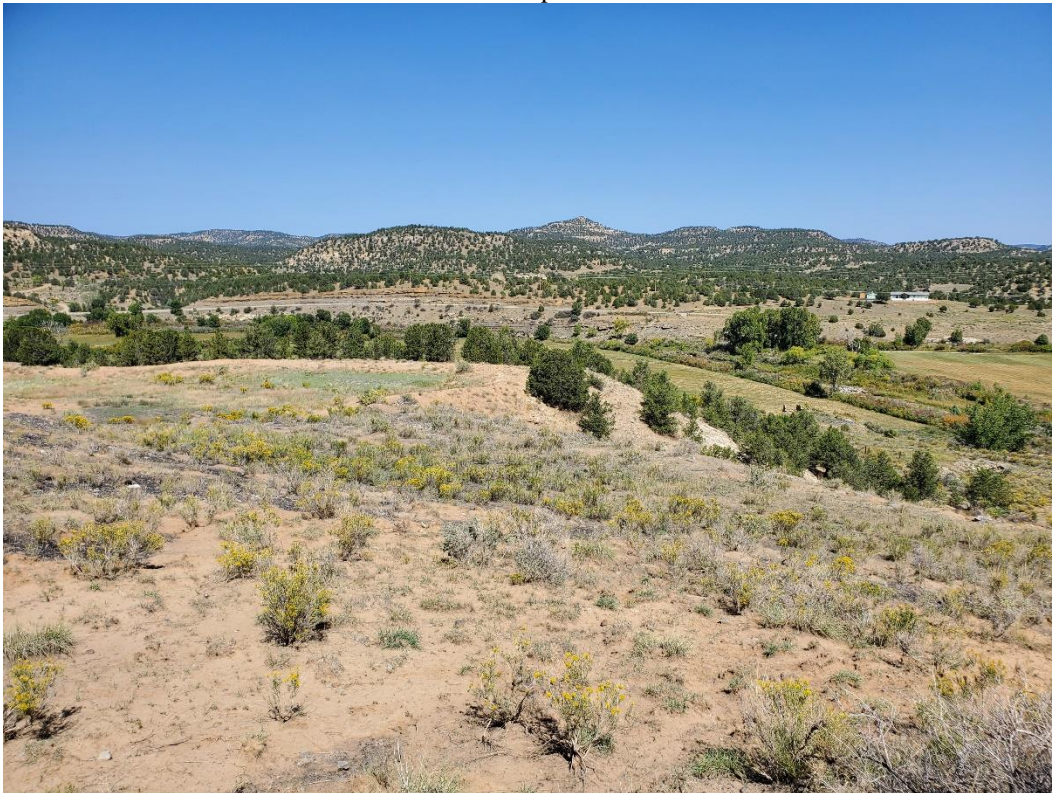
Natural vegetation on the Permit
