MINERALS PROGRAM INSPECTION REPORT
PHONE: (303) 866-3567

MINE NAME: Thomas Gravel Pit 4	MINE/PROSPECTING ID#: M-1981-286	MINERAL: Sand and gravel	COUNTY: Weld
INSPECTION TYPE: Monitoring	INSPECTOR(S): Brock Bowles	INSP. DATE: October 14, 2020	INSP. TIME: 10:00
OPERATOR: RWT Excavating and Demolition LLC	OPERATOR REPRESENTATIVE: None	TYPE OF OPERATION: 112c - Construction Regular Operation	
REASON FOR INSPECTION: Normal I&E Program	BOND CALCULATION TYPE: None	BOND AMOUNT: \$25,000.00	
DATE OF COMPLAINT: NA	POST INSP. CONTACTS: None	JOINT INSP. AGENCY: None	
WEATHER: Clear	INSPECTOR'S SIGNATURE:

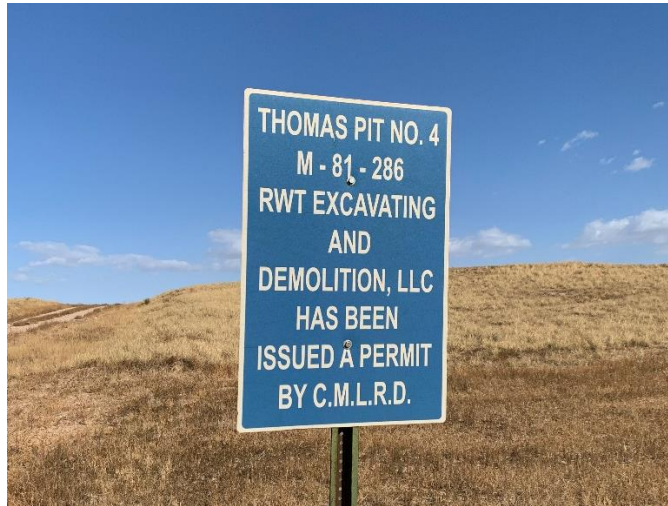
The mine entrance sign was in place (photo 1). The eastern boundary of the affected area was not marked. No marker posts were seen. There were boundary markers at both the NE and NW (photo 2) corners but both markers could not be seen at the same time due to a hill between them. Additional marker posts should be installed along the northern boundary to clearly mark the boundary. Some marker posts were in place along the western boundary but it was inconsistent. The western boundary is not a straight line and therefore additional marker posts need to be installed to clearly mark the boundary. The SW corner boundary marker was in place. The southern affected boundary markers were not seen. The southern boundary has several segments and each segment needs to be clearly marked. The affected area boundary markers were cited as a Problem/Possible Violation in the January 23, 2020 inspection report. The problem has not been resolved as of this report.

Phot 1 – Entrance sign from CR 96

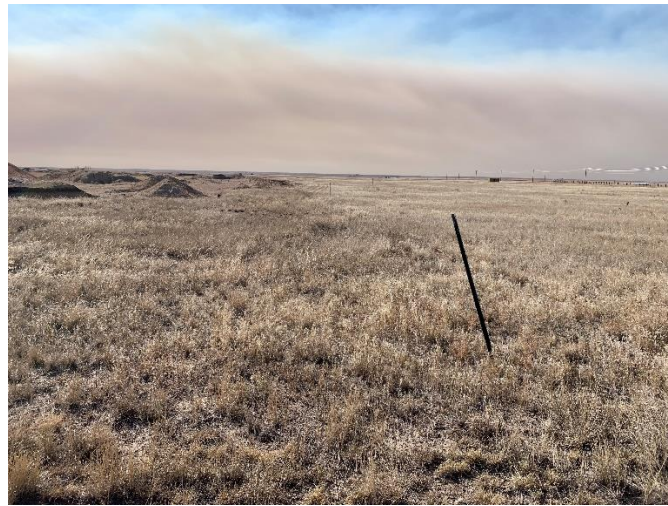
Photo 2- NW corner marker, looking south

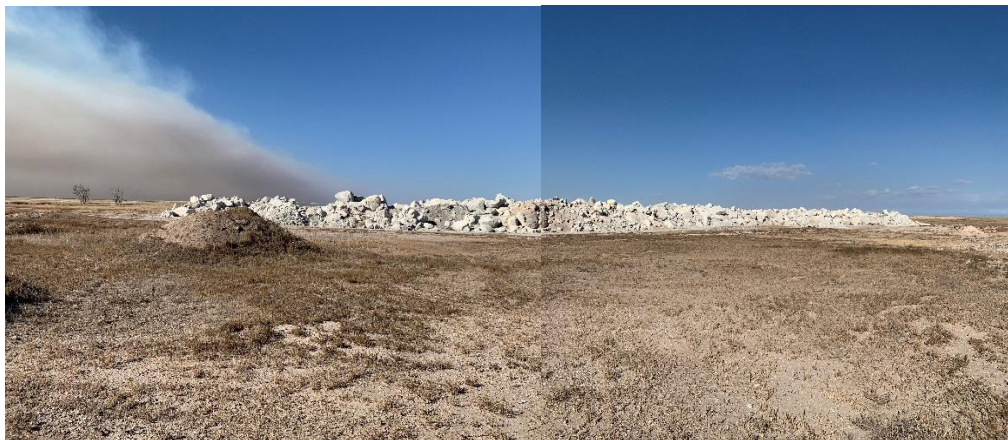
In the southeast section of the pit area there was a large pile of concrete. The footprint of the pile was not measured but it is estimated to be 1 to 2 acres in size and 8-10 feet high (photos 3 and 4). The chunks of concrete are extremely large (photo 5). The concrete pile was cited as a Problem/Possible Violation in the January 23, 2020 inspection report. The problem has not been resolved and there were no indications/signs that progress was being made to remediate the problem as of this report.

Photo 3 and 4 – Photos closely aligned to show size of concrete pile

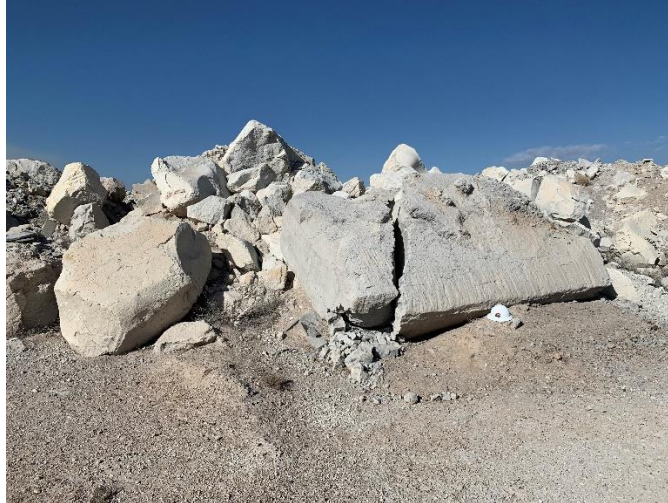
Photo 5 – Concrete chunks in pile are large. Safety helmet for scale.

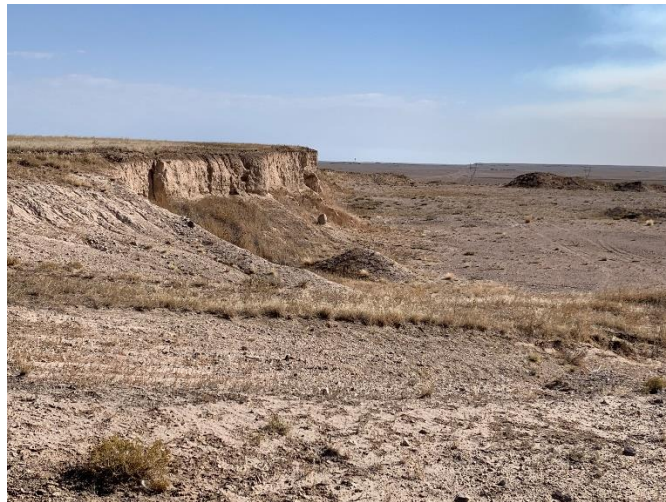
The north (photo 6) and west (photo 7) sides of the pit area contain highwalls. The highwalls are about 10 feet high. Both highwalls are close to the affected area boundary. The location of the affected boundary around the highwalls will have to be located and marked to determine if the highwalls can be graded to 4h:1v slopes as required in Exhibit D of the permit or if they will have to be backfilled.

Photo 6 – North highwall, looking east

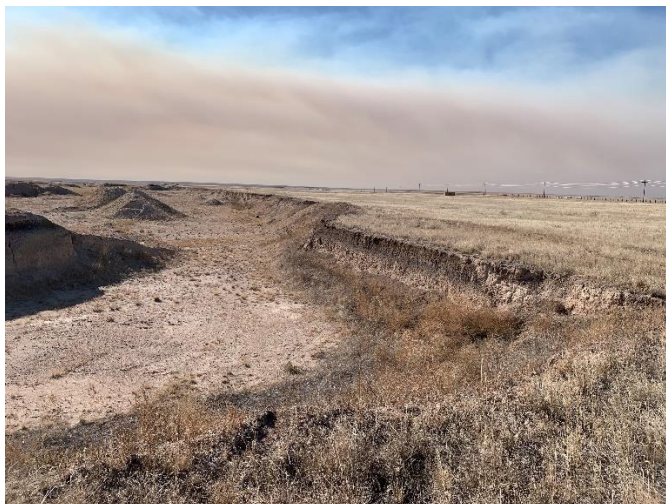
Mining activity has not taken place in a long time. This conclusion was determined because of vegetation growing on the pit floor (photo 8), vegetation growing on stockpiles (photo 9), vegetation growing around mining equipment (photo 10) and tumbleweeds collecting against the highwalls (photo 7). It appears that site conditions have not changed since the last inspection in January 2020.

Photo 7 – West highwall, looking south

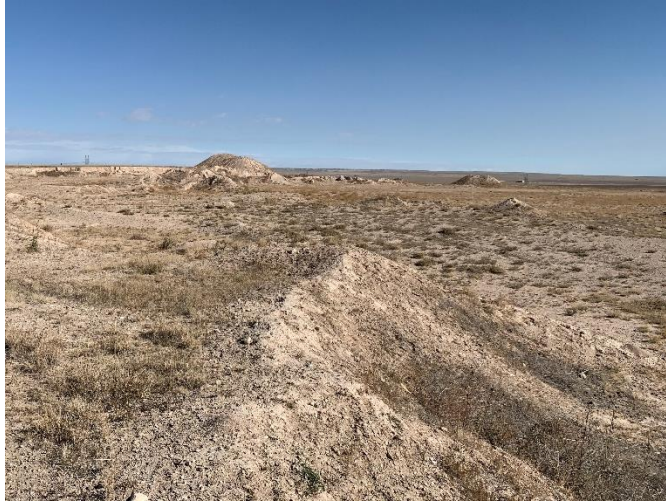
Photo 8 – Pit area, looking NE

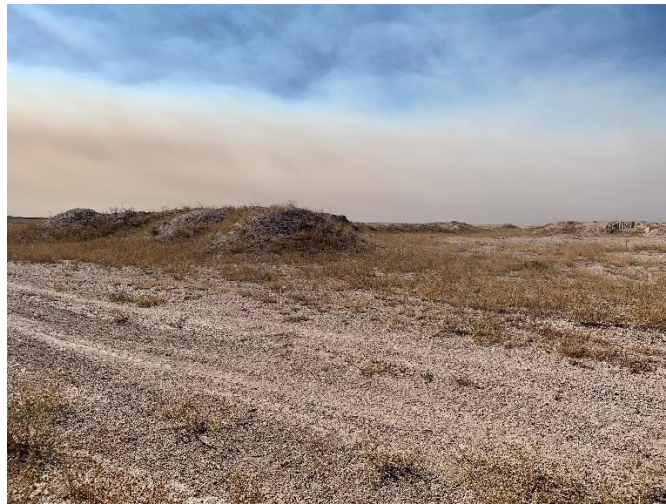
Photo 9 – Stockpiles in south end of pit area

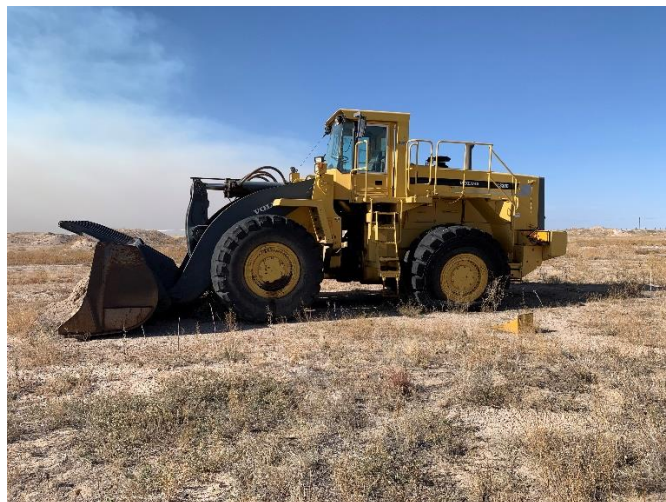
Photo 10 – Loader in middle of pit with vegetation growing around it
