MINERALS PROGRAM INSPECTION REPORT
PHONE: (303) 866-3567

MINE NAME: Emma Lode MS#7261	MINE/PROSPECTING ID#: M-2008-037	MINERAL: Silver, gold, copper,	COUNTY: Clear Creek
INSPECTION TYPE: Monitoring	INSPECTOR(S): Peter Hays	INSP. DATE: September 24, 2020	INSP. TIME: 12:30
OPERATOR: Venture Resources, Inc.	OPERATOR REPRESENTATIVE: Patrick Maher	TYPE OF OPERATION: 110(2) - Hard Rock Limited Impact	
REASON FOR INSPECTION: Normal I&E Program	BOND CALCULATION TYPE: Partial Bond	BOND AMOUNT: \$6,050.00	
DATE OF COMPLAINT: NA	POST INSP. CONTACTS: None	JOINT INSP. AGENCY: None	
WEATHER: Clear	INSPECTOR'S SIGNATURE:

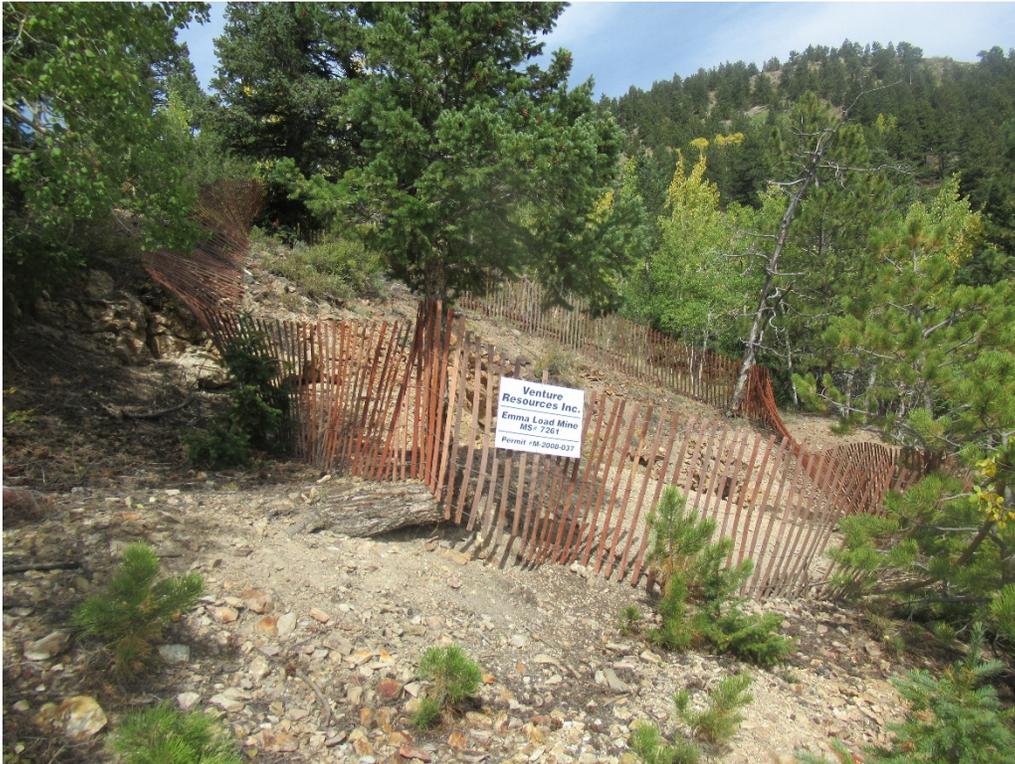
View of the mine sign and safeguarding around the shaft

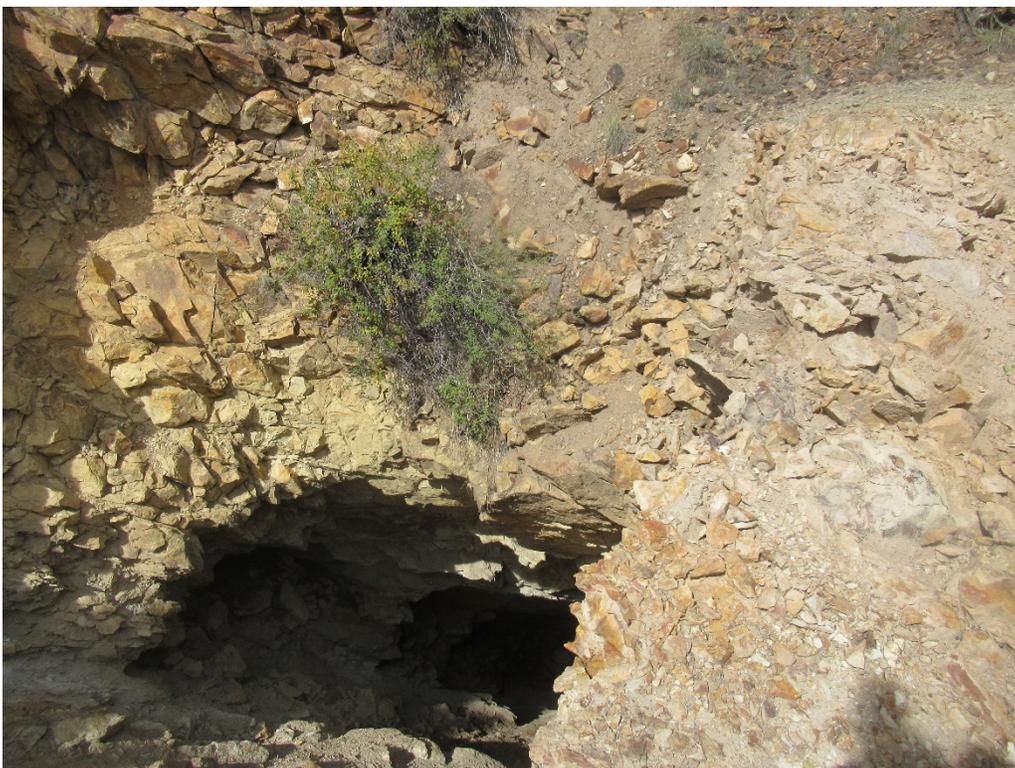
The existing disturbance consists of an open shaft without a collar or an enclosure. The shaft is approximately 240' in depth and connects to the second underground level of the Dove's Nest Mine. A plan to temporarily safeguard the Garland Adit was approved by the Division under TR-01 on January 17, 2018. The safeguarding was in-place at the time of the inspection and was adequate to warn of the existence of the open shaft. The approved Mining Plan states a shaft collar/enclosure would be constructed immediately upon the commencement of mining. The site is undisturbed by mining activity under this permit as stated by the Operator in the 2020 Annual Report. The construction of the planned shed, concrete pad, hoist building and fuel storage tank have not occurred to date. During the inspection, the Operator stated the shaft could be used as future exit for the Comstock Mine. The mine identification sign was posted at the site as required by Rule 3.1.12.

View of the open shaft
