COLORADO
Division of Reclamation,
Mining and Safety
Department of Natural Resources

Permit Number: C-1980-004 Mine Name: McClane Canyon Mine Operator: McClane Canyon Mining, LLC Operator Address: Ronald Hull 424 Lewis Hargett Circle Suite 250 Lexington, KY 40503	County: Garfield Operation Type: Underground Permit Status: Temporary Cessation Ownership: Private
	Operator Representative Present: Chuck Selingo
Operator Representative Signature: (Field Issuance Only)

Inspection Start Date: October 13, 2020 Inspection Start Time: 09:20 Inspection End Date: October 13, 2020 Inspection End Time: 10:10		Inspection Type: Coal Complete Inspection Inspection Reason: Normal I&E Program Weather: Clear	
Joint Inspection Agency: None		Joint Inspection Contacts: None	
Post Inspection Agency: None		Post Inspection Contacts: None	
Inspector(s): Clayton Wein	Inspector's Signature: <i>Clayton Wein</i>		Signature Date: 10/19/2020

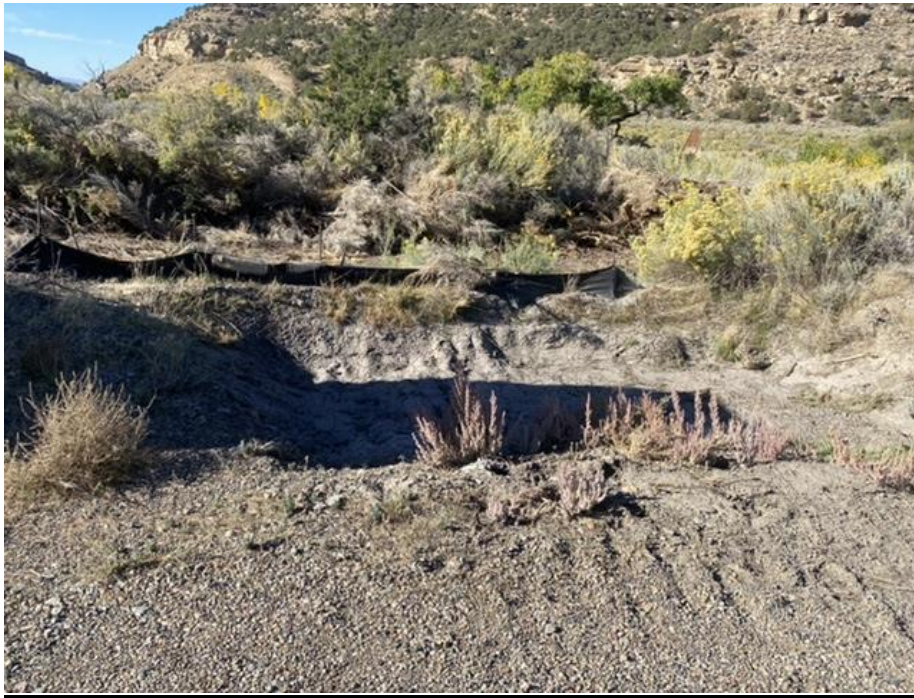
Two sumps are located at the mine office area. One sump is located on the north side of the haul road and the other on the south side of the haul road (Photo 1). Both are between the mine entrance and the mine office. The sumps were dry during the inspection. The silt fences at the outlets of the sumps were intact. The sumps were stable and there were no erosional concerns.

Photo 1: The south sump near the mine office.

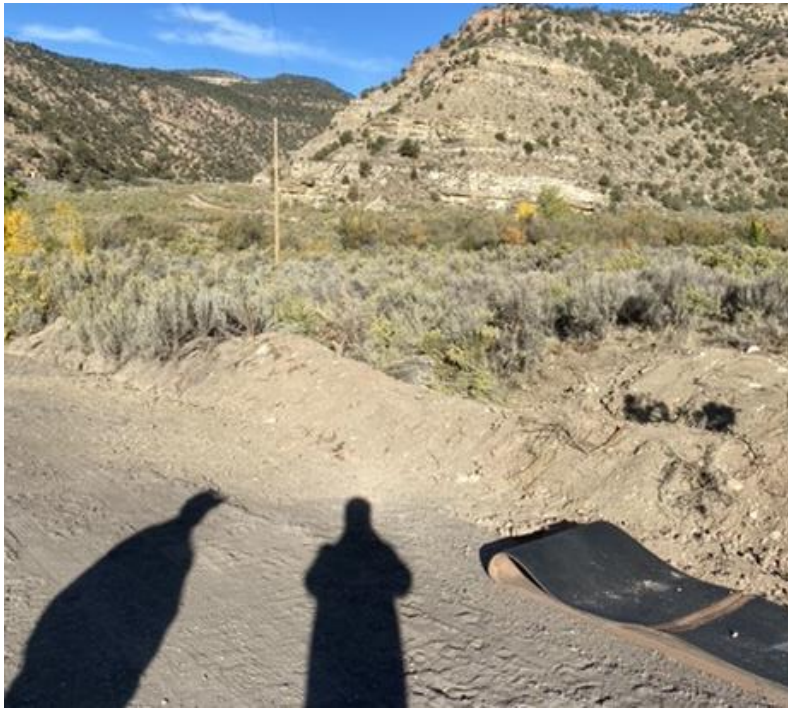
The ditches for the haul road were in good repair. The sections removed in August/September for wildfire breaks were returned (Photo 2). The first one was adjacent to the mine office across the haul road. The berm had been repaired and the ditch re-established. The second spot was at the entrance to the light use road west of the sediment pond. The berm had been replaced but not to original specs. The operator's representative assured the Division that the berm will be taken care of and the ditch will be dug out to original design specifications. For more details about the haul road and light use road, please see the Roads section of this report.

Photo 2: The repaired north berm and ditch along the haul road.

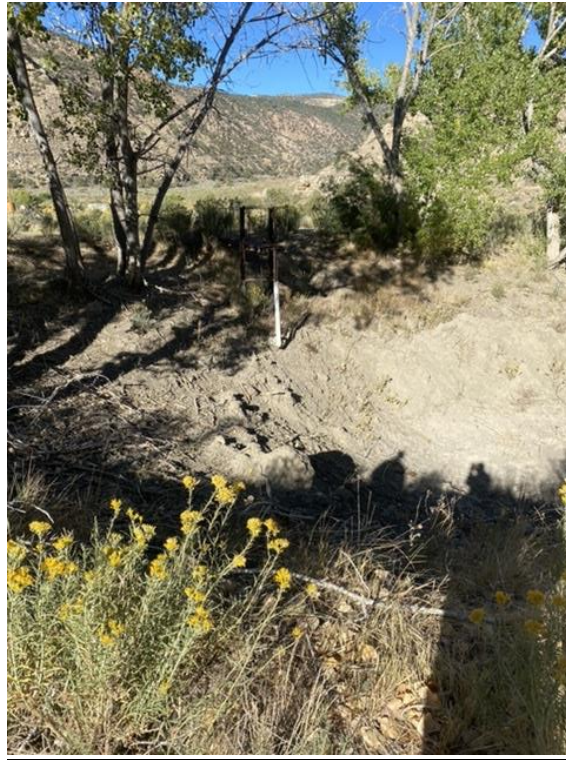
The sediment pond was dry during the inspection (Photo 3). The outlet was clear of debris. The embankment was stable with vegetation. No indications of erosion were observed. The inlet to the pond was stable.

Photo 3: The sediment pond.

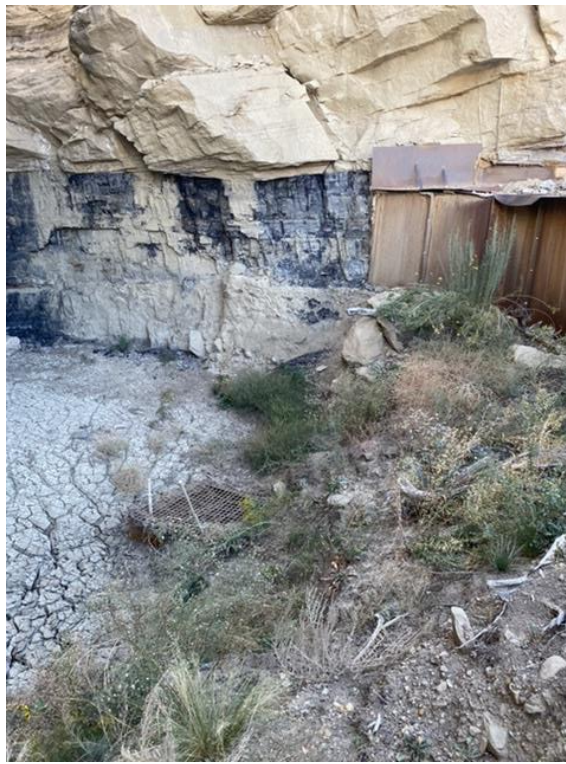
There are two sumps located at the portals area, the north sump and the east sump (Photo 4). Both sumps were dry during the inspection. The outlets were clear of debris. The sumps were stable and there were no indications of erosion.

Photo 4: The east sump at the portals area.

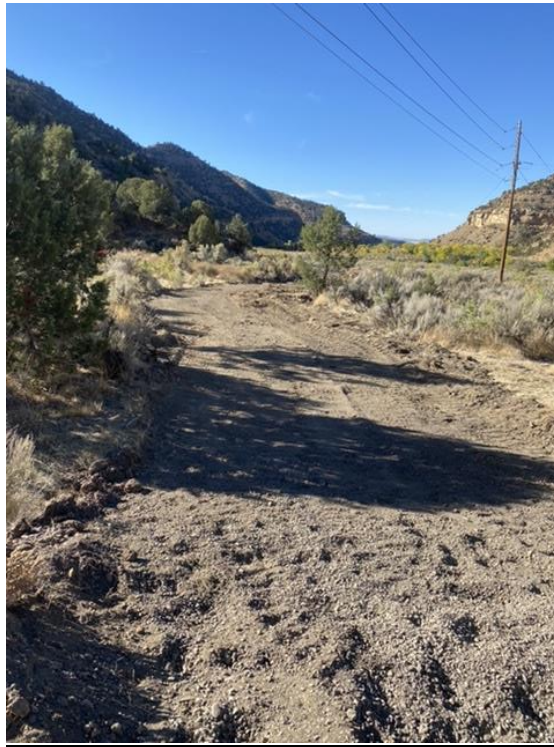
The light use road located to the west of the sediment pond had been returned to its original configuration (Photo 5). The road had been turned into a fire break. This action was conducted by the forest service and not the operator. During the inspection the road was stable and followed its original placement. No off site impacts were observed.

Photo 5: The reestablished light use road. Photo was taken looking to the south.

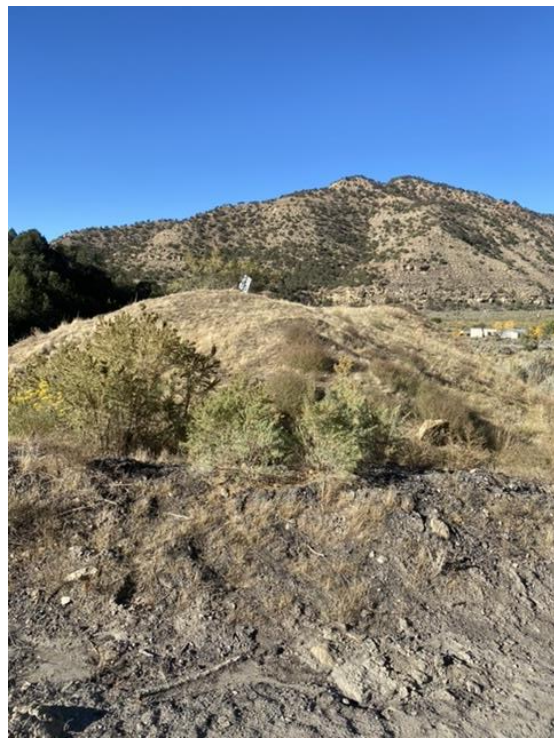
The topsoil pile is located to the south of the sediment pond. The pile was stable with vegetative cover (Photo 6). The perimeter ditch was intact with no erosional concerns. The topsoil pile marker was in place on top of the pile.

Photo 6: The topsoil pile.
