COLORADO
Division of Reclamation,
Mining and Safety
Department of Natural Resources

Permit Number: C-1981-018 Mine Name: Deserado Mine Operator: Blue Mountain Energy, Inc. Operator Address: Mr. Kurtis Blunt 3607 County Road 65 Rangely, CO, 81648	County: Moffat, Rio Blanco Operation Type: Underground Permit Status: Active Ownership: Private
	Operator Representative Present: Kurt Blunt
Operator Representative Signature: (Field Issuance Only)

Inspection Start Date: October 14, 2020 Inspection Start Time: 10:50 Inspection End Date: October 14, 2020 Inspection End Time: 14:00		Inspection Type: Coal Complete Inspection Inspection Reason: Normal I&E Program Weather: Clear	
Joint Inspection Agency: None		Joint Inspection Contacts: None	
Post Inspection Agency: None		Post Inspection Contacts: None	
Inspector(s): Clayton Wein	Inspector's Signature: <i>Clayton Wein</i>		Signature Date: 10/19/2020

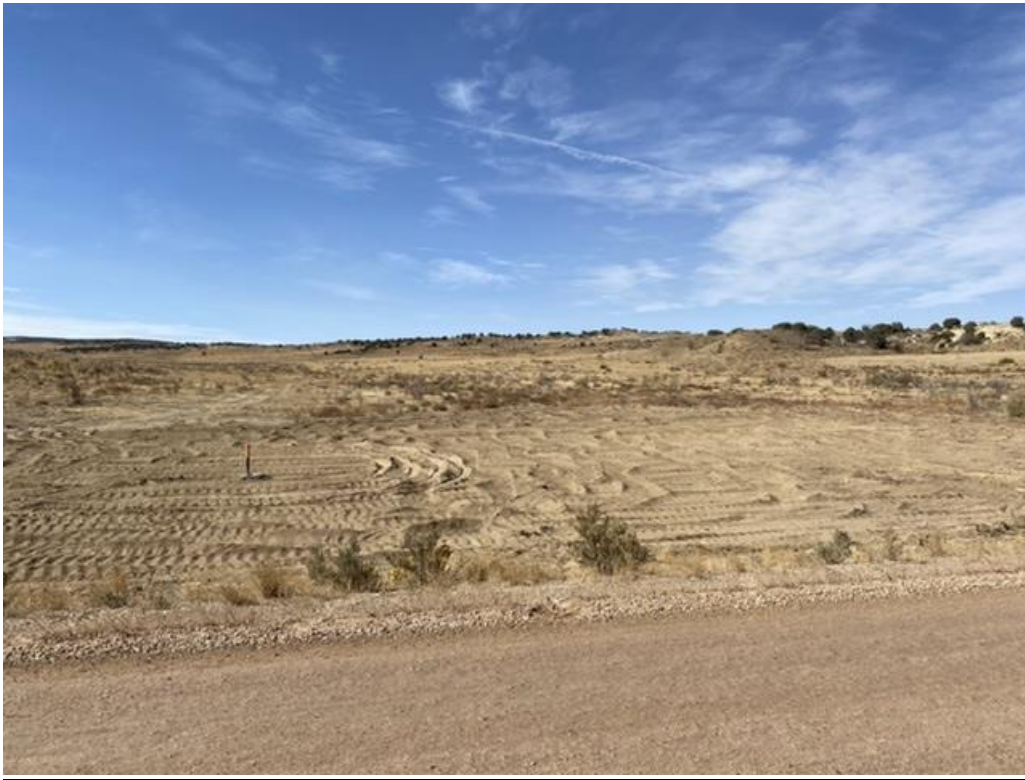
Reclaimed drill pads located just off of County Road 65, near the northern portion of the permit area were visited. These pads had been recently regarded to approximate original contour. The pads were regarded and left roughened to help promote vegetative growth (Photo 1). The pads were stable and there were no indications of surface settling or erosion.

Photo 1: One of the reclaimed 2020 drill pads.

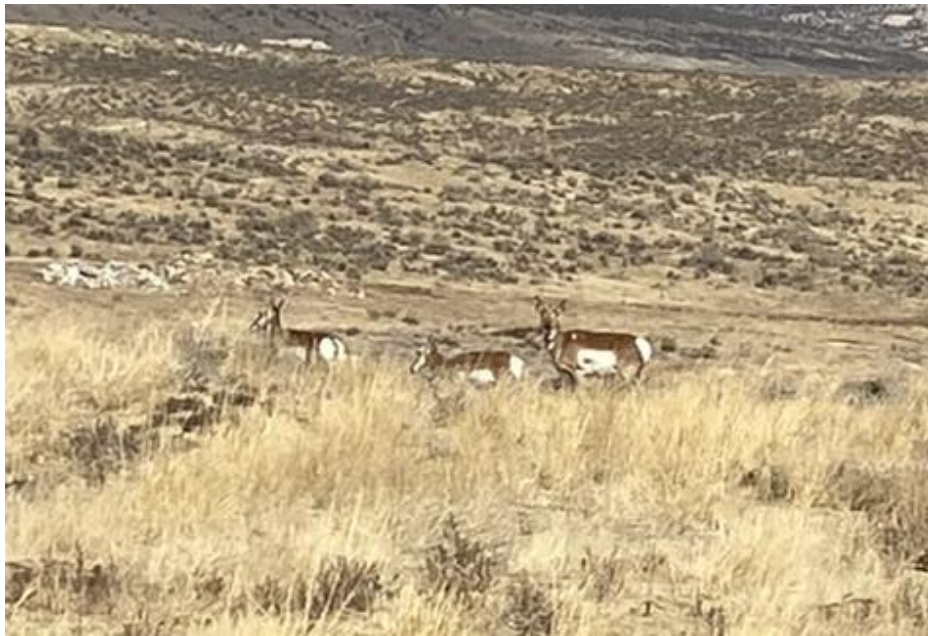
During the inspection of the B Seam Dewatering System #2, a group of Antelope were seen (Photo 2). The group was located south/southeast of the second cell in the system.

Photo 2: The group of Antelope spotted at the BSDS#2.

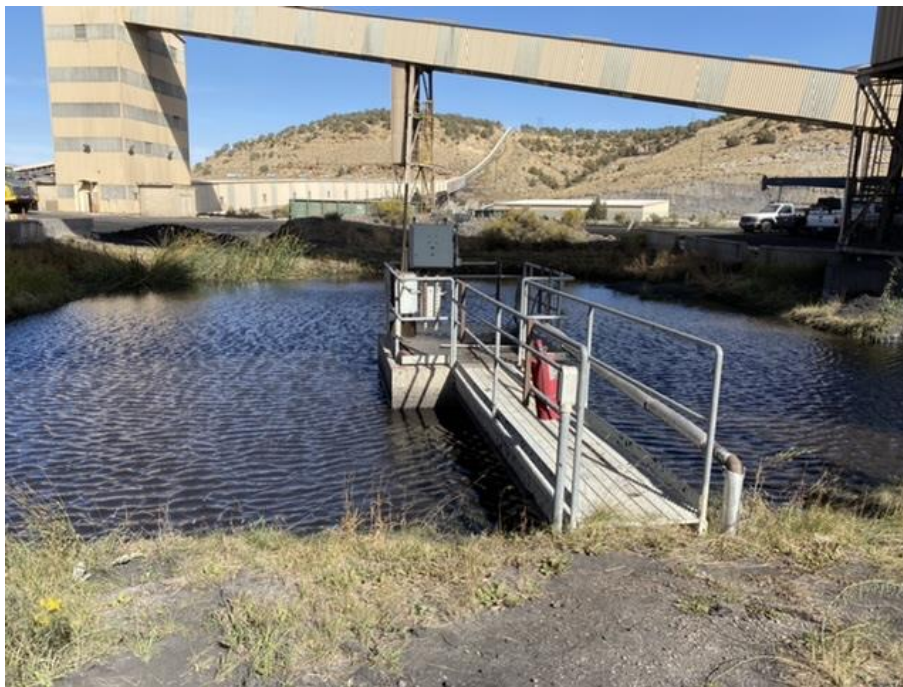
stable. There were no indications of erosion. The PP-1 Pond was holding water (Photo 3). The embankments of the pond were stable with vegetation. No erosional features were identified. The spillway was observed to be clear of debris. The PP-2 pond was holding water. The Spillway was clear of debris. The embankment was vegetated and stable. There were no erosional concerns identified.

Photo 3: The PP-1 Pond.

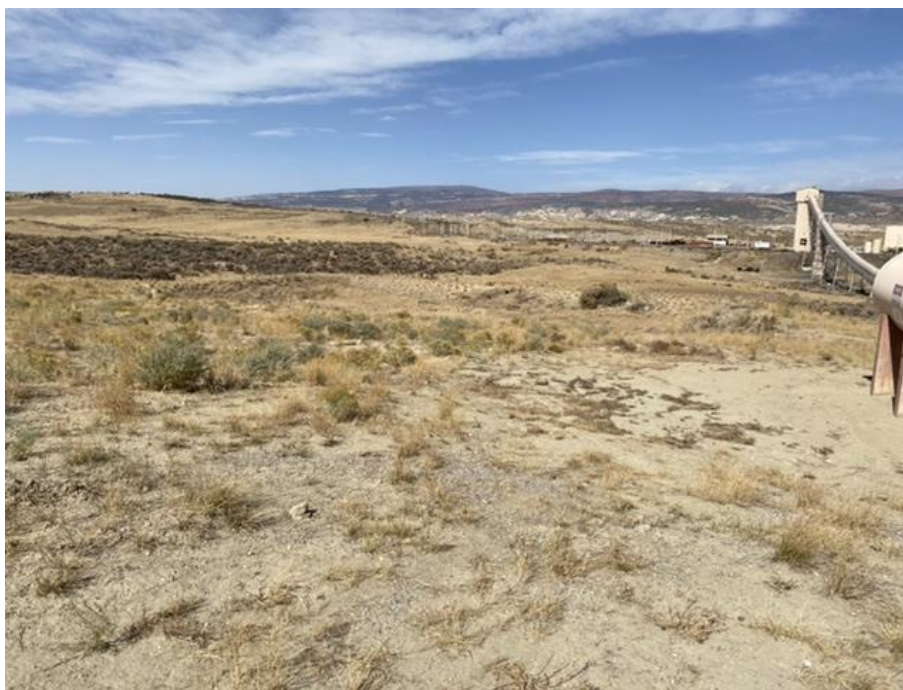
There are two ponds located to the north of the Slot Storage. The SS-1 Pond was damp during the inspection. There was no discharge from the pond. The embankments were stable with vegetation. No indications of erosion were observed. The SS-2 Pond was dry (Photo 4). The embankment was vegetated and stable. The spillway was clear of debris. No erosional features were identified.

Photo 4: The SS-2 Pond northwest of the Slot Storage.

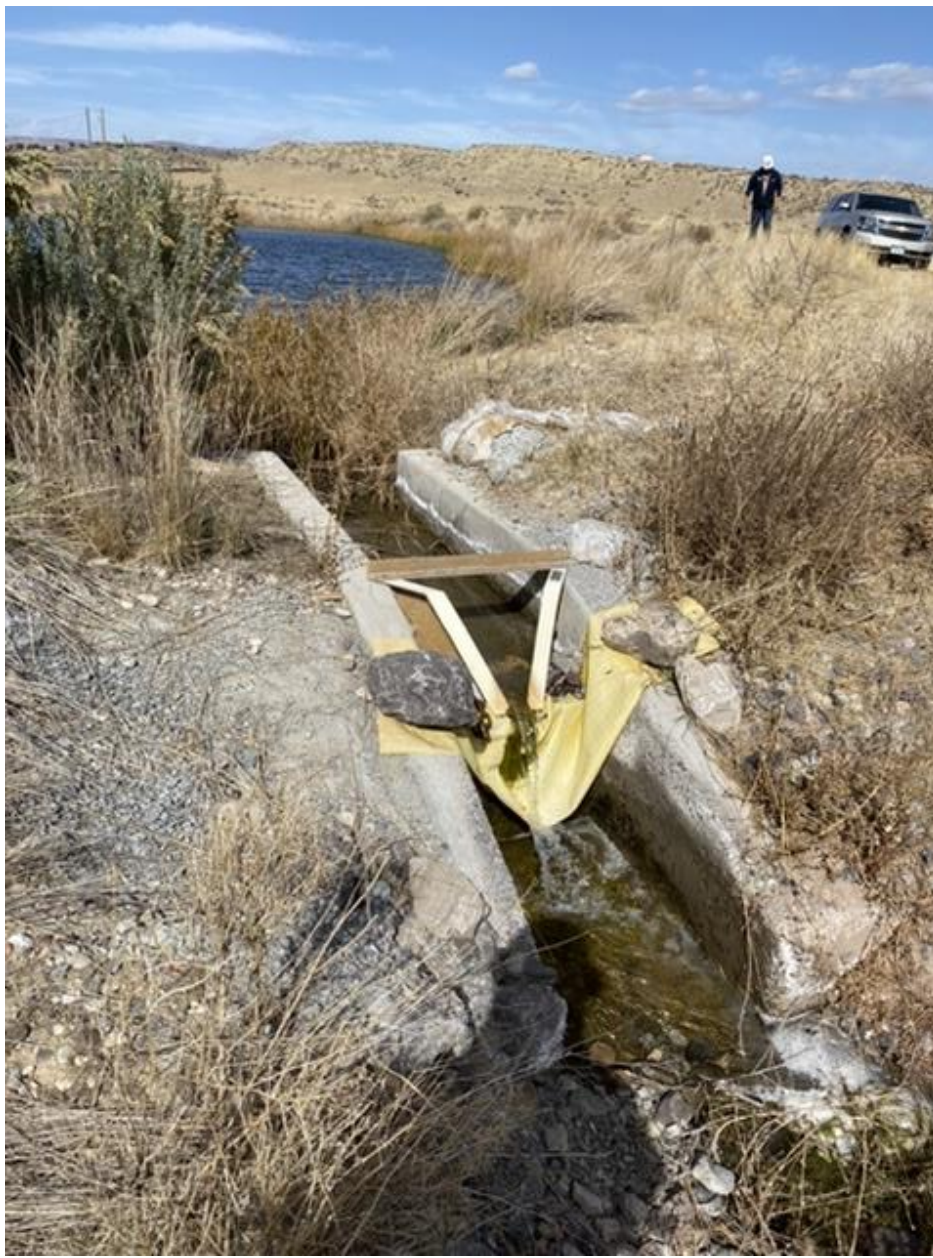
All cells of the B Seam Dewatering System #1 were holding water. The last chance pond was about full and was discharging (Photo 5). The outlet was clear of obstructions. The embankments were observed to be stable with vegetation. One large burrow was identified on the embankment of the Last Chance Pond. The burrow was filled during the inspection and will be revisited by BME staff to ensure that the hole has not reopened.

Photo 5: The outlet of the Last Chance Pond at the B Seam Dewatering System No. 1.

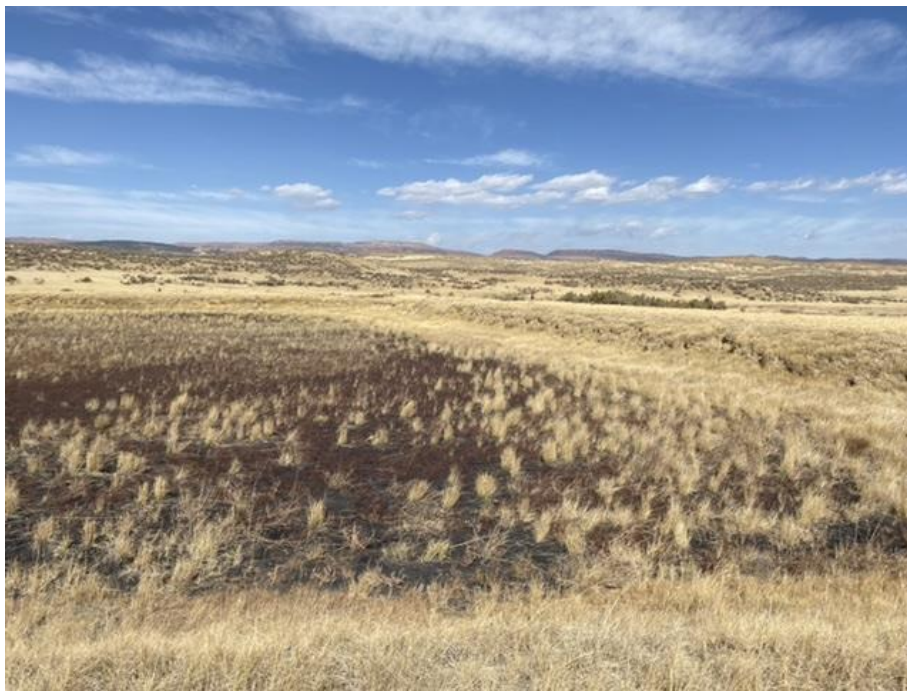
The main refuse disposal area has three ponds, the RP-2/3 pond, the RP-4 pond and the RP-5 pond. At the time of the inspection the rp-5 pond was dry (Photo 6). The trash rack over the spillway was in good condition. The embankment of the pond was vegetated and stable. No indications of erosion were observed. The RP-4 pond was dry. The trash rack on the outlet was clear of debris. The embankment was stable with vegetation. No erosional features were noted. The RP-2/3 pond consists of three cells; a main cell, a west cell and an east cell. The cells were dry during the inspection. The spillways between the east/west cell and the main cell were clear of blockages. The primary discharge outlet was in good condition and the trash rack was clear. The embankments were observed to be vegetated and stable. No erosional concerns were identified.

Photo 6: The RP-5 Pond and embankment.

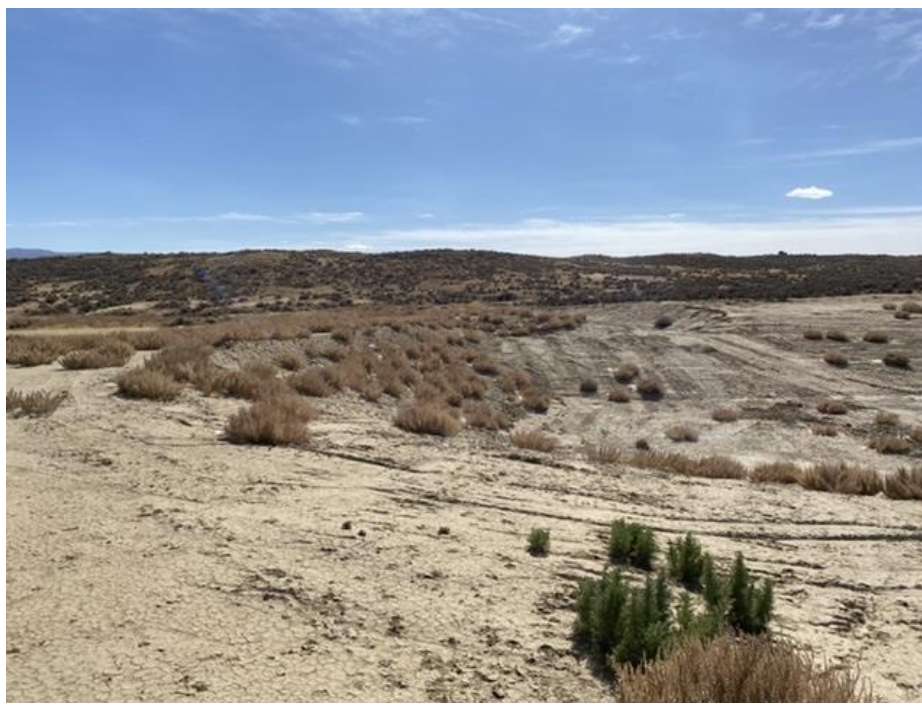
The RP-A pond is located at the eastern base of the RP-A refuse pile. The pond was dry at the time of the inspection (Photo 7). The embankment was stable and no erosional concerns were identified. The outlet was clear of debris.

Photo 7: The RP-A Pond and embankment.

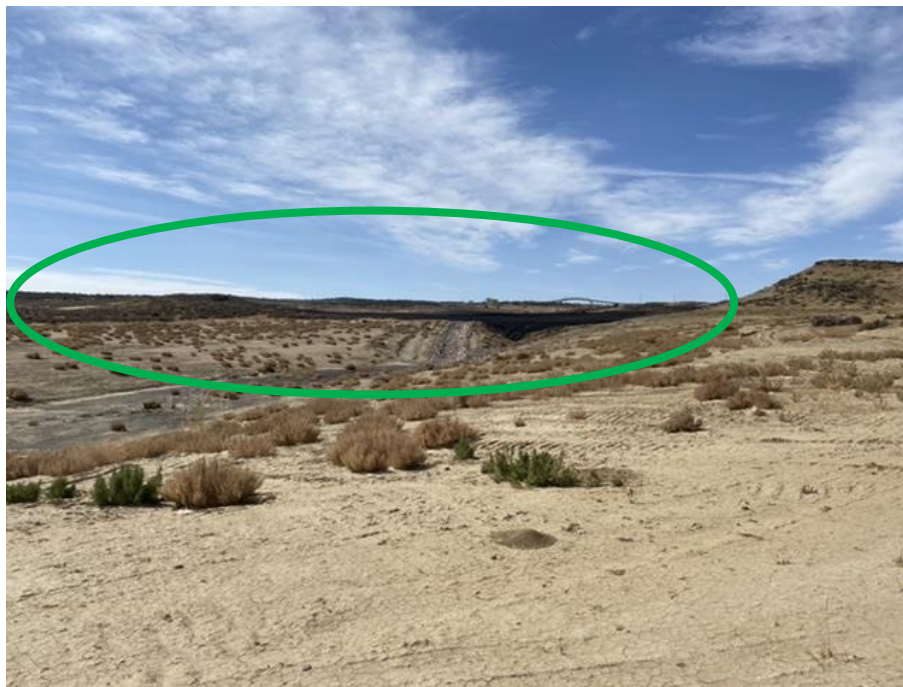
The RP-A refuse area has progressed since the September inspection. The base of the pile had been filled in. Refuse material on the site appeared to be compacted (Photo 8). There were no indications of instability or off site impacts.

Photo 8: The PR-A Refuse pile is outlined in the green oval in the photo above.

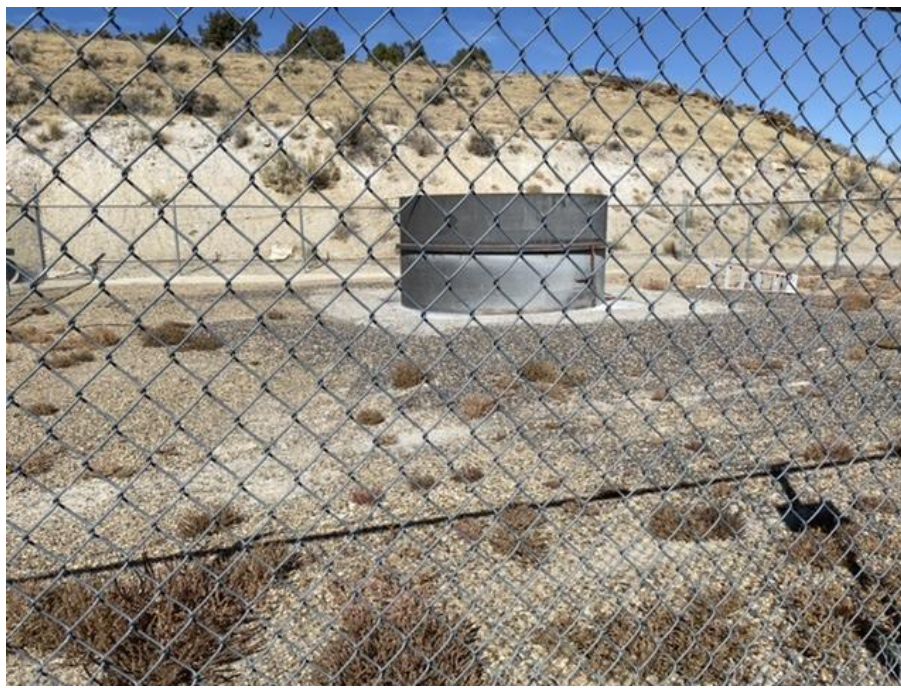
Photo 9: The B Vent Shaft No. 1.

The support facilities at the mine were well kept and in good repair. The pads for the facilities were stable. Berms were vegetated and no erosional features were seen. No off site impacts were observed. The slopes of the Slot Storage were stable with vegetative cover. No erosional concerns were noted. The Fuel Storage was well kept and no spills were identified. The berms around the storage tanks were intact.
