**COLORADO**  
Division of Reclamation,  
Mining and Safety  
Department of Natural Resources

| <b>Permit Number:</b> C-1981-015<br><b>Mine Name:</b> Fruita No 1 & 2<br><b>Operator:</b> Dorchester Coal Company<br><b>Operator Address:</b><br>Greg Lewicki<br>9054 South Forrest Drive<br>Highlands Ranch, CO 80126 | <b>County:</b> Mesa<br><b>Operation Type:</b> Underground<br><b>Permit Status:</b> Revoked<br><b>Ownership:</b> Private<br><br><b>Operator Representative Present:</b><br><br>NA |

| <b>Inspection Start Date:</b> October 13, 2020<br><b>Inspection Start Time:</b> 11:30<br><b>Inspection End Date:</b> October 13, 2020<br><b>Inspection End Time:</b> 12:20 | | <b>Inspection Type:</b> Coal Complete Inspection<br><b>Inspection Reason:</b> Normal I&E Program<br><b>Weather:</b> Clear | |

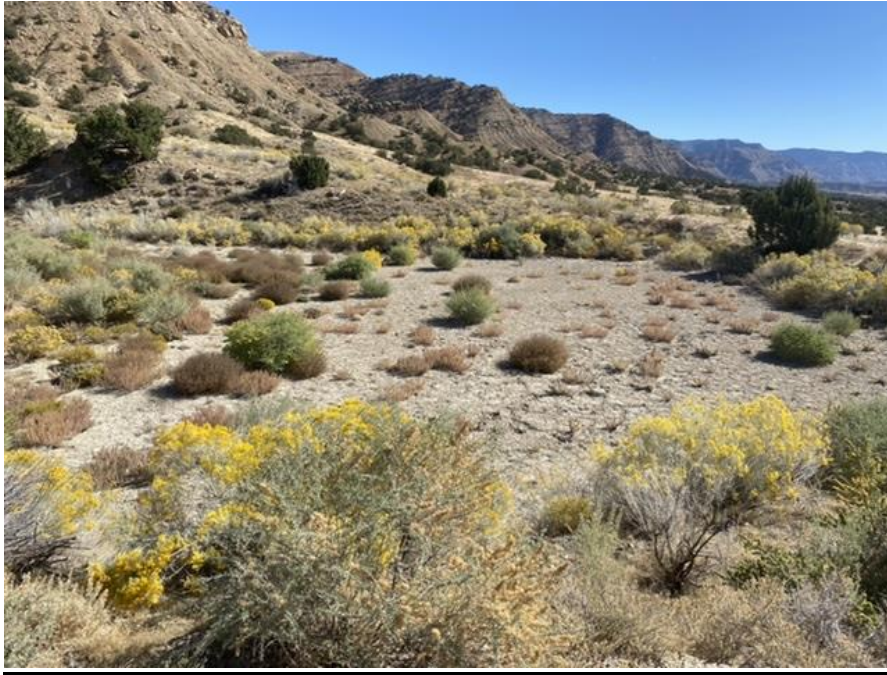
The Sediment pond located at the south end of the permit area was dry (Photo 1). The embankments were stable with vegetative cover. There were no indications of erosional features. There is a riprap lined channel leading from the reclaimed mining bench to the drainage into the pond. The channel was dry and stable (Photo 2). Gullies are located on the haul road. The gullies have been noted in previous Division inspection reports. The gullies have not increased in sized since the previous inspection. The gullies transport runoff across the reclaimed haul road and into the drainage leading to the sediment pond. There were no off site impacts noted. There is a large gully located on the reclaimed mining bench. This gully has been identified in previous Division inspection reports. The gully had not increased in size and transports any runoff to the riprap lined channel. No off site impacts have occurred.

**Photo 1:** The dry sediment pond.

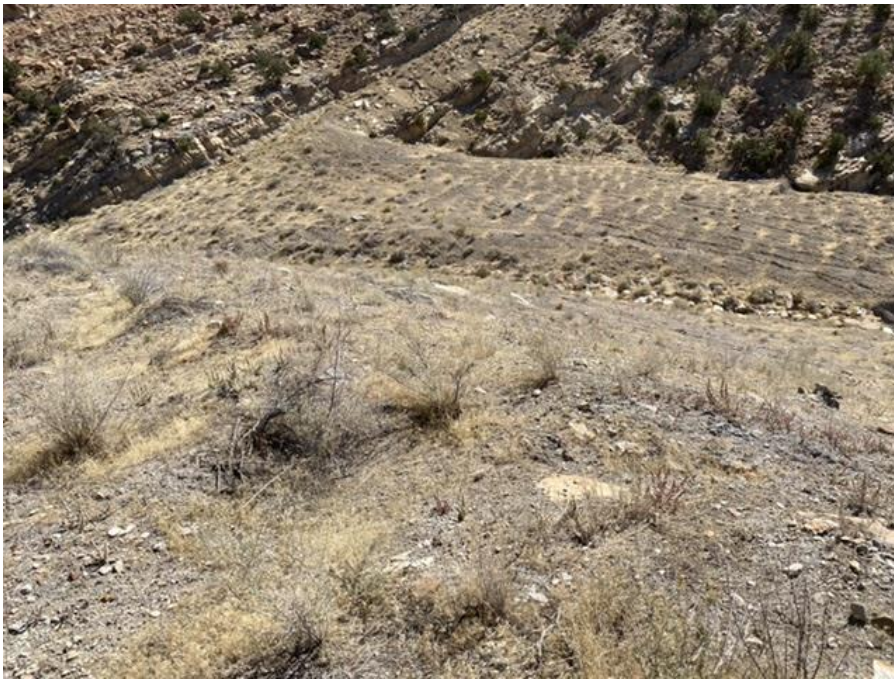
**Photo 2:** The top of the riprap channel.

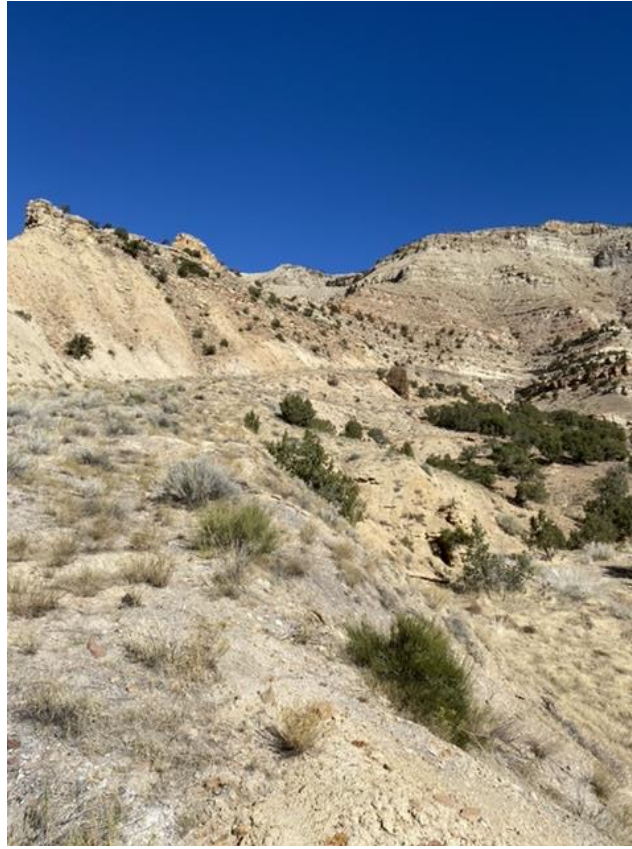
The reclaimed haul road was stable with vegetative cover (Photo 3). The cut slopes were stable and there were no erosional concerns. The fill slopes were also stable (Photo 4). No erosion has occurred. The mining bench was stable and had no erosional concerns identified (Photo 5). The bench had vegetative cover. The portals remain covered and sealed. The slope off of the bench was also stable. The slope is south facing and has minimal vegetative cover. There were no major erosional features and there were no new erosional concerns. The cut slope above the bench has not sloughed and appears to remain stable. No new erosional features were identified.

**Photo 3:** The reclaimed haul road.

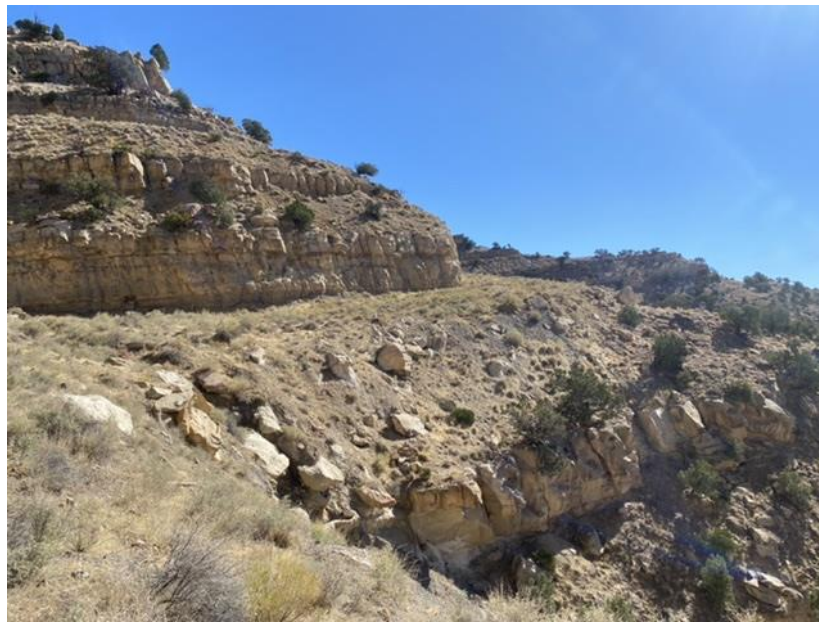
**Photo 4:** A portion of the haul road showing stable cut and fill slopes.

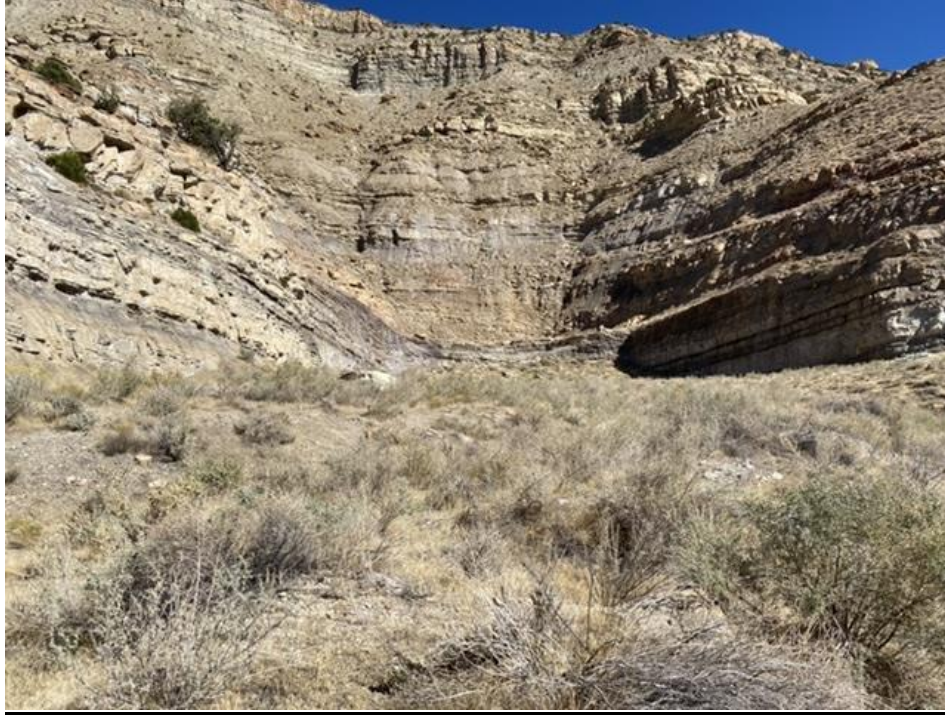
**Photo 5:** The reclaimed mining bench. Photo was taken looking back towards the portals.
