**MINERALS PROGRAM INSPECTION REPORT**  
**PHONE: (303) 866-3567**

<b>MINE NAME:</b> Hukill Gulch Millsite	<b>MINE/PROSPECTING ID#:</b> M-2009-076	<b>MINERAL:</b> Silver and gold	<b>COUNTY:</b> Clear Creek
<b>INSPECTION TYPE:</b> Monitoring	<b>INSPECTOR(S):</b> Peter Hays	<b>INSP. DATE:</b> September 24, 2020	<b>INSP. TIME:</b> 11:30
<b>OPERATOR:</b> Venture Resources, Inc.	<b>OPERATOR REPRESENTATIVE:</b> Patrick Maher	<b>TYPE OF OPERATION:</b> 110d - Designated Limited Impact	
<b>REASON FOR INSPECTION:</b> Normal I&E Program		<b>BOND CALCULATION TYPE:</b> Partial Bond	<b>BOND AMOUNT:</b> \$107,742.72
<b>DATE OF COMPLAINT:</b> NA		<b>POST INSP. CONTACTS:</b> None	<b>JOINT INSP. AGENCY:</b> None
<b>WEATHER:</b> Clear	<b>INSPECTOR'S SIGNATURE:</b>

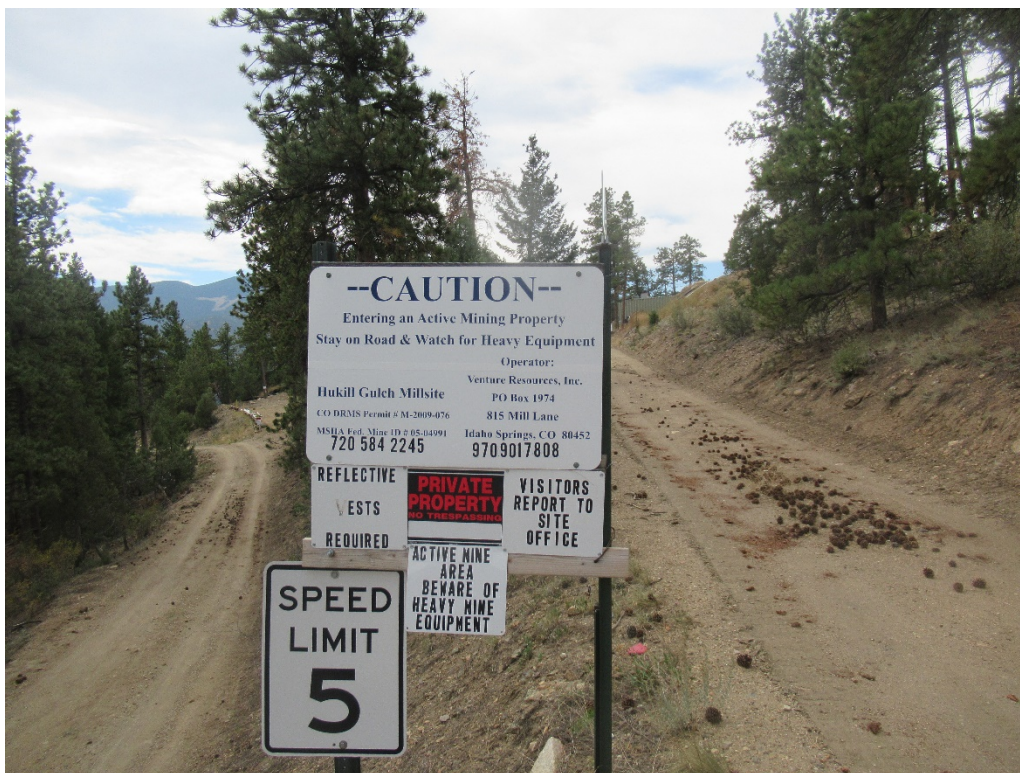
The mine identification sign was posted at the site as required by Rule 3.1.12. As cited as a problem, the northern permit boundary markers for the millsite could not be located during the inspection. The Division will require the Operator to conduct a survey and replace the boundary markers in the correct location(s). The Operator shall provide proof to the Division the markers have been installed by the corrective action date.

Hukill Gulch Millsite mine sign

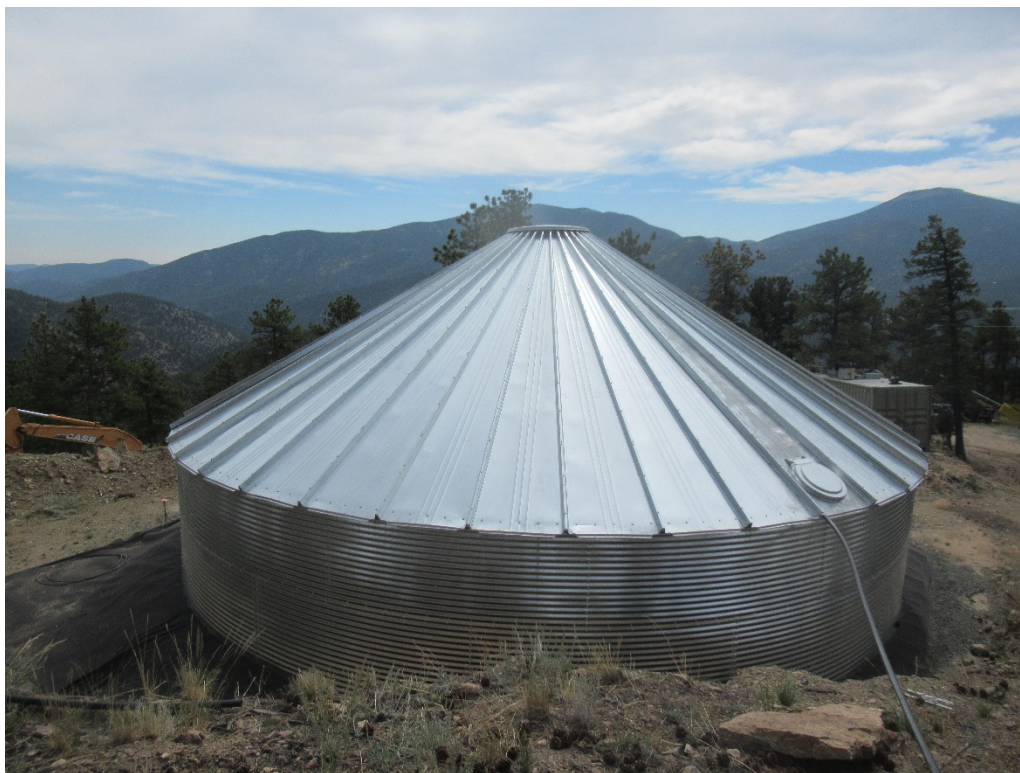
View of the 65,000 gallon water storage tank

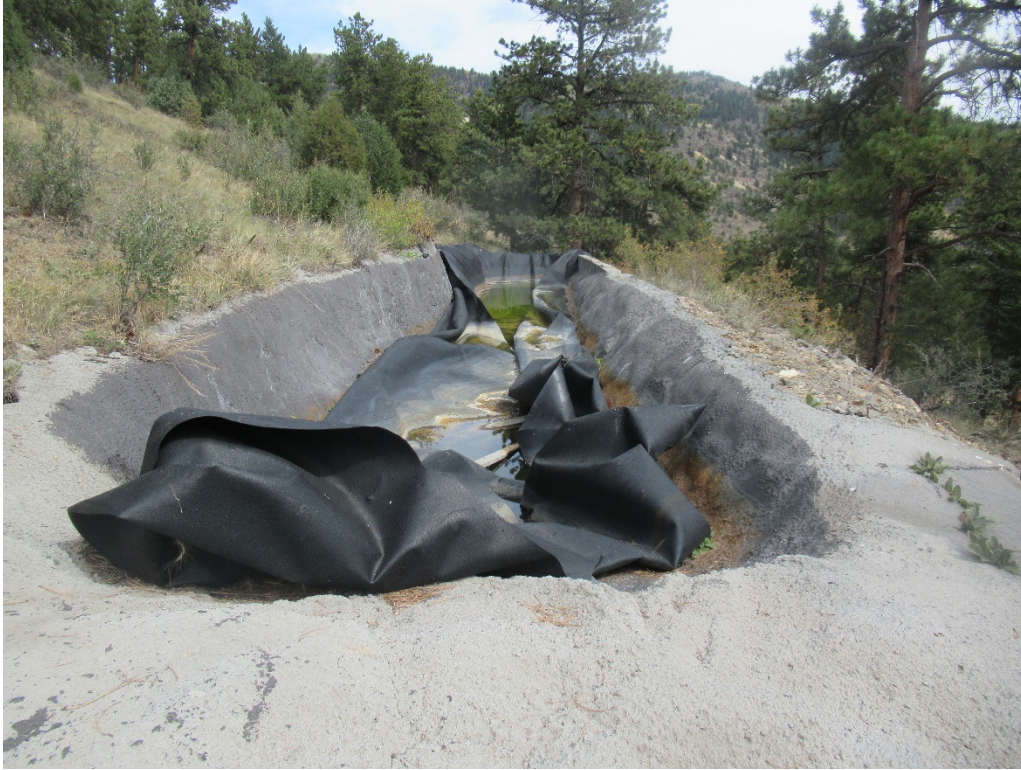
View of the inactive Water Holding Pond

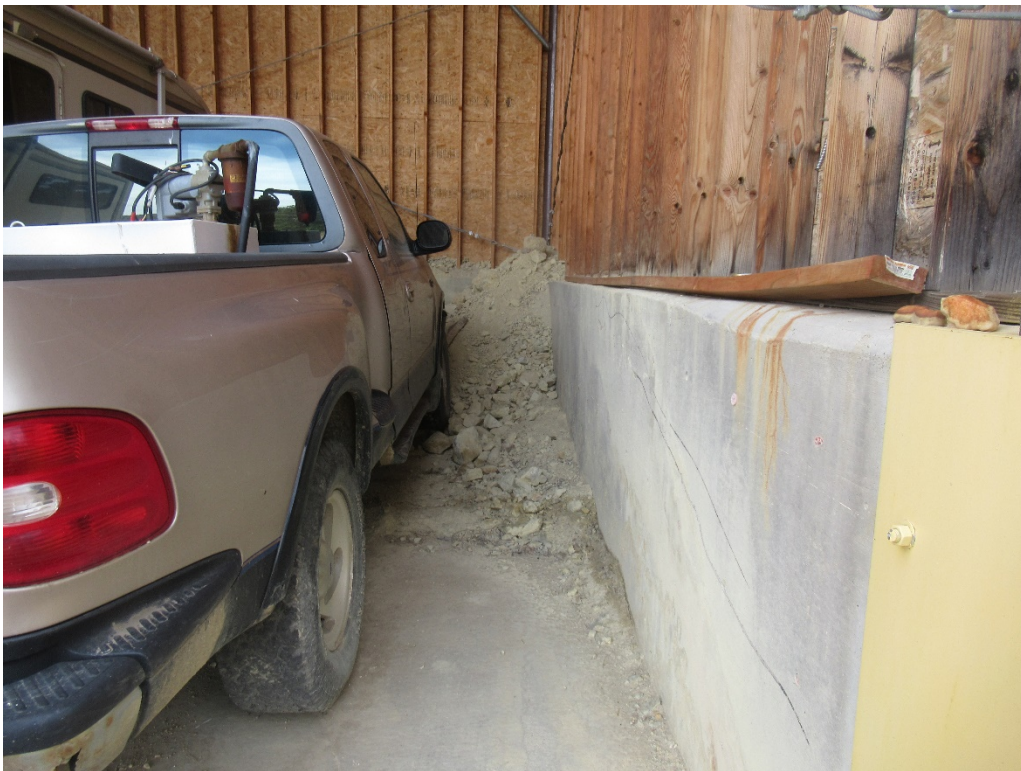
View of the tailing stockpile in the ore storage building

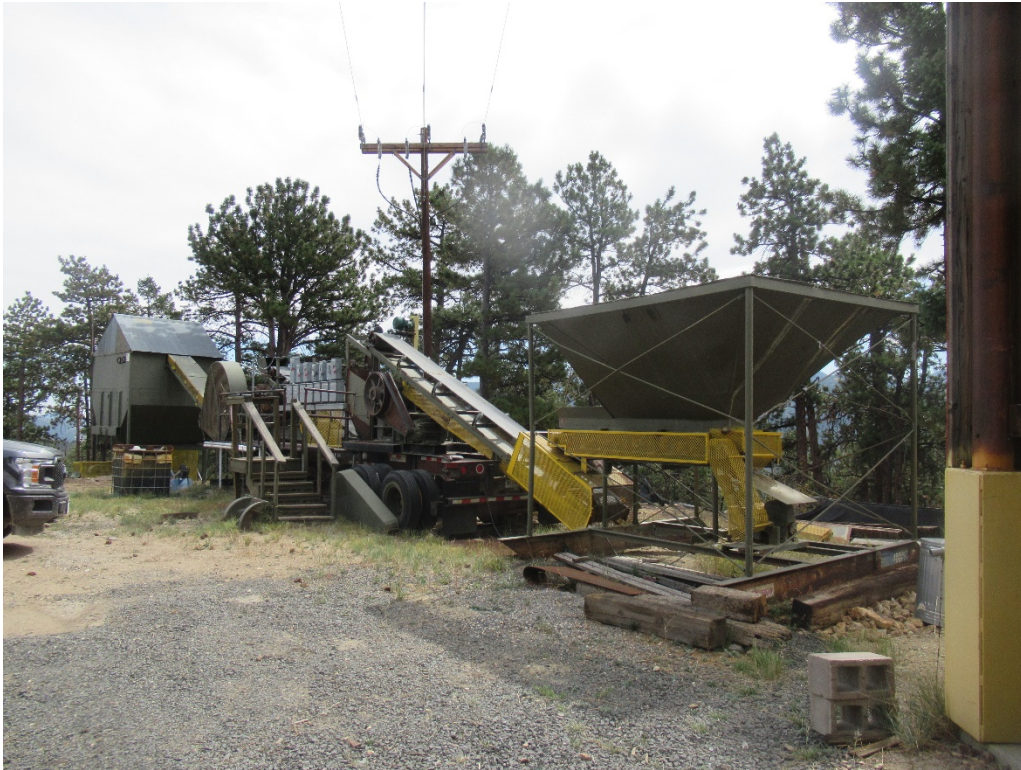
View of the crusher feed bin, primary crusher and ore bin

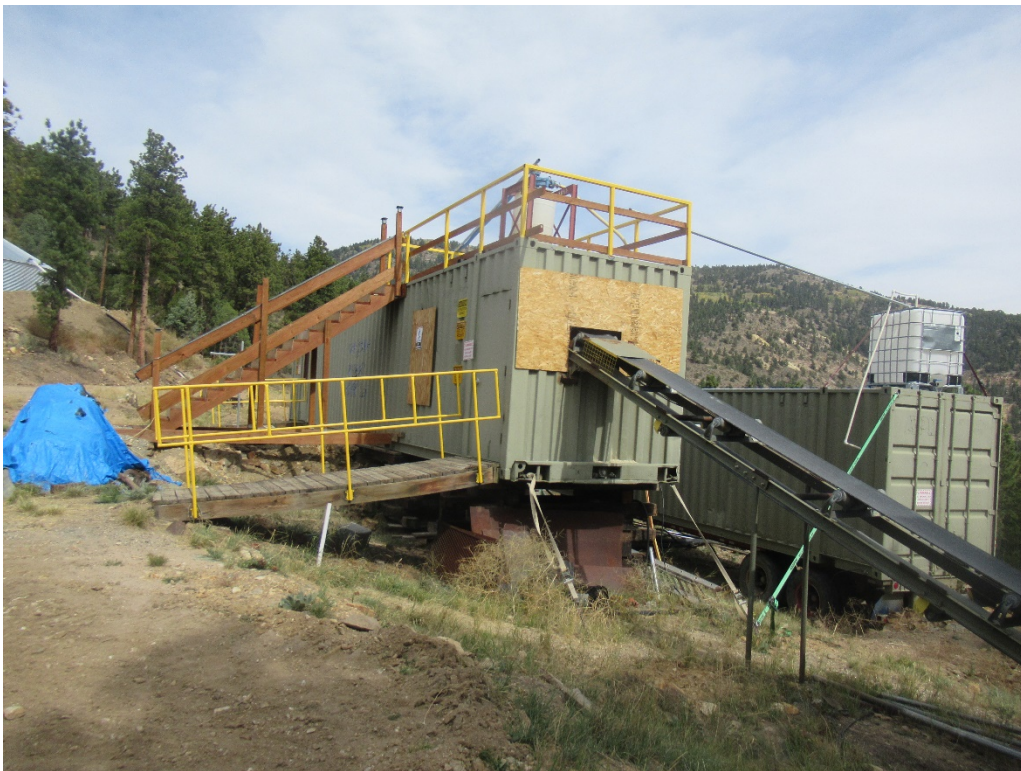
View of the ball mill and flotation trailers

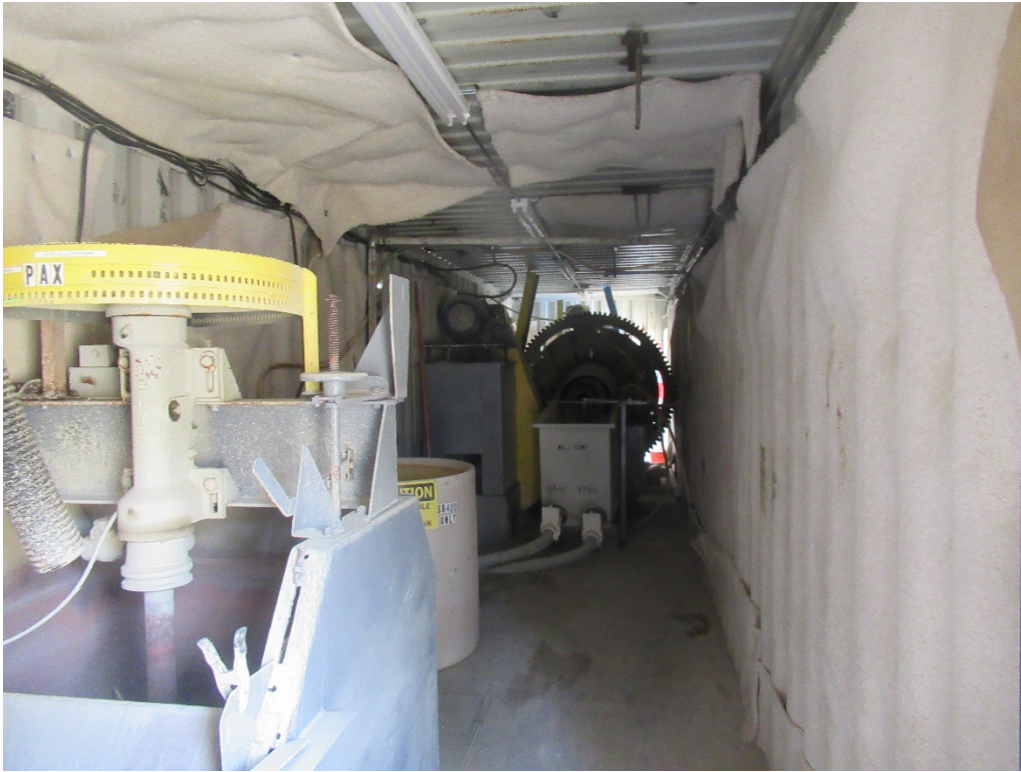
View inside the ball mill trailer

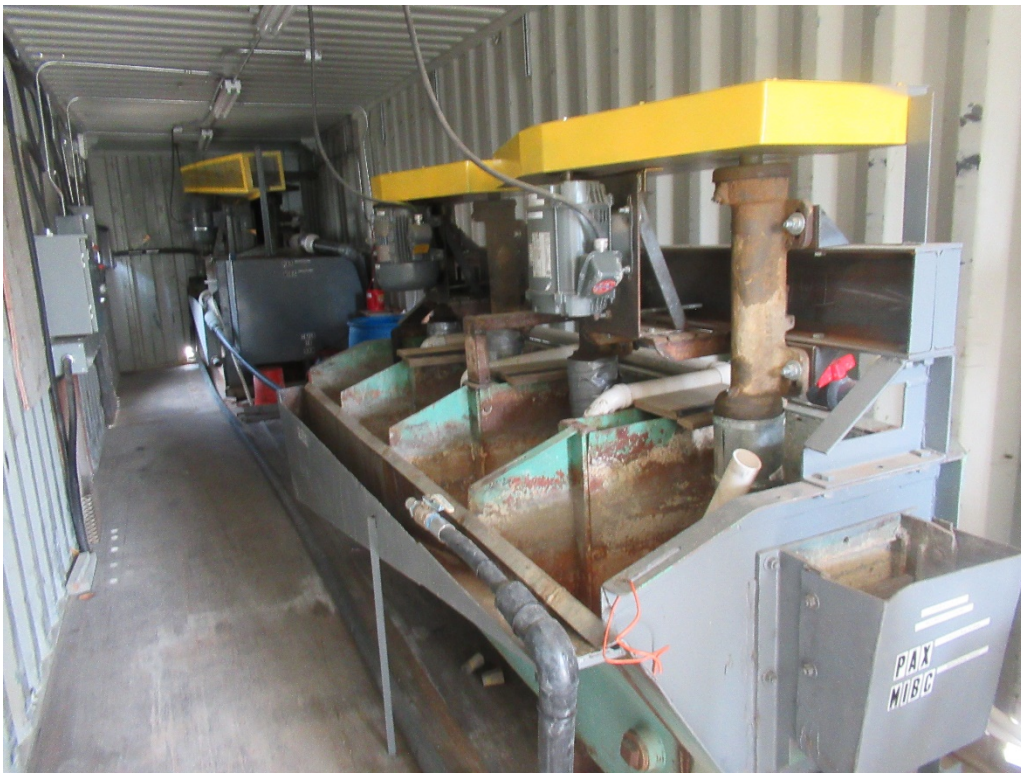
View inside the flotation trailer

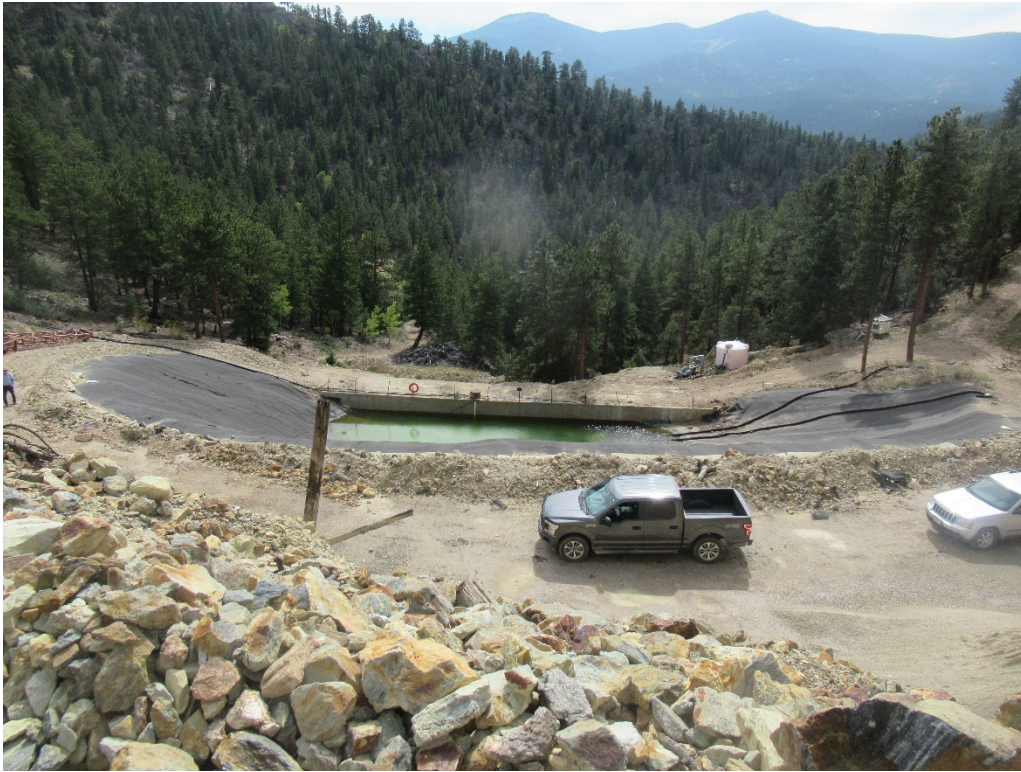
View of the tailings impoundment from the bench above the impoundment bench

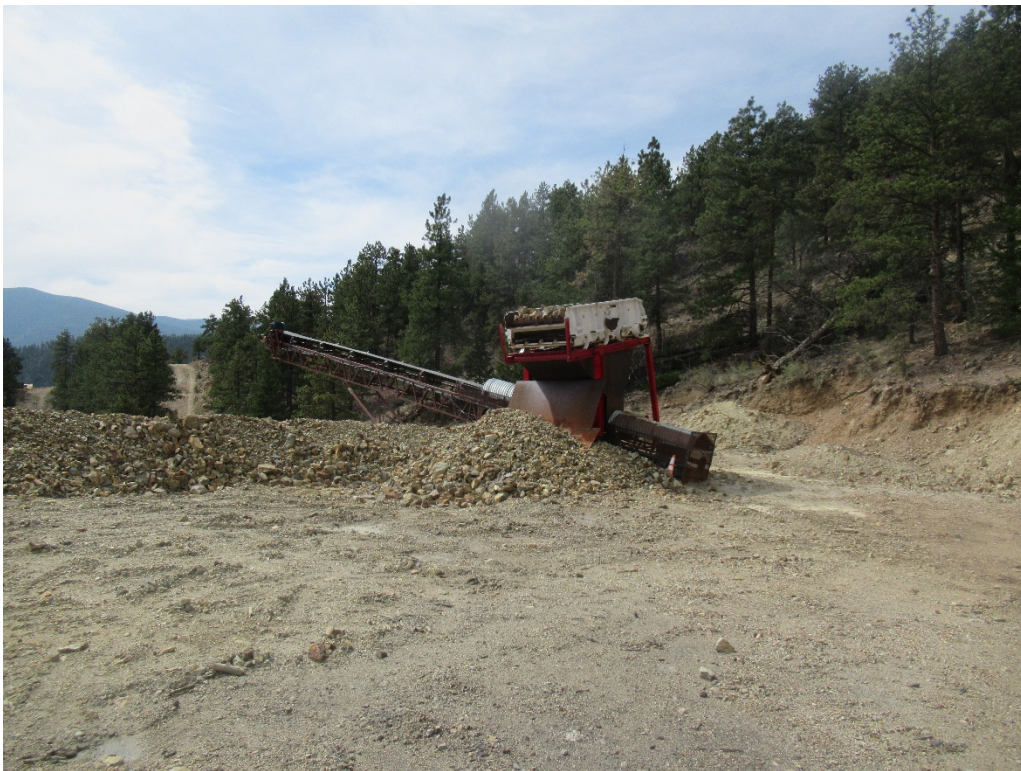
View of the grizzly on the bench above the tailing impoundment
