**MINERALS PROGRAM INSPECTION REPORT**  
**PHONE: (303) 866-3567**

| <b>MINE NAME:</b><br>Peak Ranch Resource | <b>MINE/PROSPECTING ID#:</b><br>M-2020-041 | <b>MINERAL:</b><br>Gravel/Sand | <b>COUNTY:</b><br>Summit |
| <b>INSPECTION TYPE:</b><br>Preoperation Inspection | <b>INSPECTOR(S):</b><br>Eric Scott | <b>INSP. DATE:</b><br>October 19, 2020 | <b>INSP. TIME:</b><br>09:45 |

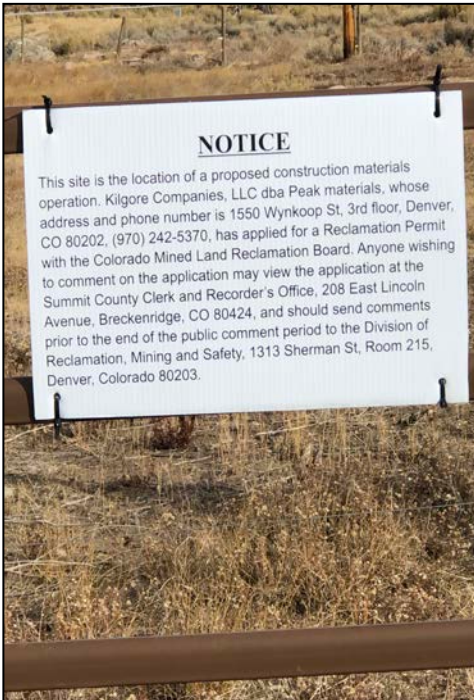
The notice of permit applied for was present at the main site entrance as required (Photo 1). DRMS noted during the inspection that the permit boundary was well delineated along the north and south ends by existing fencing. However, the permit boundary will need to be marked more thoroughly on the east and west sides, and permanent markers will need to be placed prior to commencing mining activity. DRMS suggests that offset distances and limits of excavation noted in the application also be clearly marked on the site prior to any work commencing as special care will need to be taken when operations commence to properly locate, mark and maintain the appropriate setback distances as permitted. DRMS may verify the presence and adequacy of the additional boundary and offset markers in a subsequent site inspection.

**Photo 1 – notice of permit applied for sign on gate to site entrance.**

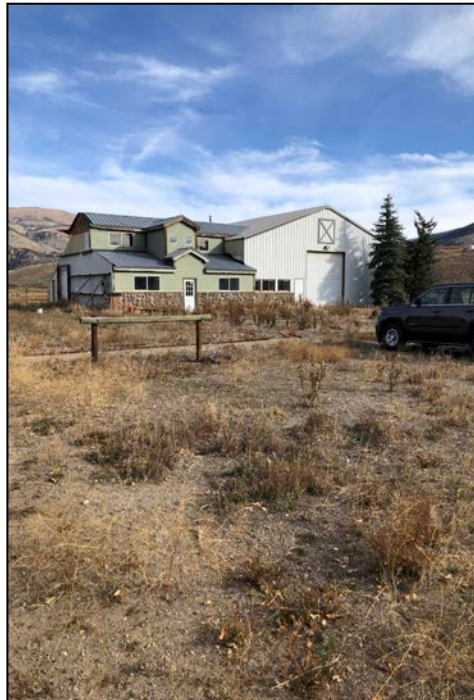
**Photo 2 – remaining site structures will be removed during mining.**

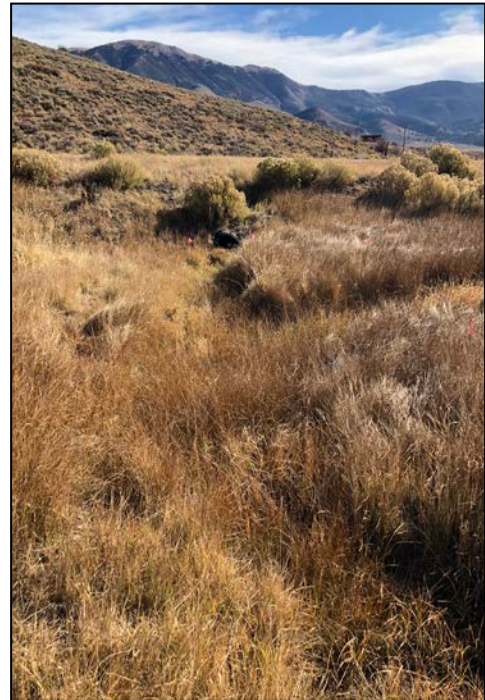
It was noted that two culverts, which are intended to provide surface flows from the east side of Highway 9 a path under the highway and into this easement for discharge to the river, do not discharge into the easement. They instead discharge approximately 40 yards north of the easement directly into the northeast area of the subject property in the "wet meadow"/wetlands area as shown on the maps. A small channel had been excavated, presumably to capture discharge from the culverts and return it to the drainage easement, but it was poorly constructed and full of vegetation. In addition, it would not be possible for the easement to return water to the river as intended as it has been completely filled and blocked in several areas along its path. Based on the misalignment of the culverts and the general condition (blocked) of the drainage easement, it would appear that this drainage easement has not functioned as intended for quite some time.

The misalignment of the culvert discharge combined with the blocked drainage easement has caused surface water that should have been conveyed to the river to instead be discharged into the northeast area of the subject property. This surface water inflow would then lead to the formation of, or increase in size of, the currently existing wet meadow/wetlands area in the northeastern portion of the subject property.

**Photo 3 – culvert discharge path from under Hwy 9 into the site.**

Mr. Larson stated that they were engaged with the Town of Breckenridge to return the drainage easement to a functional state as required by their decree. Because the wet meadow/wetlands area as it currently exists is, at least in part, due to the failure of the easement to function properly, restoring proper function of the drainage easement may have adverse effects on the existing wet meadow/wetland areas. The permittee will need to engage and work with the US Army Corps of Engineers (COE) to determine what the COE permitting implications of this may be and what, if any, mitigation measures will be required.

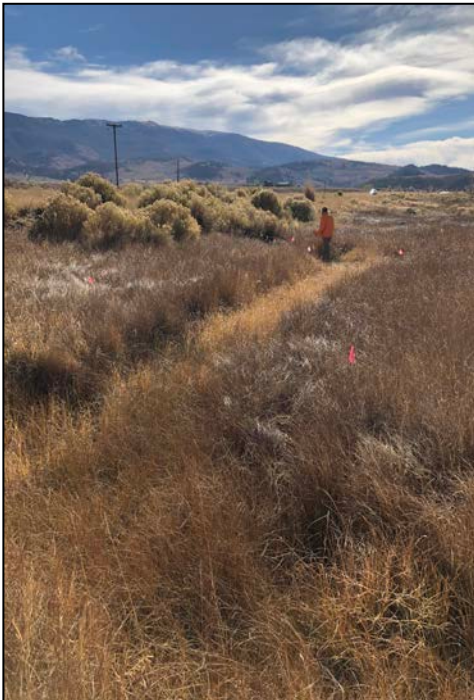
**Photo 4 – small channel excavated to guide flow from culverts south toward drainage easement.**

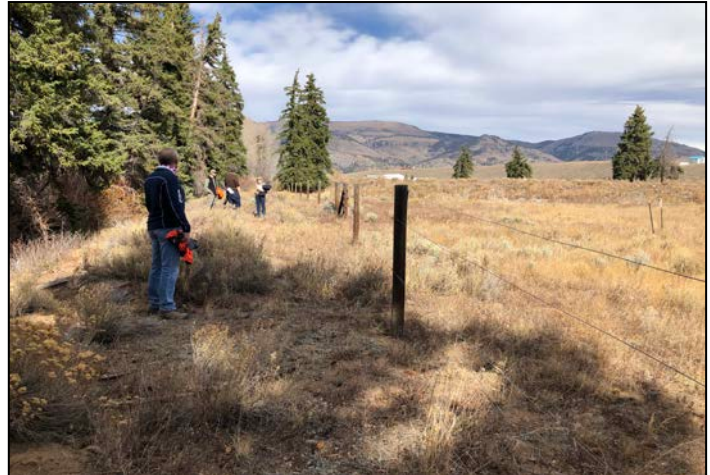
**Photo 5 – photo of SW corner of permit area looking north along west permit boundary near Blue River.**
