MINERALS PROGRAM INSPECTION REPORT
PHONE: (303) 866-3567

MINE NAME: St. Barbara Sand and Gravel Mine	MINE/PROSPECTING ID#: M-2004-013	MINERAL: Sand and gravel	COUNTY: Pueblo
INSPECTION TYPE: Monitoring	INSPECTOR(S): Patrick Lennberg	INSP. DATE: October 7, 2020	INSP. TIME: 11:30
OPERATOR: Pete Lien & Sons, Inc.	OPERATOR REPRESENTATIVE: Scott Norman	TYPE OF OPERATION: 112c - Construction Regular Operation	
REASON FOR INSPECTION: Normal I&E Program	BOND CALCULATION TYPE: Complete Bond	BOND AMOUNT: \$411,193.00	
DATE OF COMPLAINT: NA	POST INSP. CONTACTS: None	JOINT INSP. AGENCY: None	
WEATHER: Clear	INSPECTOR'S SIGNATURE:

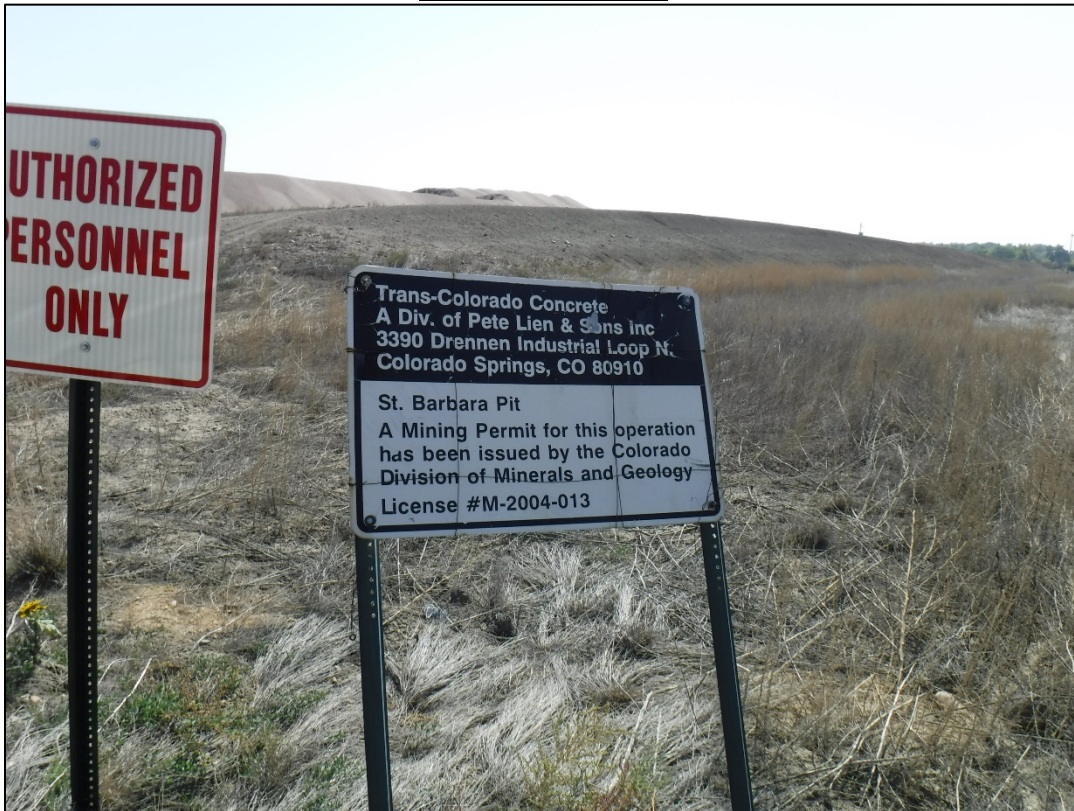
Photo 1: Mine sign at entrance to mine site

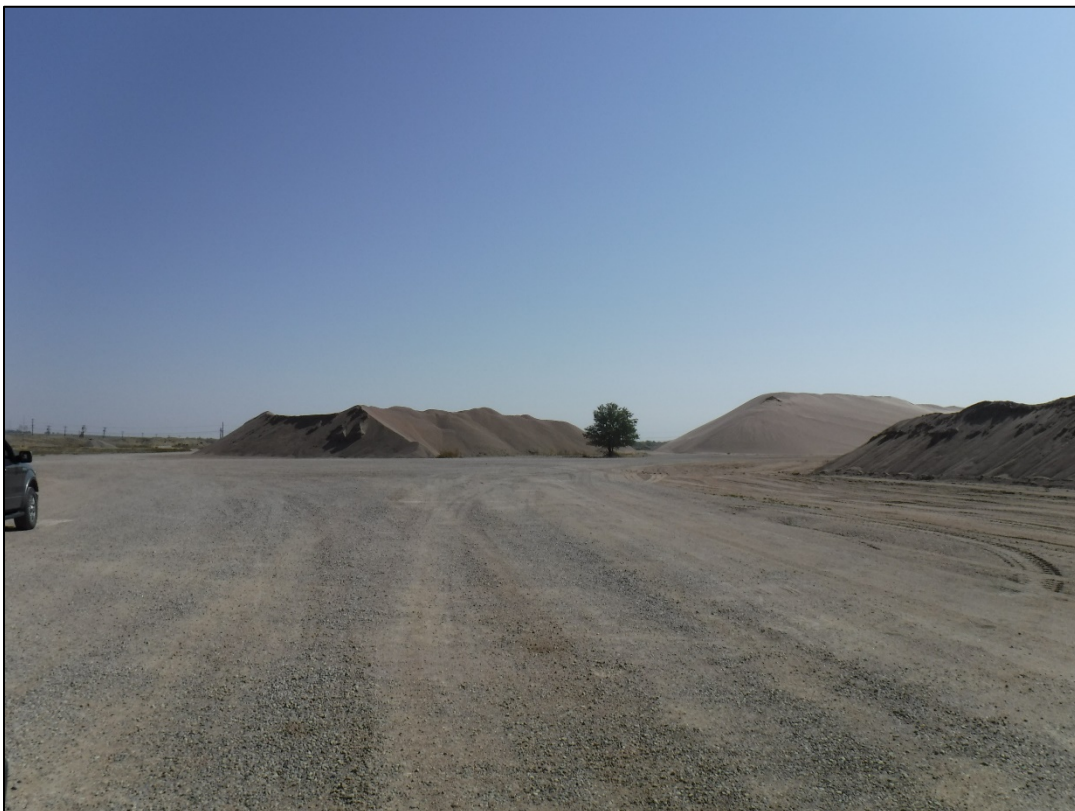
Photo 2: Product stockpiles near mine entrance

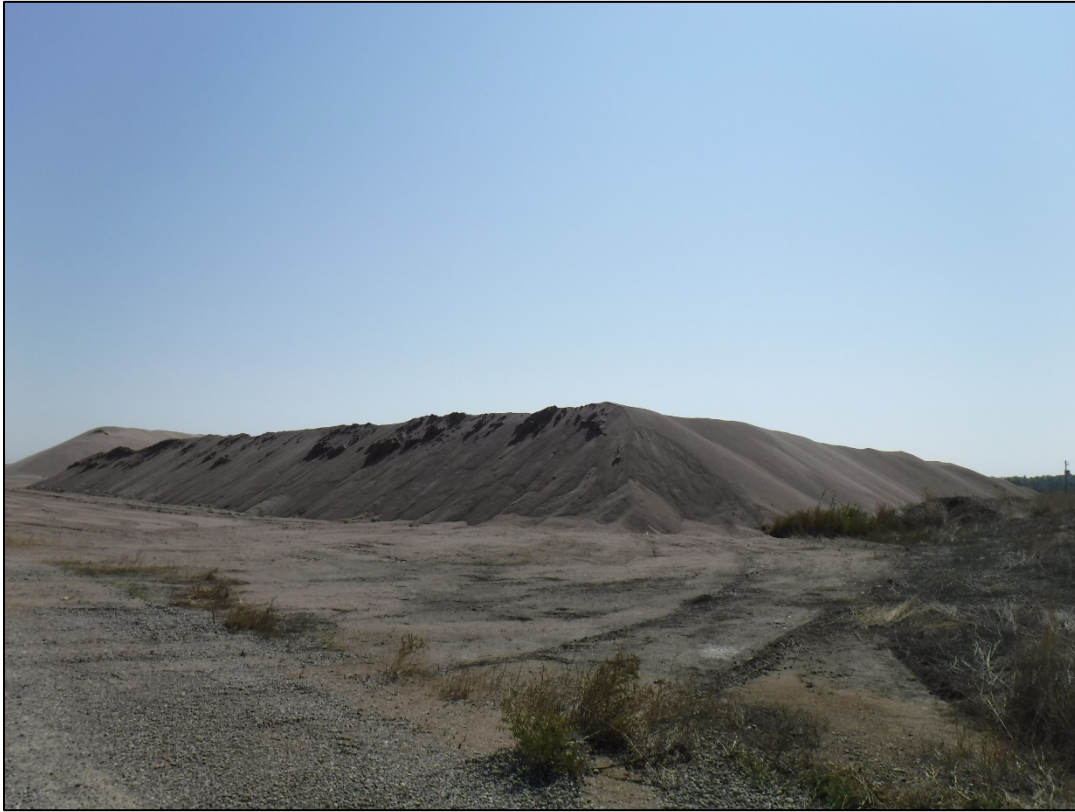
The site was not actively mining at the time of the inspection. However, a contractor was hauling material from one of the large product stockpiles to the pit area. Recently, irrigation activities to the north of the mine had stopped and the groundwater level in the pit rose exposing more groundwater than was allowed. The backfilling was being done to shrink the exposed groundwater to approximately 5.5 acres. The approved SWSP for the site allows differing areas of exposed groundwater under different scenarios. The scenario that is applicable to the site currently is Scenario B and Table 1B which allows for 9.76 acres of exposed water. The remaining exposed groundwater at the site is approximately 4.2 acres in the 4 process ponds. The depth of the water at the pit is approximately 30 feet and the process ponds are about 22 feet deep.

Photo 3: Product stockpile being used to backfill

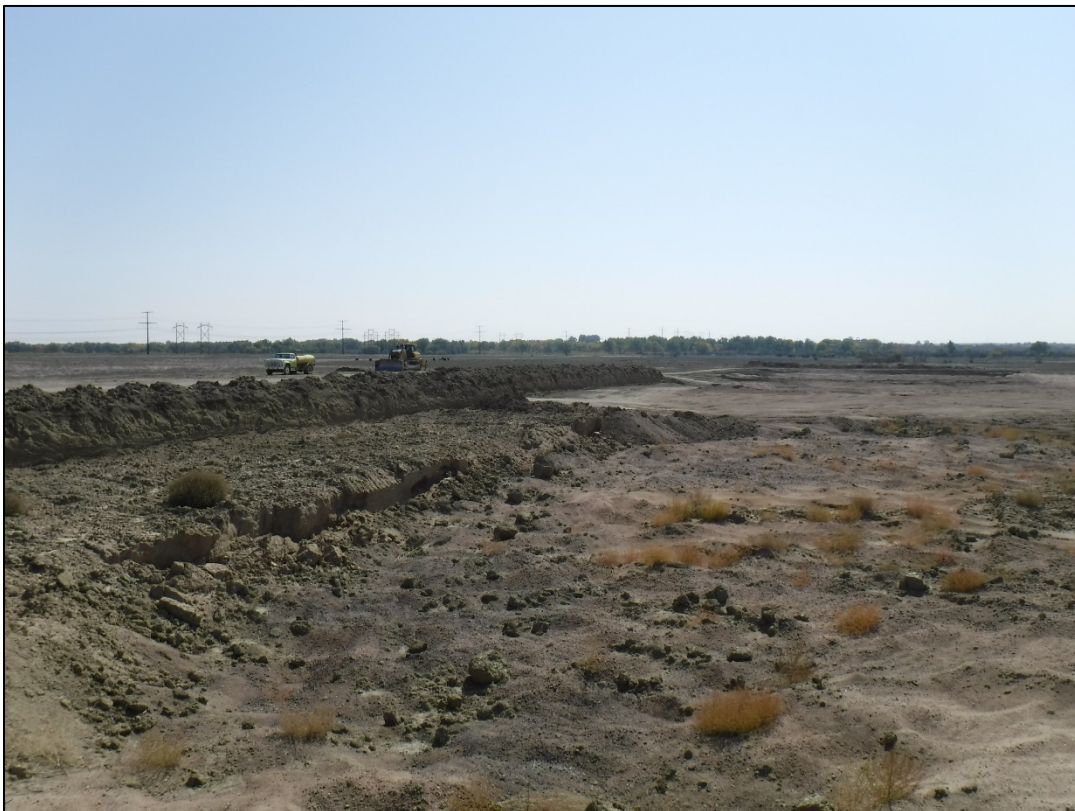
To the east of the pit pond area was an area that had been stripped in advance of mining. The overburden from this area was used to backfill previously mined areas. During mining the pit area is pumped down using pumps to expose the sand and gravel to be mined. Mining is completed using loaders and excavators that transport material to be processed near the mine entrance.

Photo 4: Area stripped ahead of mining

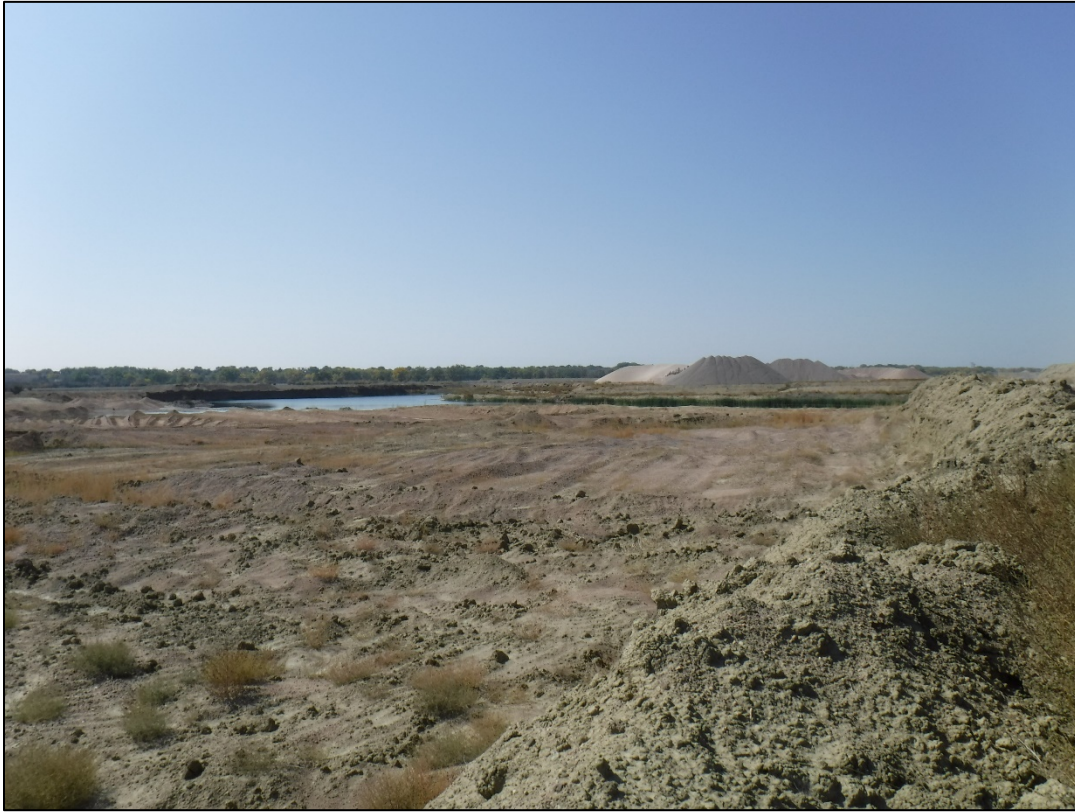
Photo 5: Open water in background marks the limits of current mining, area in the foreground has been stripped of overburden in preparation of mining

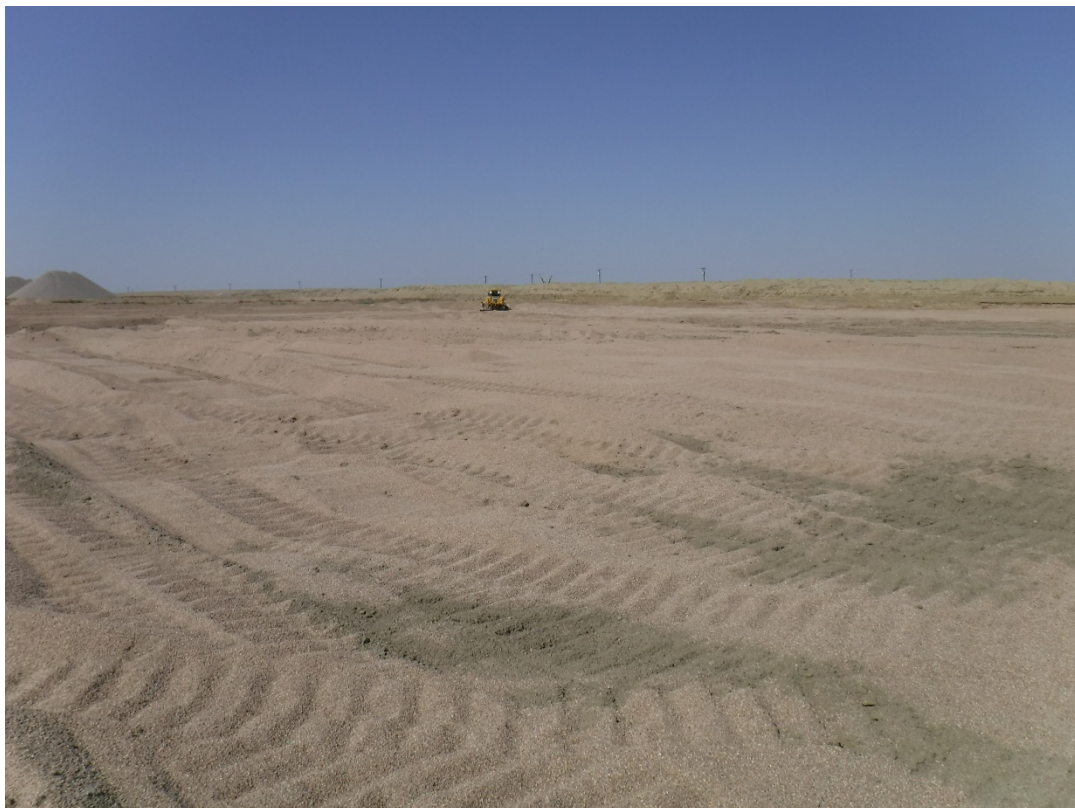
Photo 6: Area has been backfilled to prevent groundwater exposure

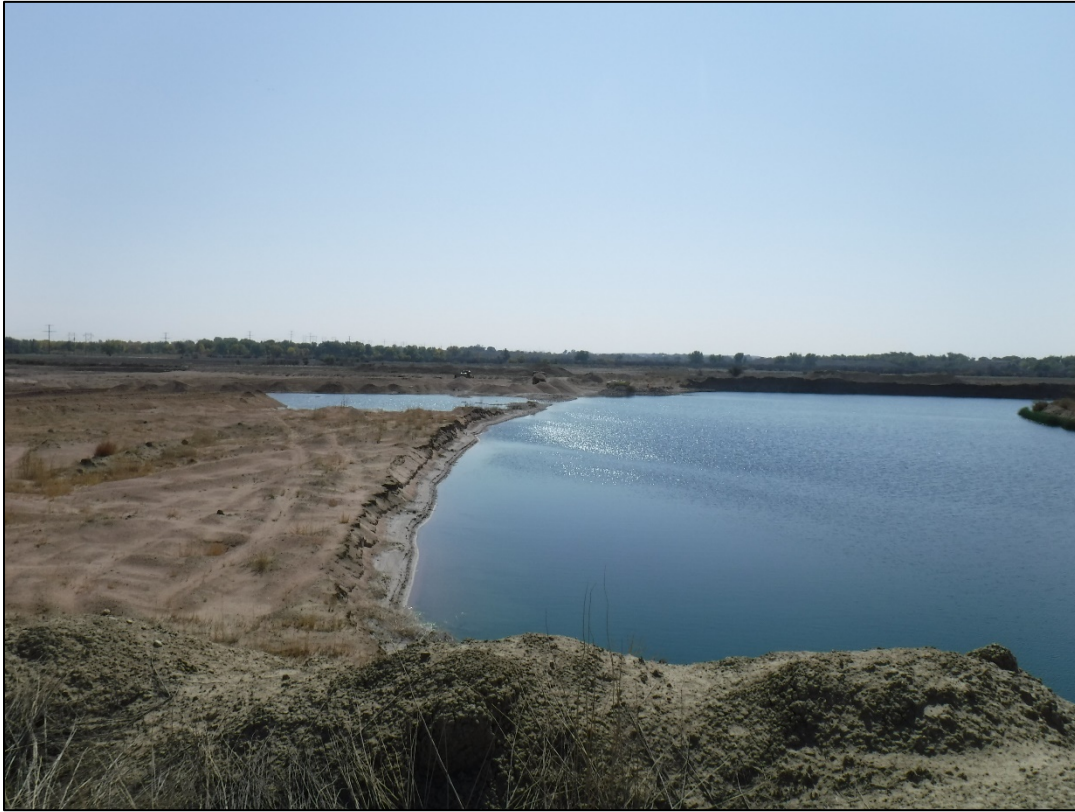
Photo 7: Exposed water to the center left of picture is being backfilled, the remaining open water is permitted for exposure

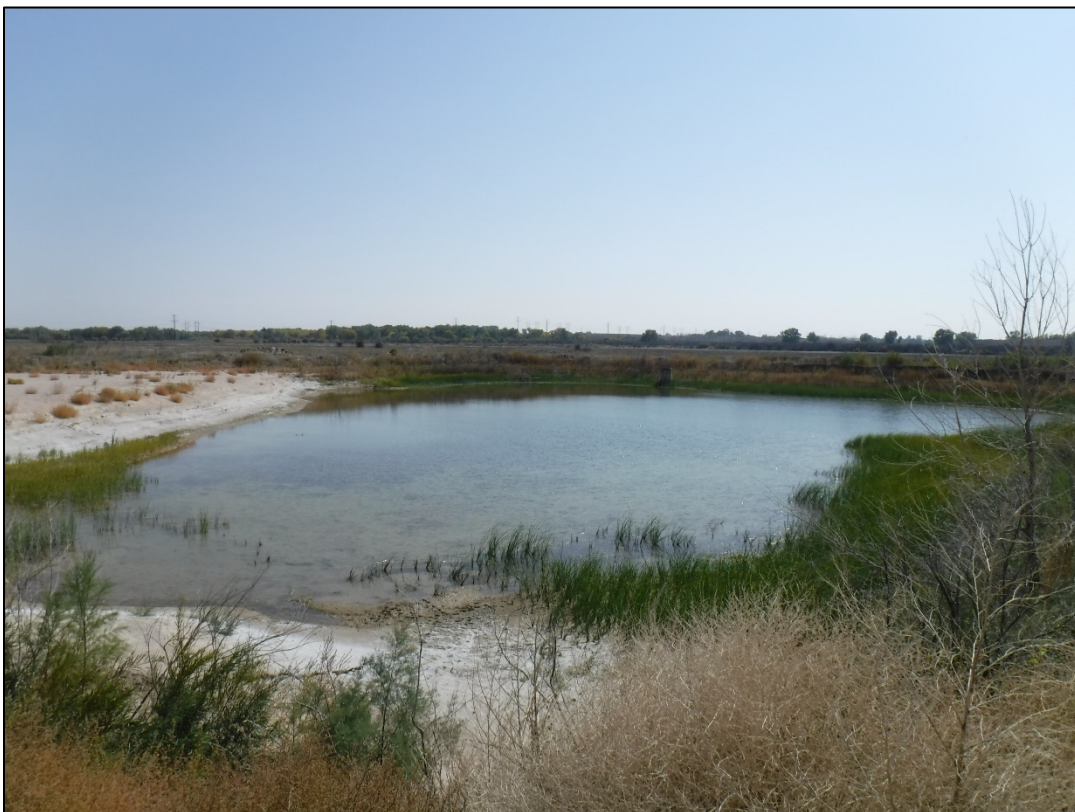
Photo 8: Typical process settling pond

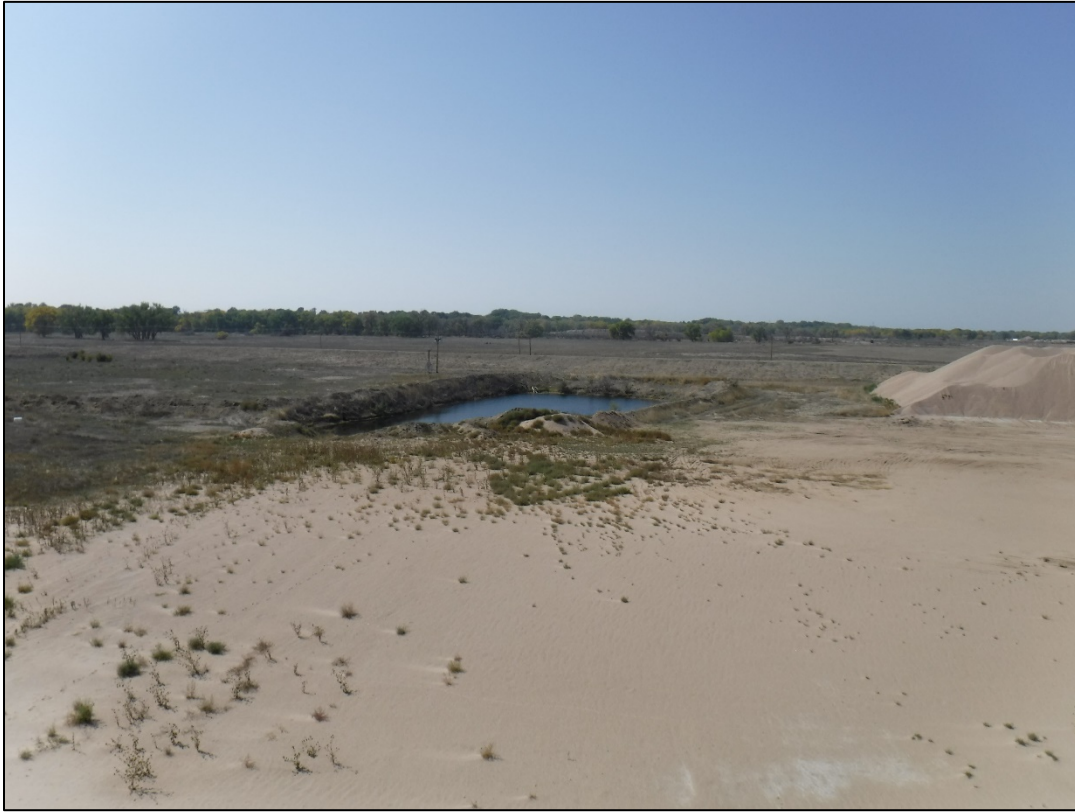
Photo 9: Westernmost process pond

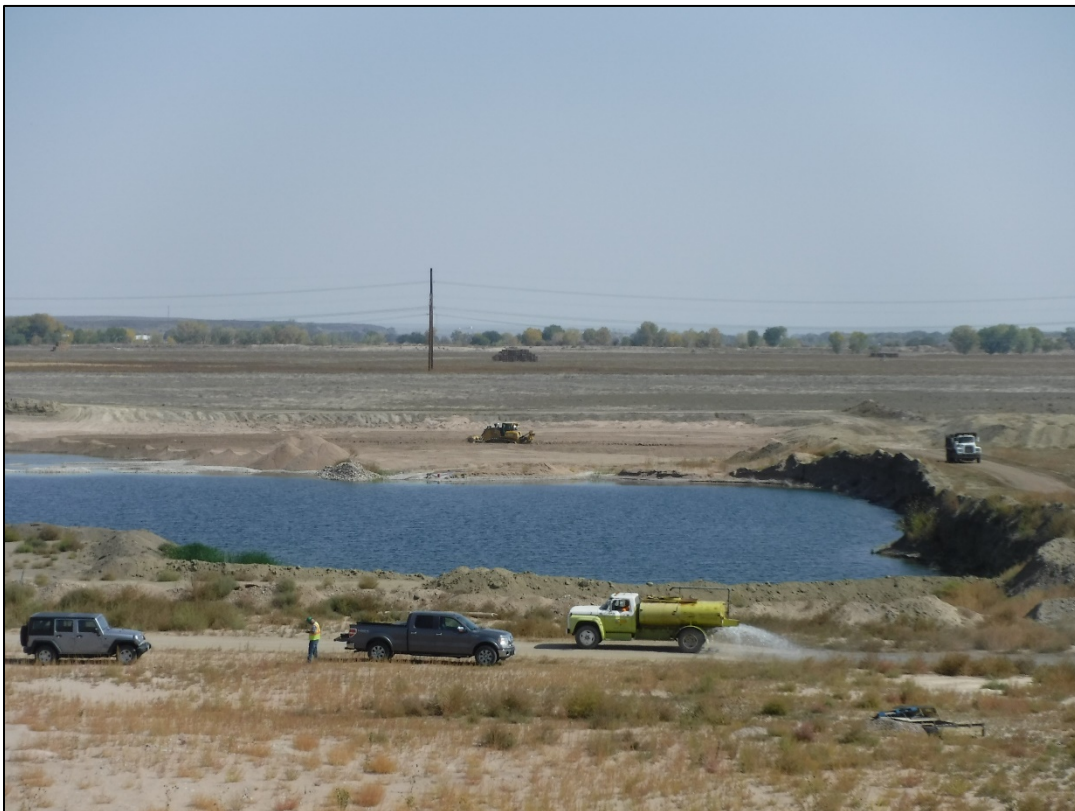
Photo 10: Backfilling activities at open water area

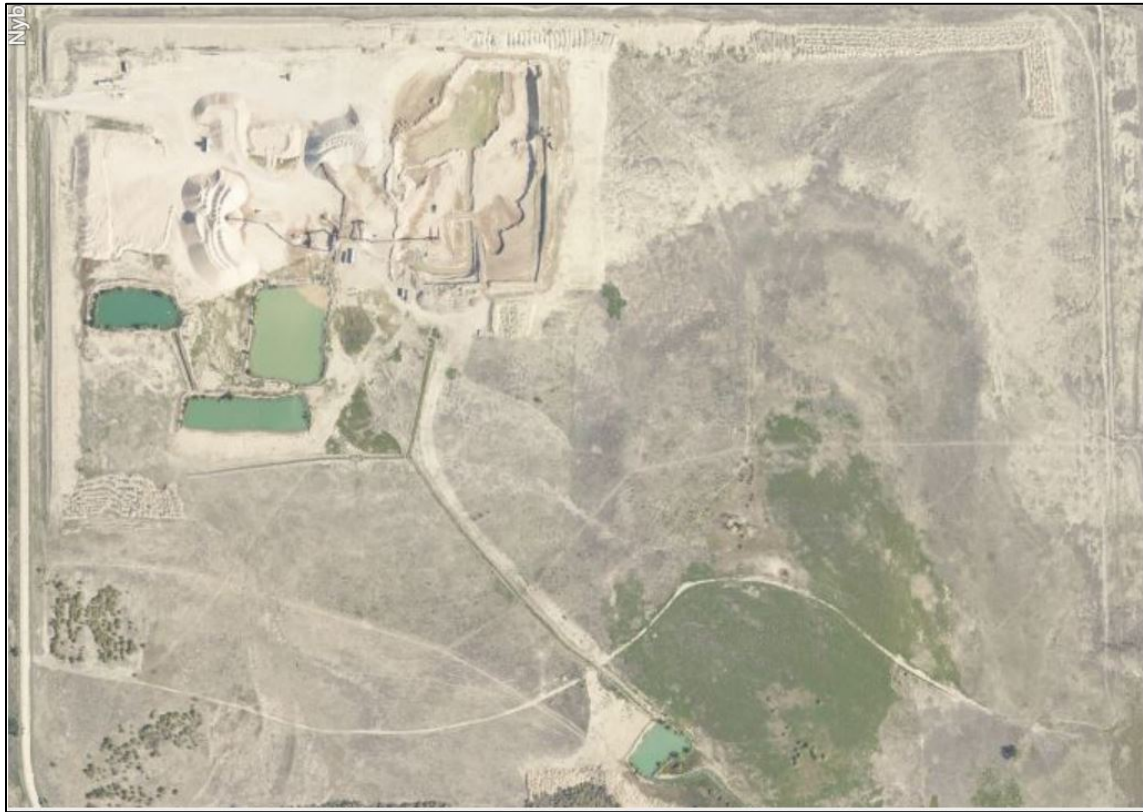
Photo 11: Aerial overview of permit from Bing Maps, date unknown

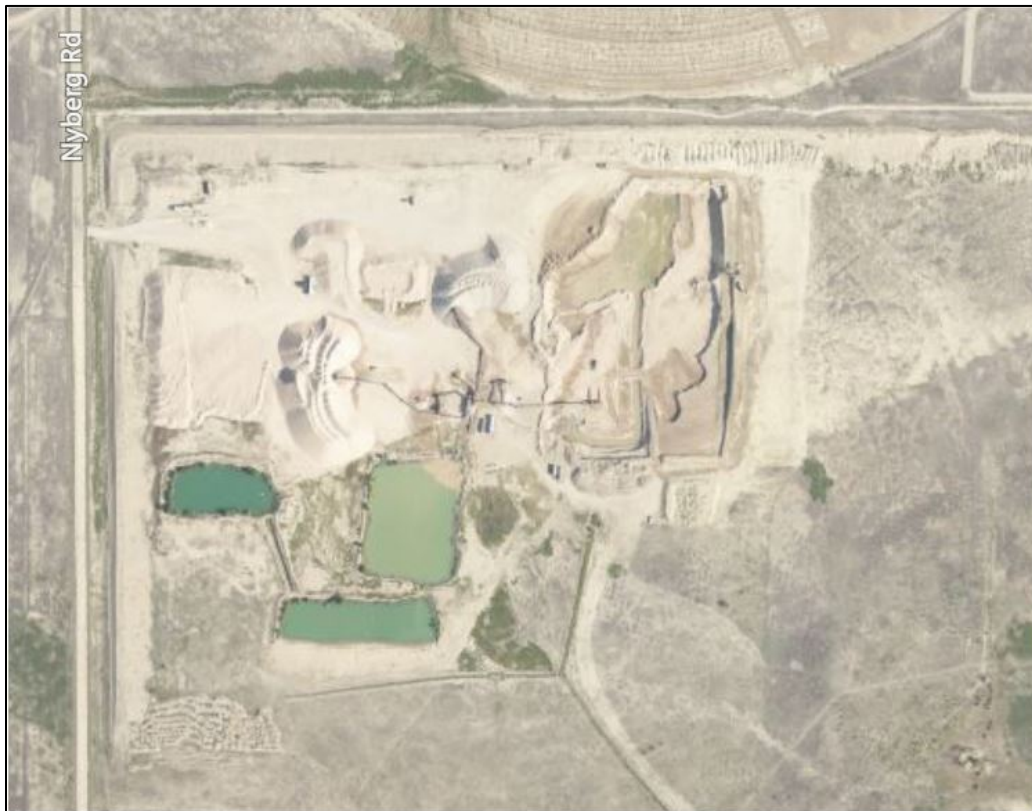
A review of the annual report in conjunction with the inspection it appears that mining related disturbance is approximately 80 acres, the annual report stated 90 acres had been affected but upon further investigation this value is inaccurate. The Division recommends that the Operator submit a Technical Revision to increase the disturbed area from 80 acres to at least 100 acres. In doing so the Operator can allow for expanding mining activities while remaining below the maximum allowed disturbed limit.

Photo 12: Aerial overview of active mining area from Bing Maps, date unknown
