MINERALS PROGRAM INSPECTION REPORT
PHONE: (303) 866-3567

MINE NAME: Schwartzwalder Mine	MINE/PROSPECTING ID#: M-1977-300	MINERAL: Uranium	COUNTY: Jefferson
INSPECTION TYPE: Monitoring	INSPECTOR(S): Amy Eschberger, Tim Cazier	INSP. DATE: October 16, 2020	INSP. TIME: 12:30
OPERATOR: Colorado Legacy Land, LLC	OPERATOR REPRESENTATIVE: Billy Ray, Sam Lowe	TYPE OF OPERATION: 112d-2 - Designated Mining Operation	
REASON FOR INSPECTION: Normal I&E Program	BOND CALCULATION TYPE: None	BOND AMOUNT: \$8,900,000.00	
DATE OF COMPLAINT: NA	POST INSP. CONTACTS: None	JOINT INSP. AGENCY: None	
WEATHER: Clear	INSPECTOR'S SIGNATURE:

OBSERVATIONS

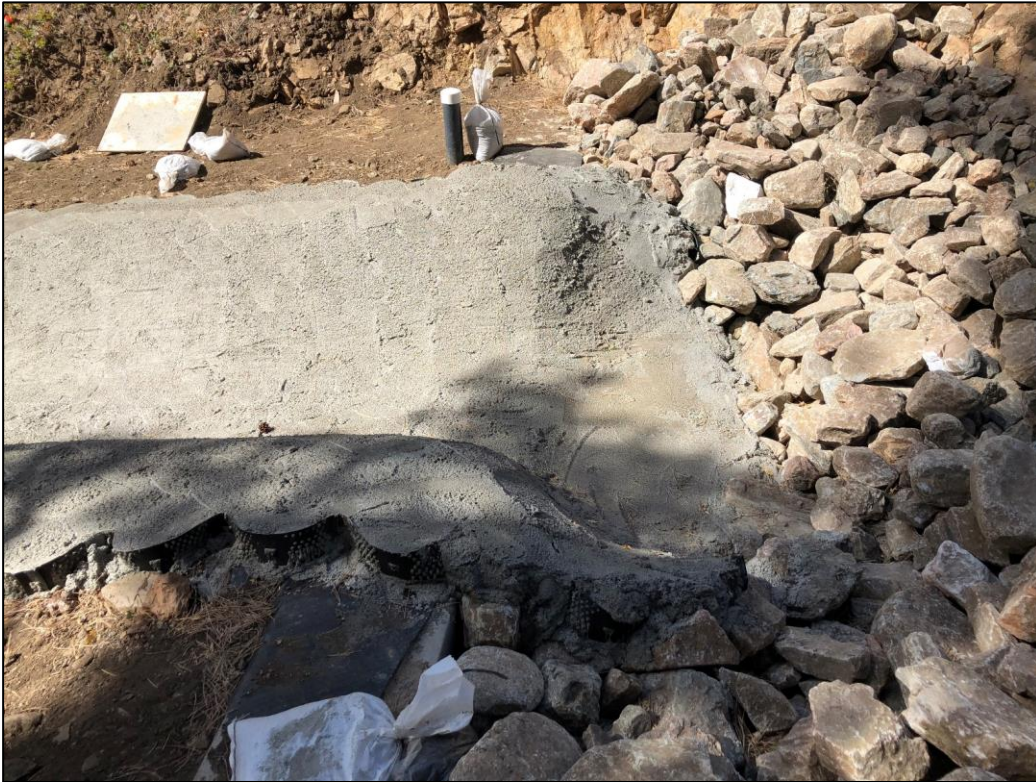
At the upper end of the diversion channel where the water intake structure is installed in the ephemeral drainage above the NWRP, Mr. Lowe explained the Geoweb components had been mechanically attached to the

upstream face of the concrete seal wall using concrete anchor bolts, and concrete was placed into the Geoweb cells exposed above the riprap. During the inspection, there was discussion regarding whether the riprap should be pushed down to cover the upper edge of the concrete-lined channel above the seal wall. The Division has no issue with the current placement of the riprap which should minimize migration of the riprap down channel during a storm event.

Photo 1. View of water intake structure installed at upper end of NWRP diversion channel. Geoweb components have been mechanically attached to upstream face of concrete seal wall using concrete anchor bolts, and concrete has been placed into Geoweb cells exposed above riprap.

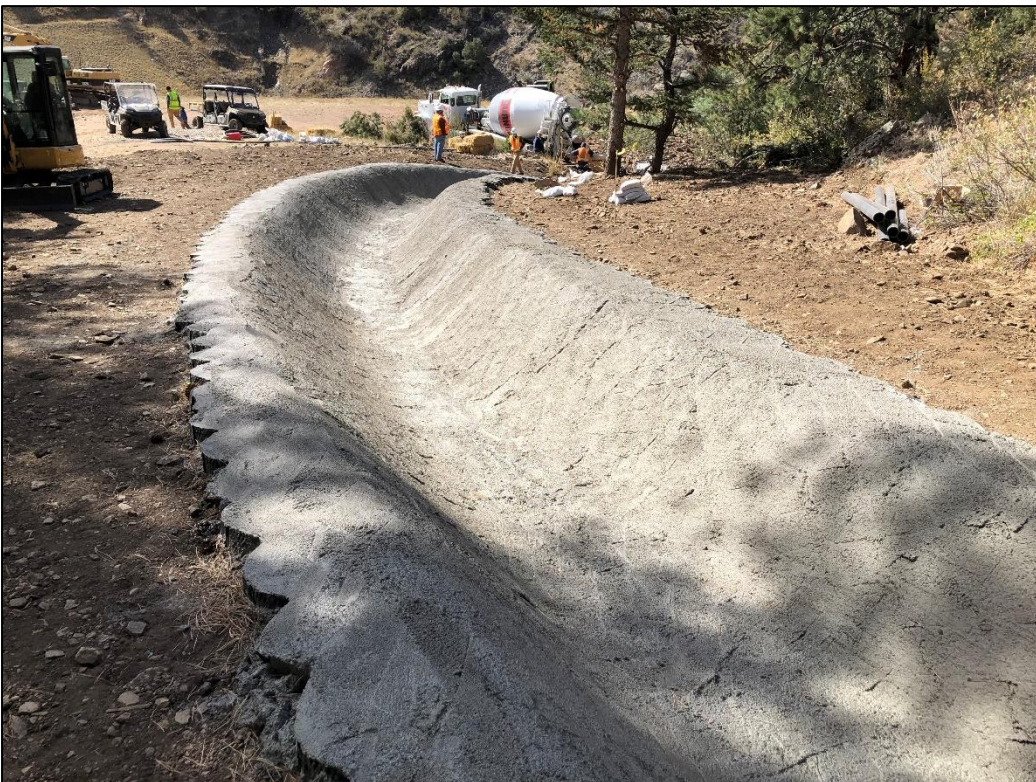
Photo 2. View looking southwest across upper section of NWRP diversion channel with concrete infill placed into Geoweb cells.

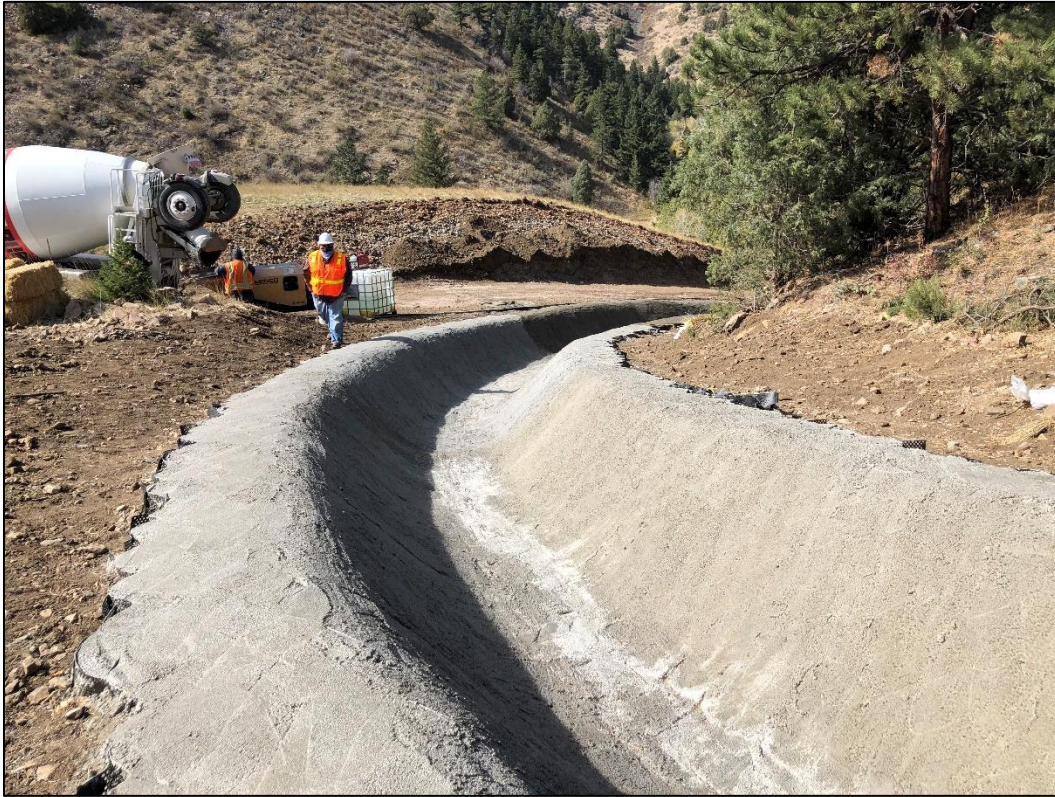
Photo 3. View looking west across NWRP diversion channel with concrete infill placed into Geoweb cells, at point where channel curves around edge of slope.

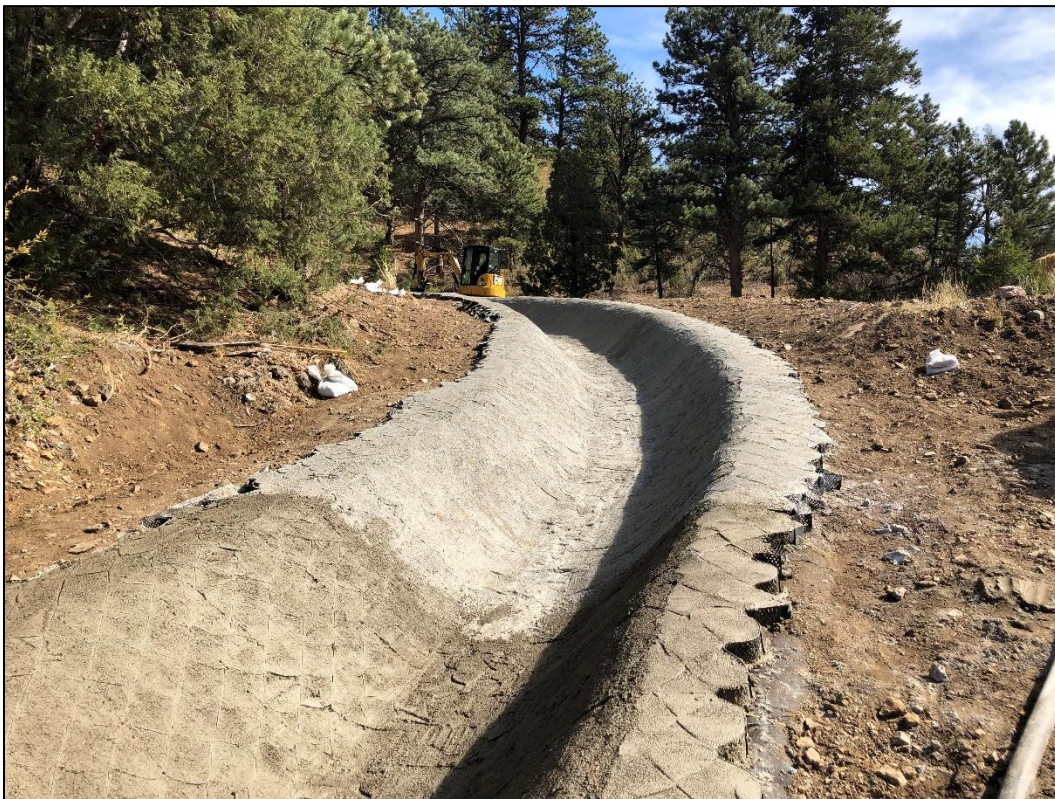
Photo 4. View looking east across NWRP diversion channel with concrete infill placed into Geoweb cells, at point where channel curves around edge of slope.

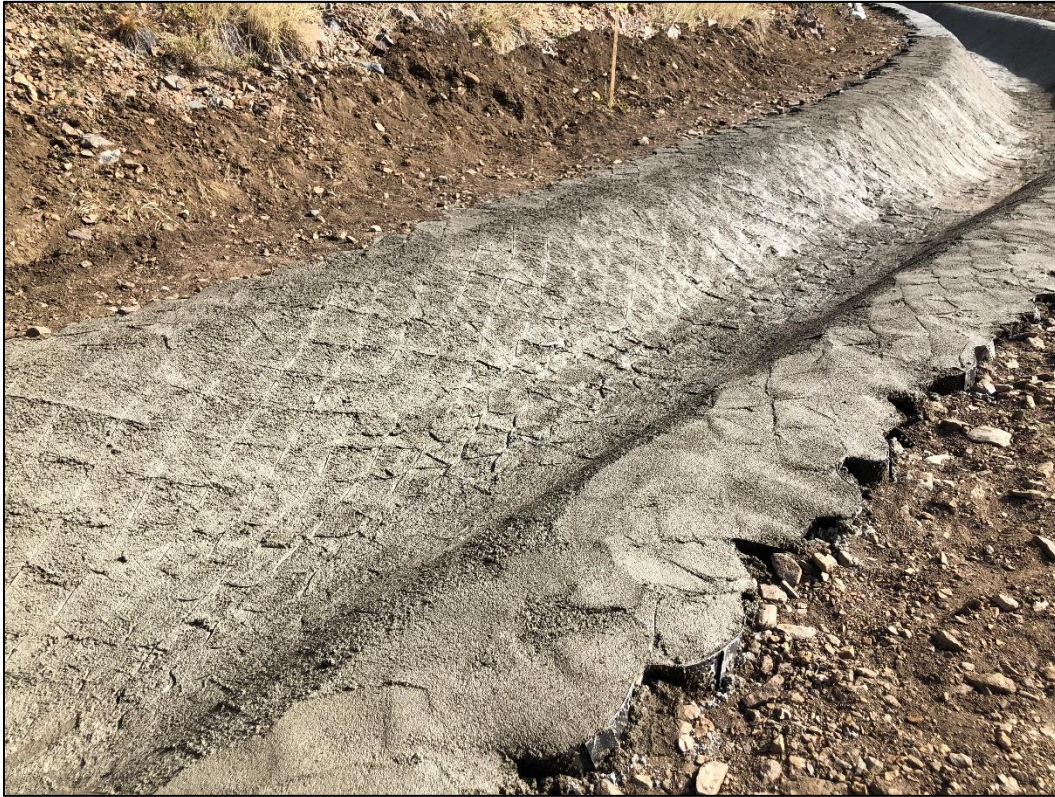
Photo 5. Closer view of NWRP diversion channel with concrete infill placed into Geoweb cells.

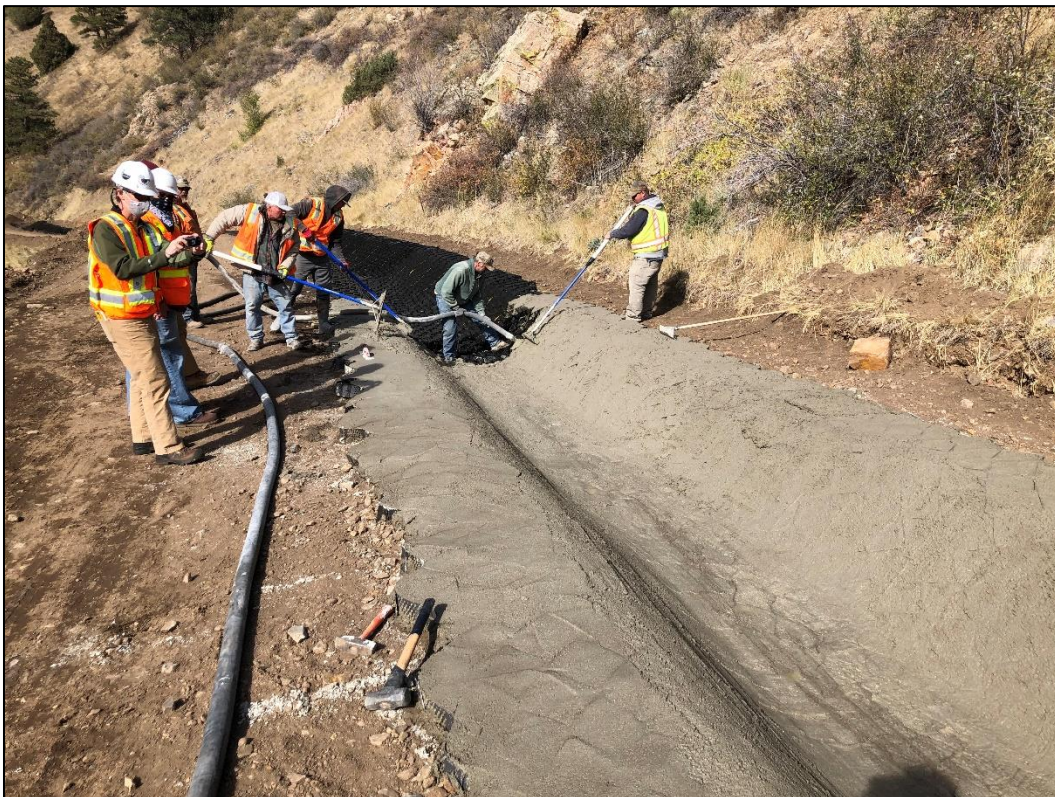
Photo 6. View looking northwest across middle section of NWRP diversion channel, showing crew pouring concrete into Geoweb cells during inspection.

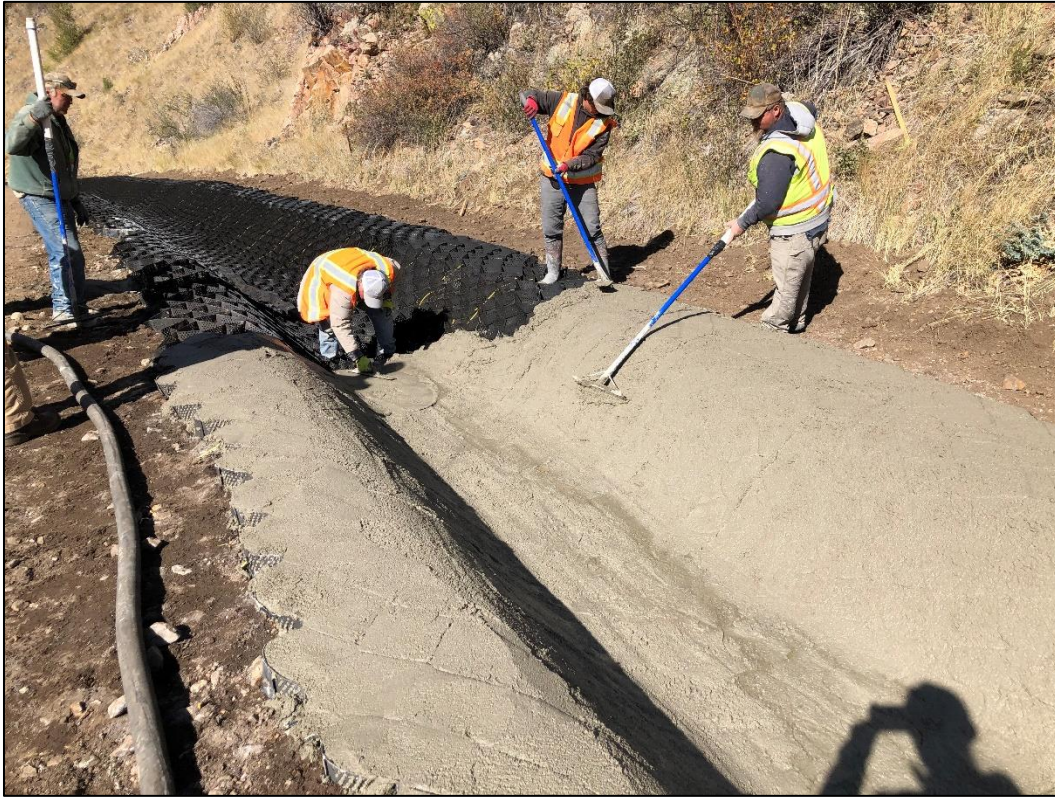
Photo 7. View of middle section of NWRP diversion channel, showing crew shaping final concrete placement into Geoweb cells for the day.

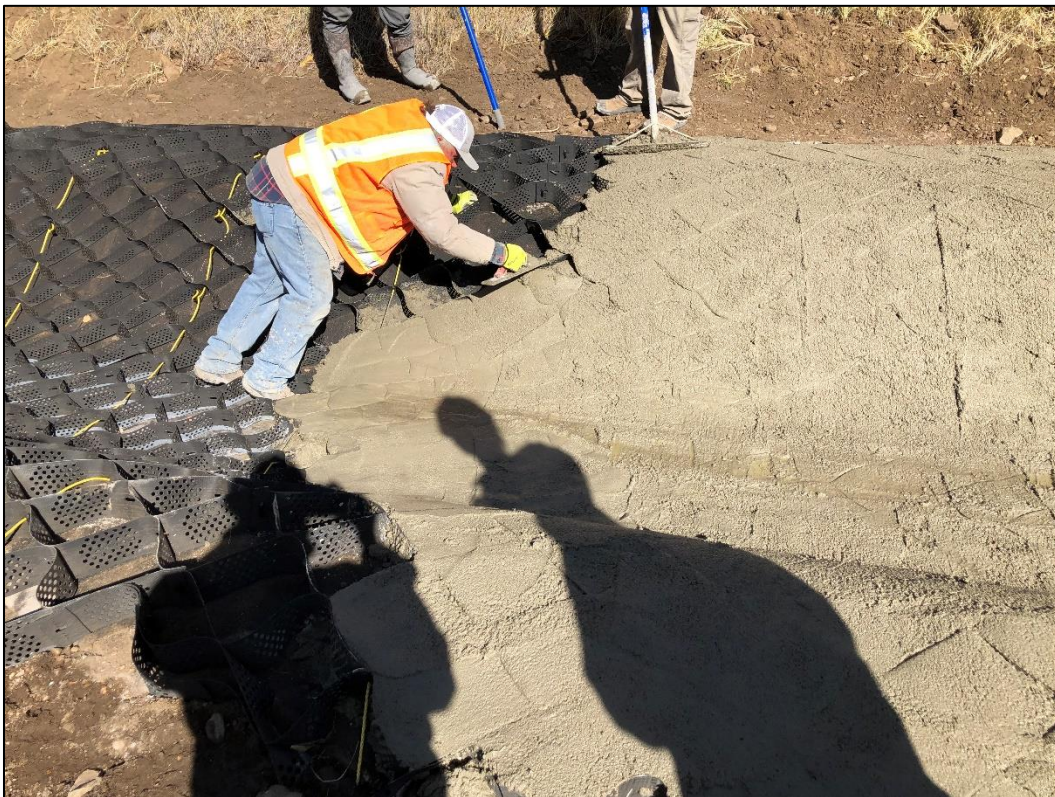
Photo 8. Closer view of middle section of NWRP diversion channel, showing crew shaping final concrete placement into Geoweb cells for the day, ensuring no cells are left partially filled.

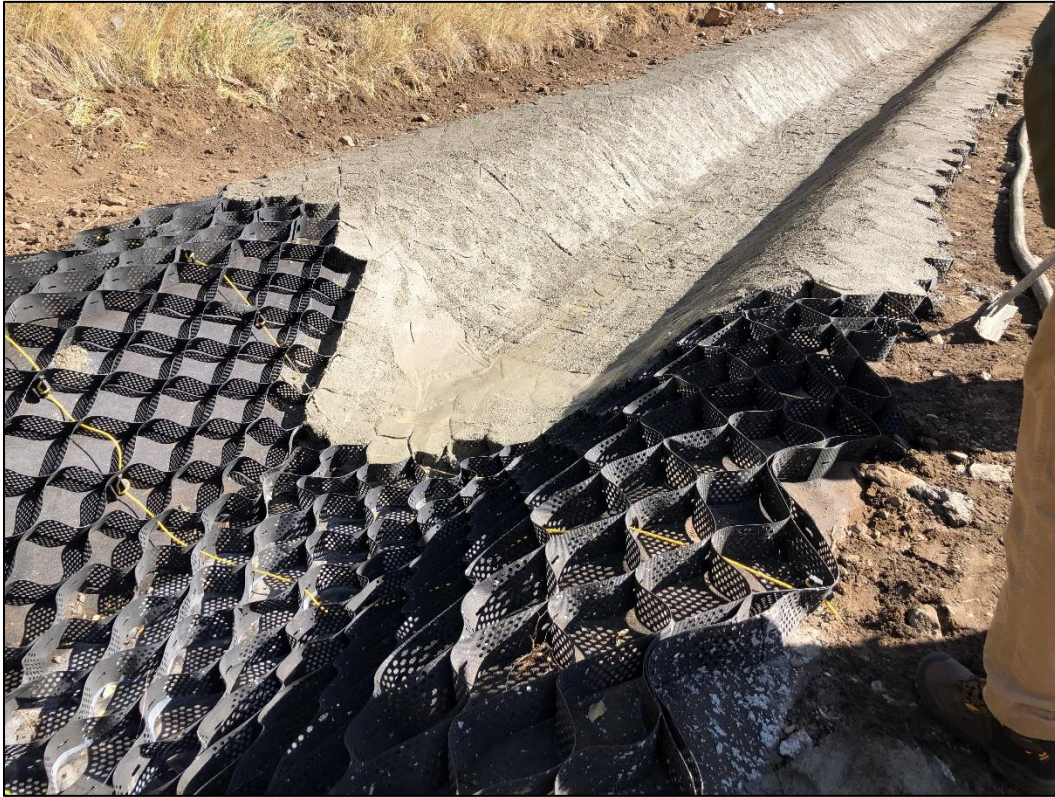
Photo 9. Closer view of middle section of NWRP diversion channel where concrete placement terminated for the day. Note no Geoweb cells left partially filled in between pours.

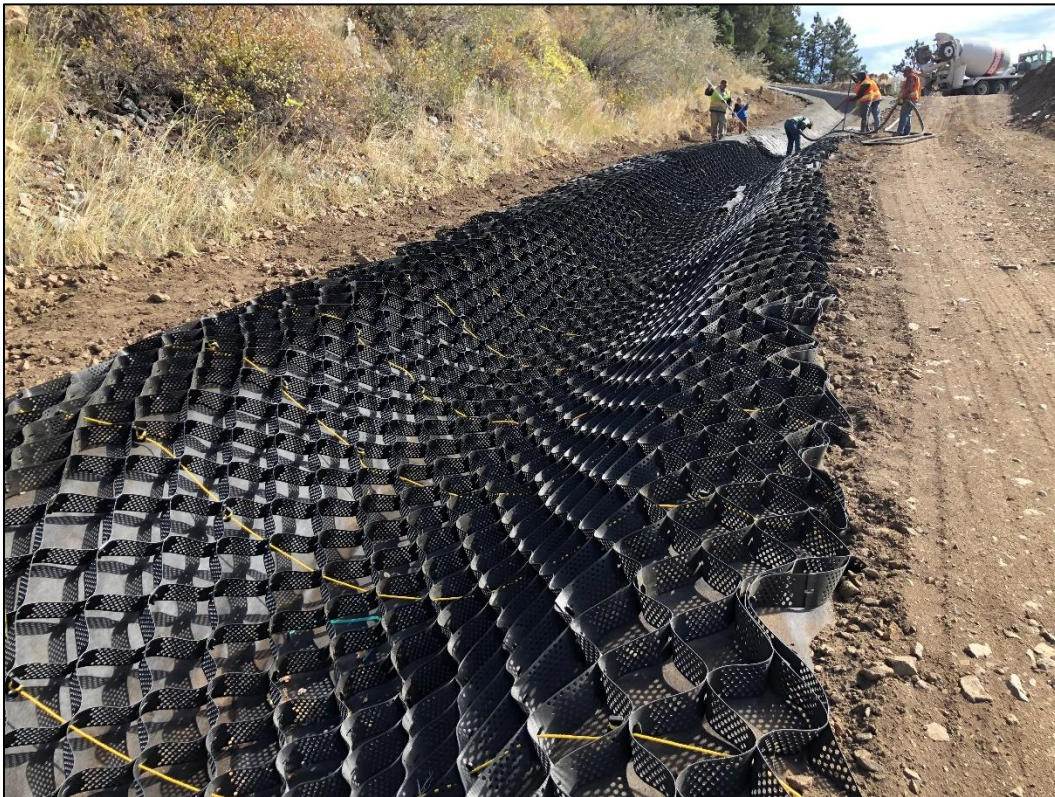
Photo 10. View looking southeast across lower section of NWRP diversion channel with Geoweb components installed, ready for concrete infill.

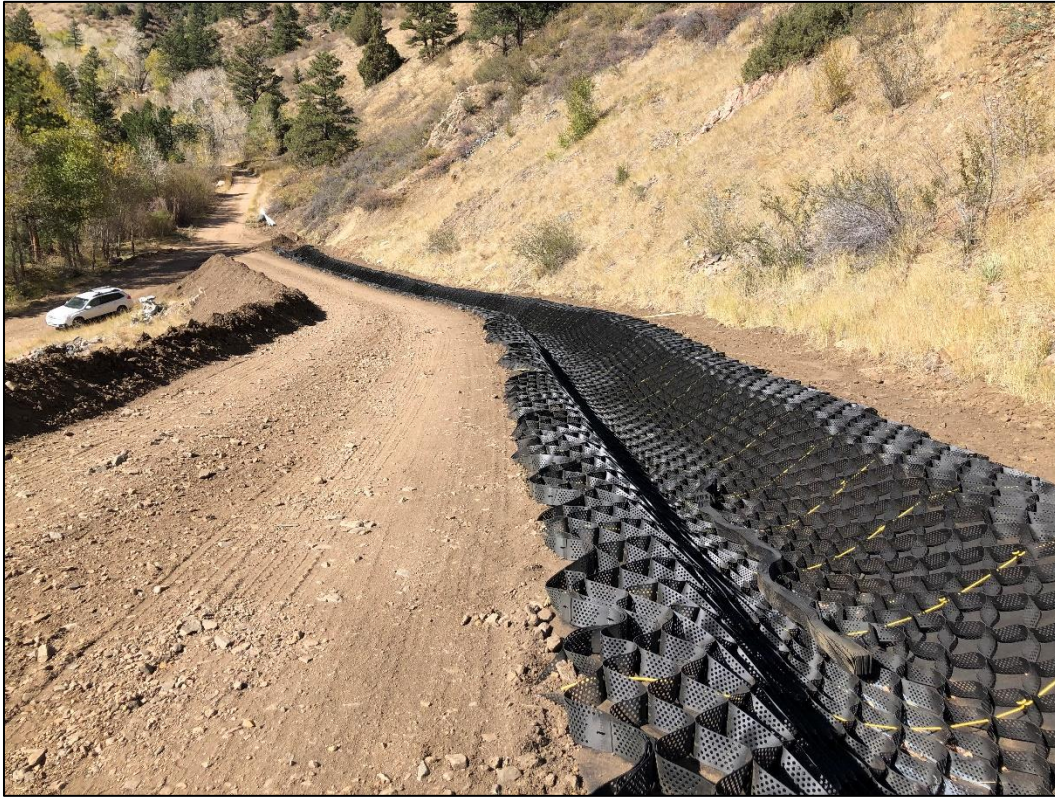
Photo 11. View looking northwest across lower section of NWRP diversion channel with Geoweb components installed, ready for concrete infill.

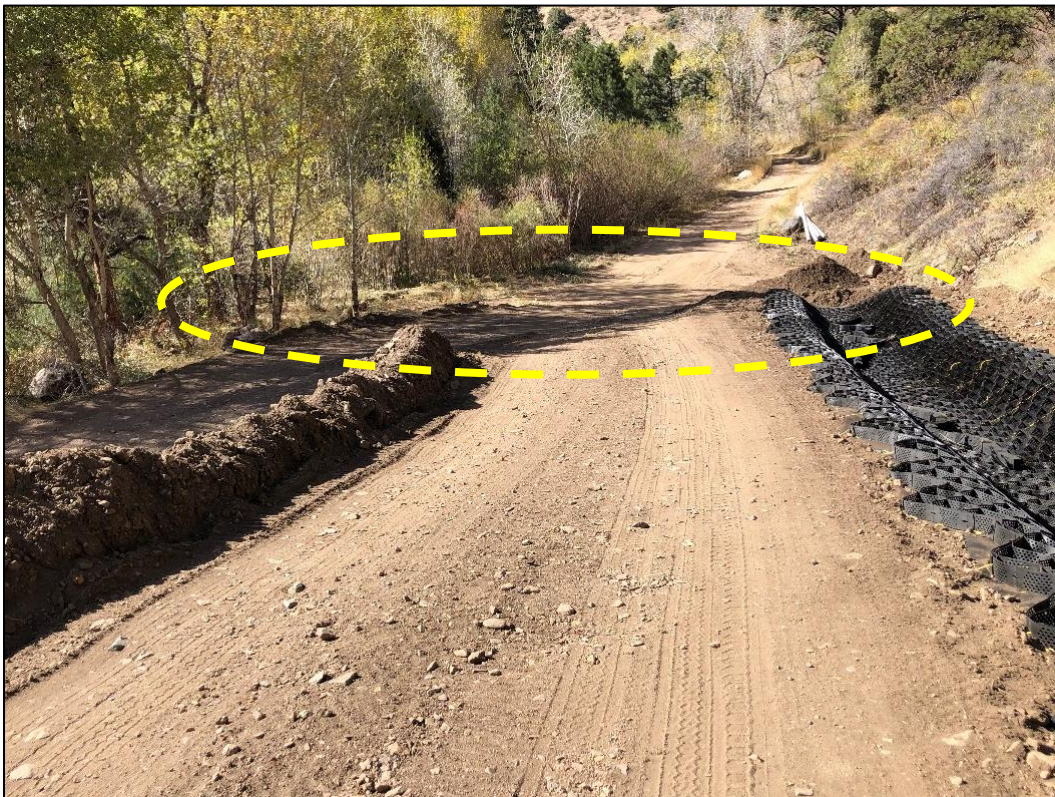
Photo 12. View looking west at lower end of NWRP diversion channel, showing approximate location (circled) of energy dissipation basin and road crossing which will be constructed to convey channel flows across the road to Ralston Creek.

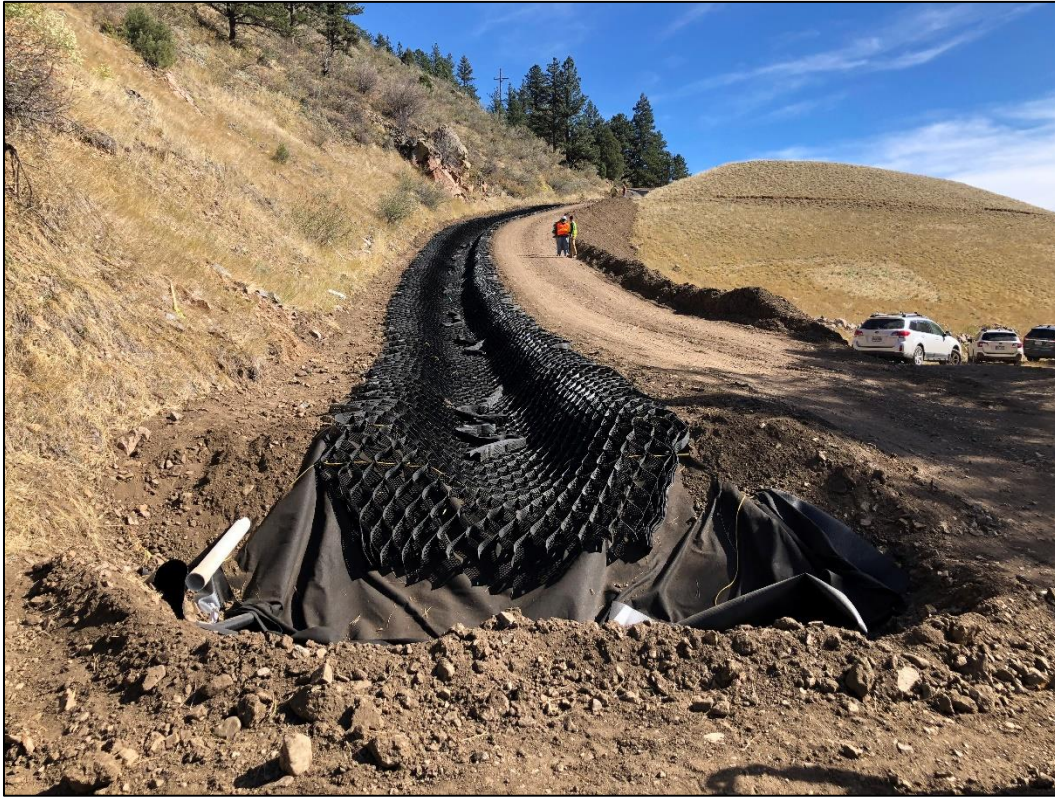
Photo 13. View looking east at lower end of NWRP diversion channel, showing location (in foreground) where riprap energy dissipation basin will be constructed.

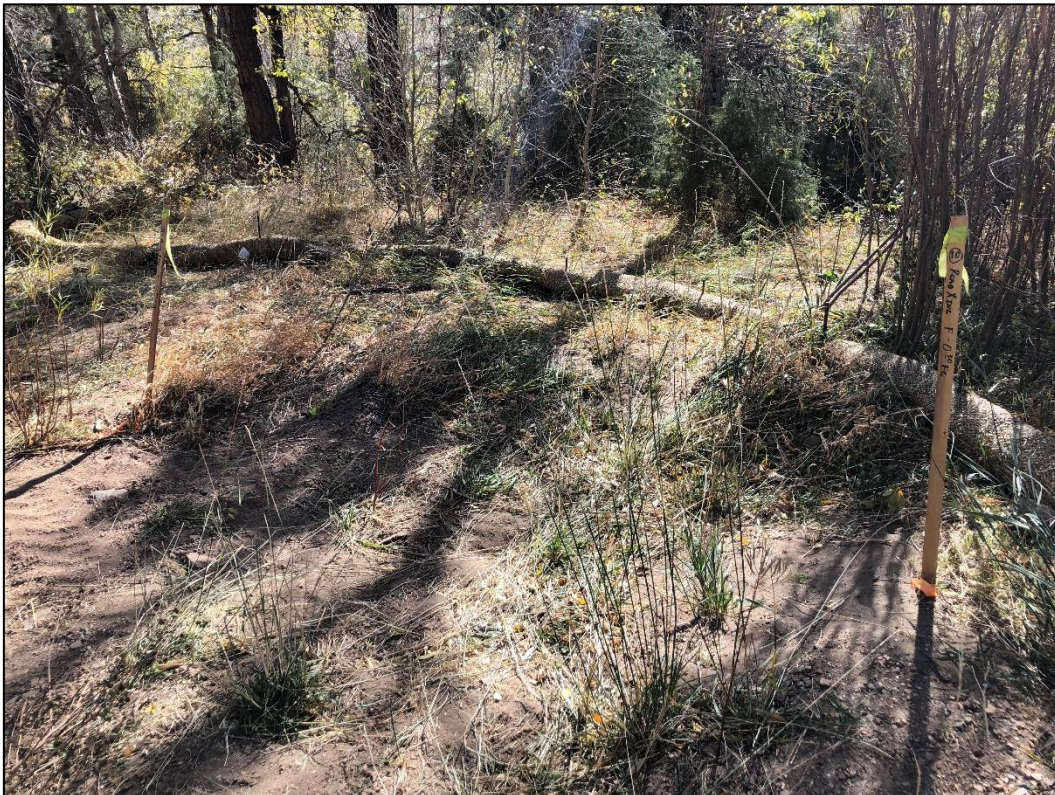
Photo 14. View looking south (toward Ralston Creek) at anticipated location for NWRP diversion channel road crossing, marked with survey laths.

After the concrete placement is completed, the operator will begin backfilling and grading the ground surface along the outside edges of the channel to create positive drainage into the channel. Water bars will be installed primarily on the north sides of the channel for erosion control. Water bars or berms are also planned for the south side of the diversion channel where necessary to convey runoff from the NWRP access road and the area north of the NWRP and east of the ephemeral drainage into the diversion channel. The operator will also begin construction of the energy dissipation basin and road crossing at the lower end of the diversion channel. During the inspection, the operator indicated they are reconsidering the road crossing design which currently calls for installing a Geoweb-lined, concrete-filled, low-flow road crossing. The operator is considering whether installation of a larger sized Geoweb system (6 inches depth rather than the 4 inches depth installed in the diversion channel) filled with gravel rather than concrete may be more appropriate for the road crossing.
