**MINERALS PROGRAM INSPECTION REPORT**  
**PHONE: (303) 866-3567**

<b>MINE NAME:</b> Indio Red Quarry Number 1 & 2	<b>MINE/PROSPECTING ID#:</b> M-1999-062	<b>MINERAL:</b> Sandstone (silica, st quartzite)	<b>COUNTY:</b> Larimer
<b>INSPECTION TYPE:</b> Monitoring	<b>INSPECTOR(S):</b> Robert Zuber, P.E.	<b>INSP. DATE:</b> September 22, 2020	<b>INSP. TIME:</b> 11:45
<b>OPERATOR:</b> Hector Rodriguez	<b>OPERATOR REPRESENTATIVE:</b> Raul Vasquez	<b>TYPE OF OPERATION:</b> 110c - Construction Limited Impact

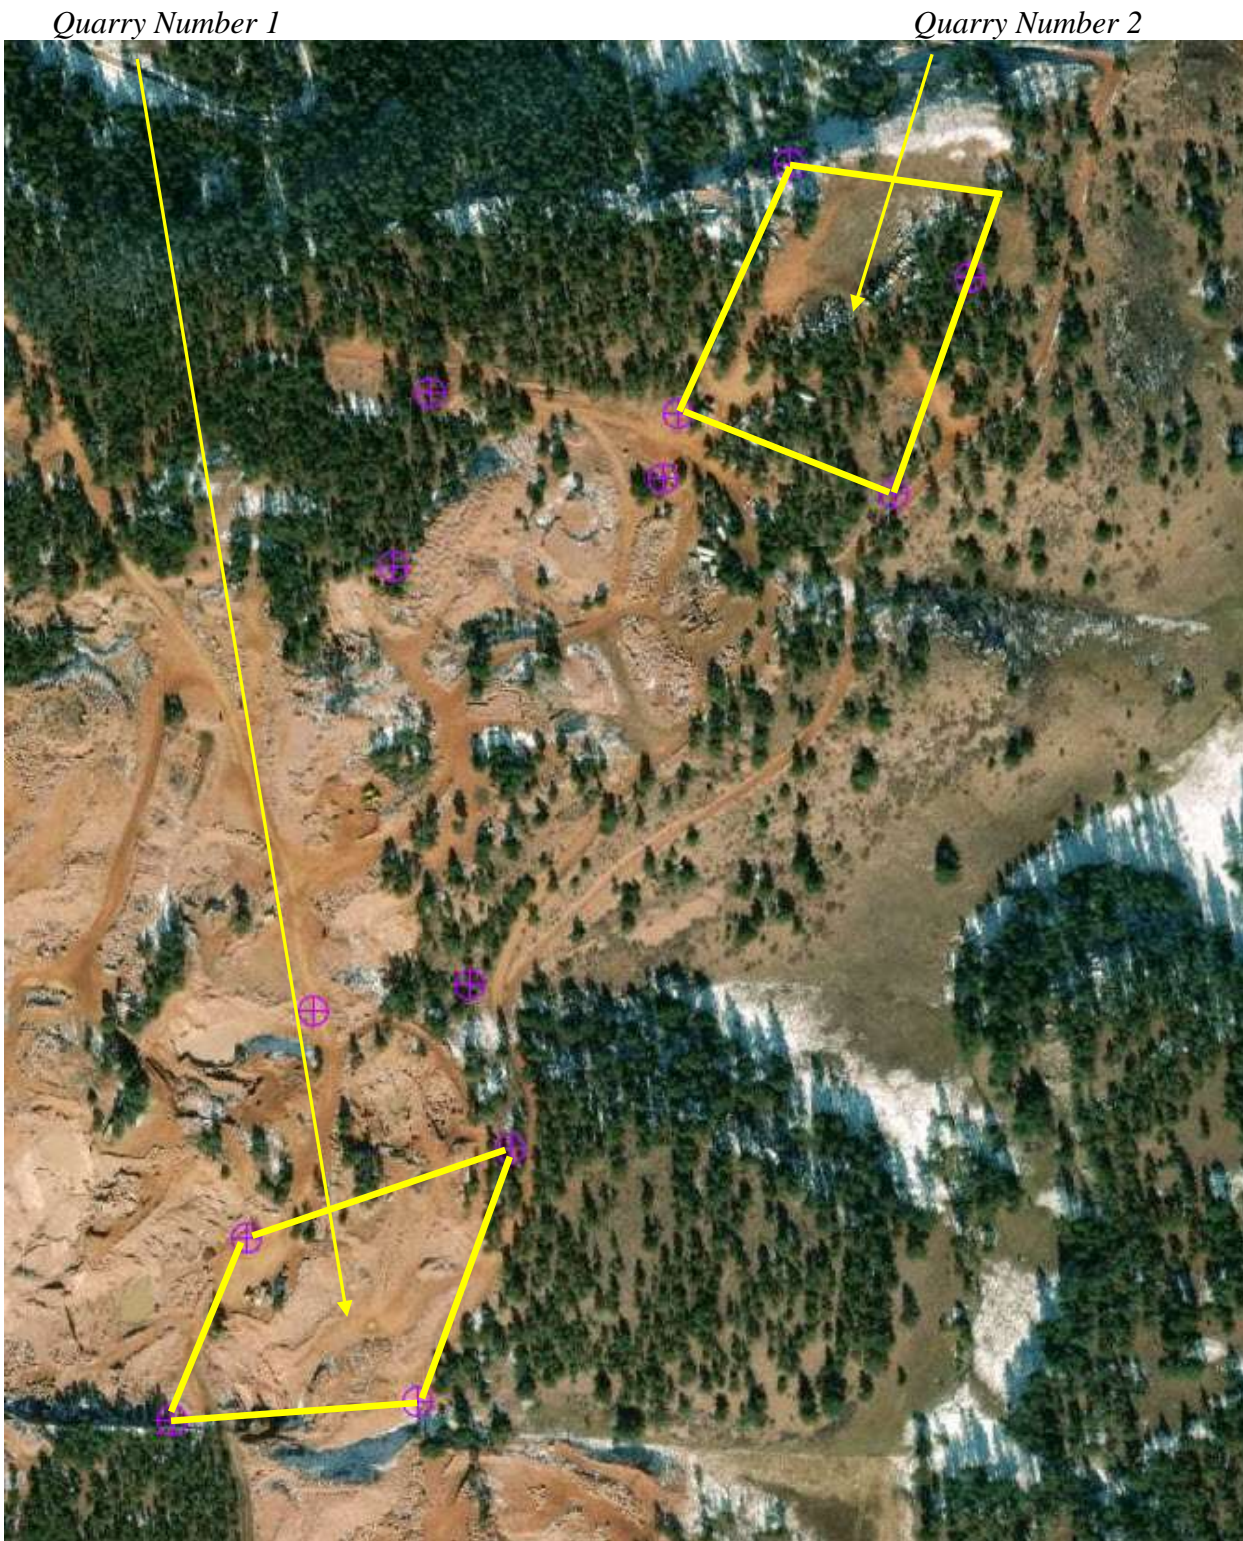
**Figure 1. Boundary of Indio Red Quarries Number 1 and 2 per Markers on the Ground**

**PROBLEM/POSSIBLE VIOLATION:** Problem: The affected area boundary markers are incorrectly placed. This is a problem for failure to maintain boundary markers around the affected area as required by Section 3.1.12(2) of the rule.

Permit boundary markers were found at the corners of the two areas that make up the site, and these were checked using GPS and by comparing to the boundary outline in the site plan from the permit application. There appears to be one or more issues with the marking of the boundary. The shapes of the areas based on the on-the-ground markers are different than the shapes in the site plan. Also, the dimensions may be off. For example at Quarry Number 2, the south side is about 350 feet long per Google Earth, but the site plan indicates that it should be 445 feet.

**CORRECTIVE ACTIONS:** The operator shall conduct a survey and replace the boundary markers in the correct location(s). The operator shall provide proof to the Division that this has been done by the corrective action date.

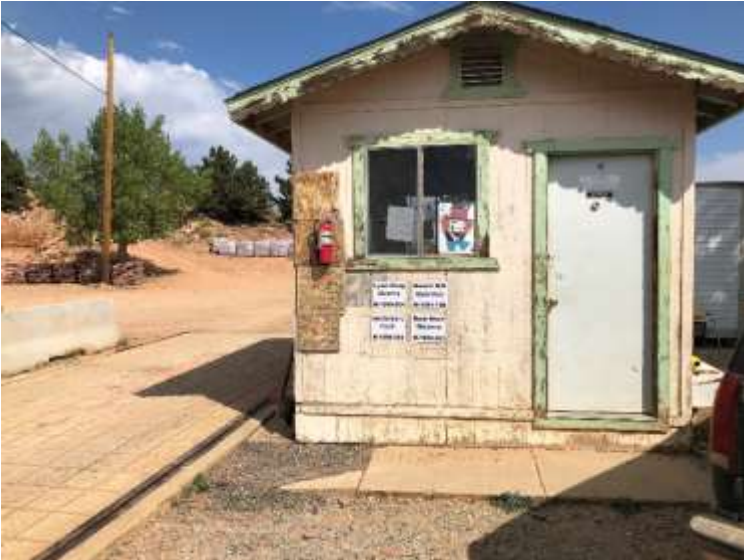
**PROBLEM/POSSIBLE VIOLATION:** Problem: The mine identification sign at the entrance of the mine site did not contain all of the necessary information. This is a problem for failure to post an adequate mine identification sign as required by Section 3.1.12(1) of the rule. The Operator shall, at the entrance of the mine site post a sign, which shall be clearly visible from the access road, with a minimum size equaling one hundred and eighty-seven (187) square inches, such as eleven (11) inches in height and seventeen (17) inches in width, with appropriate font size, with the following: the name of the Operator, a statement that a reclamation permit for the operation has been issued by the Colorado Mined Land Reclamation Board; and the permit number.

The mine entrance sign was seen at the scale house, near the south end of the permit boundary. It contained the quarry name and DRMS permit number. It did not list the name of the operator or mention DRMS. This information should be added to the sign.

**Entrance sign for Indio Red Quarry #1 and #2  
(and signs for other permits)**

**CORRECTIVE ACTIONS:** The operator shall, at the entrance of the mine site, post a sign which shall be clearly visible from the access road with the following: the name of the operator, a statement that a reclamation permit for the operation has been issued by the Colorado Mined Land Reclamation Board; and the permit number. The operator shall submit photo documentation that a proper sign has been posted by the corrective

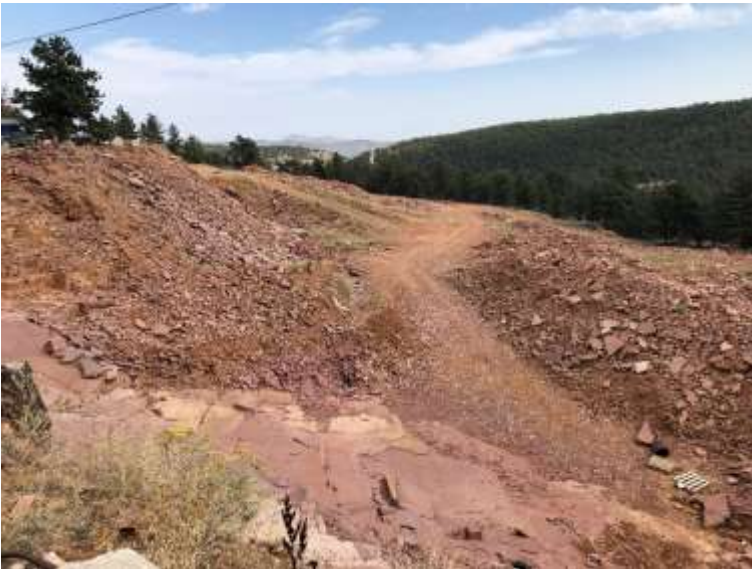
The primary quarry to be reclaimed, at the south end of Quarry Number 1, is approximately 0.8 acre, as measured with Google Earth. In the field it was measured to be approximately 250 feet by 220 feet (estimated with a Rangefinder), which is 1.3 acres. The Division is using the lower number (0.8 acre) for the reclamation cost estimate, as it is likely more accurate. The average depth was estimated to be eight feet. Mr. Vasquez indicated that no more mining will be done at this quarry, and he said that rubble from the Red Wolf Quarry will be used to fill it.

**Large quarry to be reclaimed on Quarry Number 1 site**

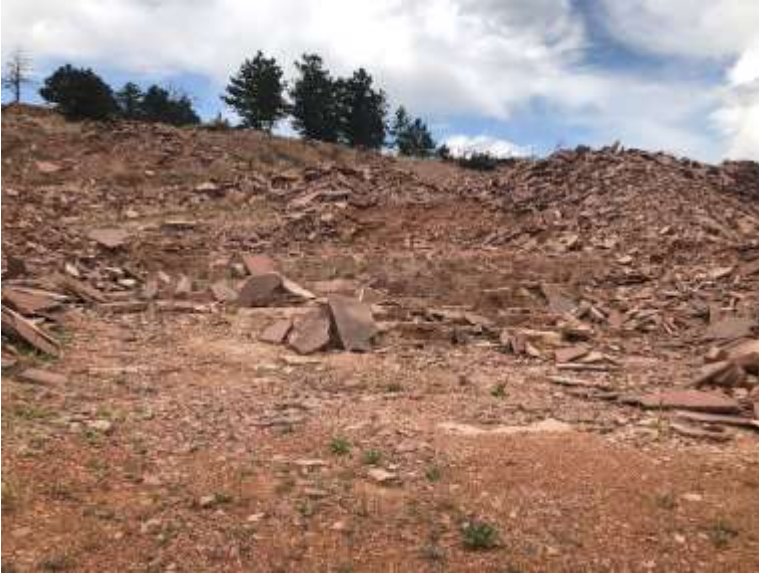
A smaller quarry north of the large one will also be reclaimed. It is approximately 70 feet by 50 feet (0.08 acre) and seven feet deep (average). Using Google Earth, the Division confirmed that this area is an accurate estimate.

**Small quarry to be reclaimed on Quarry Number 1 site**

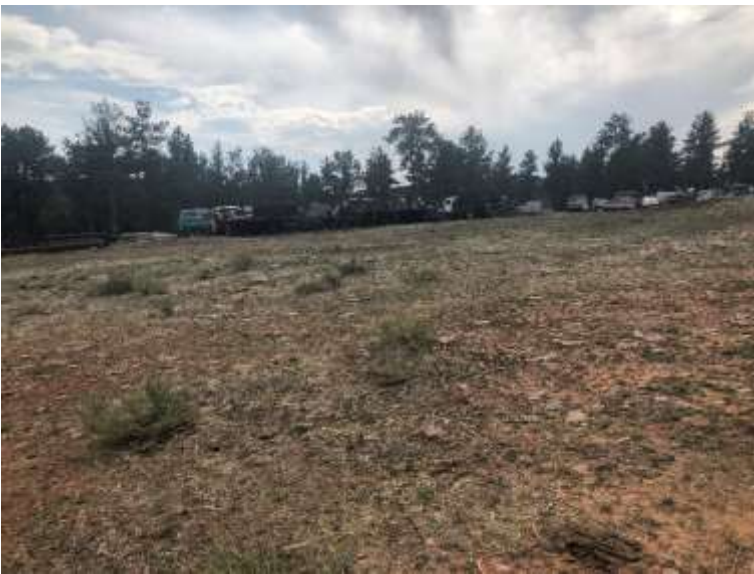
At the north side of Quarry Number 2, the reclaimed area contains many small buildings, storage of vehicles, and storage of other equipment/material. Also, the reclaimed area has scarce vegetation due to grazing of cattle. Many mullein plants were seen in the area around the reclaimed area.

**Reclaimed area on Quarry Number 2**
