MINERALS PROGRAM INSPECTION REPORT
PHONE: (303) 866-3567

MINE NAME: Clapper Sand Pit	MINE/PROSPECTING ID#: M-2015-010	MINERAL: Gravel and sand	COUNTY: Kit Carson
INSPECTION TYPE: Monitoring	INSPECTOR(S): Elliott Russell	INSP. DATE: September 4, 2020	INSP. TIME: 14:30
OPERATOR: Castle Rock Construction Company of Colorado, LLC	OPERATOR REPRESENTATIVE: Matt Fonte	TYPE OF OPERATION: 111 - Construction for Government Agency	
REASON FOR INSPECTION: Normal I&E Program	BOND CALCULATION TYPE: None	BOND AMOUNT: \$70,000.00	
DATE OF COMPLAINT: NA	POST INSP. CONTACTS: None	JOINT INSP. AGENCY: None	
WEATHER: Clear	INSPECTOR'S SIGNATURE:

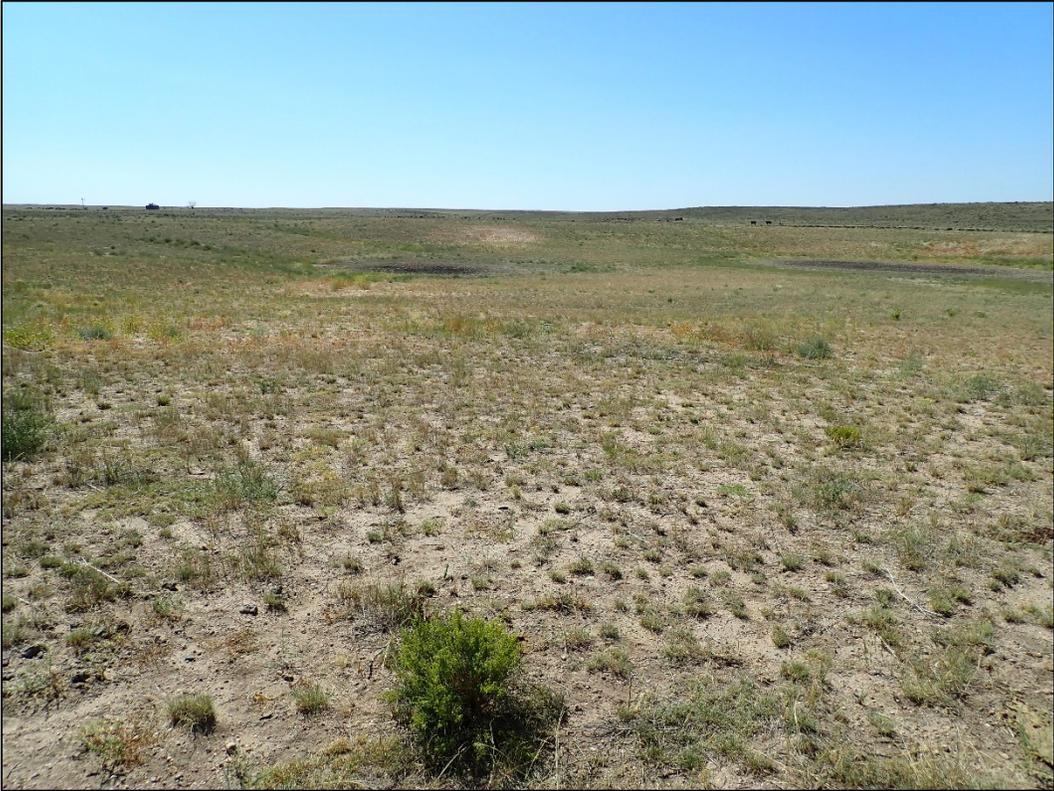
Photo 1. Site overview; looking southwest.

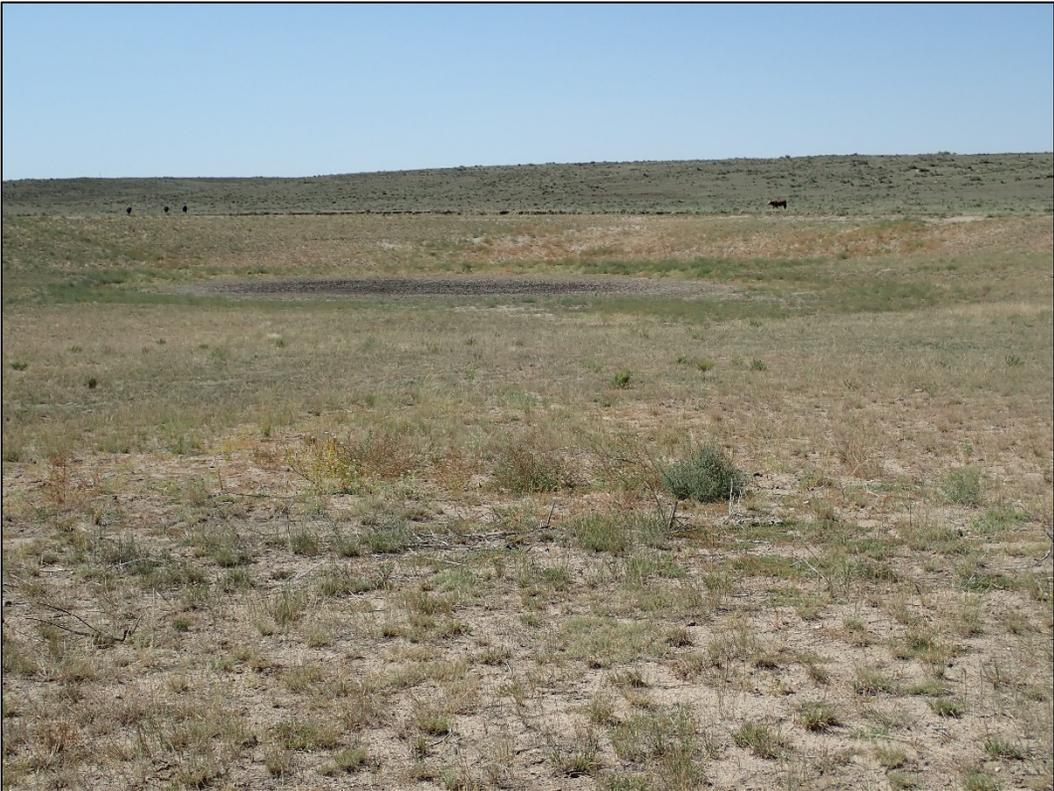
Photo 2. Sample photo of the reclaimed affected lands; looking west.

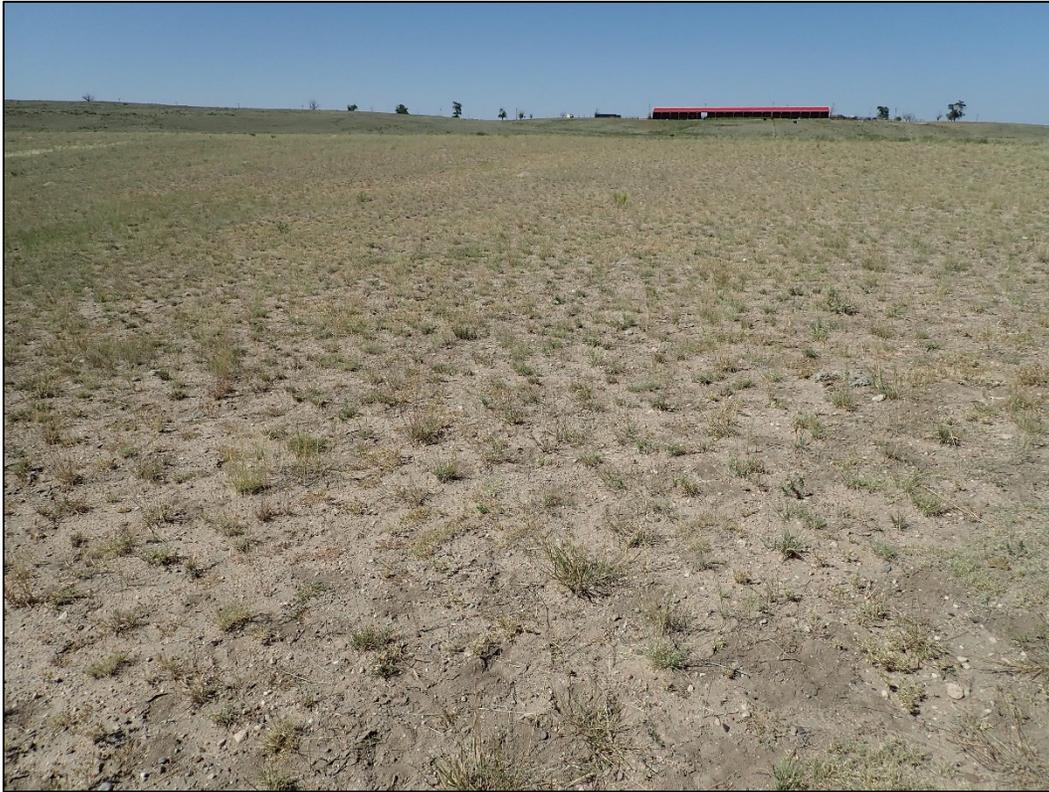
Photo 3. Sample photo of the reclaimed affected lands; looking northwest.

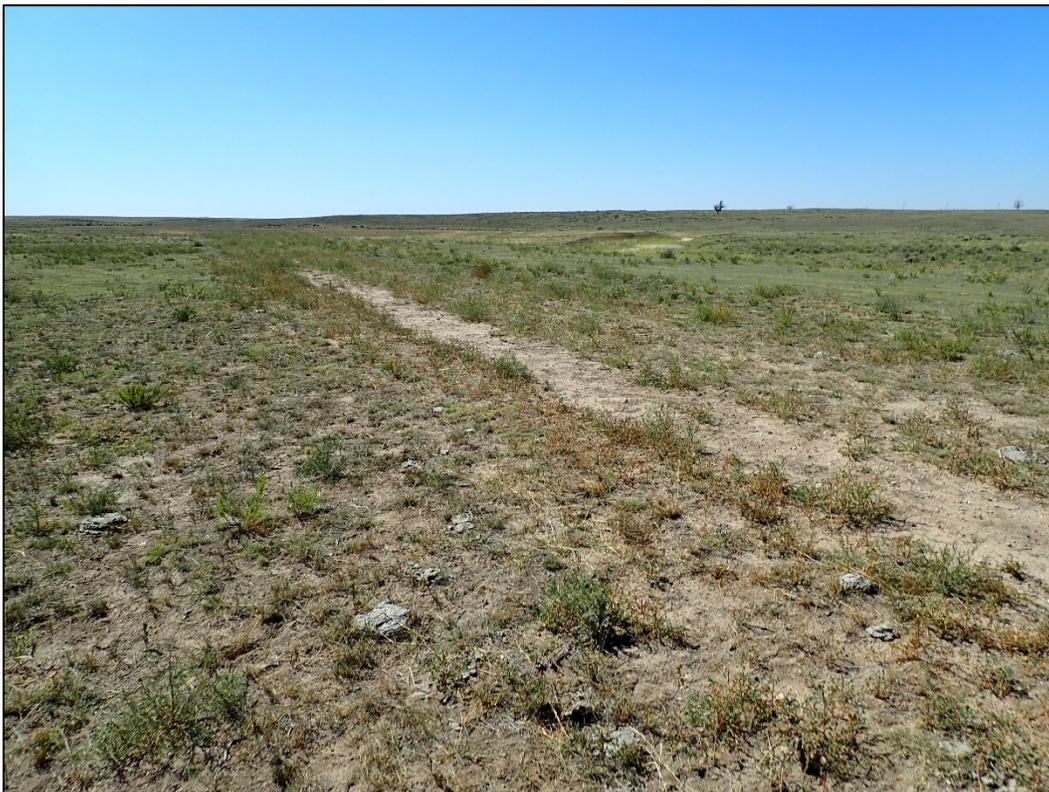
Photo 4. Sample photo of the reclaimed access road; looking southwest.

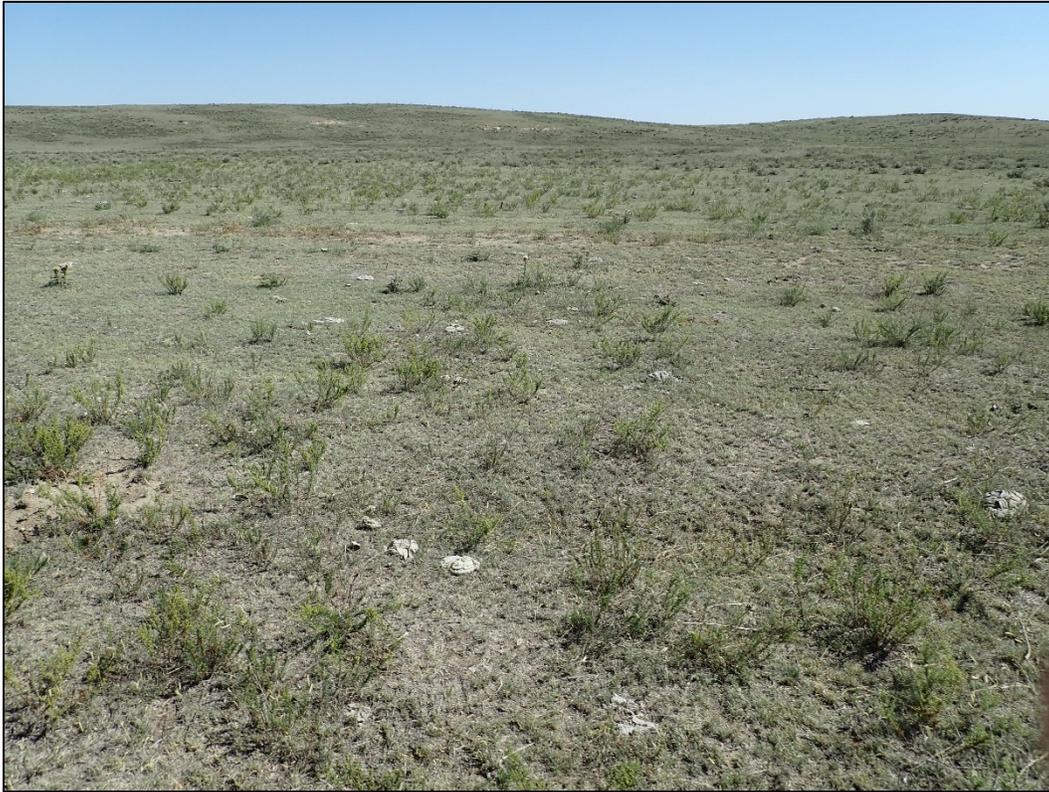
Photo 5. Sample photo of adjacent undisturbed lands; looking east.
