MINERALS PROGRAM INSPECTION REPORT
PHONE: (303) 866-3567

MINE NAME: Rueb Borrow Pit	MINE/PROSPECTING ID#: M-2015-011	MINERAL: Borrow material	COUNTY: Kit Carson
INSPECTION TYPE: Monitoring	INSPECTOR(S): Elliott Russell	INSP. DATE: September 4, 2020	INSP. TIME: 15:00
OPERATOR: Castle Rock Construction Company of Colorado, LLC	OPERATOR REPRESENTATIVE: Matt Fonte	TYPE OF OPERATION: 111 - Construction by Government Agency	
REASON FOR INSPECTION: Normal I&E Program	BOND CALCULATION TYPE: None	BOND AMOUNT: \$25,000.00	
DATE OF COMPLAINT: NA	POST INSP. CONTACTS: None	JOINT INSP. AGENCY: None	
WEATHER: Clear	INSPECTOR'S SIGNATURE:

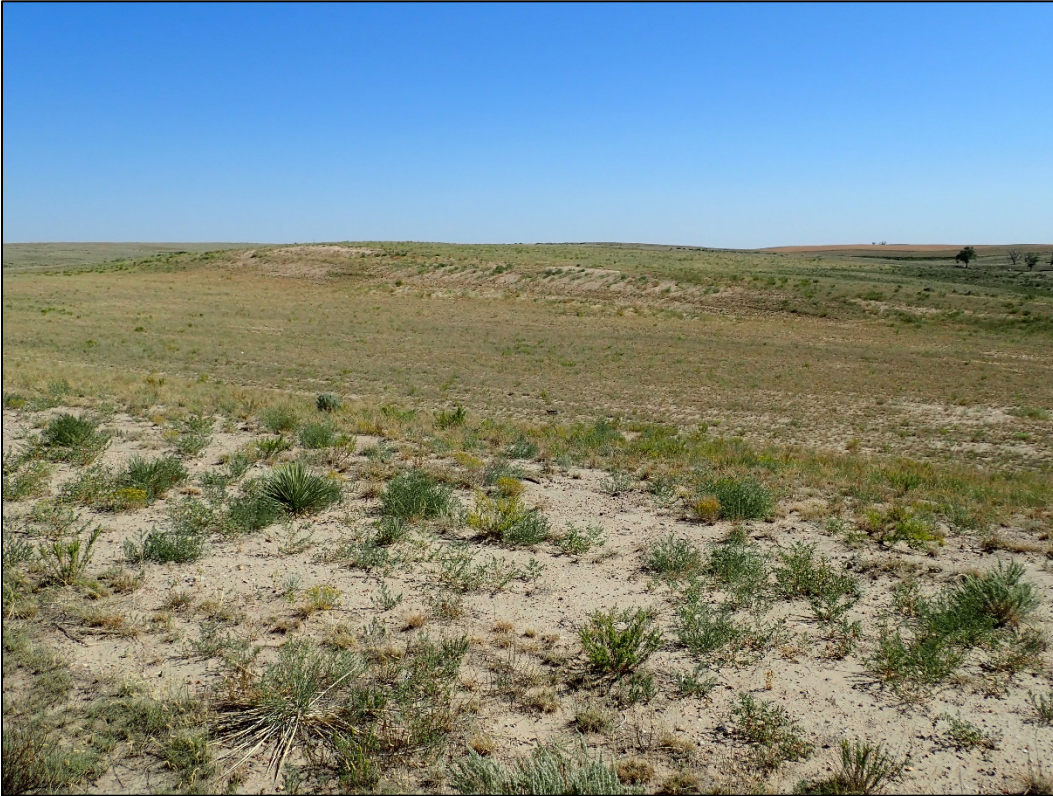
Photo 1. Site overview; looking southeast.

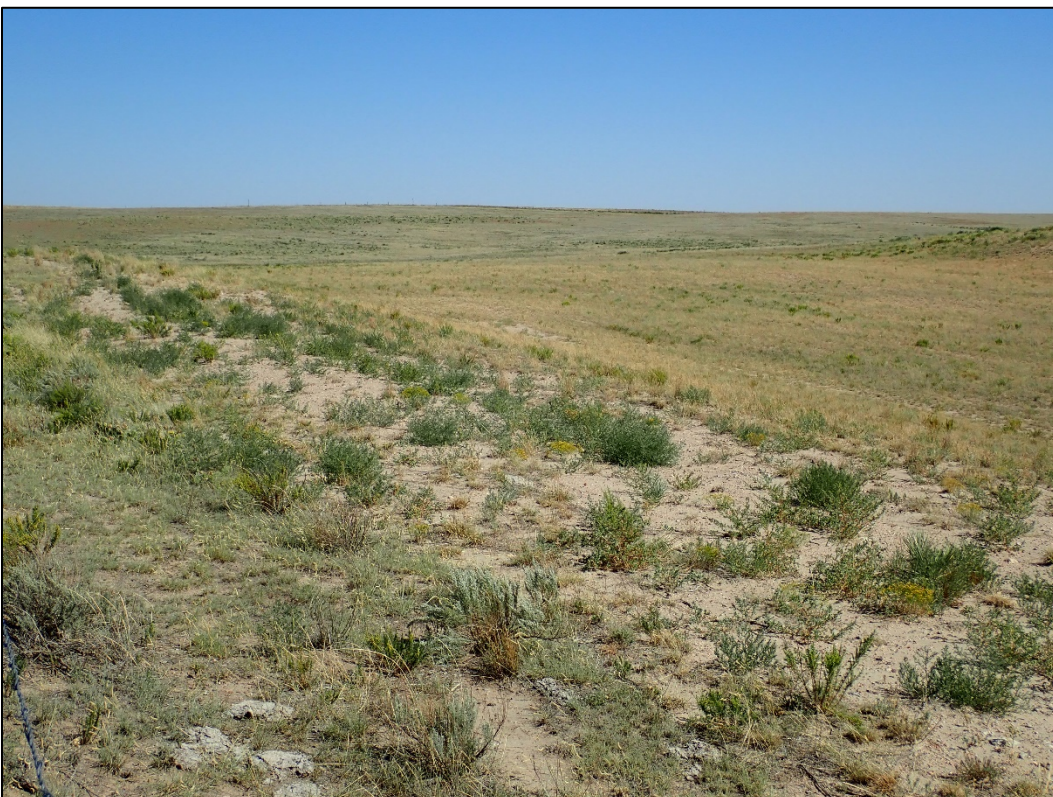
Revegetation: The affected lands were vegetated with a diverse stand of mature grass species. Vegetative cover appeared to match adjacent off-site areas. No noxious weed infestations were observed. The Division observed blue grama, sideoats grama, purple three awn, buffalo grass, and small amounts of annual weeds.

Photo 2. Sample photo of the reclaimed affected lands; looking southeast.

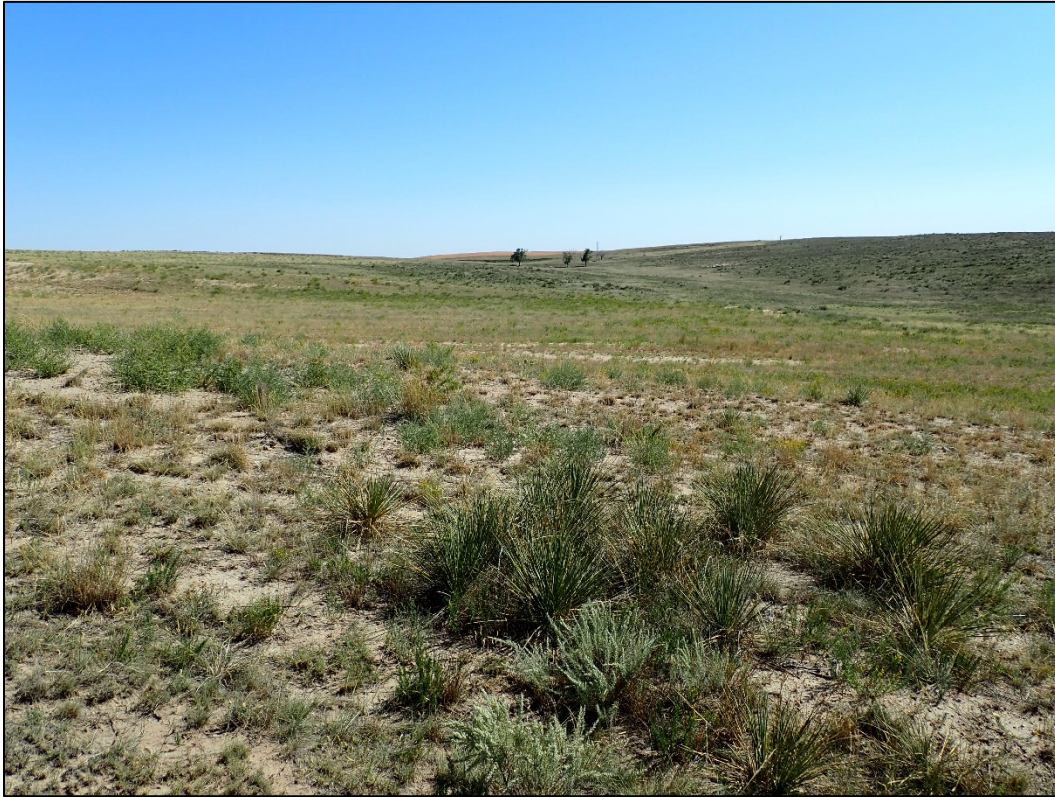
Photo 3. Sample photo of the reclaimed affected lands; looking south.
