**COLORADO**Division of Reclamation,
Mining and Safety

MINERALS PROGRAM INSPECTION REPORT**PHONE: (303) 866-3567**

MINE NAME: The Orr Pit	MINE/PROSPECTING ID#: M-2009-074	MINERAL: Sand, gravel and bor for construction	COUNTY: Pueblo
INSPECTION TYPE: Preoperation Inspection	INSPECTOR(S): Elliott R. Russell	INSP. DATE: October 23, 2017	INSP. TIME: 15:20
OPERATOR: Colorado Backhoe Service	OPERATOR REPRESENTATIVE: None	TYPE OF OPERATION: 110c - Construction Limited Impact	
REASON FOR INSPECTION: Pre-operation Inspection	BOND CALCULATION TYPE: Complete Bond	BOND AMOUNT: \$37,602.00	
DATE OF COMPLAINT: NA	POST INSP. CONTACTS: None	JOINT INSP. AGENCY: None	
WEATHER: Clear	INSPECTOR'S SIGNATURE:

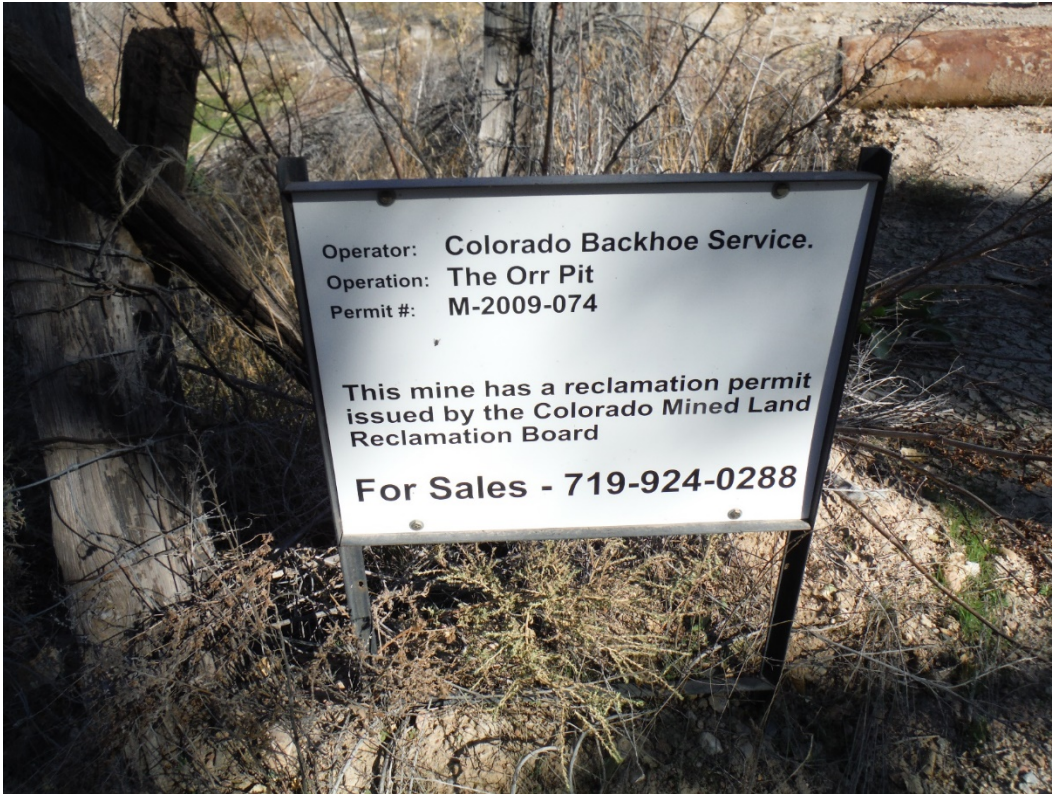
Photo 1. Mine identification sign; looking northeast.

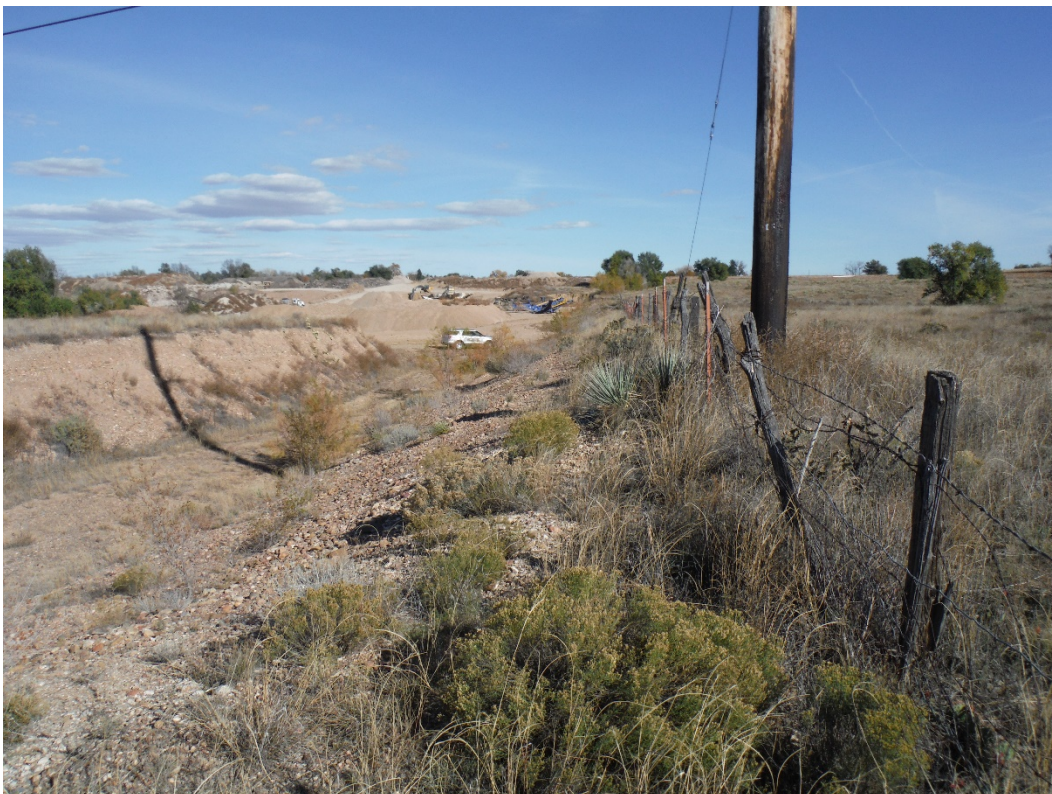
Photo 2. Southern permit boundary; looking east near the southwest permit boundary corner.

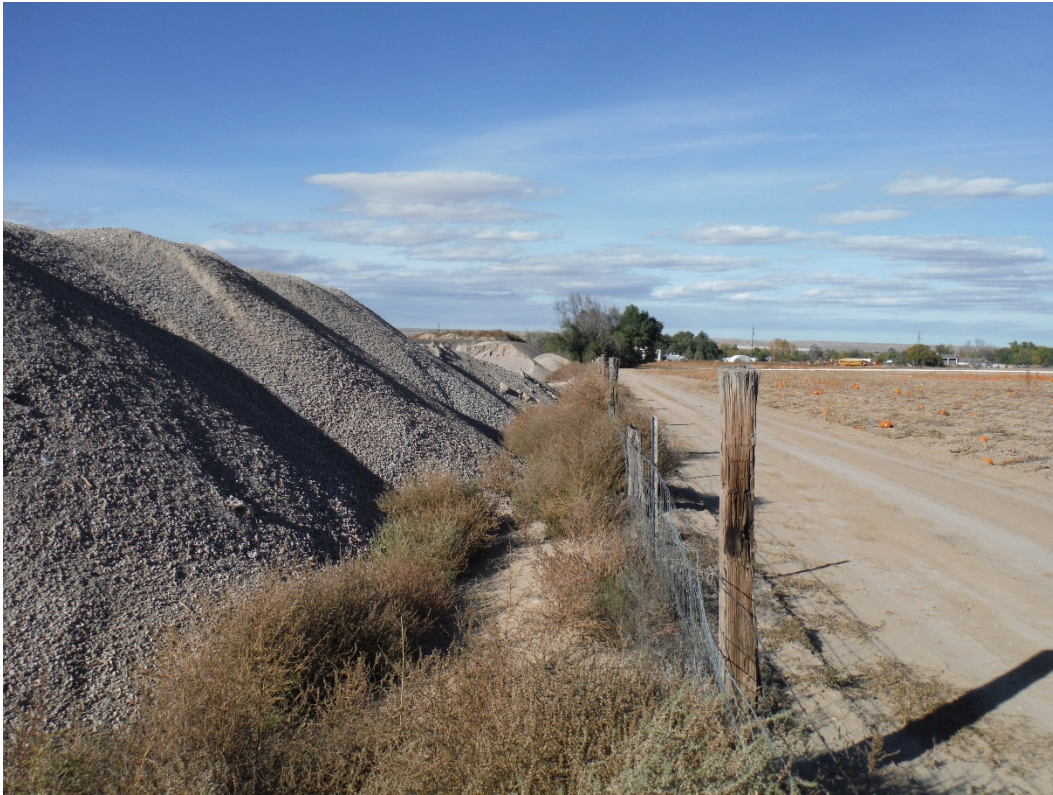
Photo 3. CN-01 proposed eastern permit boundary, southern portion; looking north.

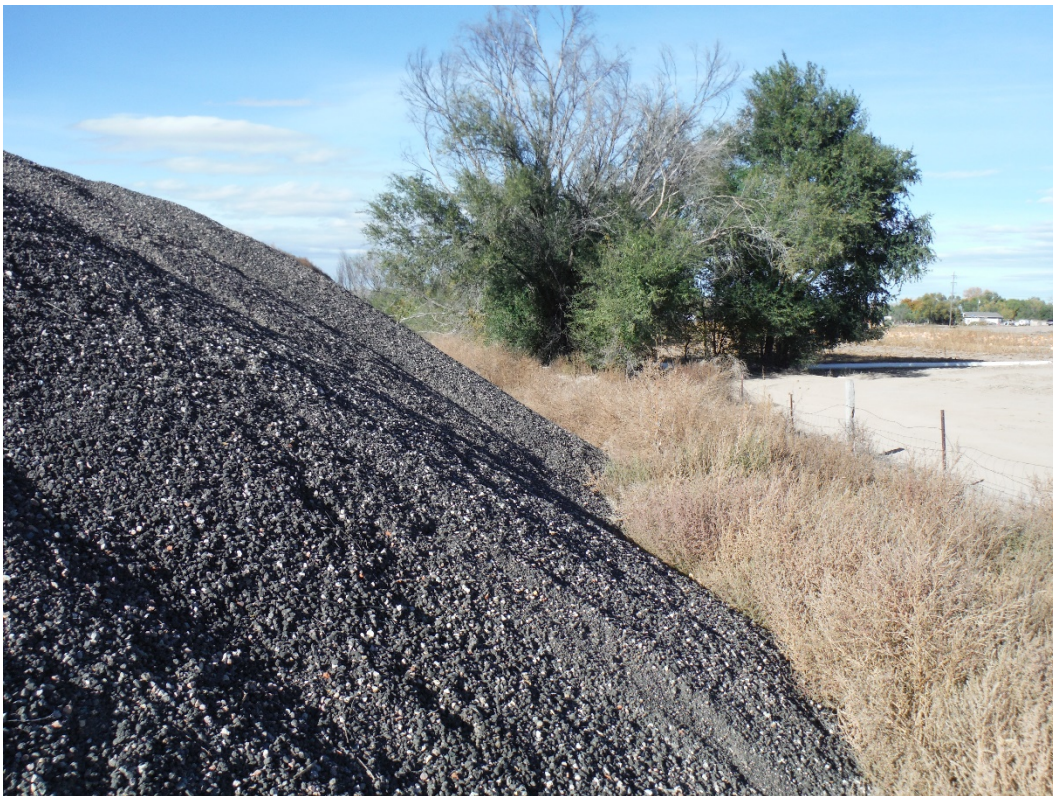
Photo 4. CN-01 proposed eastern permit boundary, northern portion; looking north.
