MINERALS PROGRAM INSPECTION REPORT

MINE NAME: Beeman Pit #1	MINE/PROSPECTING ID#: M-2002-009	MINERAL: Sand, gravel, borrow	COUNTY: Pueblo
INSPECTION TYPE: Monitoring	INSPECTOR(S): Elliott R. Russell	INSP. DATE: May 23, 2018	INSP. TIME: 11:30
OPERATOR: Martin Marietta Materials, Inc.	OPERATOR REPRESENTATIVE: Rusty Cochran and Julie Mikulas	TYPE OF OPERATION: 112c - Construction Regular Operation	
REASON FOR INSPECTION: Normal I&E Program	BOND CALCULATION TYPE: Partial Bond	BOND AMOUNT: \$62,335.00	
DATE OF COMPLAINT: NA	POST INSP. CONTACTS: None	JOINT INSP. AGENCY: None	
WEATHER: Clear	INSPECTOR'S SIGNATURE:

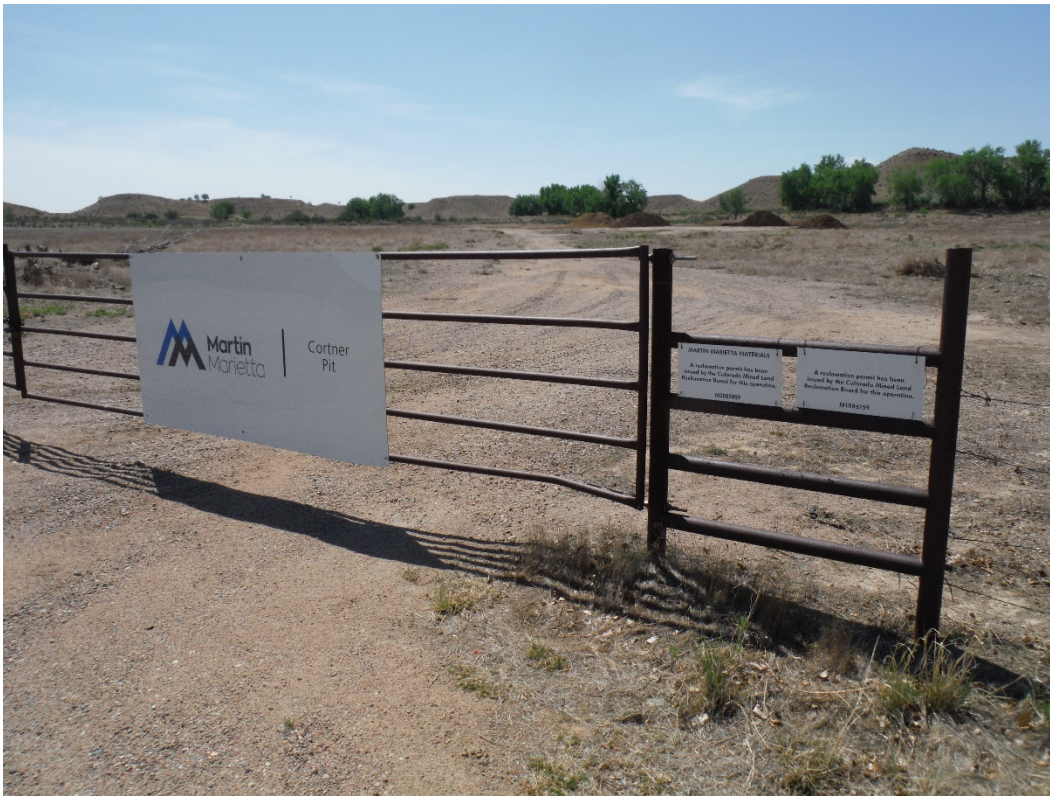
The Division met Mr. Cochran and Mrs. Mikulas at the mine site entrance on the south side of Cortner Road, approximately 1.5 miles east of 27th Lane/Doyle Road. The mine site identification sign was posted at the entrance and was in compliance with Rule 3.1.12(1).

Photo 1. Mine identification sign along Cortner Road; looking southeast.

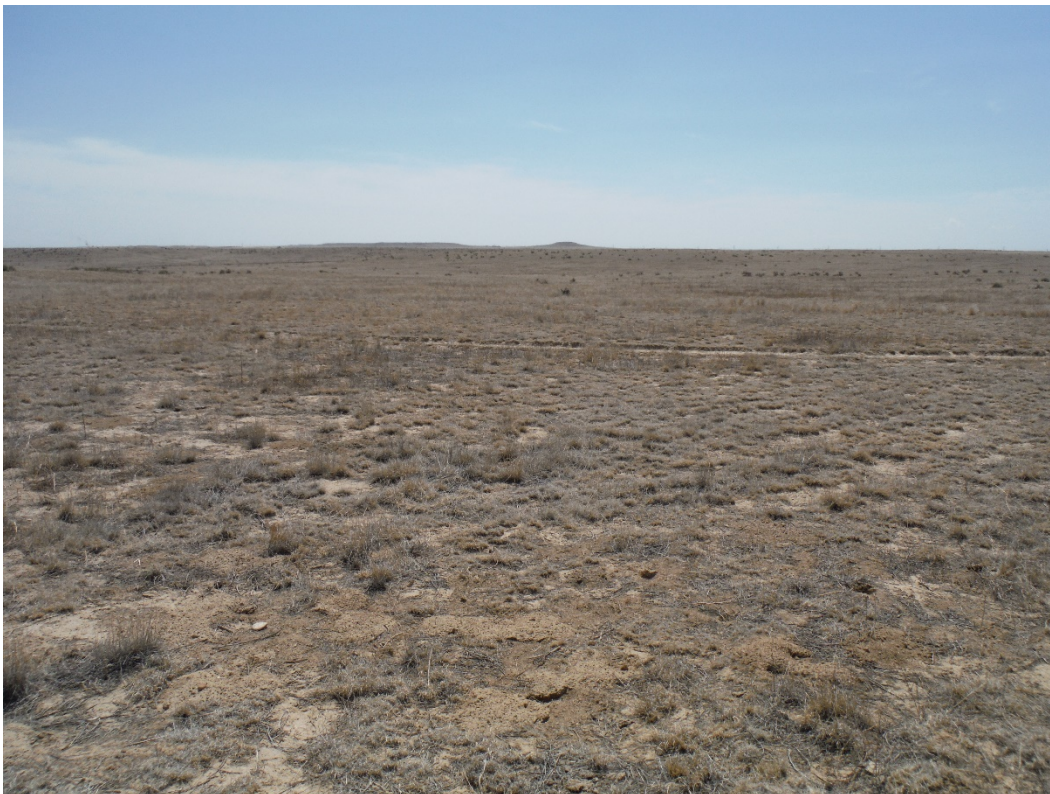
Photo 2. Western permit area; looking southeast.

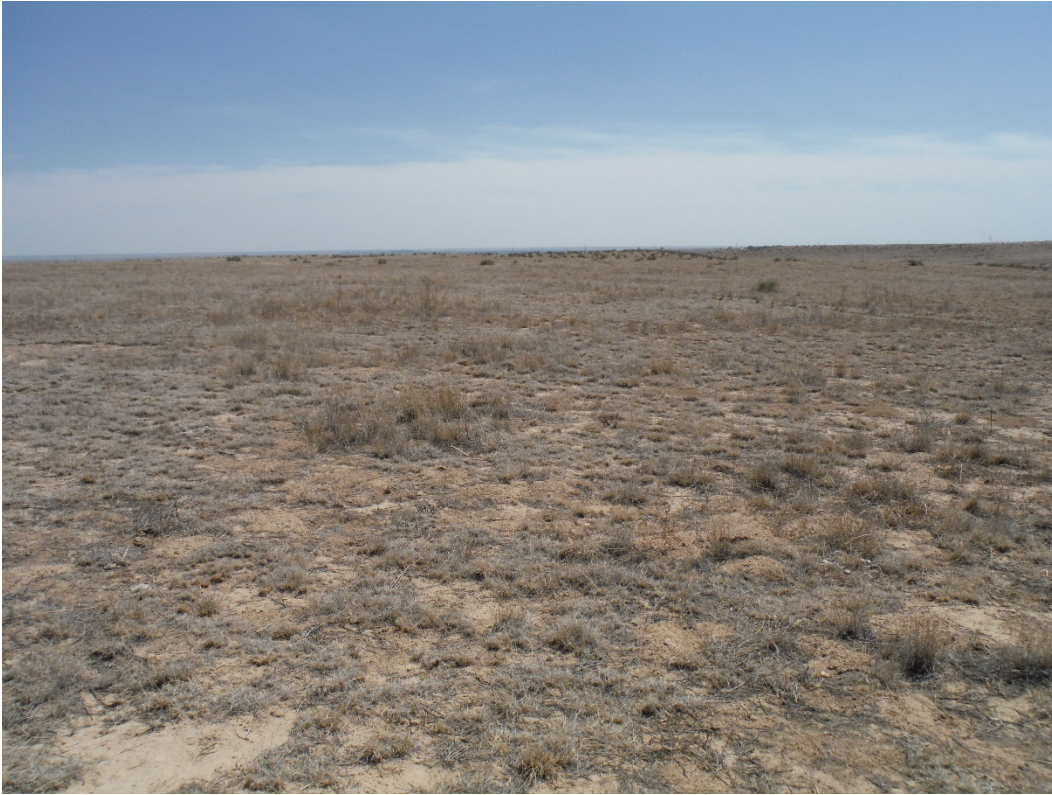
Photo 3. Western permit area; looking east.

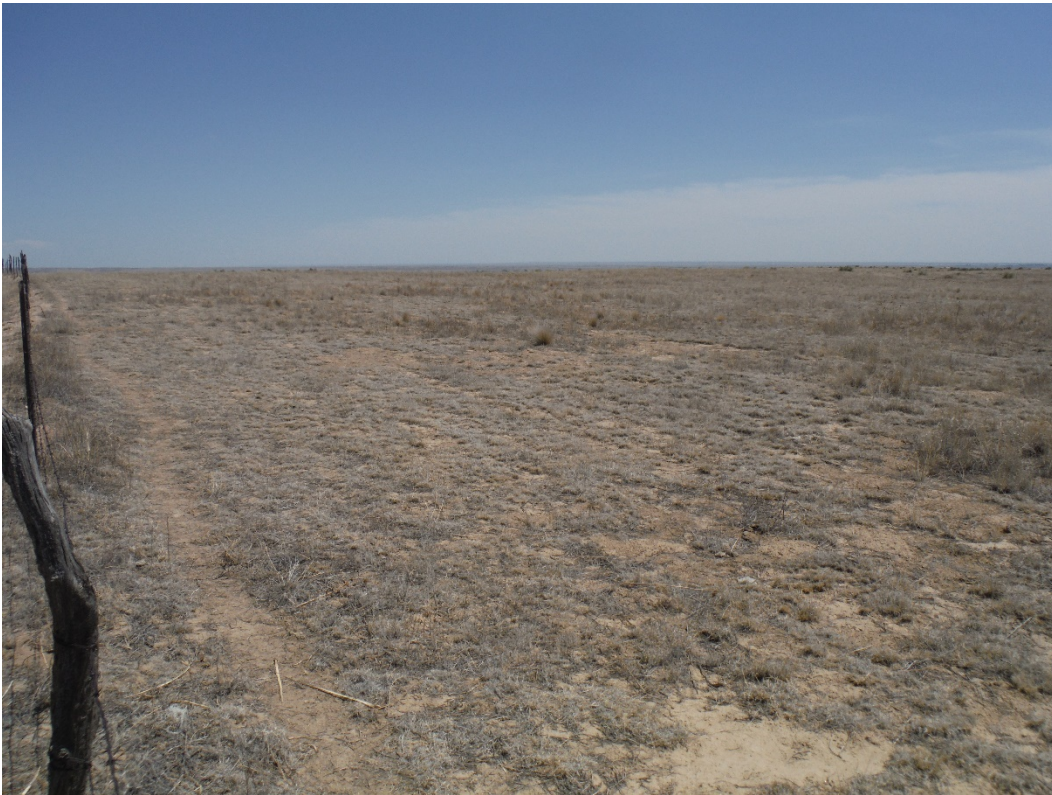
Photo 4. Western permit area; looking northeast.
