MINERALS PROGRAM INSPECTION REPORT
PHONE: (303) 866-3567

MINE NAME: Cortner Pit	MINE/PROSPECTING ID#: M-1986-159	MINERAL: Sand and gravel	COUNTY: Pueblo
INSPECTION TYPE: Monitoring	INSPECTOR(S): Elliott R. Russell	INSP. DATE: May 23, 2018	INSP. TIME: 11:00
OPERATOR: Martin Marietta Materials, Inc.	OPERATOR REPRESENTATIVE: Rusty Cochran and Julie Mikulas	TYPE OF OPERATION: 112c - Construction Regular Operation

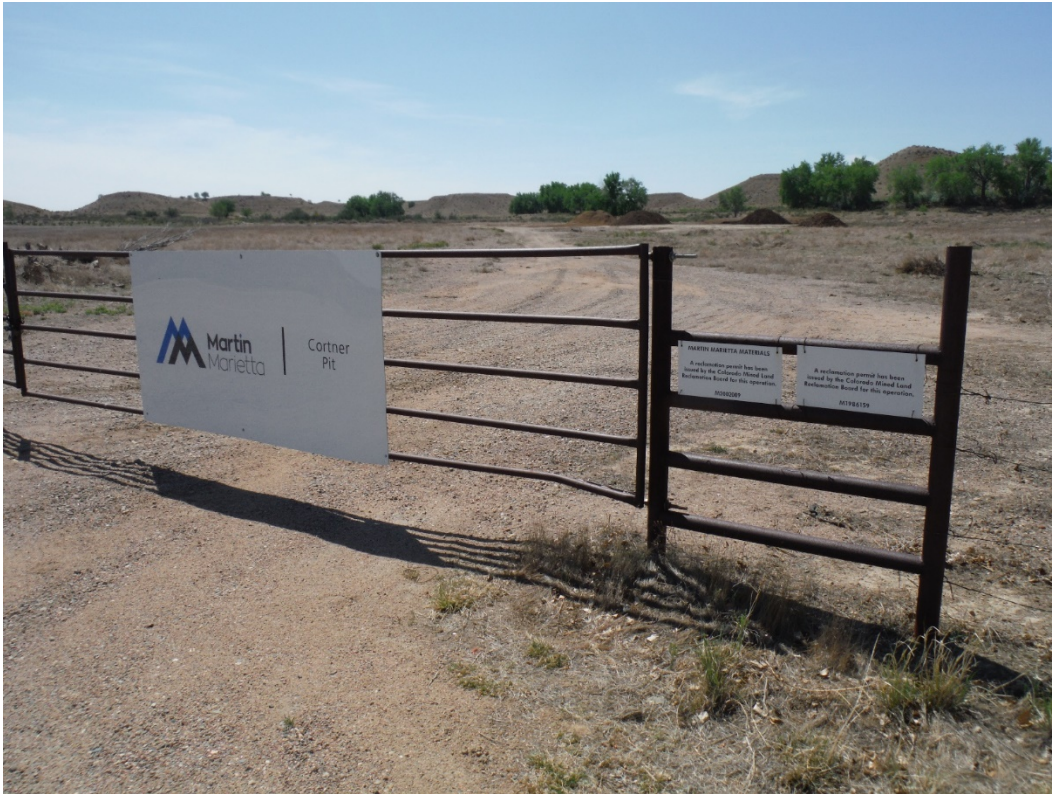
The Division met Mr. Cochran and Mrs. Mikulas at the mine site entrance on the south side of Cortner Road, approximately 1.5 miles east of 27th Lane/Doyle Road. The mine site identification sign was posted at the entrance and was in compliance with Rule 3.1.12(1).

Photo 1. Mine identification sign along Cortner Road; looking southeast.

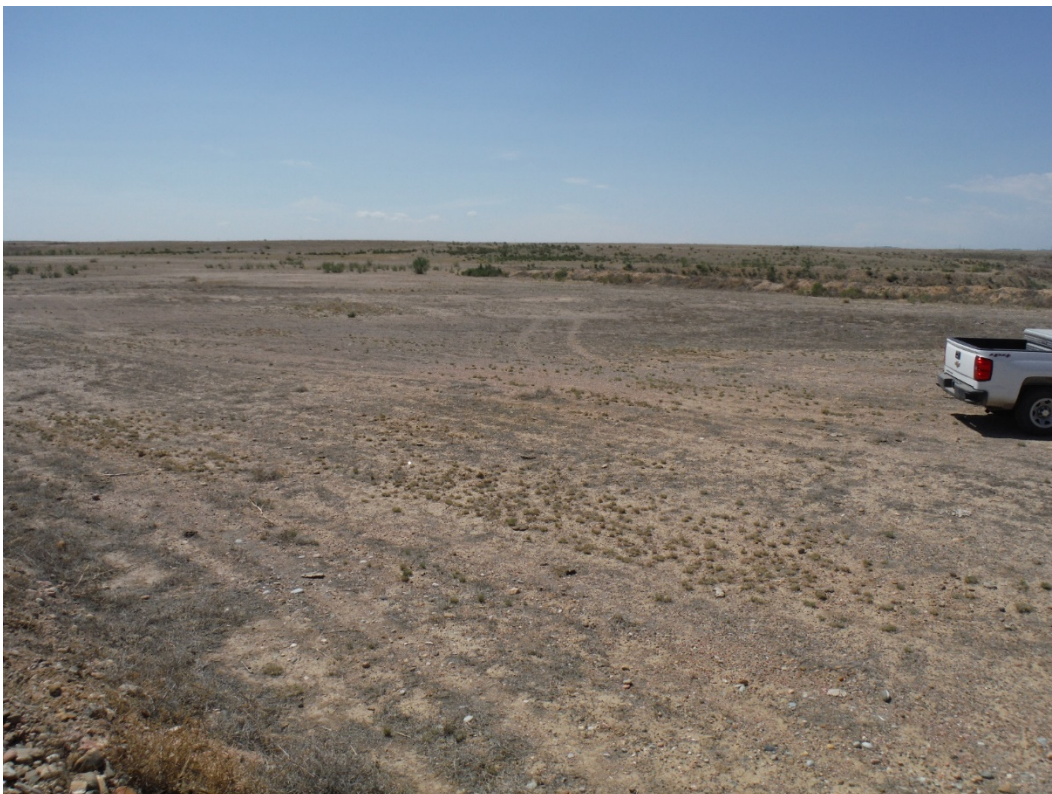
Mining operations have been completed at the site and the site is in final reclamation. The site consist of two mined-out areas, one on the northern portion of the permit and the other in the central portion of the permit. There is also another area south of the central pit which wasn't mined. The northern mined-out area is approximately 30 acres in size and daylights to the north. The central mined out-area is an excavated pit, approximately 14 acres in size. Reclaimed slopes appeared stable and no erosion control measures are needed at this time. Revegetation efforts have had varying amounts of success. The reclaimed slopes of the northern mining area (southern and eastern sides) as well as the majority of the central mining area have started to become reestablished with grass and shrubs. However, the large flat area of the northern mined out area is barren and revegetation efforts have largely failed so far. The Operator will need to re-seed this area and will likely need to incorporate organics and/or fertilizers into the soil to improve the soil conditions.

Photo 2. Example of barren area of the northern mining area which will need to be reseeded; looking south.

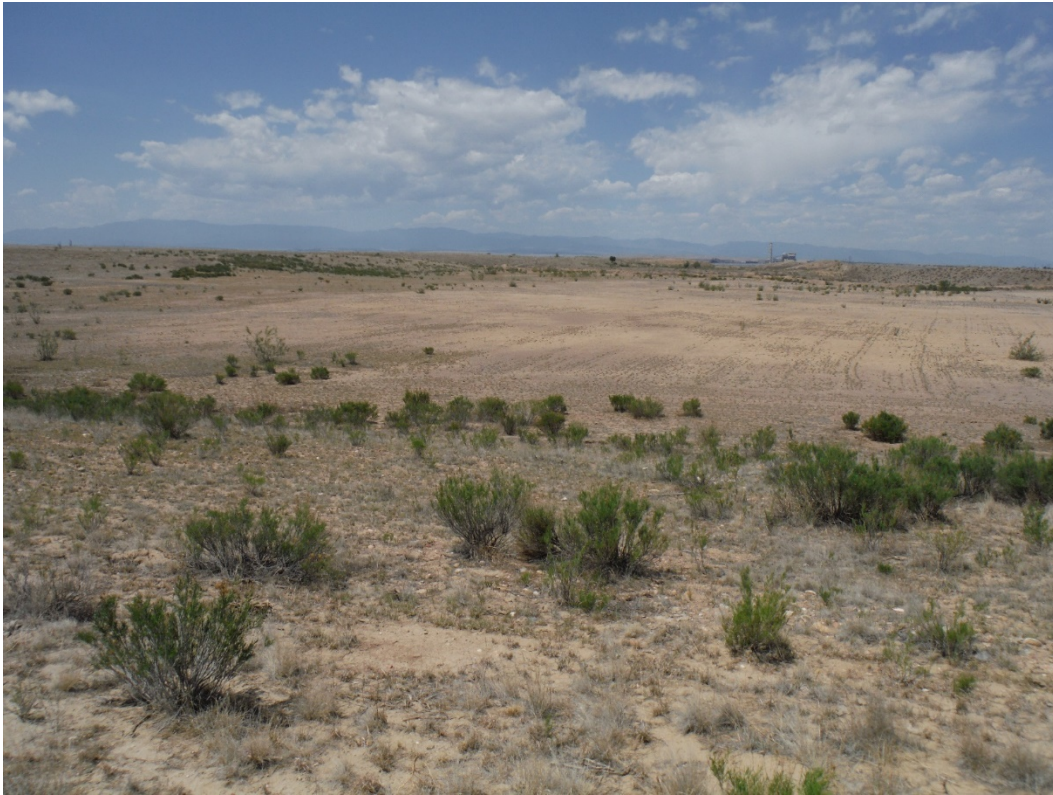
Photo 3. Reclaimed slope on south side of the northern mining area; looking northwest.

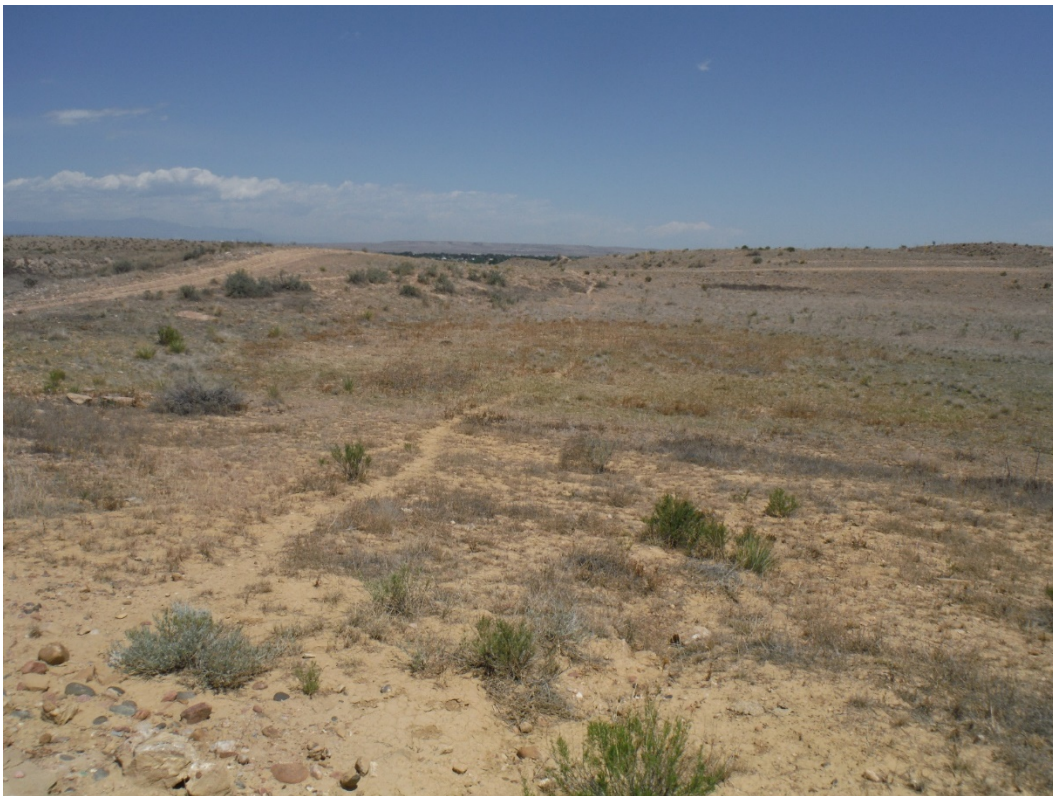
Photo 4. Western half of the central mining area; looking north.

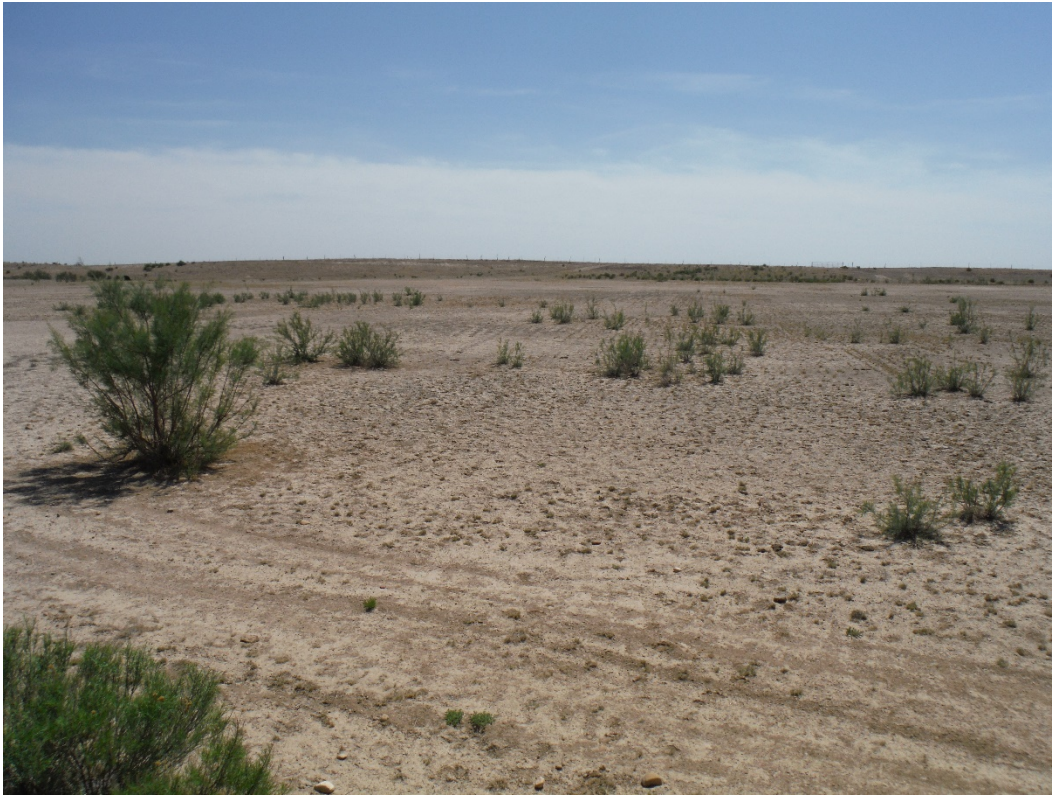
Photo 5. Small tamarisk trees starting to re-establish which will need to be treated; looking east.

Tamarisk (salt cedar) has been cited as a compliance problem at the site in the past. The Operator implemented the weed control plan and removed the tamarisk in 2013. The Operator will now need to treat and/or remove the small tamarisk trees which are starting to re-establish again to ensure this listed noxious weed prevents a future release request once the site has been revegetated.
