**MINERALS PROGRAM INSPECTION REPORT**  
**PHONE: (303) 866-3567**

<b>MINE NAME:</b> Edmundson Clay Mine	<b>MINE/PROSPECTING ID#:</b> M-1985-203	<b>MINERAL:</b> Clay (general)	<b>COUNTY:</b> Pueblo
<b>INSPECTION TYPE:</b> Monitoring	<b>INSPECTOR(S):</b> Elliott R. Russell	<b>INSP. DATE:</b> October 24, 2017	<b>INSP. TIME:</b> 13:10
<b>OPERATOR:</b> Summit Brick & Tile Co.	<b>OPERATOR REPRESENTATIVE:</b> Matt Welte	<b>TYPE OF OPERATION:</b> 110c - Construction Limited Impact	
<b>REASON FOR INSPECTION:</b> Normal I&E Program	<b>BOND CALCULATION TYPE:</b> Complete Bond	<b>BOND AMOUNT:</b> \$19,350.00	
<b>DATE OF COMPLAINT:</b> NA	<b>POST INSP. CONTACTS:</b> None	<b>JOINT INSP. AGENCY:</b> None	
<b>WEATHER:</b> Clear	<b>INSPECTOR'S SIGNATURE:</b>

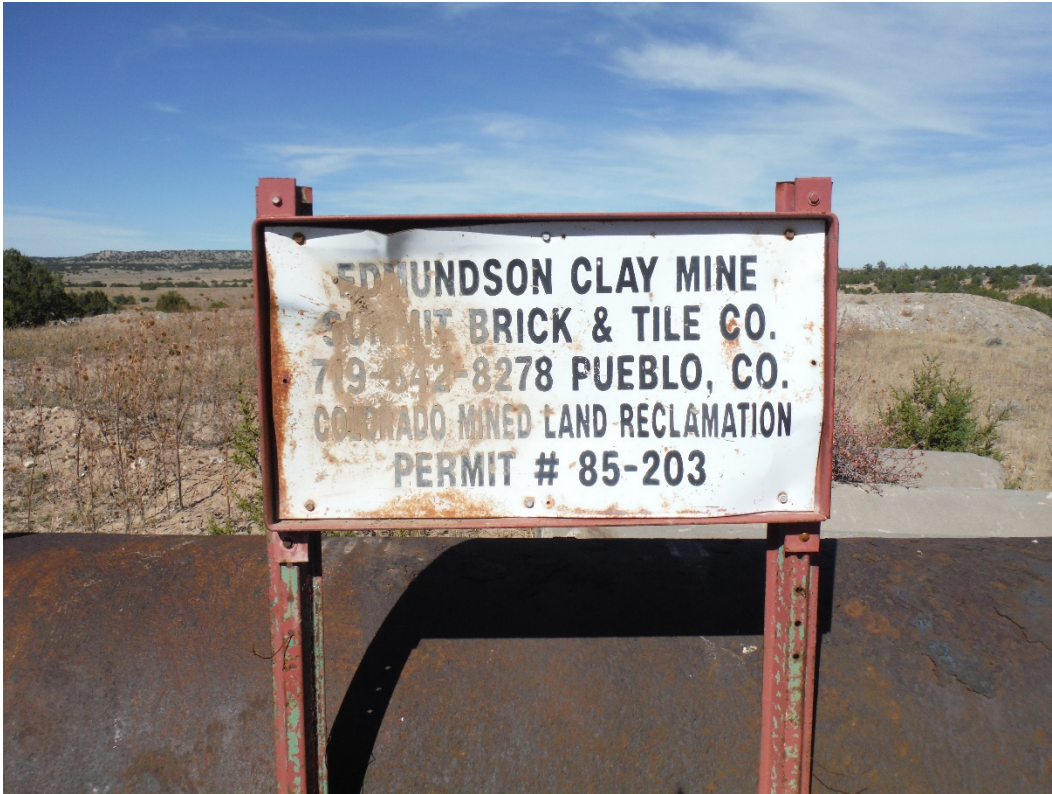
The Division met Matt Welte at the intersection of Colorado Highway 10 and Huerfano CR 120 and traveled 19.5 miles north to the remote mine site. The mine site identification sign was posted at the site and was in compliance with Rule 3.1.12(1). One front-end loader was on site at the time of the inspection. The site was not active, but the Division observed evidence of recent activity. The Operator stated this clay mine is campaign mined ever few years. When enough clay is stockpiled, mining stops and then the Operator occasionally hauls material to Pueblo when the material is needed in their brick plant.

**Photo 1.** Mine identification; looking north.

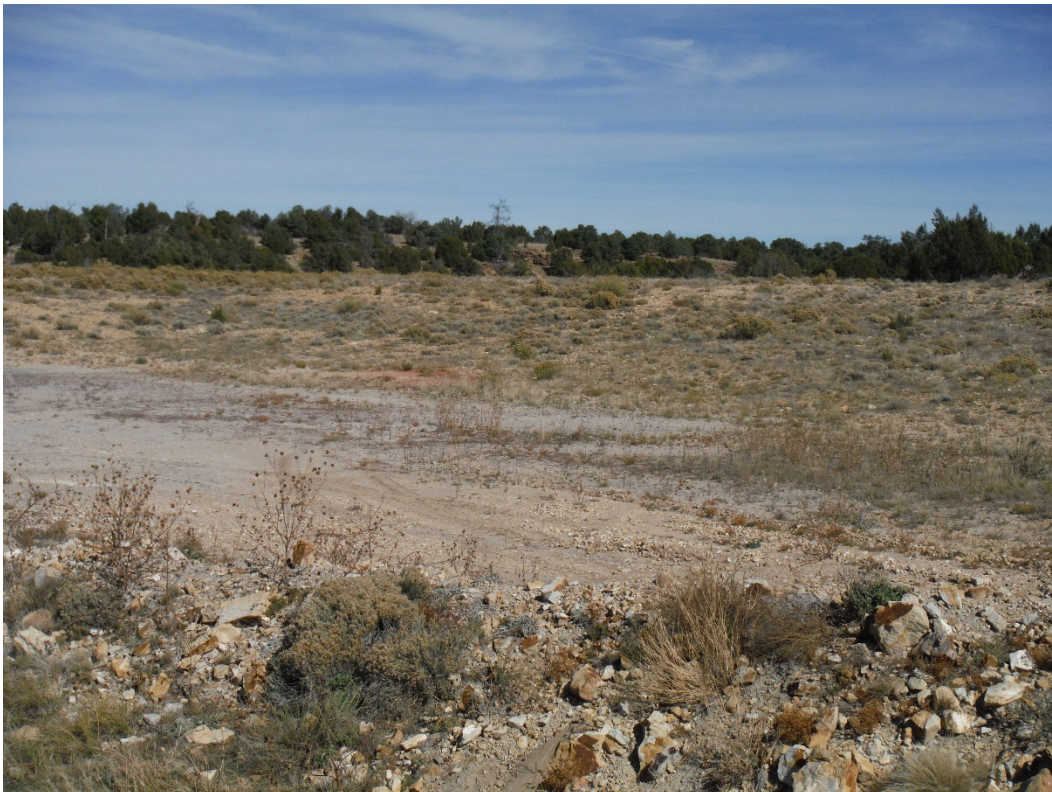
**Photo 2.** Eastern portion of the mine site; looking northeast.

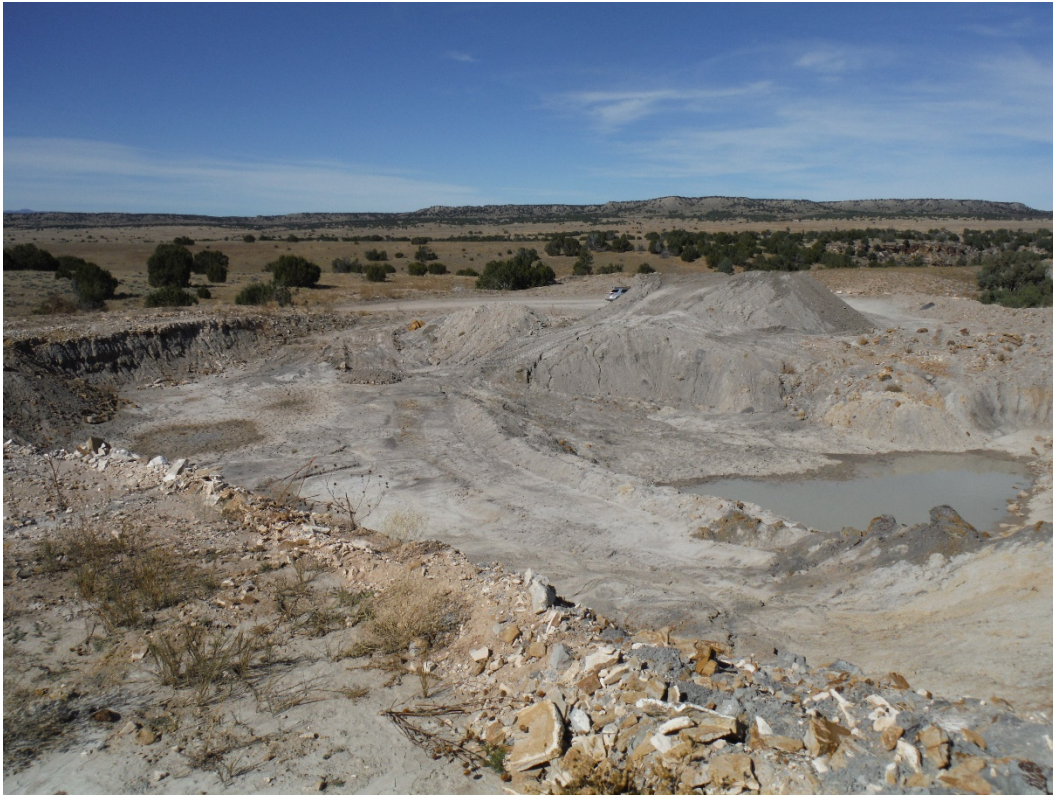
The site consists of two mining areas which are separated by a small drainage. The eastern half has been mined and mostly reclaimed. The northern portion of the western half has been partially reclaimed and the southern portion is where the active pit is located. The pit is approximately 15-20 feet deep. A small amount of storm water was ponded in the lowest area of the pit. A clay stockpile is located just north of the pit. Topsoil is stockpiled in various locations around the site. One topsoil stockpile is located south of the eastern reclaimed area and is approximately signed as such to ensure it isn't used as backfill or product.

**Photo 3.** Pit overview; looking northwest.

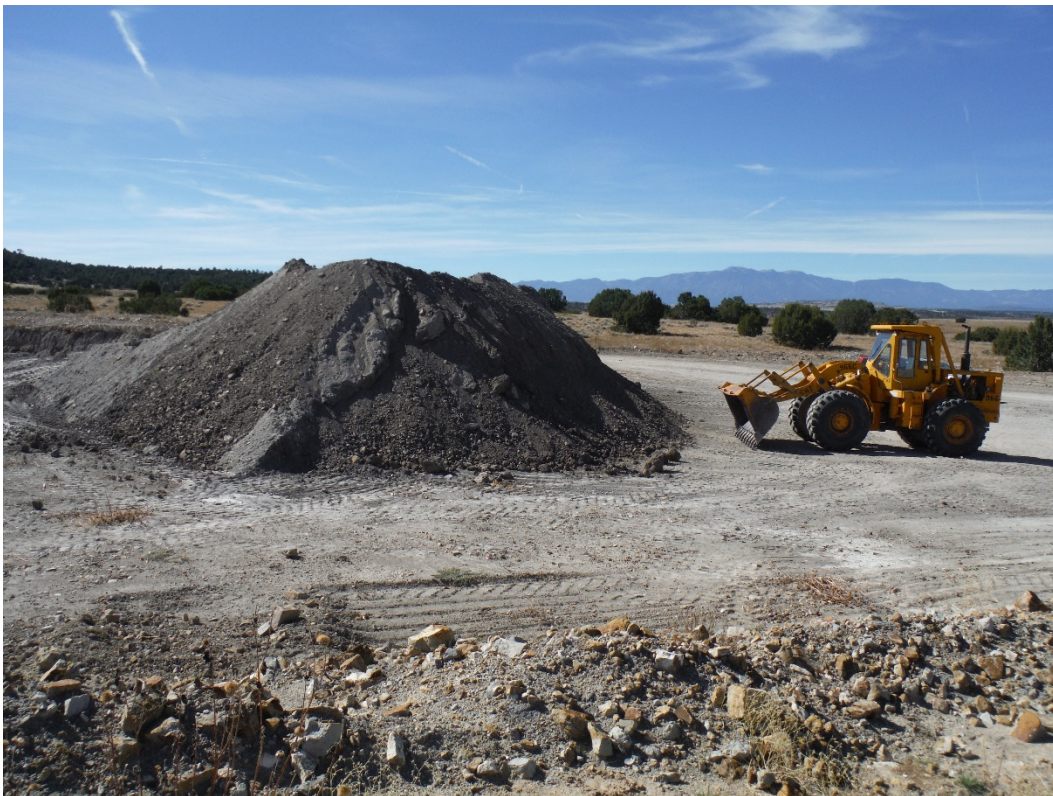
**Photo 4.** Clay topsoil; looking west.

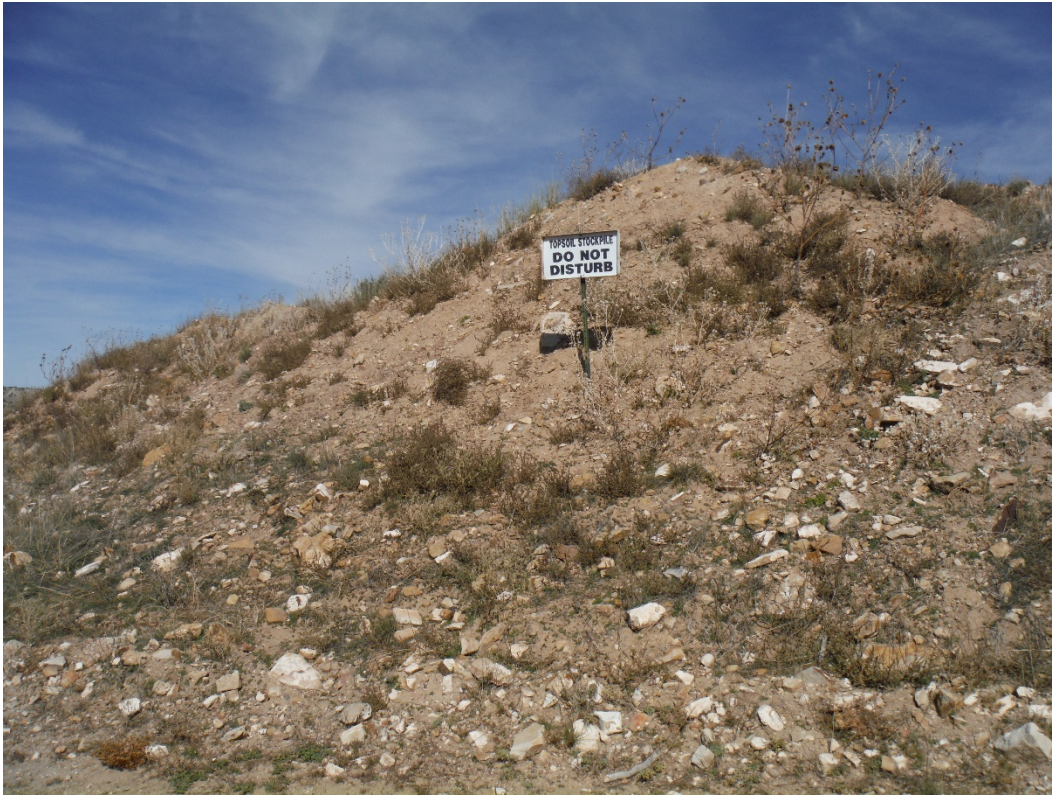
**Photo 5.** Topsoil stockpile located in the eastern portion of the site; looking northeast.
