## MINE SITE INSPECTION NARRATIVE

COMPANY: MINEREC, Inc.

MINE: North Thompson Creek

DATE OF INSPECTION: September 15, 2020

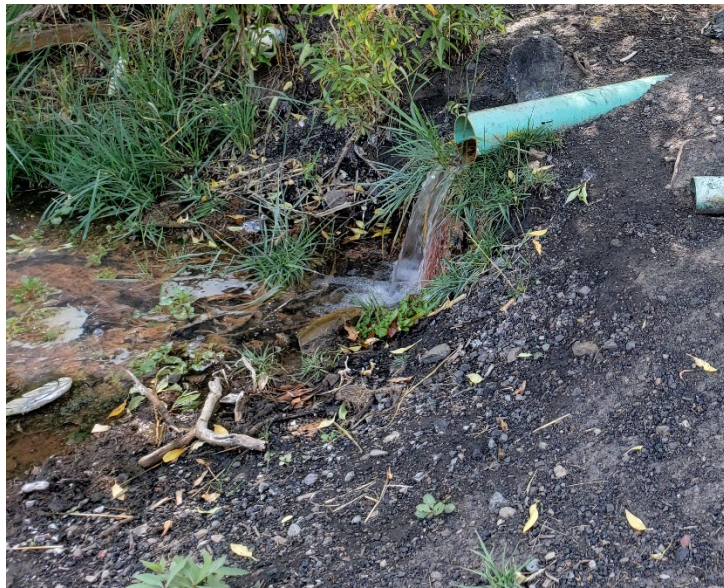
Figure 1 - Portal Discharge at a normal flow rate at the time of inspection.

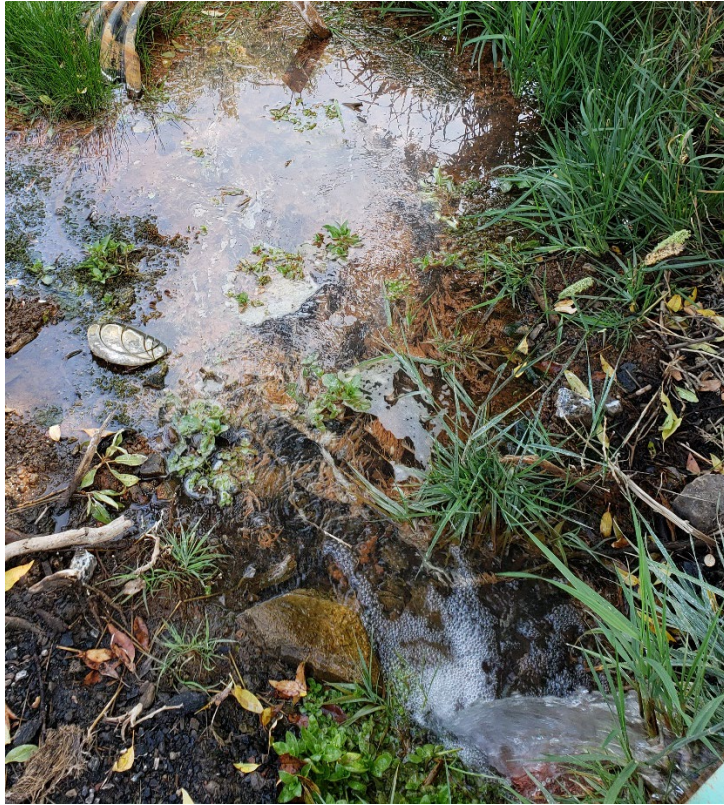
Figure 2 - Portal Discharge precipitate; only seen a few feet further than the pipe and not seen in any other ditch or pond.

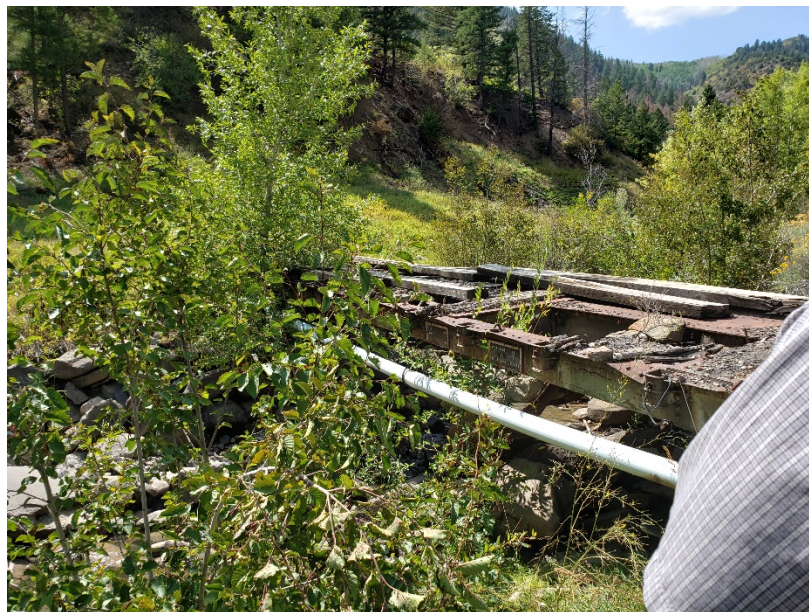
We began the field inspection with an overview of the mine and its history. We then hiked to the underground discharge pipes and walked the entire drainage. A PVC pipe diverts water from two reclaimed portals to the surface; according to a DRMS visual approximation, it was discharging at a normal volume at the time of inspection (Figure 1). Orange precipitate was seen where the pipe discharges into the ditch; this is normal according to DRMS and the orange precipitate was only present within the first few feet of this ditch at the time of inspection (Figure 2). The bridge that supports a section of this pipeline is in disrepair, and only two of the three cables that anchored this pipe to the bridge were functioning at the time of inspection (Figure 3). The lack of proper support caused a sag in

the pipe; this pipe should be further supported to prevent the sag. DRMS has been monitoring the bridge and will discuss its condition and re-stabilization of the pipe with the operator.

Figure 3 - Although difficult to see in this picture, one support of the portal pipe attaching it to the bridge failed, creating a sag in the pipe. The pipe should be re-supported to eliminate this sag.

- Place the missing documents in the Garfield County building in Glenwood Springs.
- Re-stabilize the portal pipe to the bridge.
- Continue to monitor all ponds and ditches.

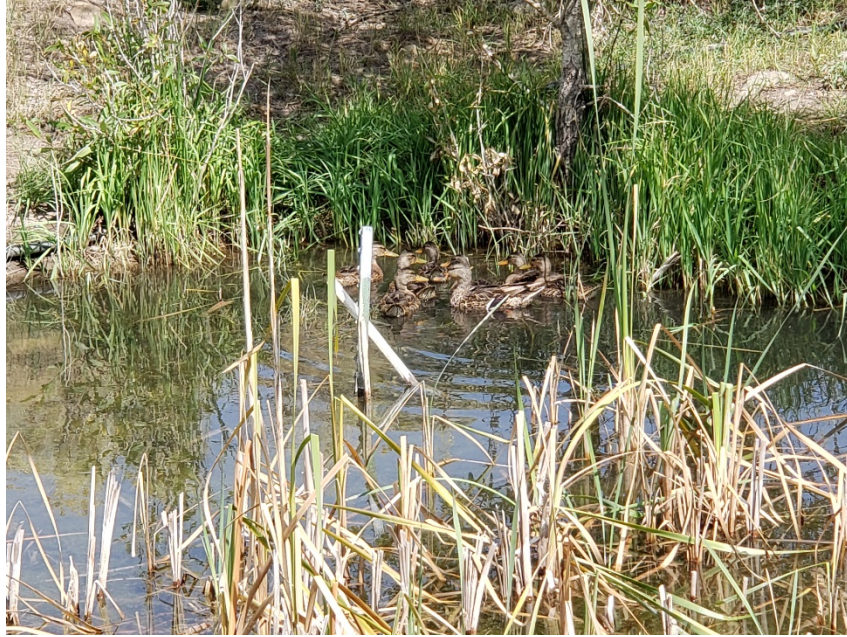
The aeration ditch which collects the water from the discharging portals was functioning as designed at the time of inspection. Long Pond was holding water and had a family of ducks present (Figure 4). This pond discharged into a fully competent ditch, then into another stable pond (T-1 Pond). Pond T-2 was also holding water. Another ditch led water to Pond 9, which was also fully functional at the time of inspection. All ponds and ditches to this point were fully functional.

Figure 4 - A paddling of ducks on The Long Pond.

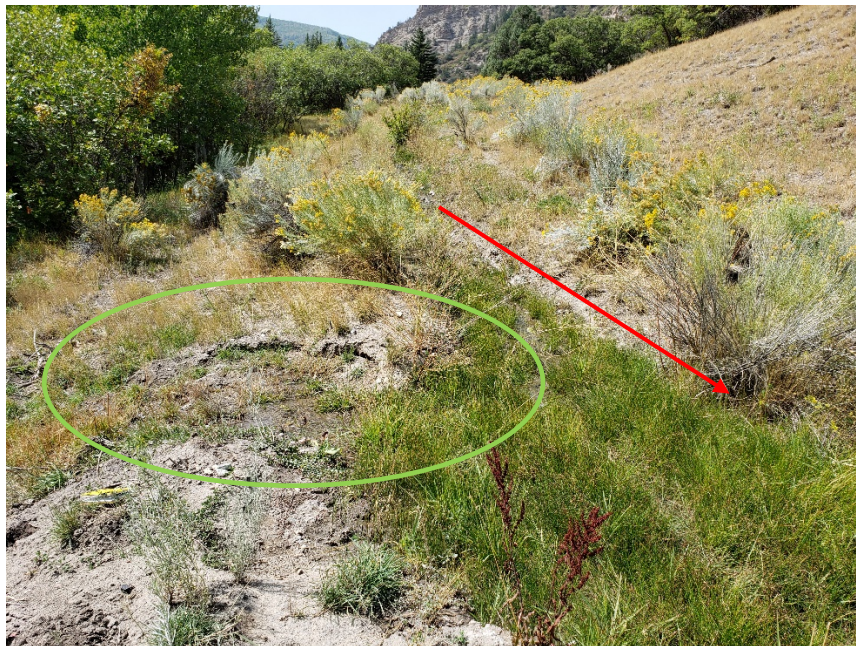
The ditch connecting Pond 9 to the Refuse Pond was breached and discharging water into the stream buffer zone (Figure 5). The surface flow from this breach meandered 50-75 feet downslope where it appeared to infiltrate into the soil, well before reaching the stream (Figure 6). DRMS contacted the operator who repaired the breach by September 17, 2020 as confirmed by DRMS' inspection report.

Figure 5 - The breach (green oval) of a ditch (red arrow) leading from Pond 9 to the Refuse Pond required repair, which DRMS confirmed upon re-inspection on September 17, 2020.

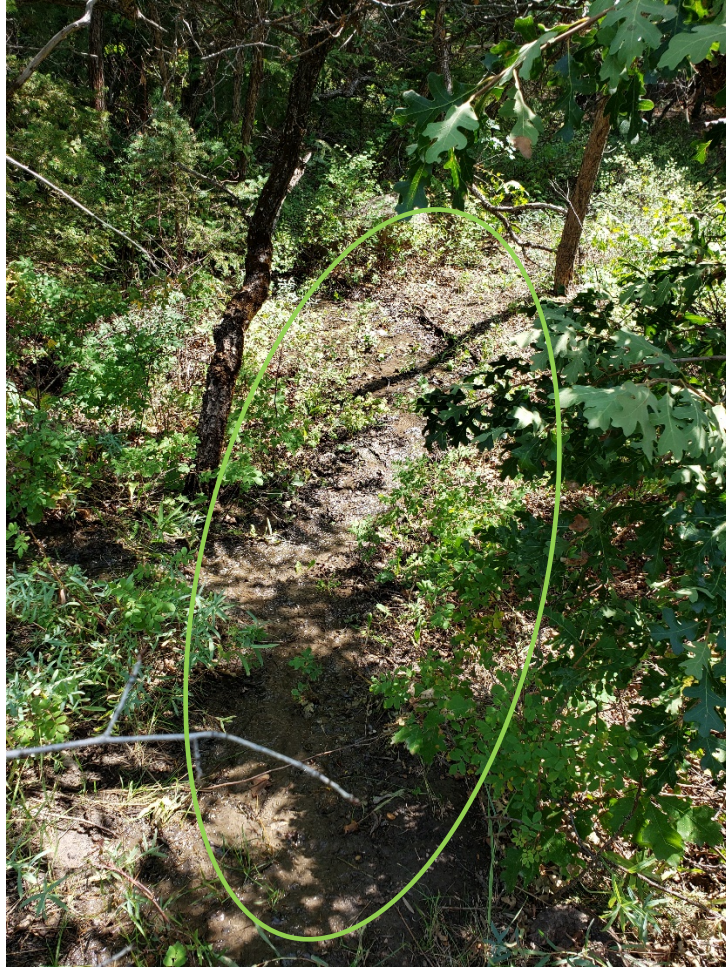
Figure 6 - Water flow (green oval) from the breach in the ditch (Figure 5) into the stream buffer zone. This breach only created surface flow 50-75 feet from the ditch and did not reach the stream; instead it infiltrated into the groundwater.
