## MINERALS PROGRAM INSPECTION REPORT

<b>MINE NAME:</b> Varra-Coulson Resource Project	<b>MINE/PROSPECTING ID#:</b> M-2013-064	<b>MINERAL:</b> Gravel and sand	<b>COUNTY:</b> Weld
<b>INSPECTION TYPE:</b> Monitoring	<b>INSPECTOR(S):</b> Peter Hays	<b>INSP. DATE:</b> September 28, 2020	<b>INSP. TIME:</b> 10:00
<b>OPERATOR:</b> Varra Companies, Inc.	<b>OPERATOR REPRESENTATIVE:</b> Garrett Varra, Brad Janes, Brad Jones	<b>TYPE OF OPERATION:</b> 112c - Construction Regular Operation	
<b>REASON FOR INSPECTION:</b> Normal I&E Program	<b>BOND CALCULATION TYPE:</b> Complete Bond	<b>BOND AMOUNT:</b> \$205,801.00	
<b>DATE OF COMPLAINT:</b> NA	<b>POST INSP. CONTACTS:</b> None	<b>JOINT INSP. AGENCY:</b> None	
<b>WEATHER:</b> Clear	<b>INSPECTOR'S SIGNATURE:</b>

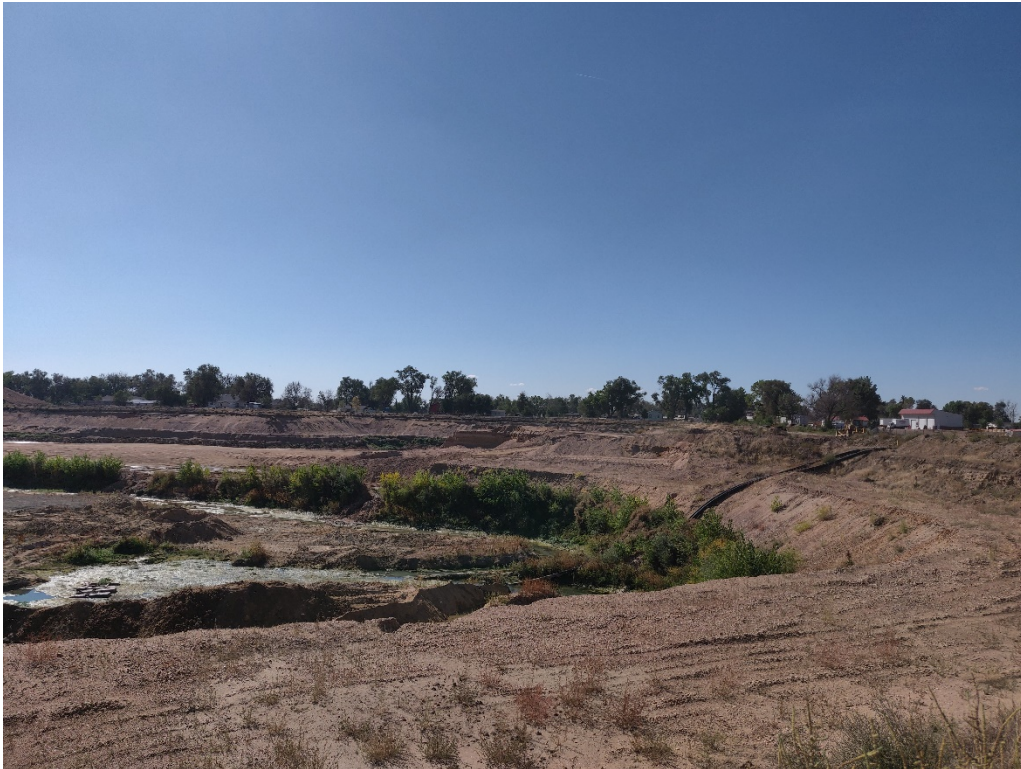
View of the South Field from the northwest corner looking south

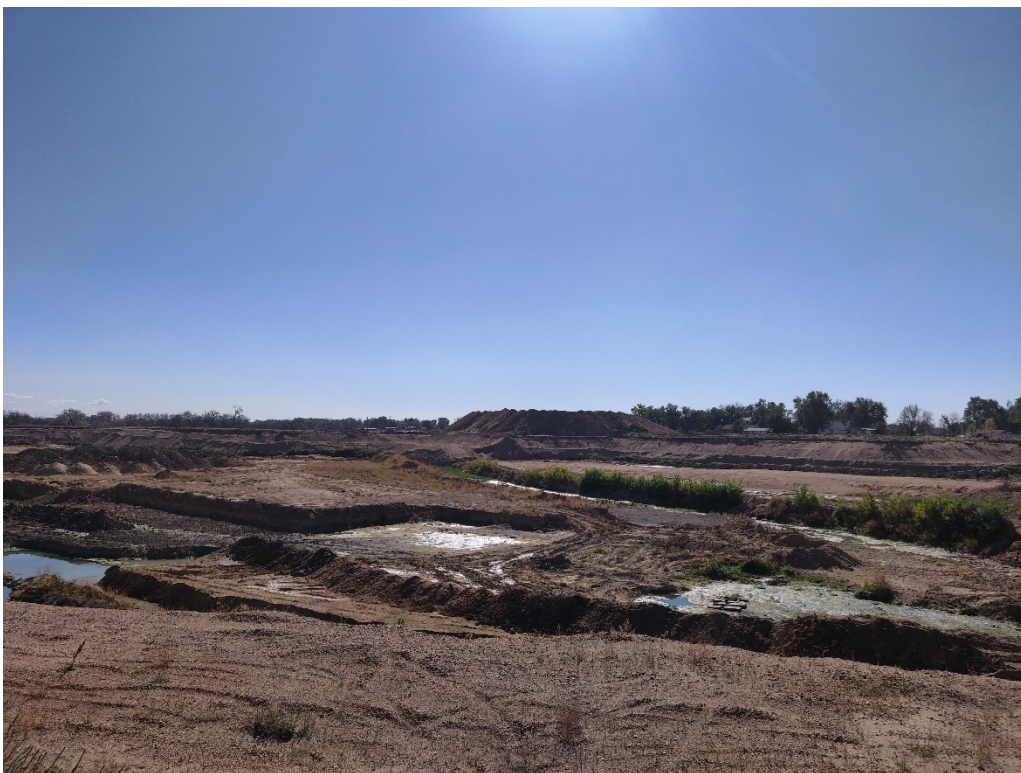
View of the South Field from the northwest corner looking southeast

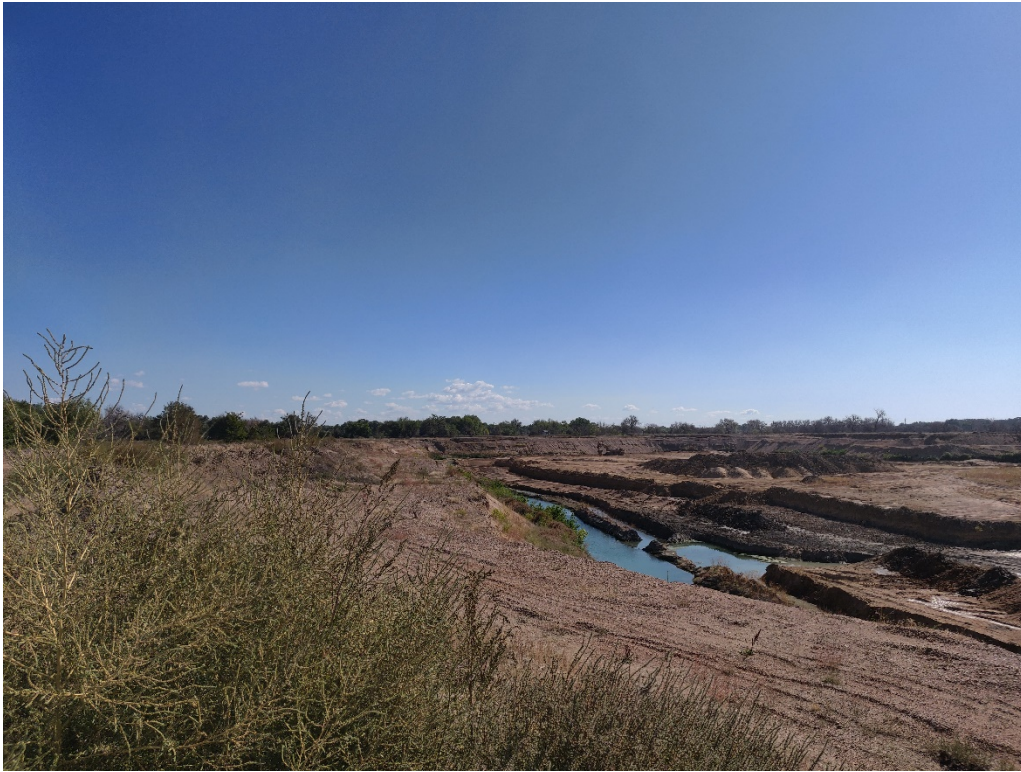
View of the South Field from the northwest corner looking east

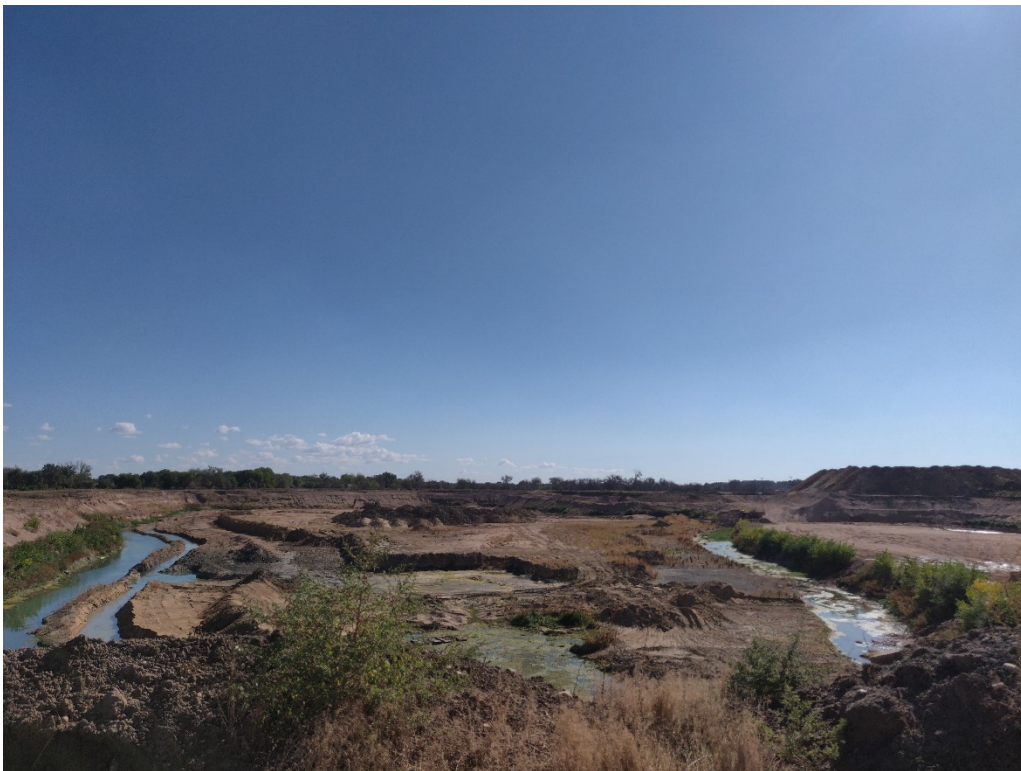
View of the South Field from the west side looking east

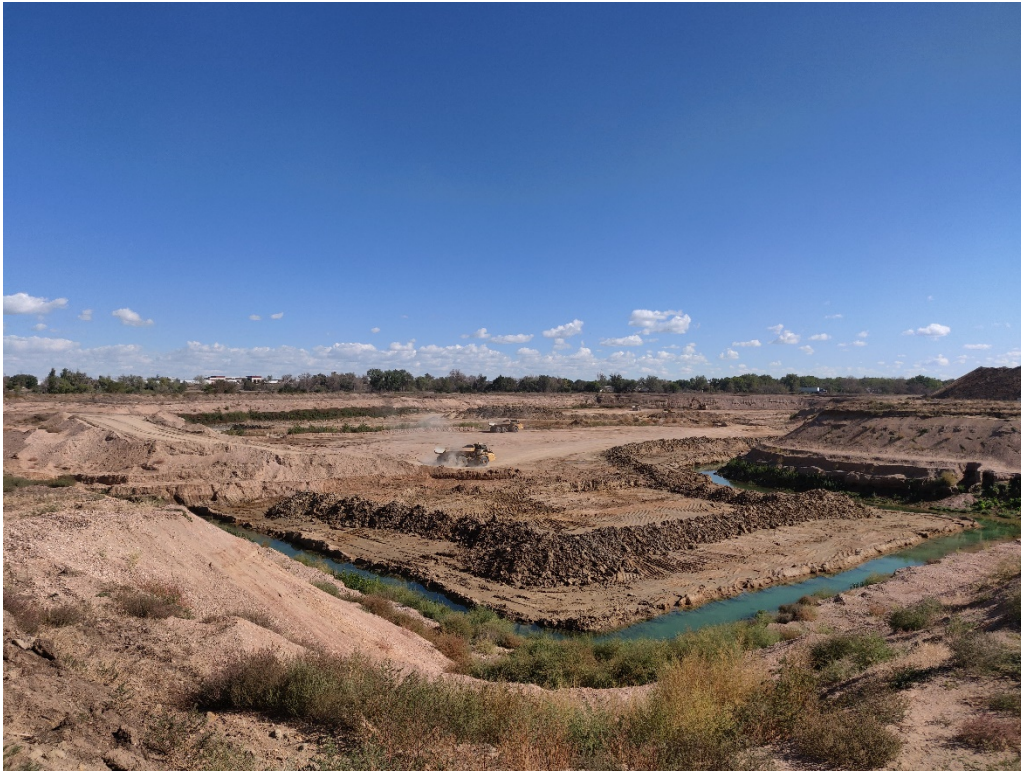
View of the South Field from the southwest corner looking northeast

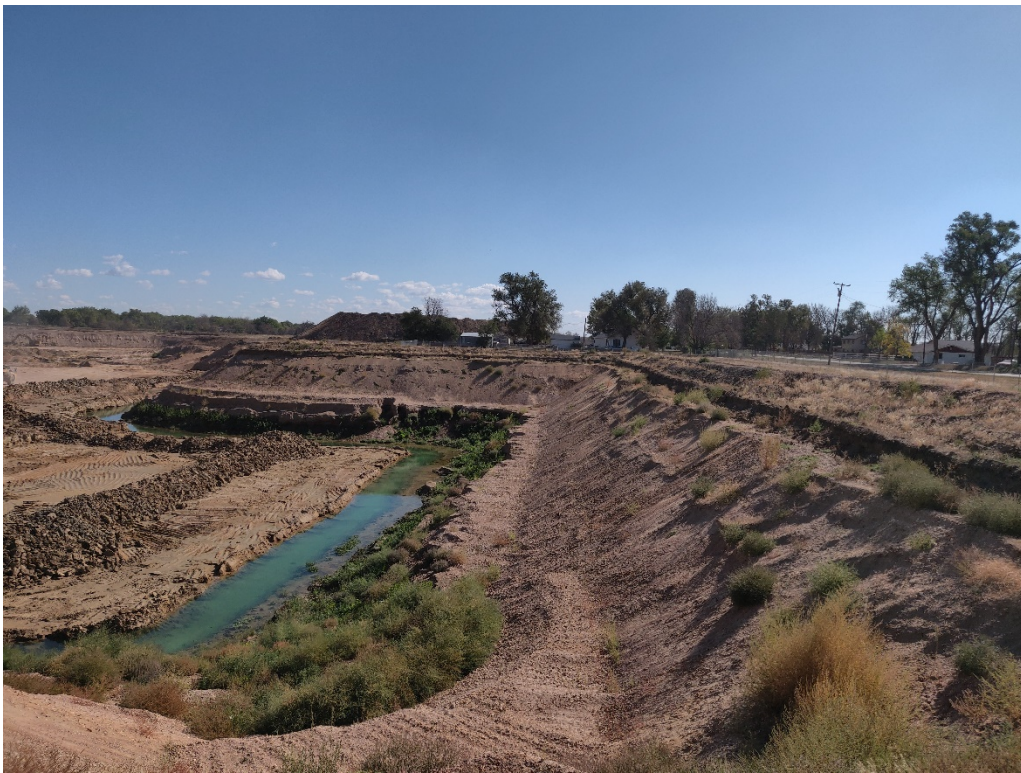
View of perimeter slope at the southwest corner of the South Field looking east

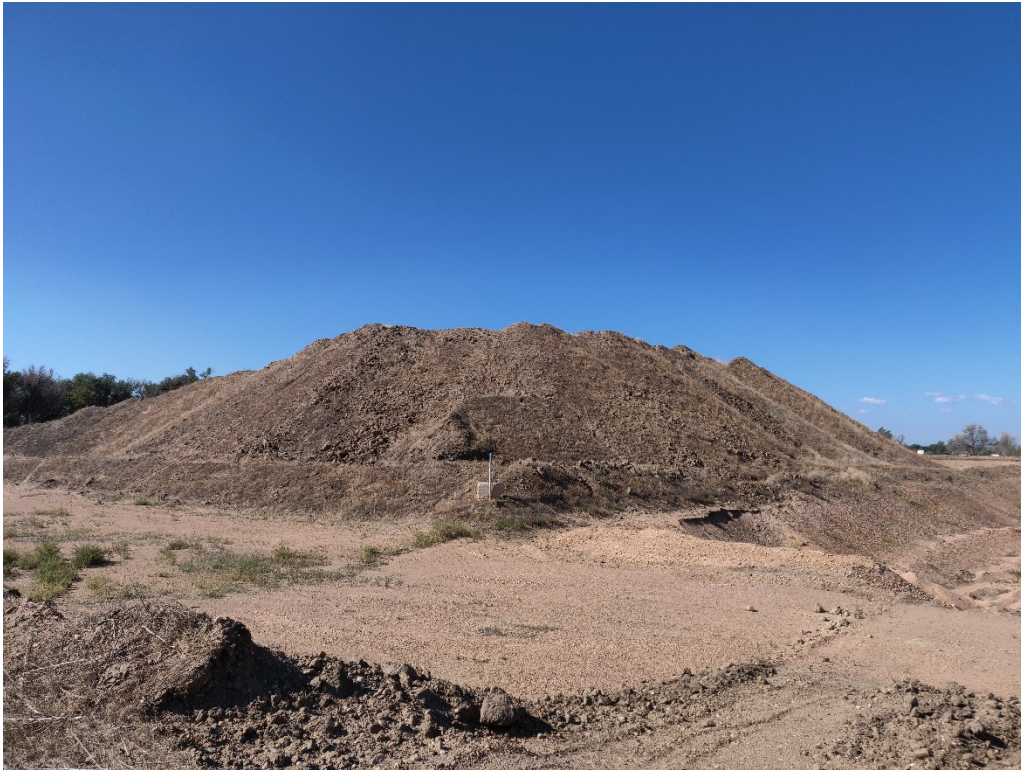
View of the topsoil stockpile located in the southern portion of the South Field

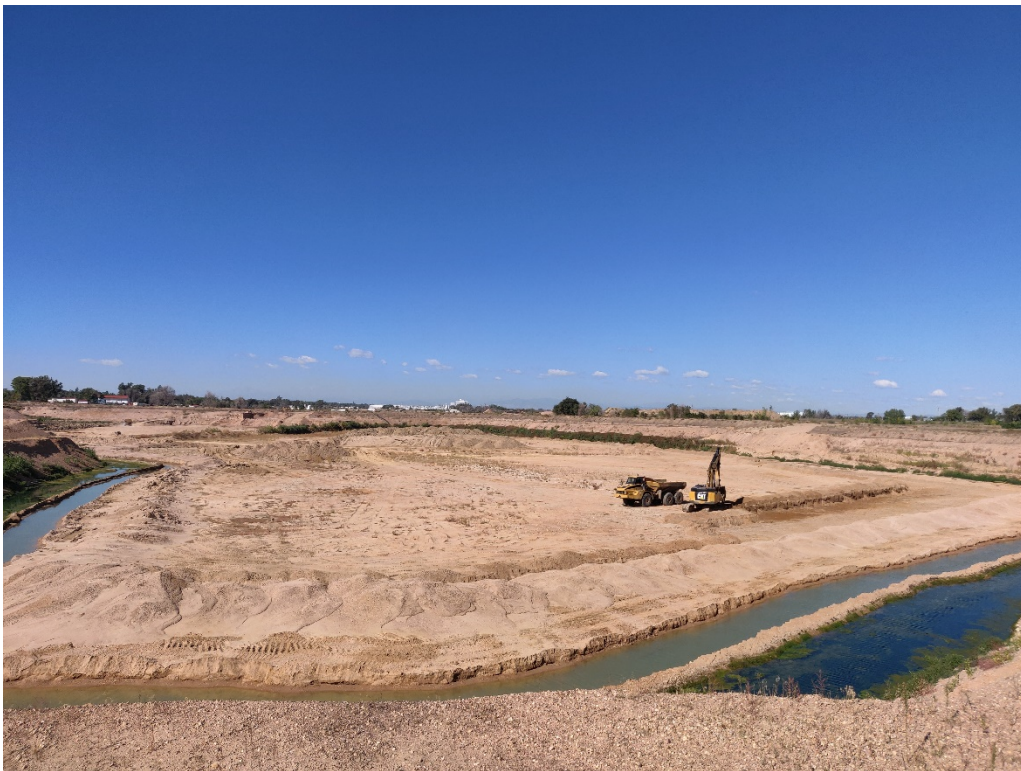
View of the South Field from the east side looking northwest

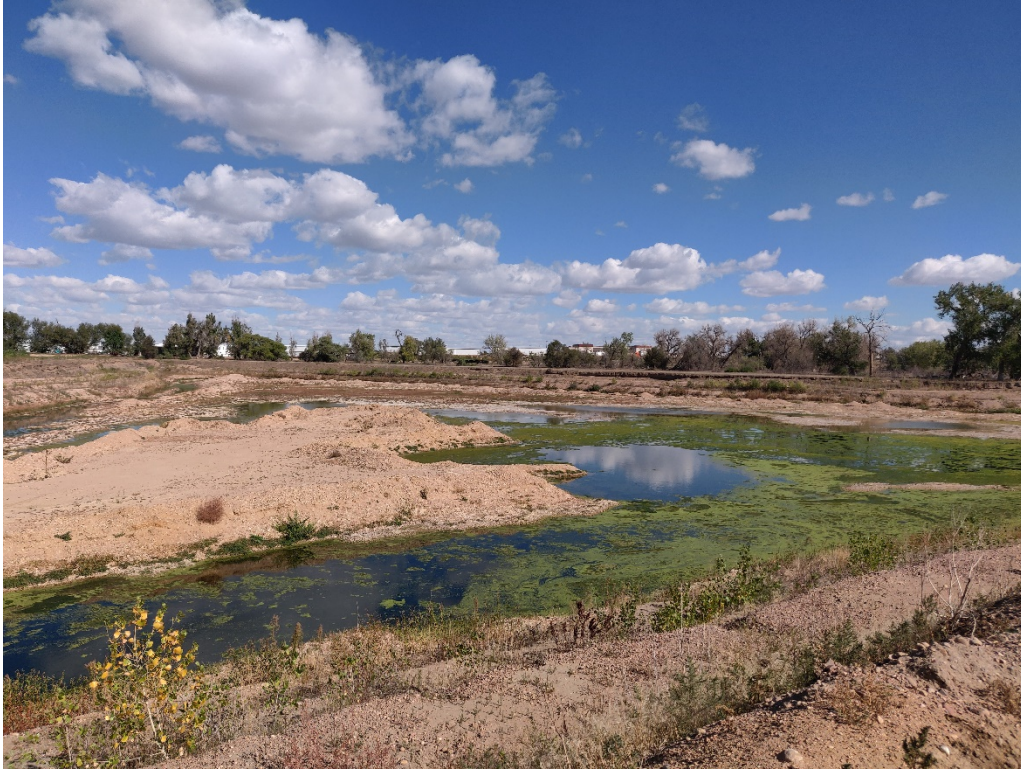
View of the Middle Field from the south side looking north

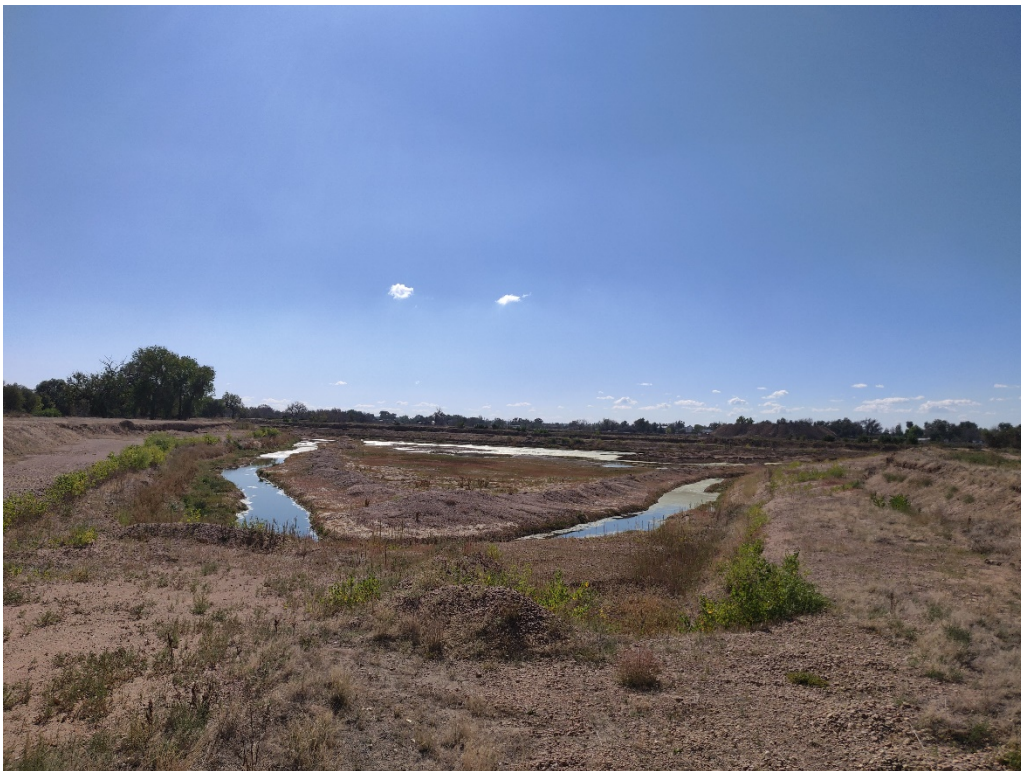
View of the Middle Field from the southwest corner looking northeast

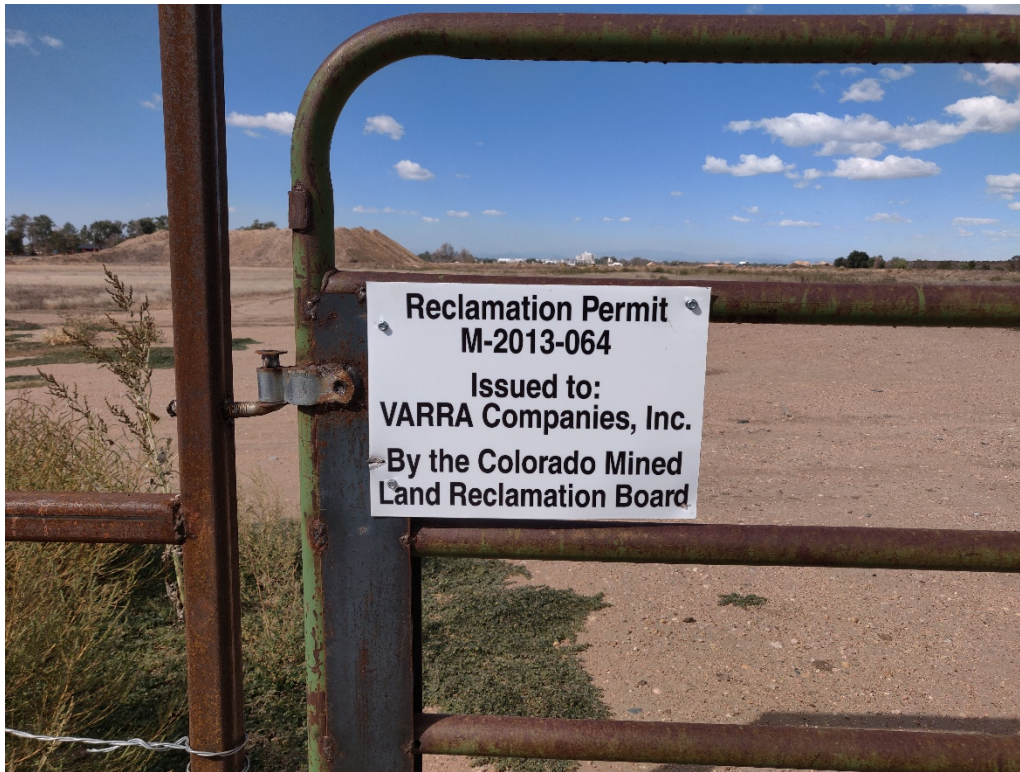
The mine sign and boundary markers were observed as required by Rule 3.1.12.

Varra Coulson mine sign
