MINERALS PROGRAM INSPECTION REPORT
PHONE: (303) 866-3567

MINE NAME: Humming Bird Mine	MINE/PROSPECTING ID#: M-2017-035	MINERAL: Gemstones, fluorine, copper	COUNTY: Mesa
INSPECTION TYPE: Preoperation Inspection	INSPECTOR(S): Amy Yeldell	INSP. DATE: October 20, 2020	INSP. TIME: 16:20
OPERATOR: Miners Mall, LLC	OPERATOR REPRESENTATIVE: Dennis Schneider	TYPE OF OPERATION: 110(1) - Hard Rock Limited Impact	
REASON FOR INSPECTION: Preoperation Inspection	BOND CALCULATION TYPE: Complete Bond	BOND AMOUNT: \$2,588.30	
DATE OF COMPLAINT: NA	POST INSP. CONTACTS: DRMS	JOINT INSP. AGENCY: None	
WEATHER: Clear	INSPECTOR'S SIGNATURE:

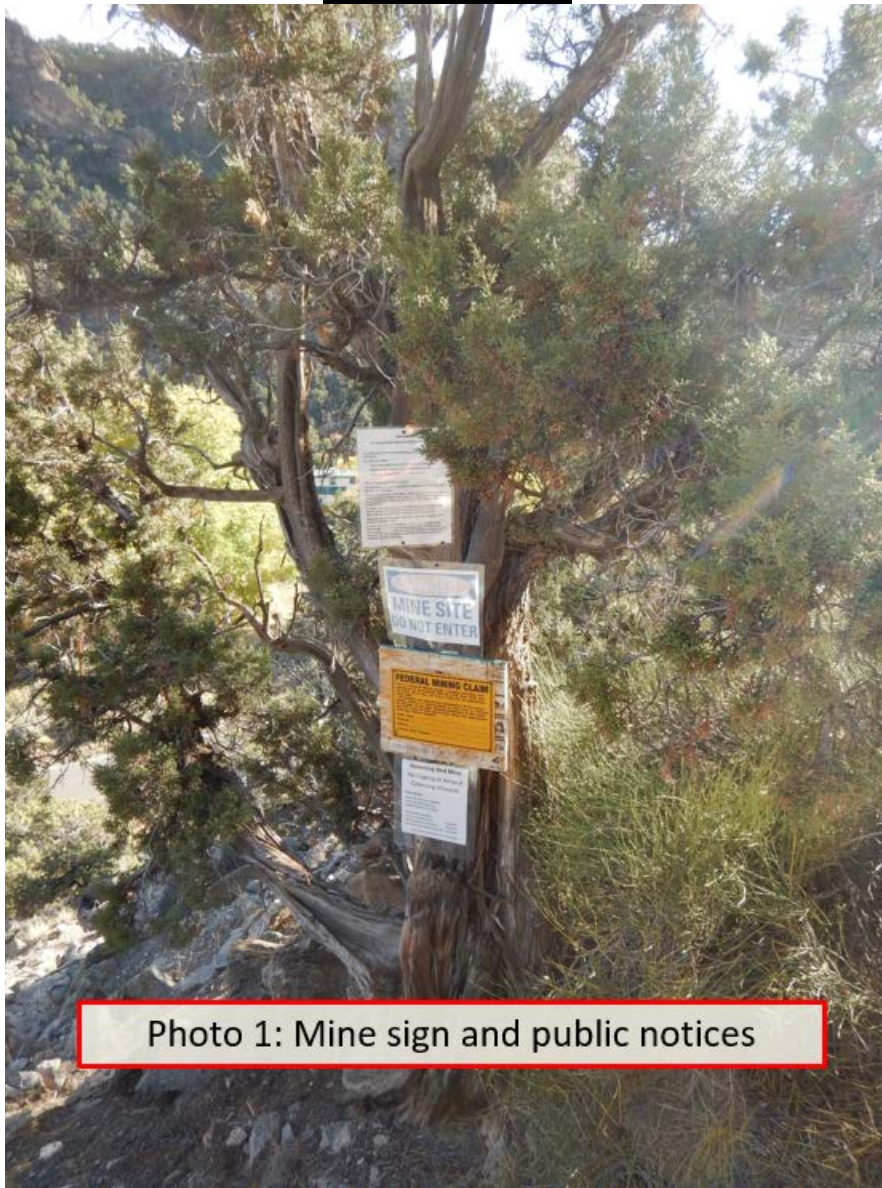
The mine sign and boundary markers remain in place and in compliance with Rule 3.1.12. (See Photo 1). The waste rock and topsoil piles associated with the Ridgetop Project area appear to be stable. There is no erosion from the piles. The topsoil has good vegetation establishment. No weeds were observed. All mining equipment is stored neatly and properly secured (See Photo 2). No fuel, trash or structures are located on site.

Photo 1: Mine sign and public notices

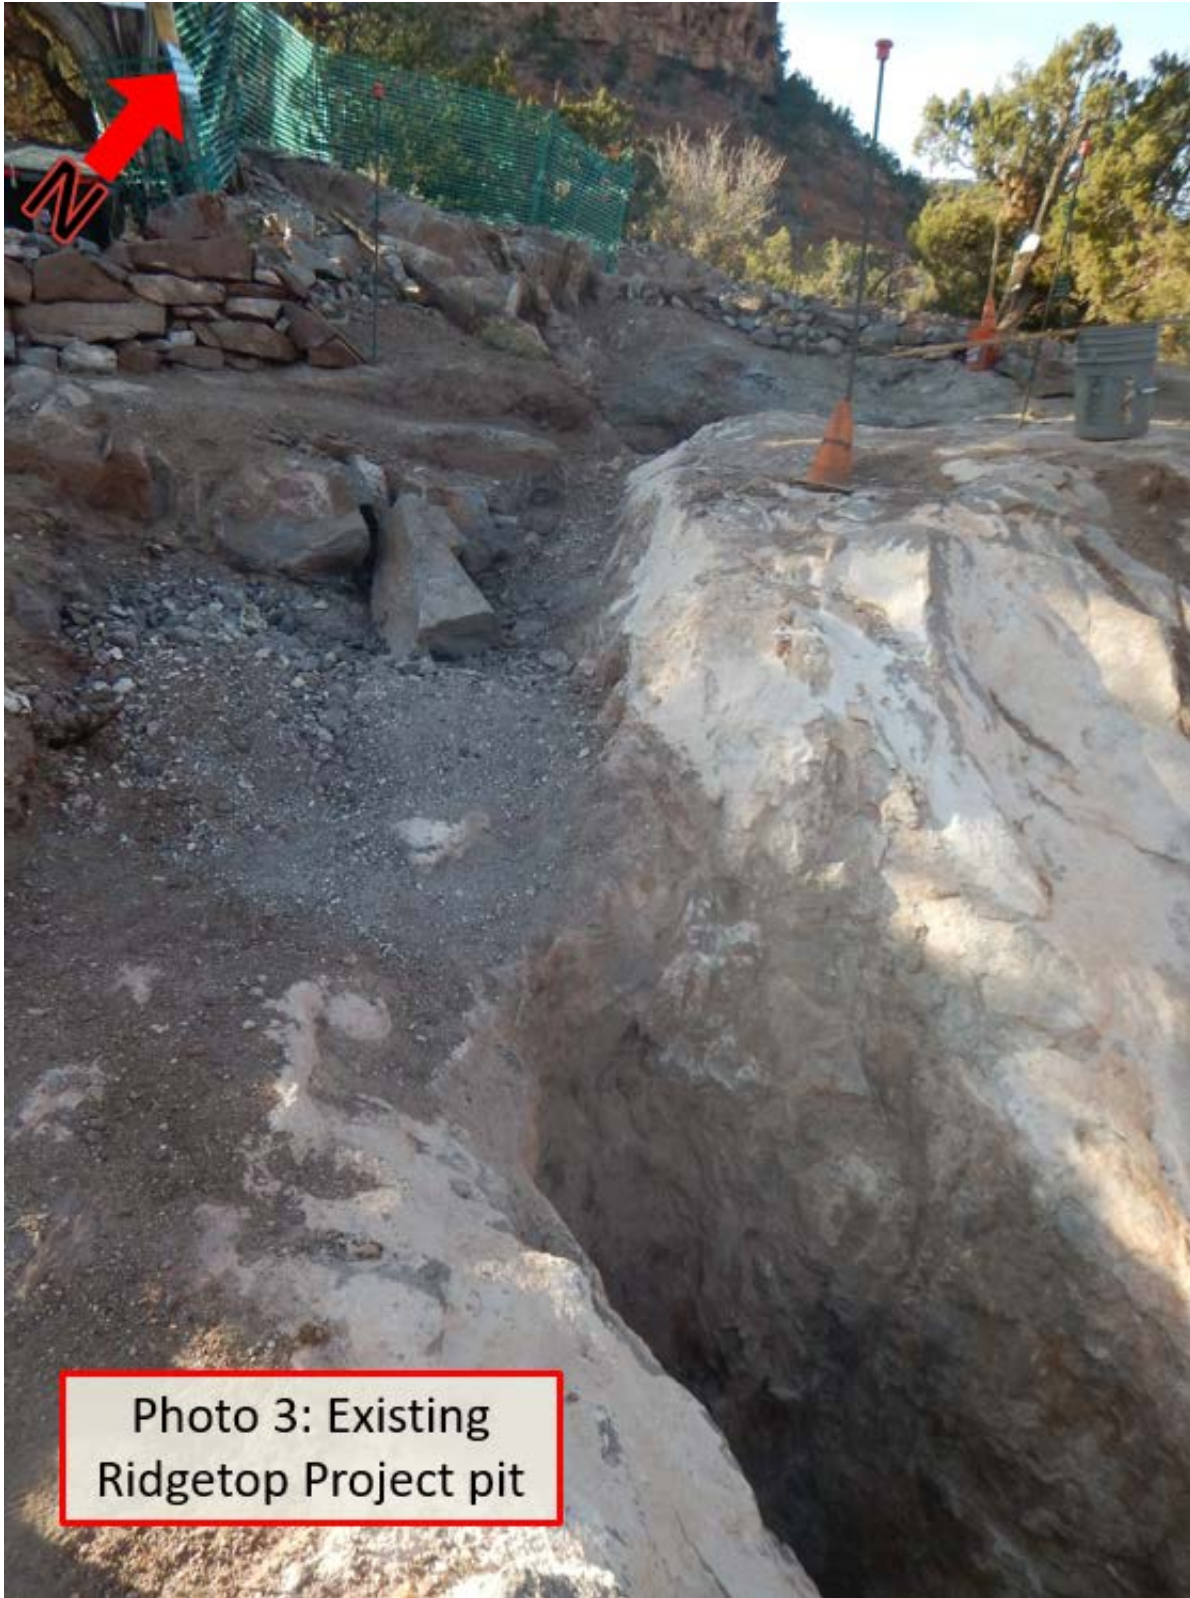
The Ridgetop Project Area is the current mining operation. The area was historically mined for copper and is now being reworked. This is a surface mine that follows the fault trending north-south. The current excavation is approximately 25 feet long, 3-10 feet wide and up to 15 feet deep (See Photos 3-5). In time the pit could be excavated up to 40 feet deep. All excavated waste material will be sorted and stored in piles on the north east side of the fault. All available topsoil will be salvaged. The Operator believes to have intercepted the historical shaft which connects with other underground workings (See Photo 6). Given the unstable rock over this portal the pit will need to be widened or taken back to the east. In expanding the pit, the support area may be moved to the east to maintain size. Upon completion of mining waste rock will be used to fill the pit. Fines and enriched topsoil material will then be spread and revegetated.

Photo 3: Existing
Ridgetop Project pit

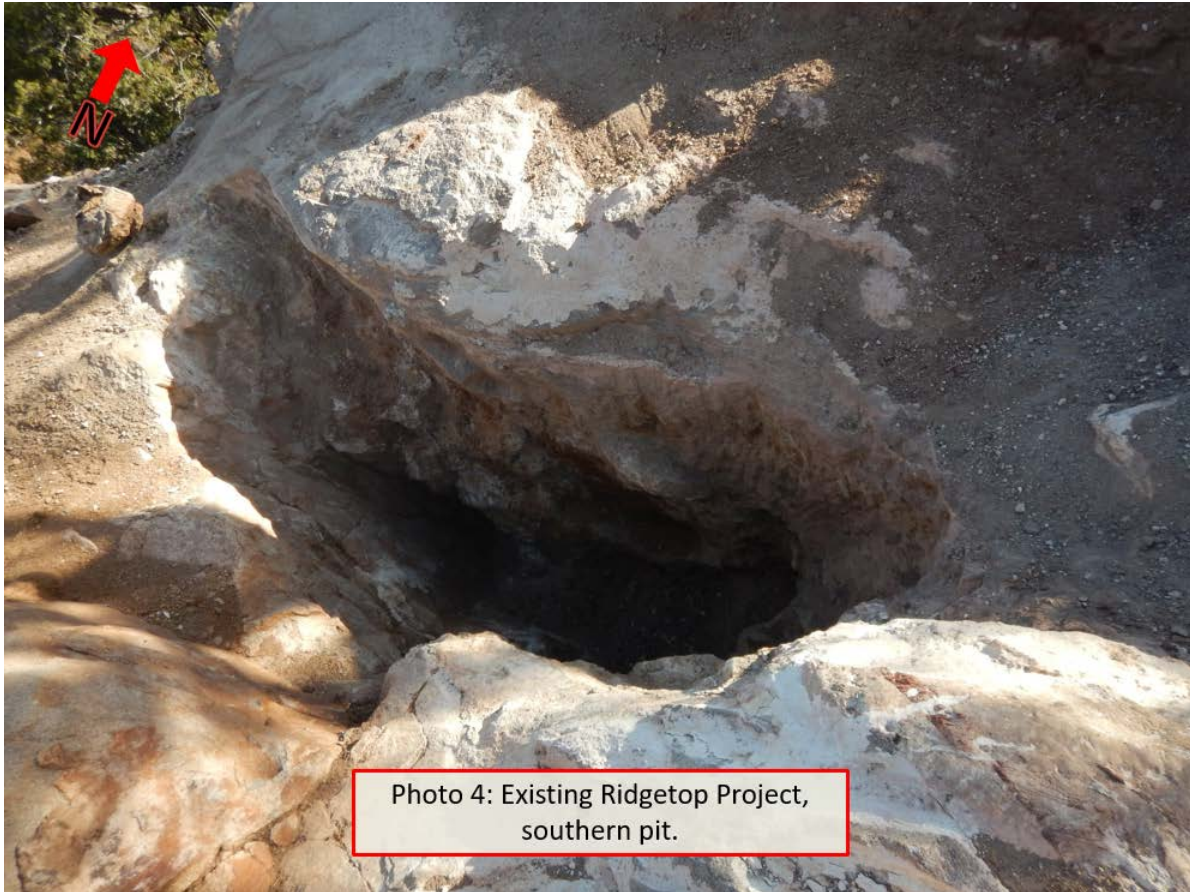
Photo 4: Existing Ridgetop Project,
southern pit.

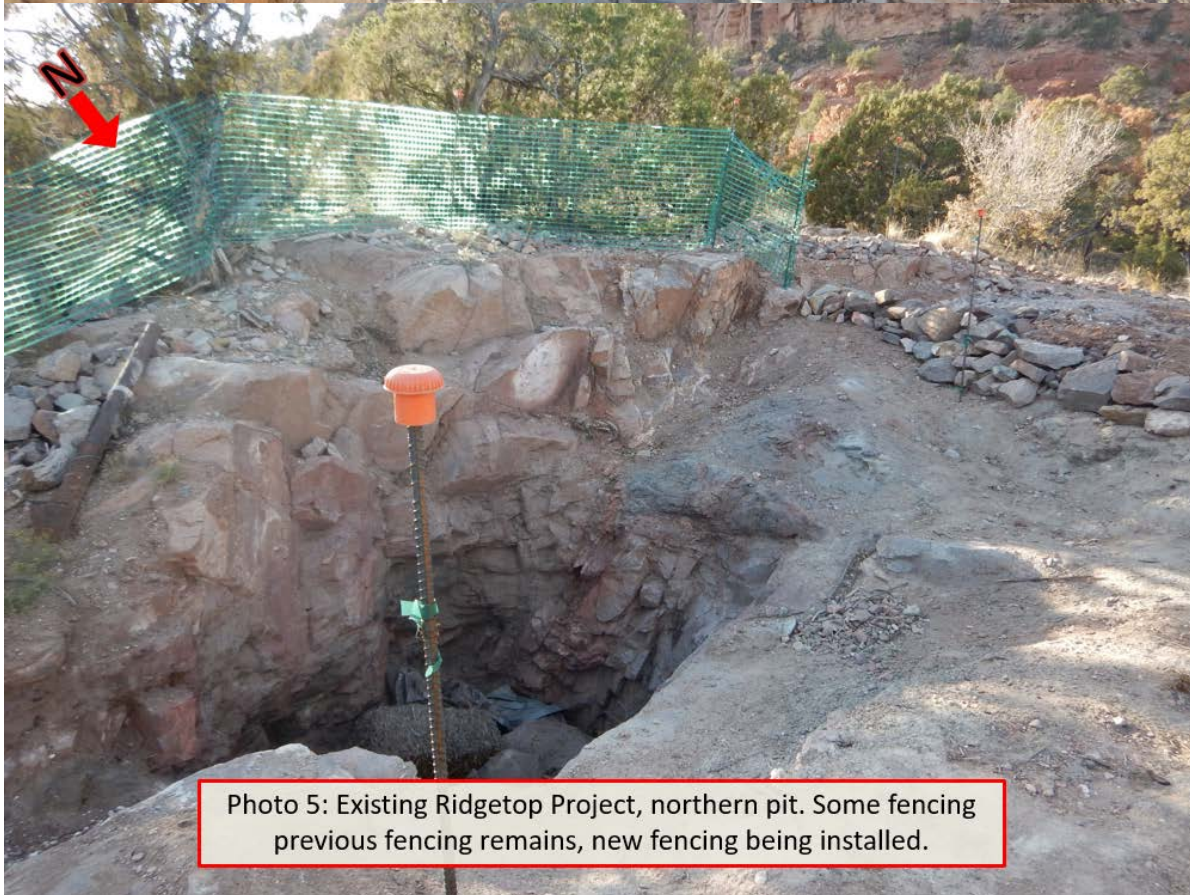
Photo 5: Existing Ridgetop Project, northern pit. Some fencing
previous fencing remains, new fencing being installed.

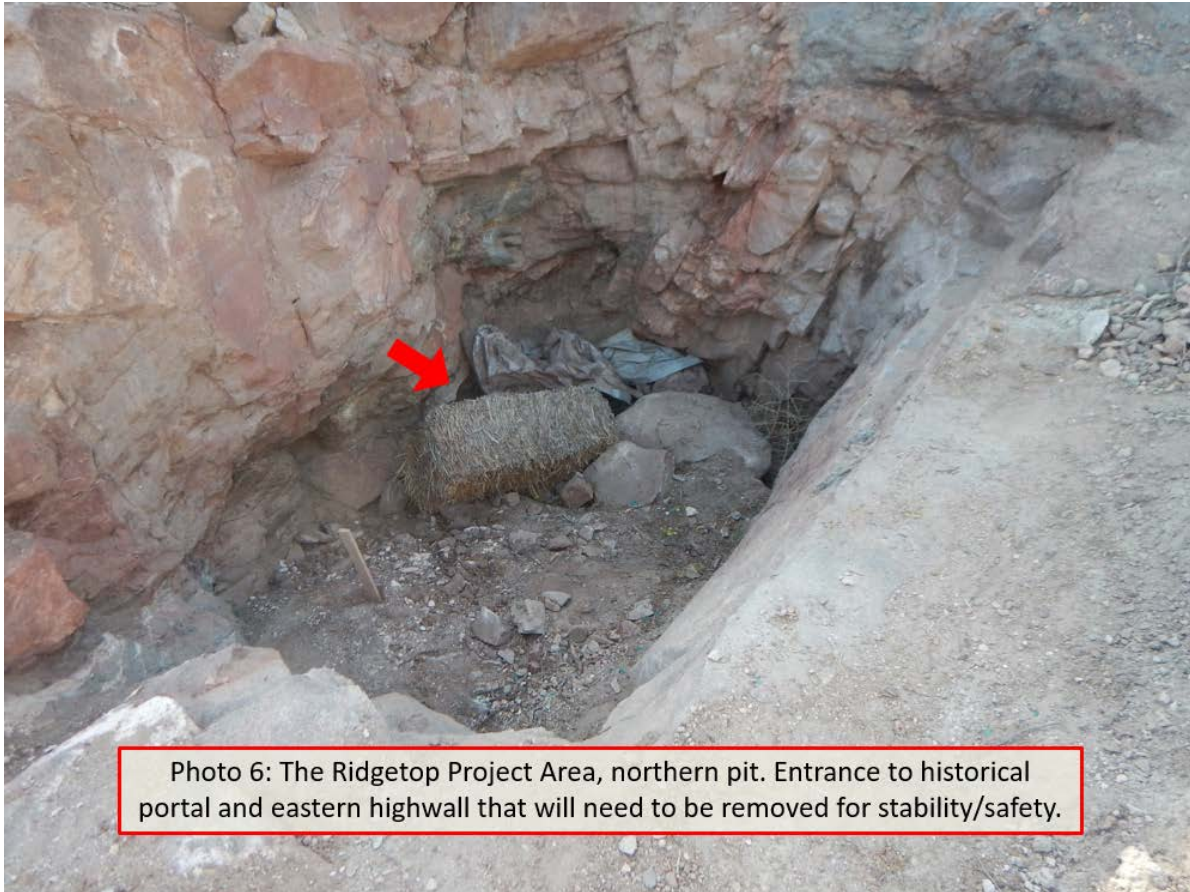
Photo 6: The Ridgetop Project Area, northern pit. Entrance to historical portal and eastern highwall that will need to be removed for stability/safety.

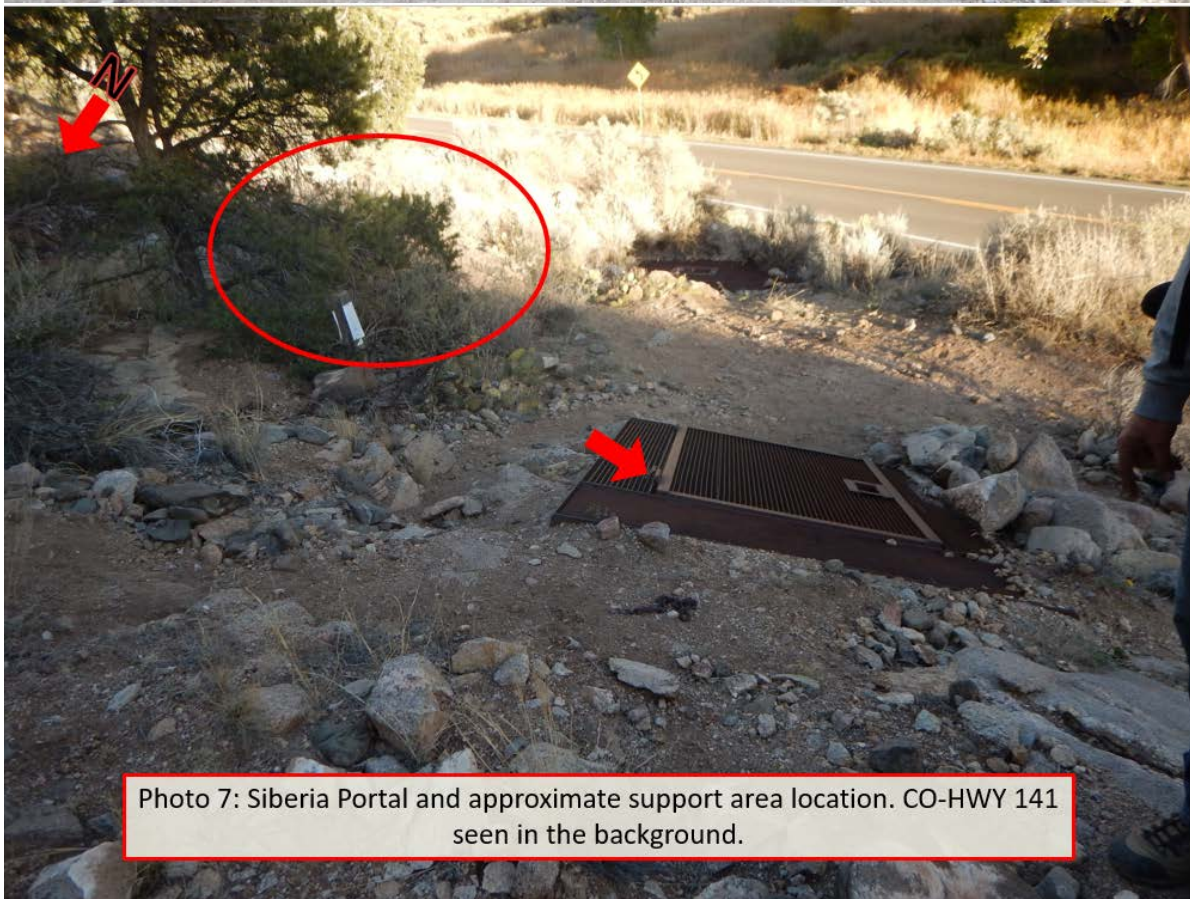
This area will access a historical DRMS grated portal. This is the northern grated portal adjacent to CO-HWY 141 (See Photo7). The portal is located in an open area with limited vegetation. A small support area will be created to the northeast of the portal. All materials pulled from underground will be processed off site. There will be no waste rock piles located outside of the portal. Upon completion of mining the support area will be reclaimed and control of the portal will be turned over to DRMS/BLM.

Photo 7: Siberia Portal and approximate support area location. CO-HWY 141 seen in the background.

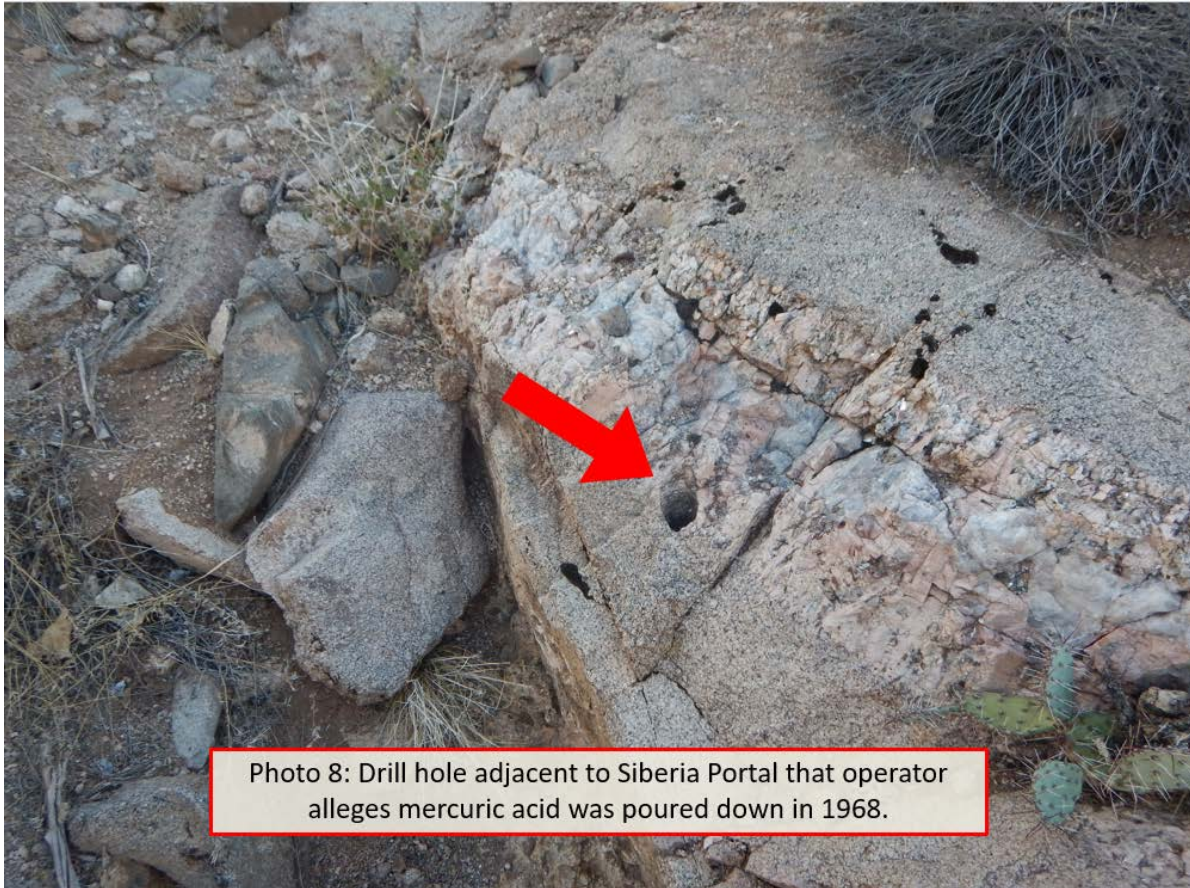
*According to the Operator in 1968, 150 gallons of mercuric acid was poured down a drill hole into the Siberia Portal in an effort to get the gems to fall from the formation. The Division was able to see a drill hole adjacent to the portal (See Photo 8). The stability or impacts of this alleged action on the formations competency is unbeknownst to the Division.

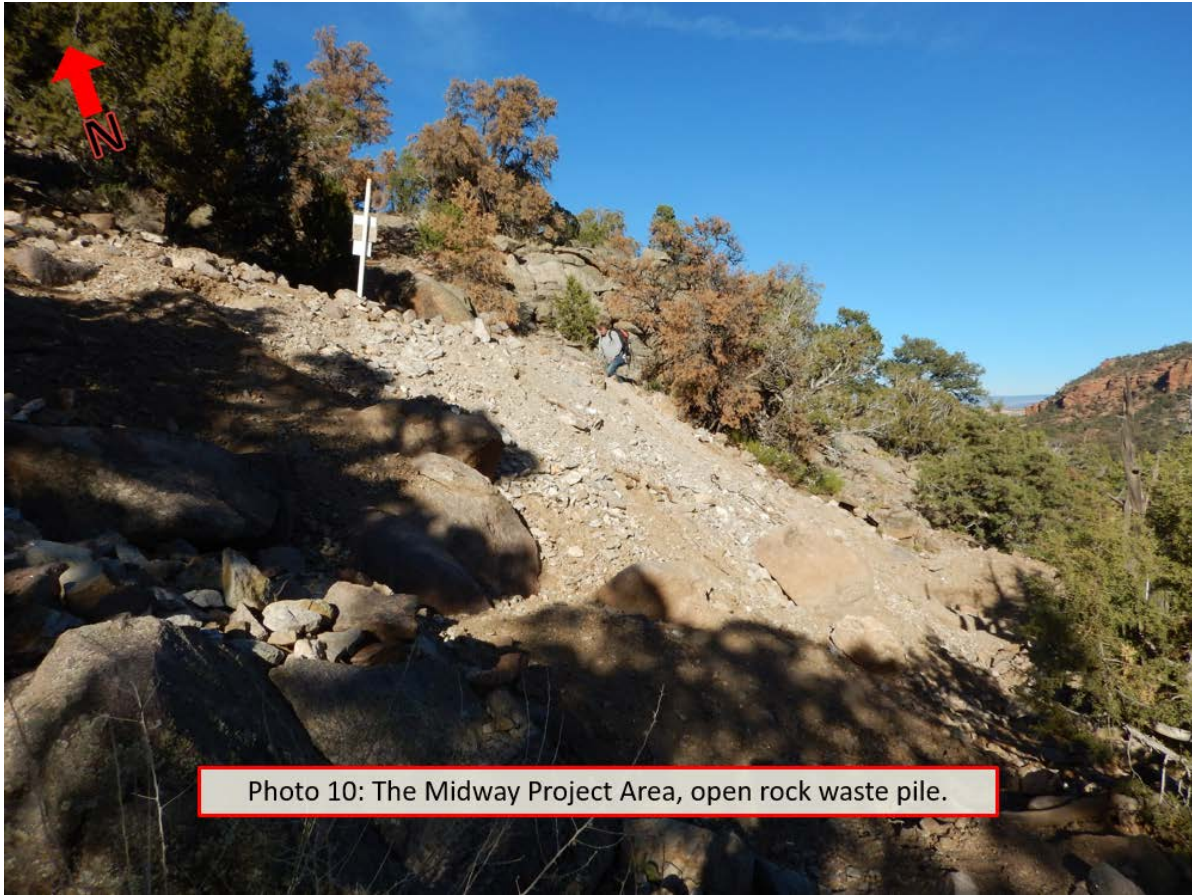
The Midway Project Area is primarily a reclamation project. Historic tailing/waste rock piles will be re-mined starting in the southwest corner and moving northeast along the hill side. Currently this is a clearing in the trees with exposed rock of various size and fines with some historic mining trash (See Photos 9 and 10). All residual copper and gems will be harvested. Fines or soil material will be screened and saved for reclamation throughout the site. All other waste rock will be placed back in the cut. The goal is to make slopes stable and as close to a 3H: 1V. Once contouring is finished fines/topsoil will be placed and revegetated.

Photo 10: The Midway Project Area, open rock waste pile.

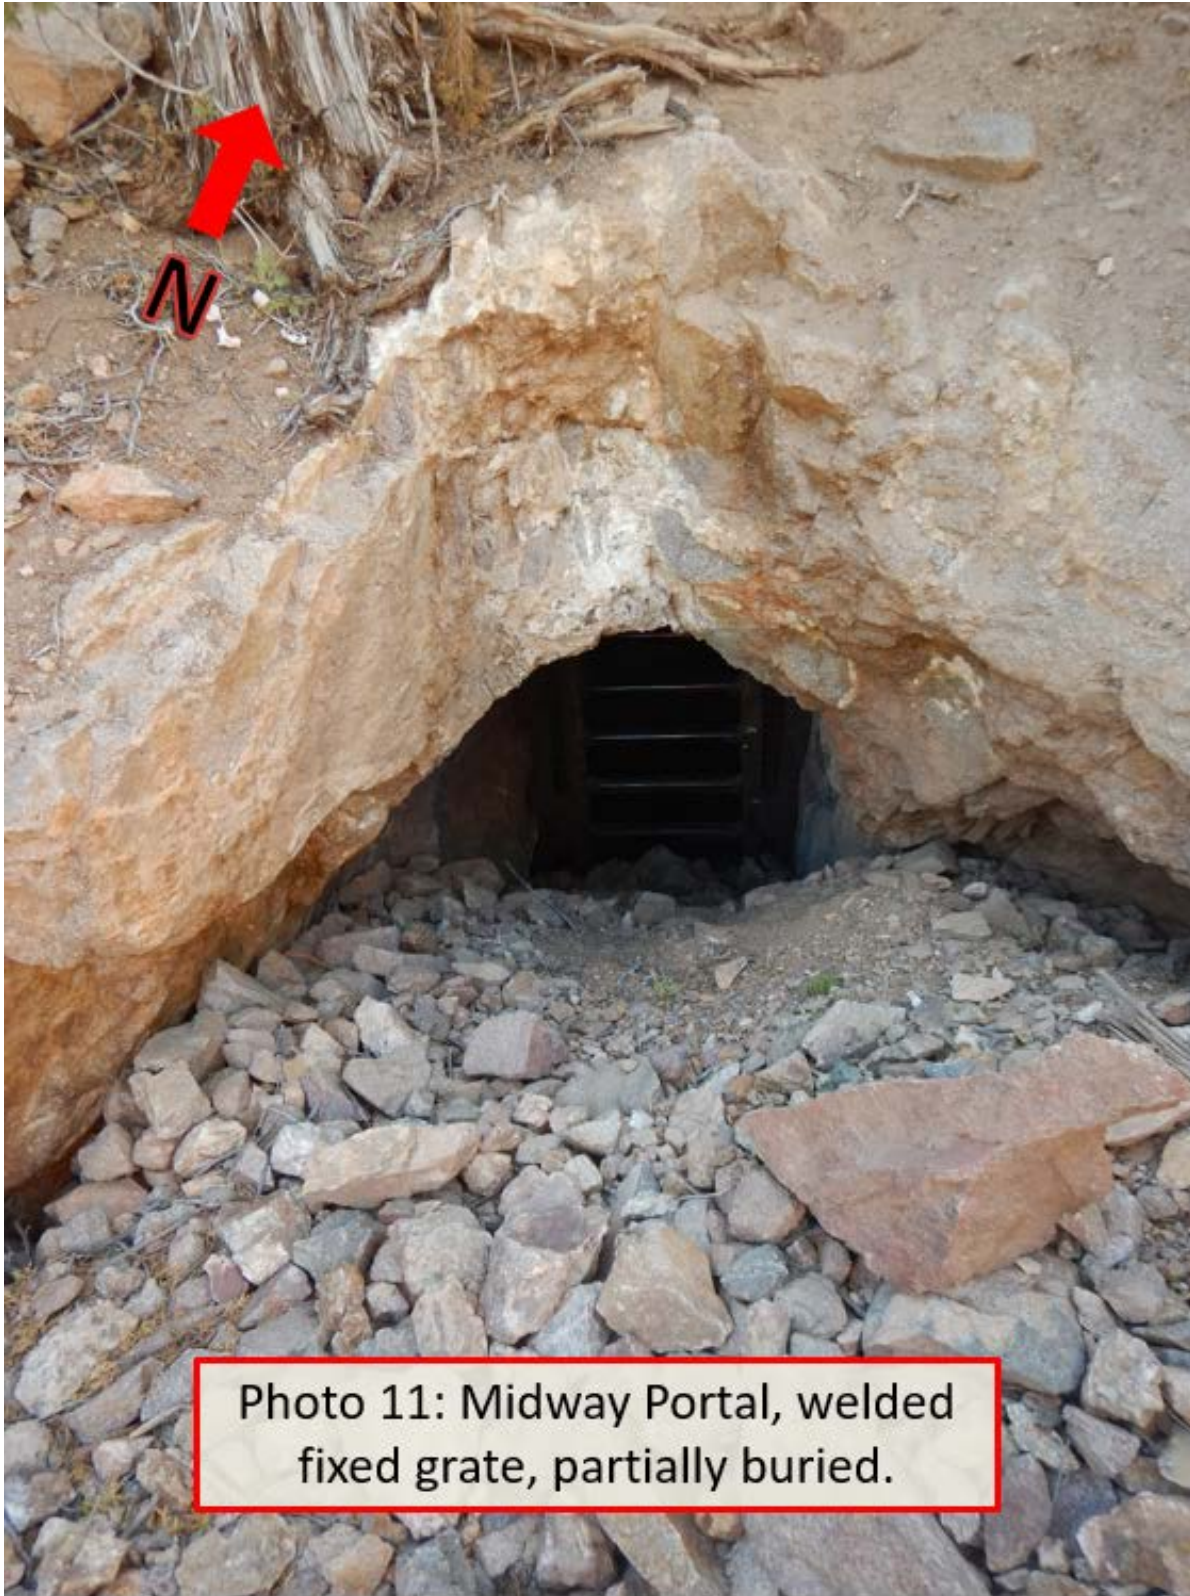
The Midway Portal consists of an existing fixed DRMS grate. No hinges are present, would need to be re-welded to be used for future mine access. Rocks from the hillside above the portal have slid partially blocking the portal entrance (See Photo 11). The operator intends to clear the path to the portal by stacking rocks on either side. If the Operator wishes to access underground using this portal additional permitting will be required. This project area will be completed in conjunction with activities at the Connector Project Area.

Photo 11: Midway Portal, welded fixed grate, partially buried.

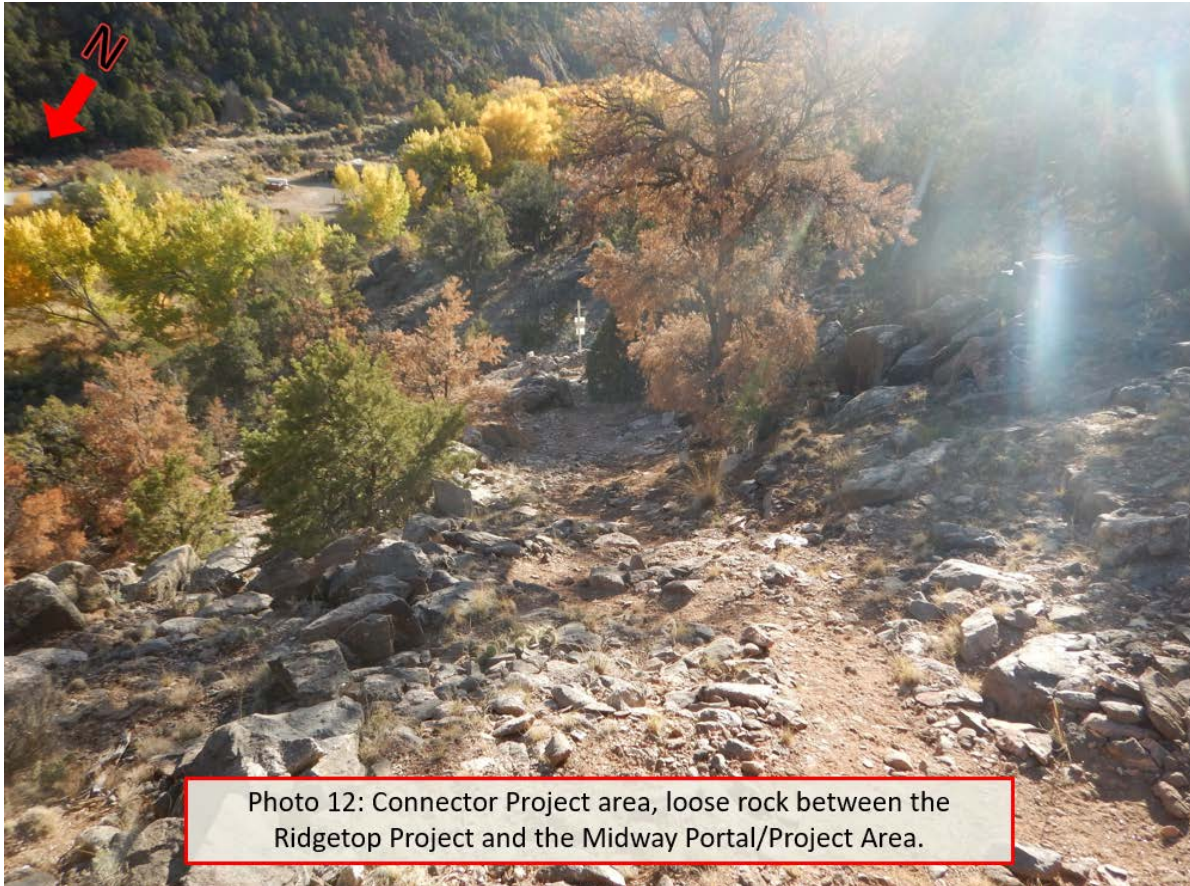
The Connector Project Area is primarily a reclamation and slope stabilization project. Debris from this area continues to slide, blocking the Midway Portal (See Photo 12). Loose material will be sorted through and moved to the west. Terracing or benching may be used given the steepness of this area. Any disturbed areas will be reclaimed.

Photo 12: Connector Project area, loose rock between the Ridgetop Project and the Midway Portal/Project Area.

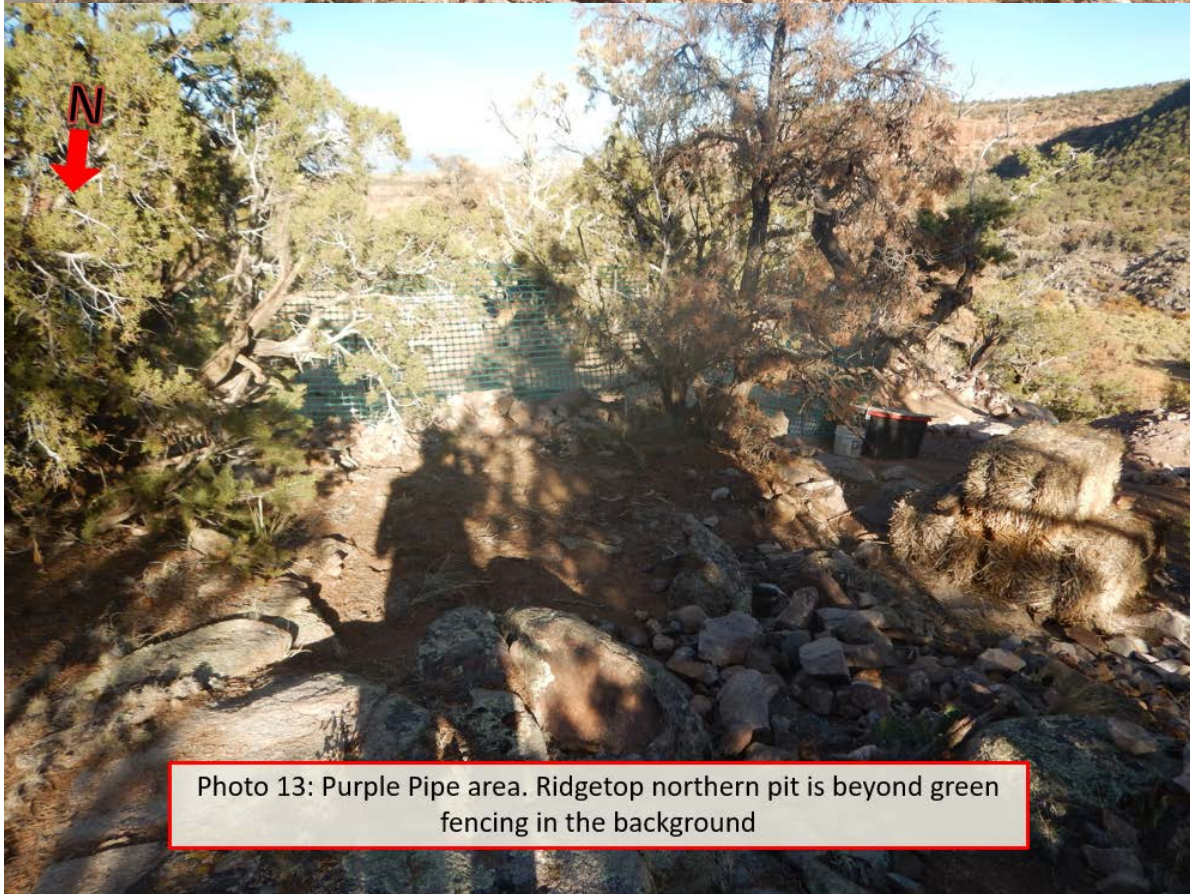
The Purple Pipe is an extension of the Ridgetop Project Area (See Photo 13). It is believed by the Operator that underground workings extend into this area. At this time mining is proposed to be underground and no surface disturbances will be associated with this phase. Limited backfilling of waste rock will be required for final reclamation. Future revisions will likely be necessary to address this project area as mining progresses and plans solidify.

Photo 13: Purple Pipe area. Ridgetop northern pit is beyond green fencing in the background

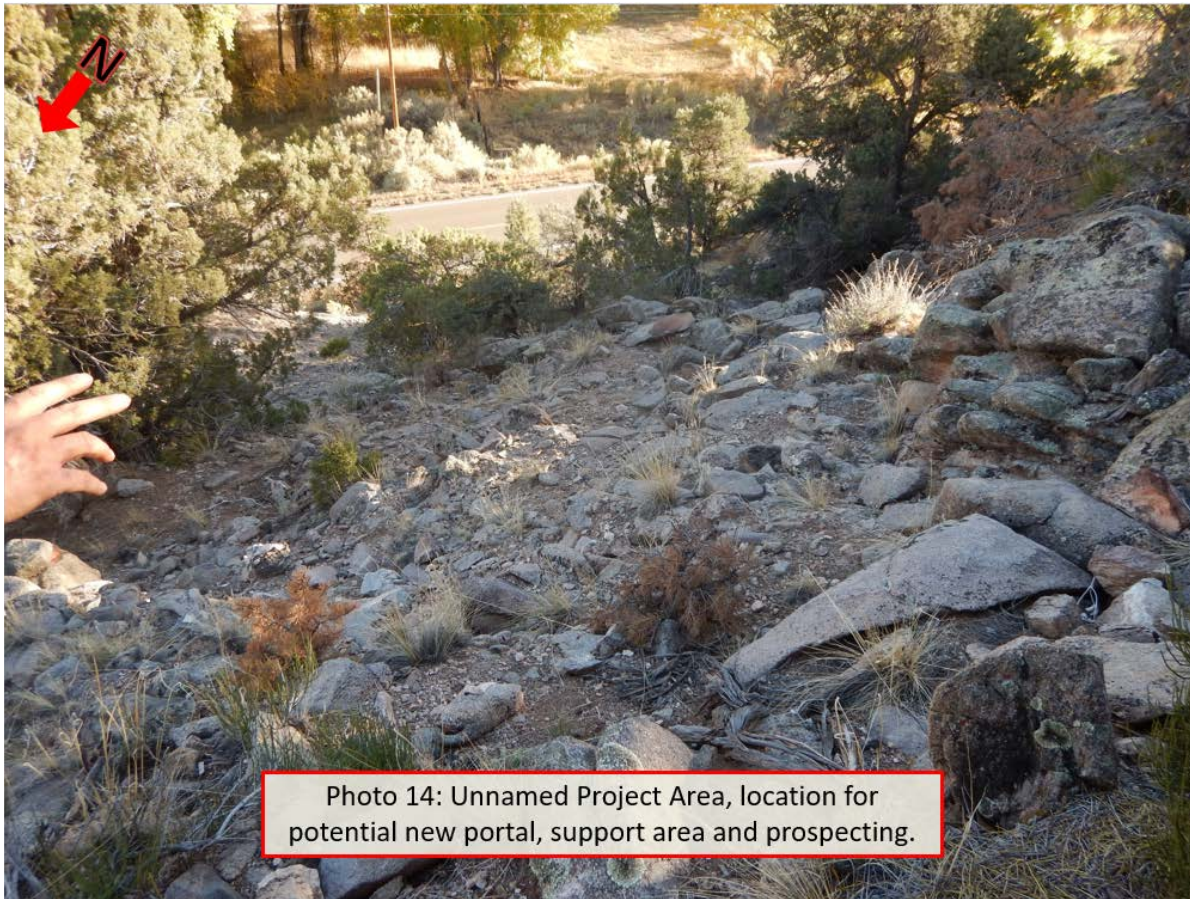
The Unnamed Project Area is intended to become a new portal to further explore the resource. A small pad will be created and the excavated portal will have a gate. This area will be similar to the Siberia Project area. At this time this area is only included for the purposes of increasing the permit acreage (See Photo 14). The technical plan regarding mining and reclamation of this phase will be forthcoming. No mining in this area will commence until permit revisions are made with DRMS.

Photo 14: Unnamed Project Area, location for potential new portal, support area and prospecting.

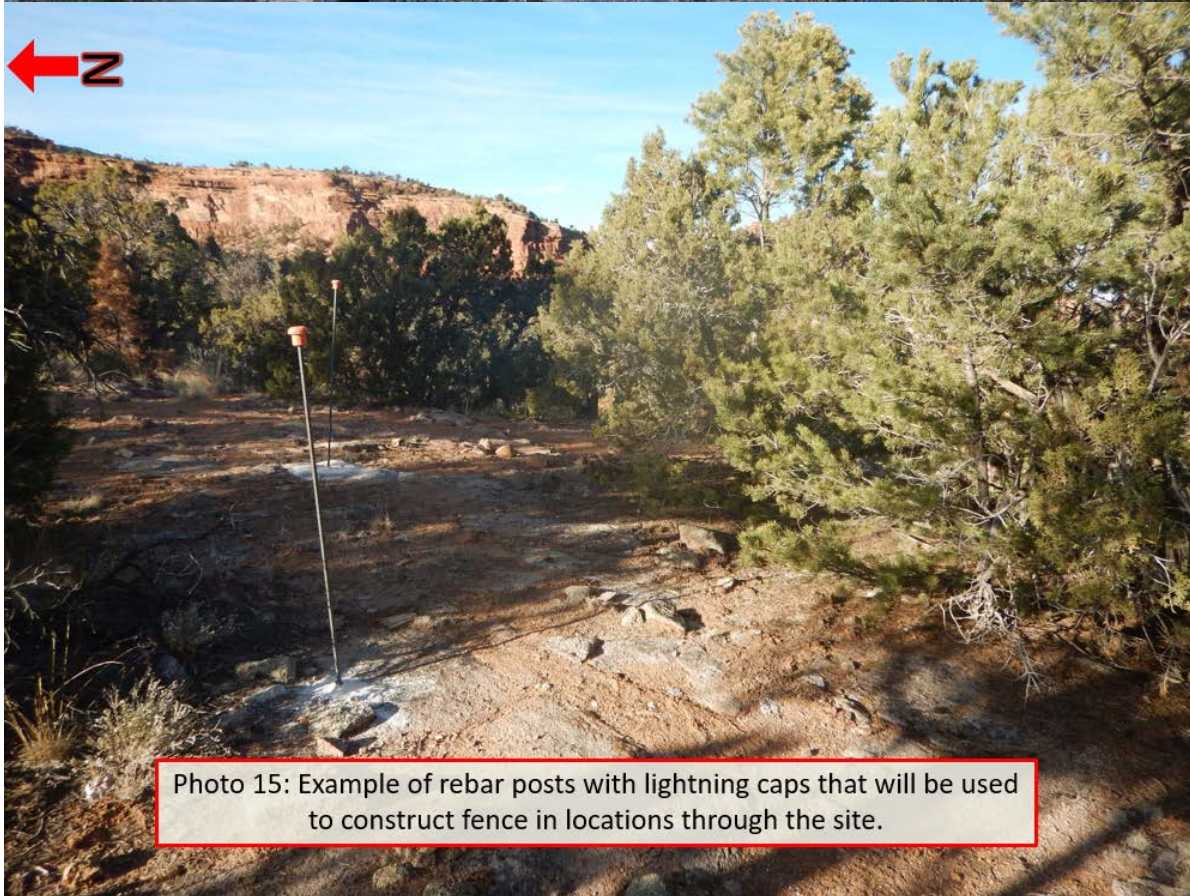
This site is located on BLM and thus open to the public. This presents a problem for maintaining public safety with an ongoing mining operation. Holes will be drilled for rebar with lightning caps and a three-string wire fence will be attached (See Photo 15). The upper fence will primarily encompass the Ridgetop Project Area because of the open pit. Portions of the Purple Pipe and Connector Project Areas will also be included in the upper fence area. A second fence will be installed along the lower access trail at the mine entrance to limit access and post important information prior to entering the mine. Additional fencing may be necessary as mining progresses. The Operator shall update the permit accordantly to account for all features on site.

Photo 15: Example of rebar posts with lightning caps that will be used to construct fence in locations through the site.
