FIELD WEEKLY PROGRESS REPORT

PROJECT: VALLEY LEACH FACILITY (VLF2) PHASE 2 CQA
SITE: CRIPPLE CREEK & VICTOR GOLD MINE (COLORADO)
CONTRACTOR: TEZAK HEAVY EQUIPMENT
WEEK ENDING: SATURDAY, JULY 4, 2020

REPORTING PERIOD: 06.28.2020 THROUGH 07.4.2020

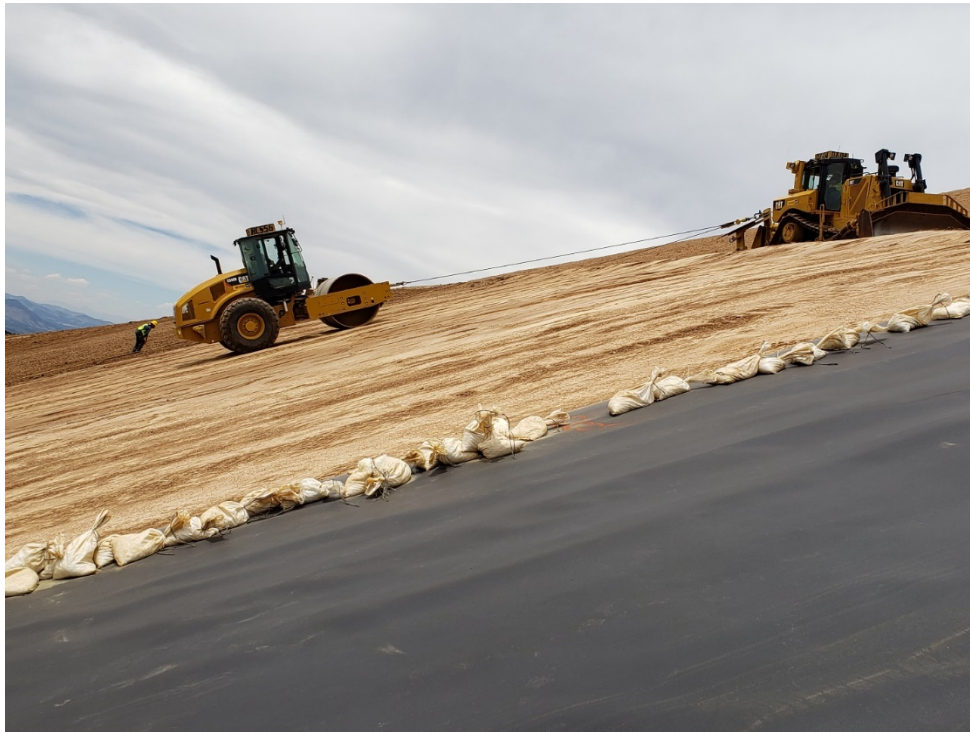
June 29, 2020 – Compacting Soil Liner Fill (BM)

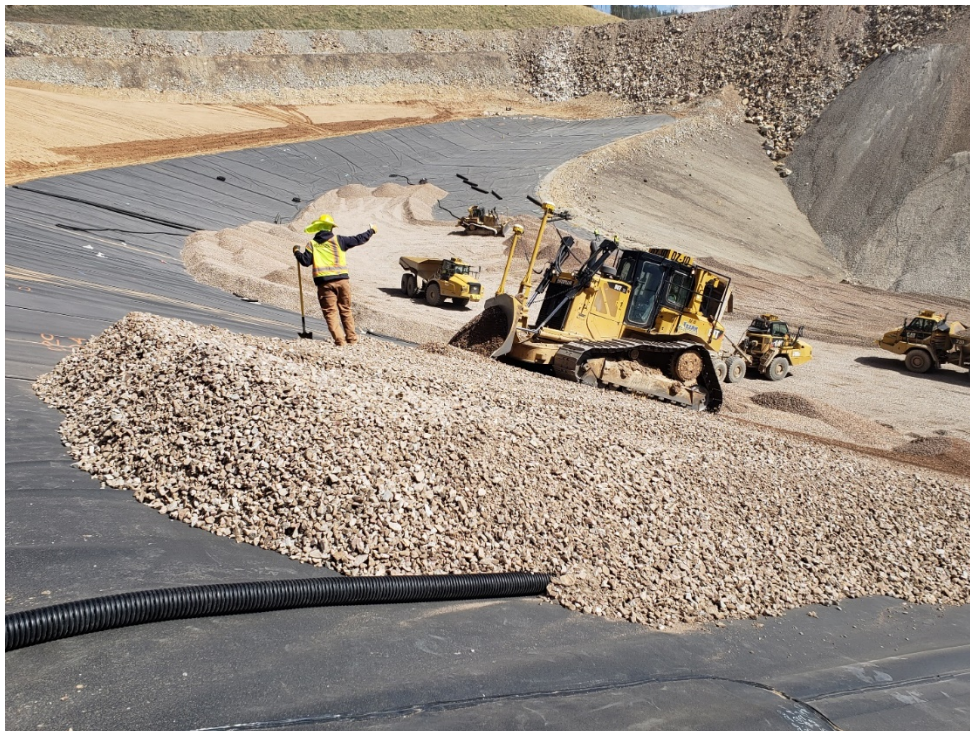
June 30, 2020 – Drain Cover Fill placement (BM)

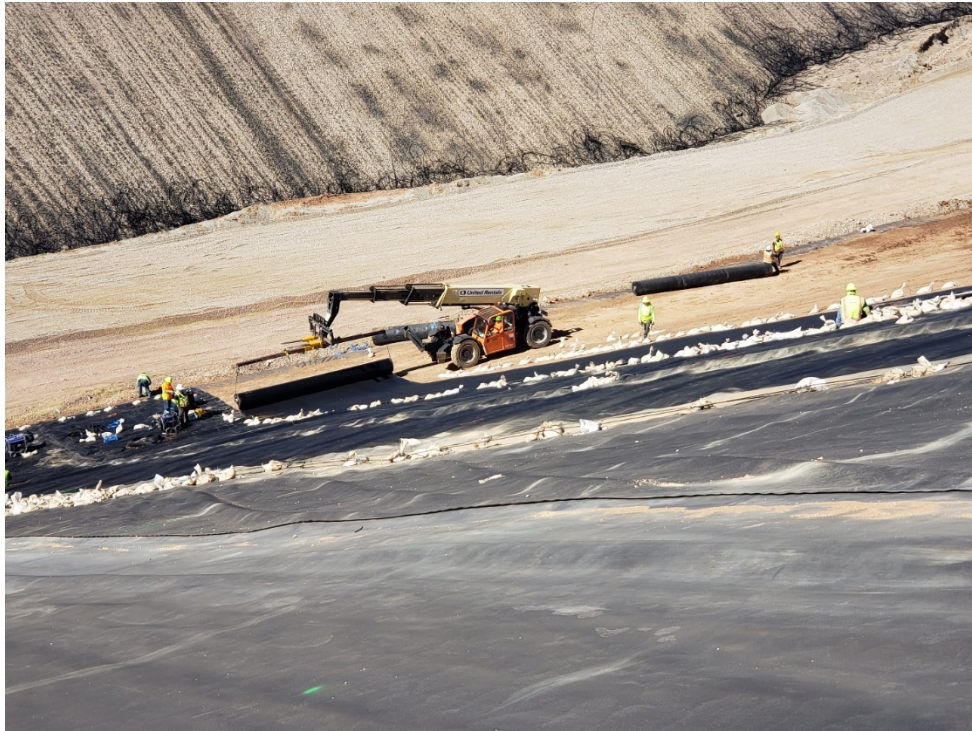
July 1, 2020 – Geomembrane deployment (BM)

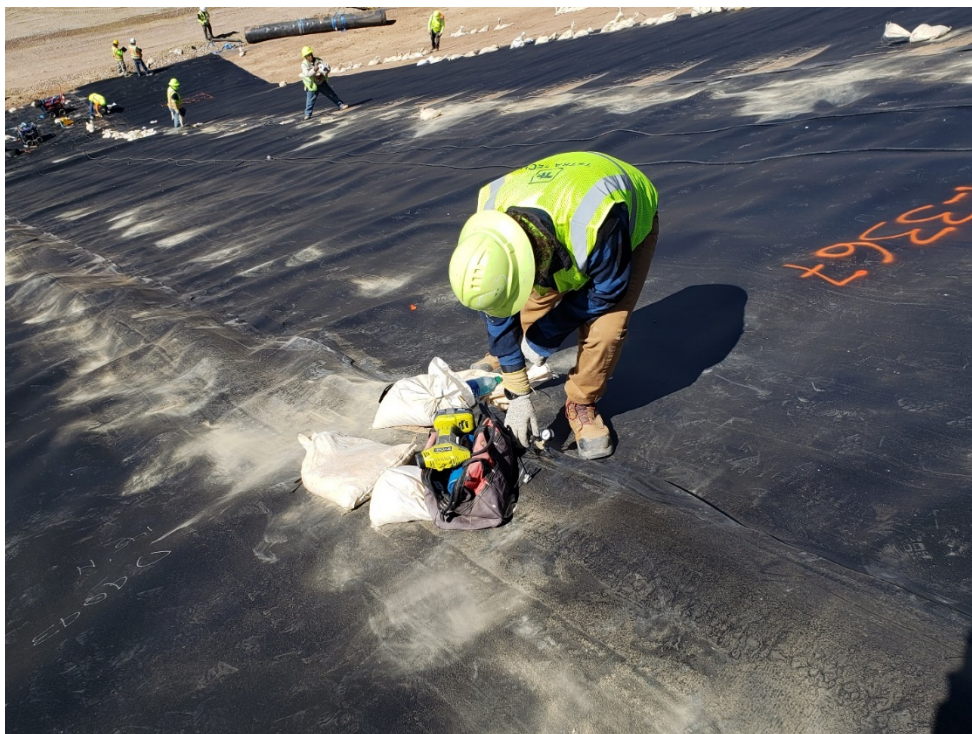
July 1, 2020 – Pressure testing fusion welds (BM)

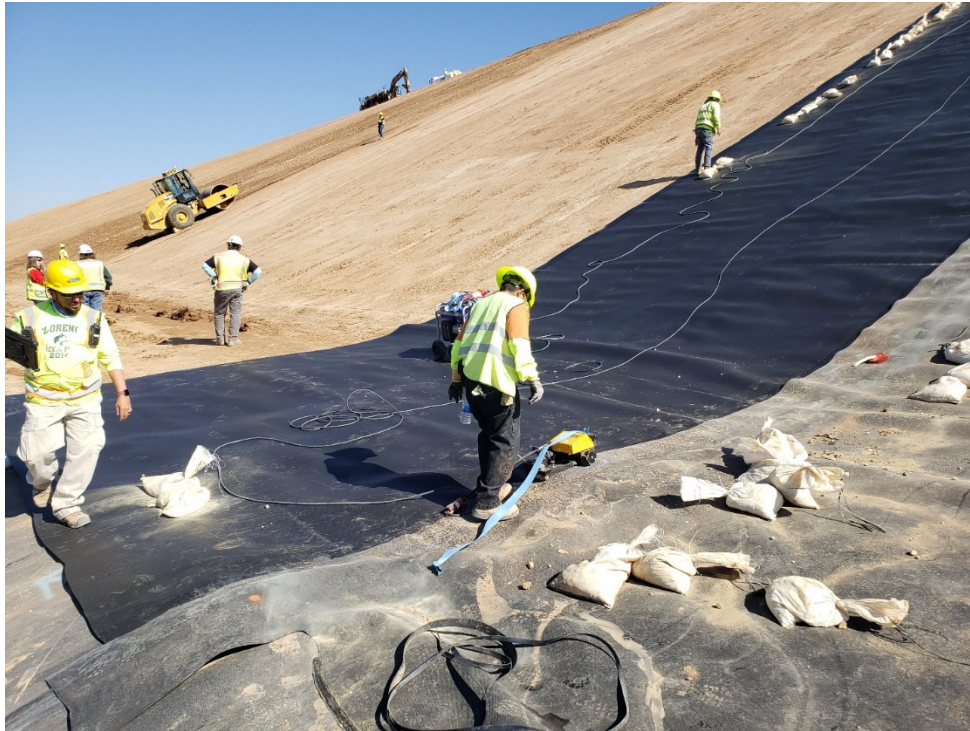
July 2, 2020 – Fusion welding seams (BM)

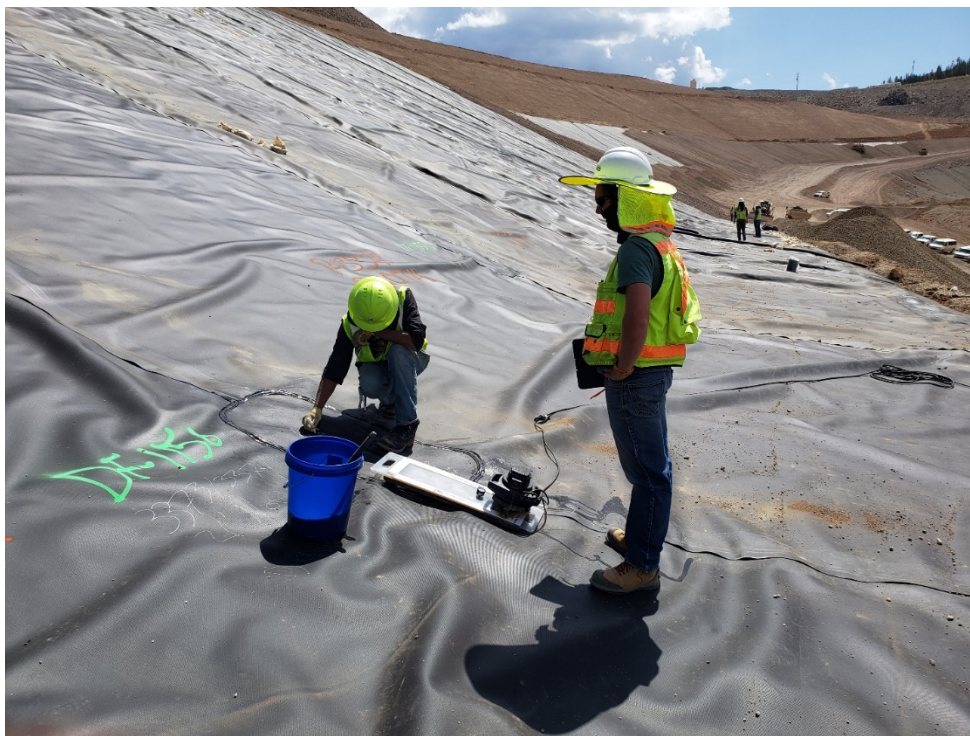
July 3, 2020 – Vacuum testing extrusion welds (BM)

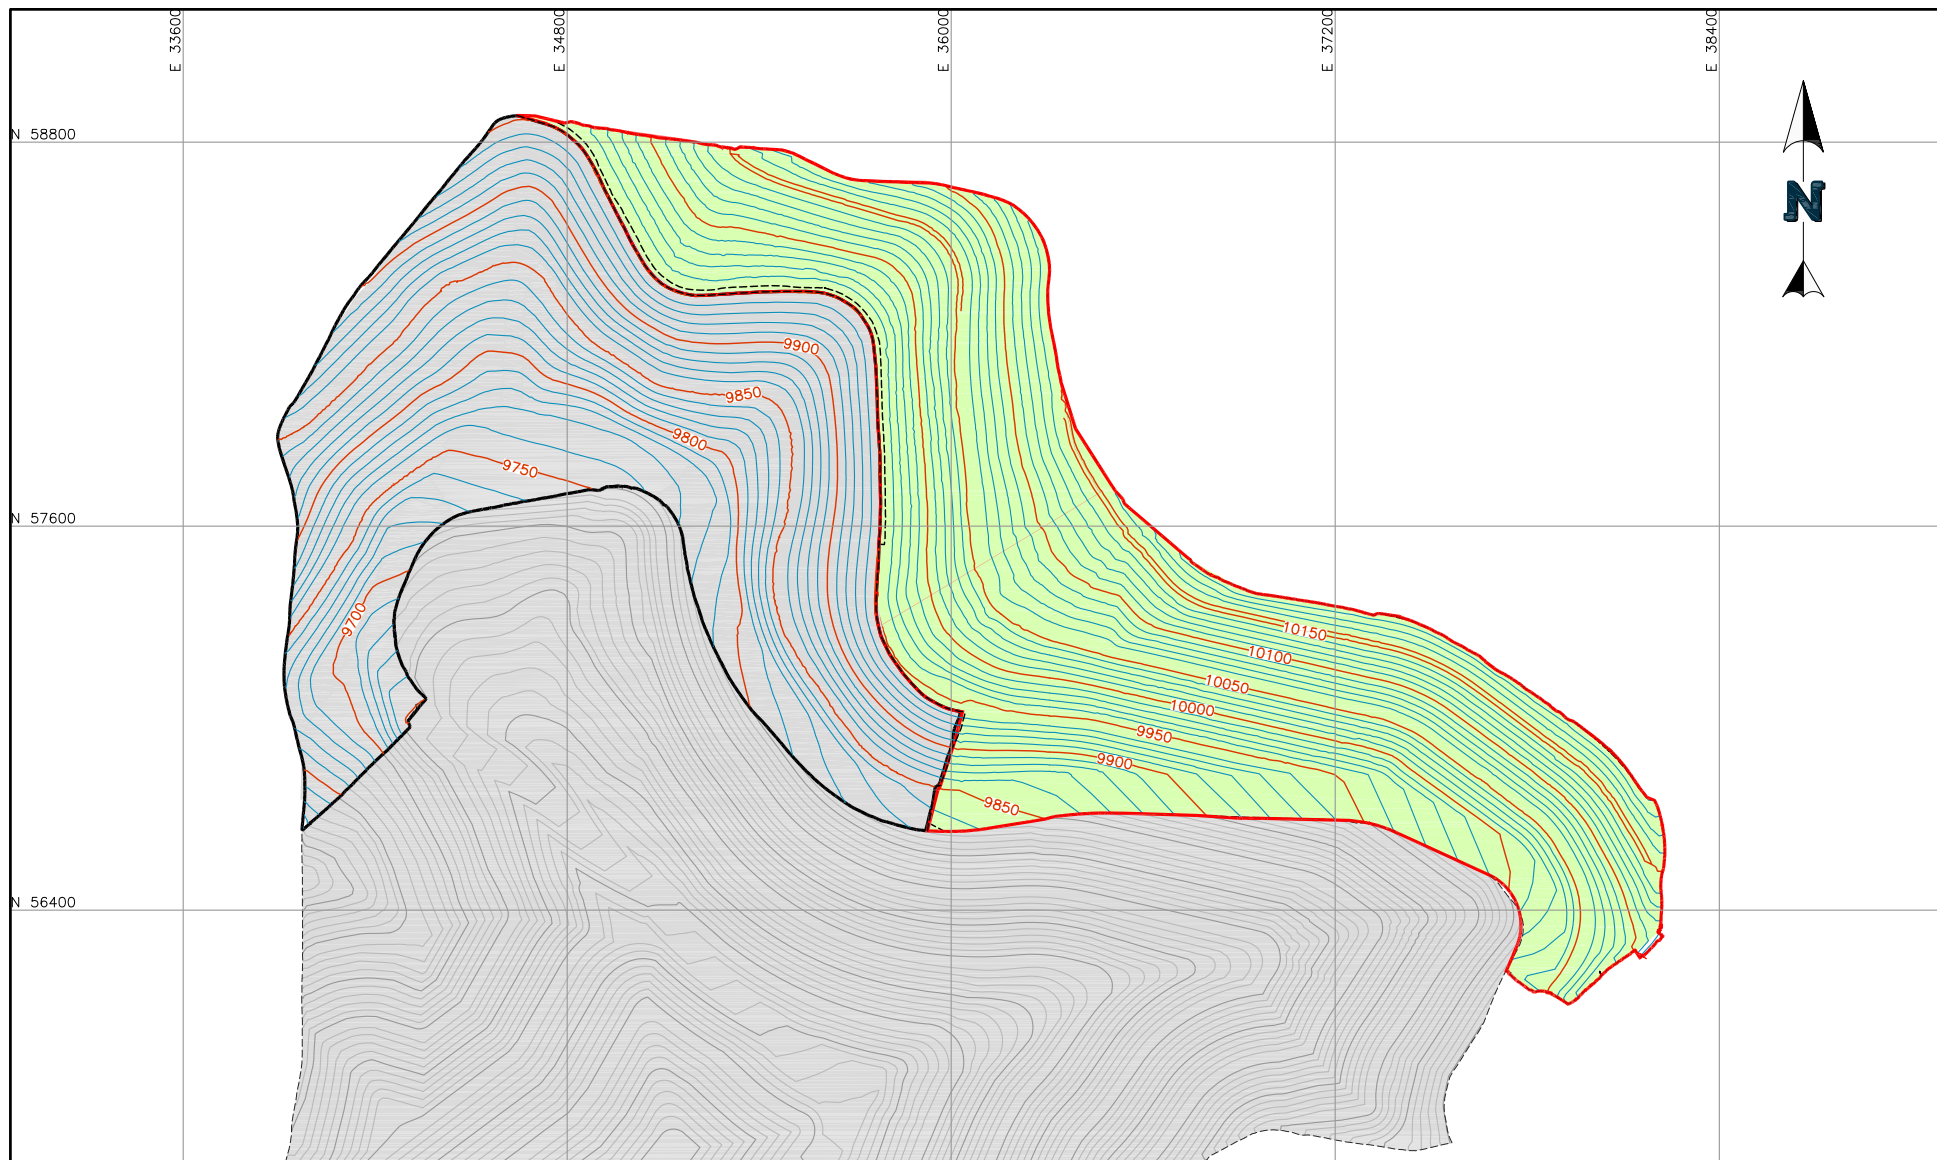
FILENAME SA WE200704	
FIGURE NO. 1	REVISION 1

All subgrade has been approved for 2020 construction. Figure 1 shows the current area of subgrade acceptance.

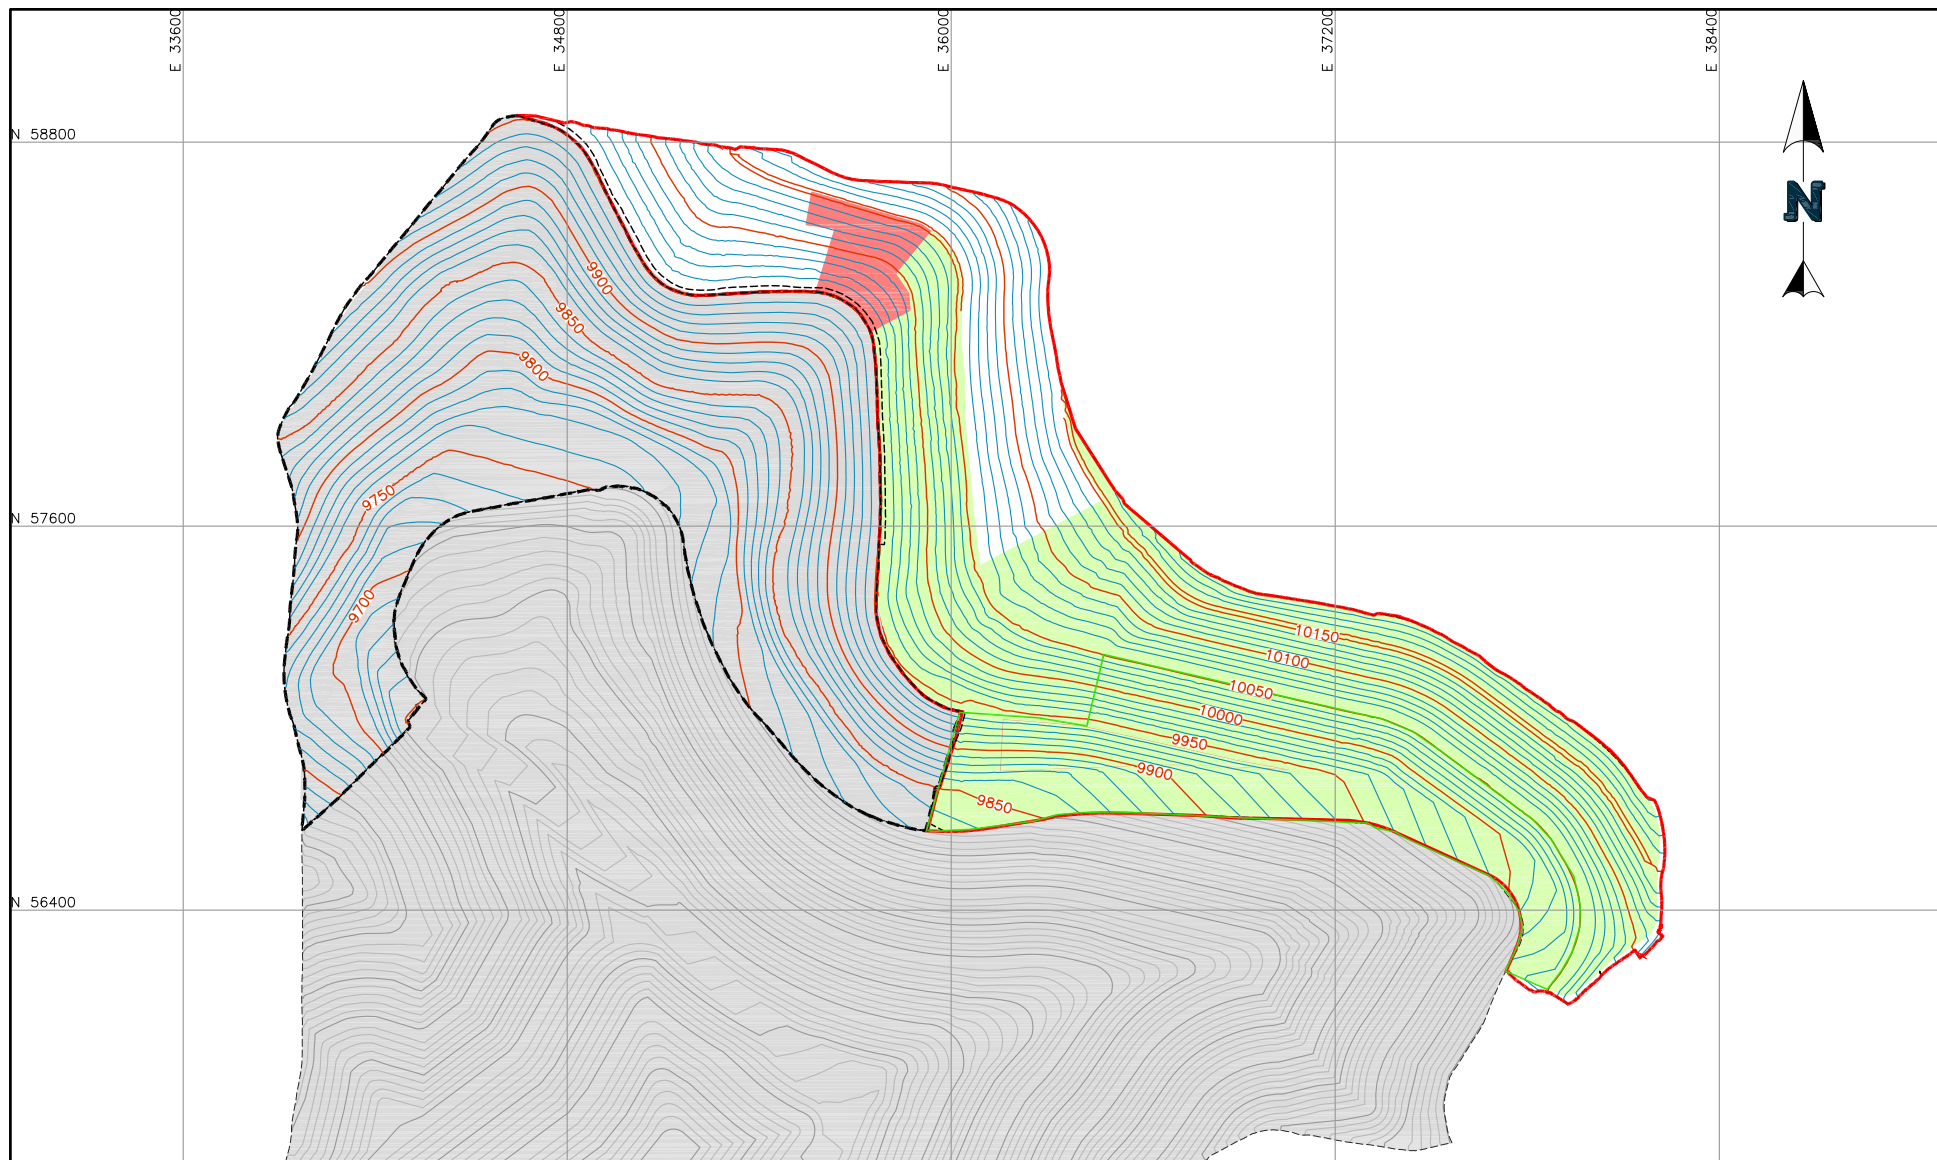
CLIENT Cripple Creek & Victor Gold Mining Company	
PROJECT		VLF2 Phase 2 CQA	
TITLE	WEEKLY SLF PLACEMENT WEEK ENDING 07-04-20	FILENAME SLF WE200704	
		FIGURE NO. 2	REVISION 1

Soil Liner Fill (SLF) placement continued in the northern portion of Phase 2B between the 9,950' and 10,050' benches. SLF material was hauled from the Dump 1 stockpile using articulating haul trucks. The material was then spread with low ground pressure CAT dozers equipped with GPS. Moisture conditioning of SLF material was performed in place using a water truck, and compaction was done using a vibratory smooth drum compactor. Figure 2 shows the area of SLF placement during this reporting period.

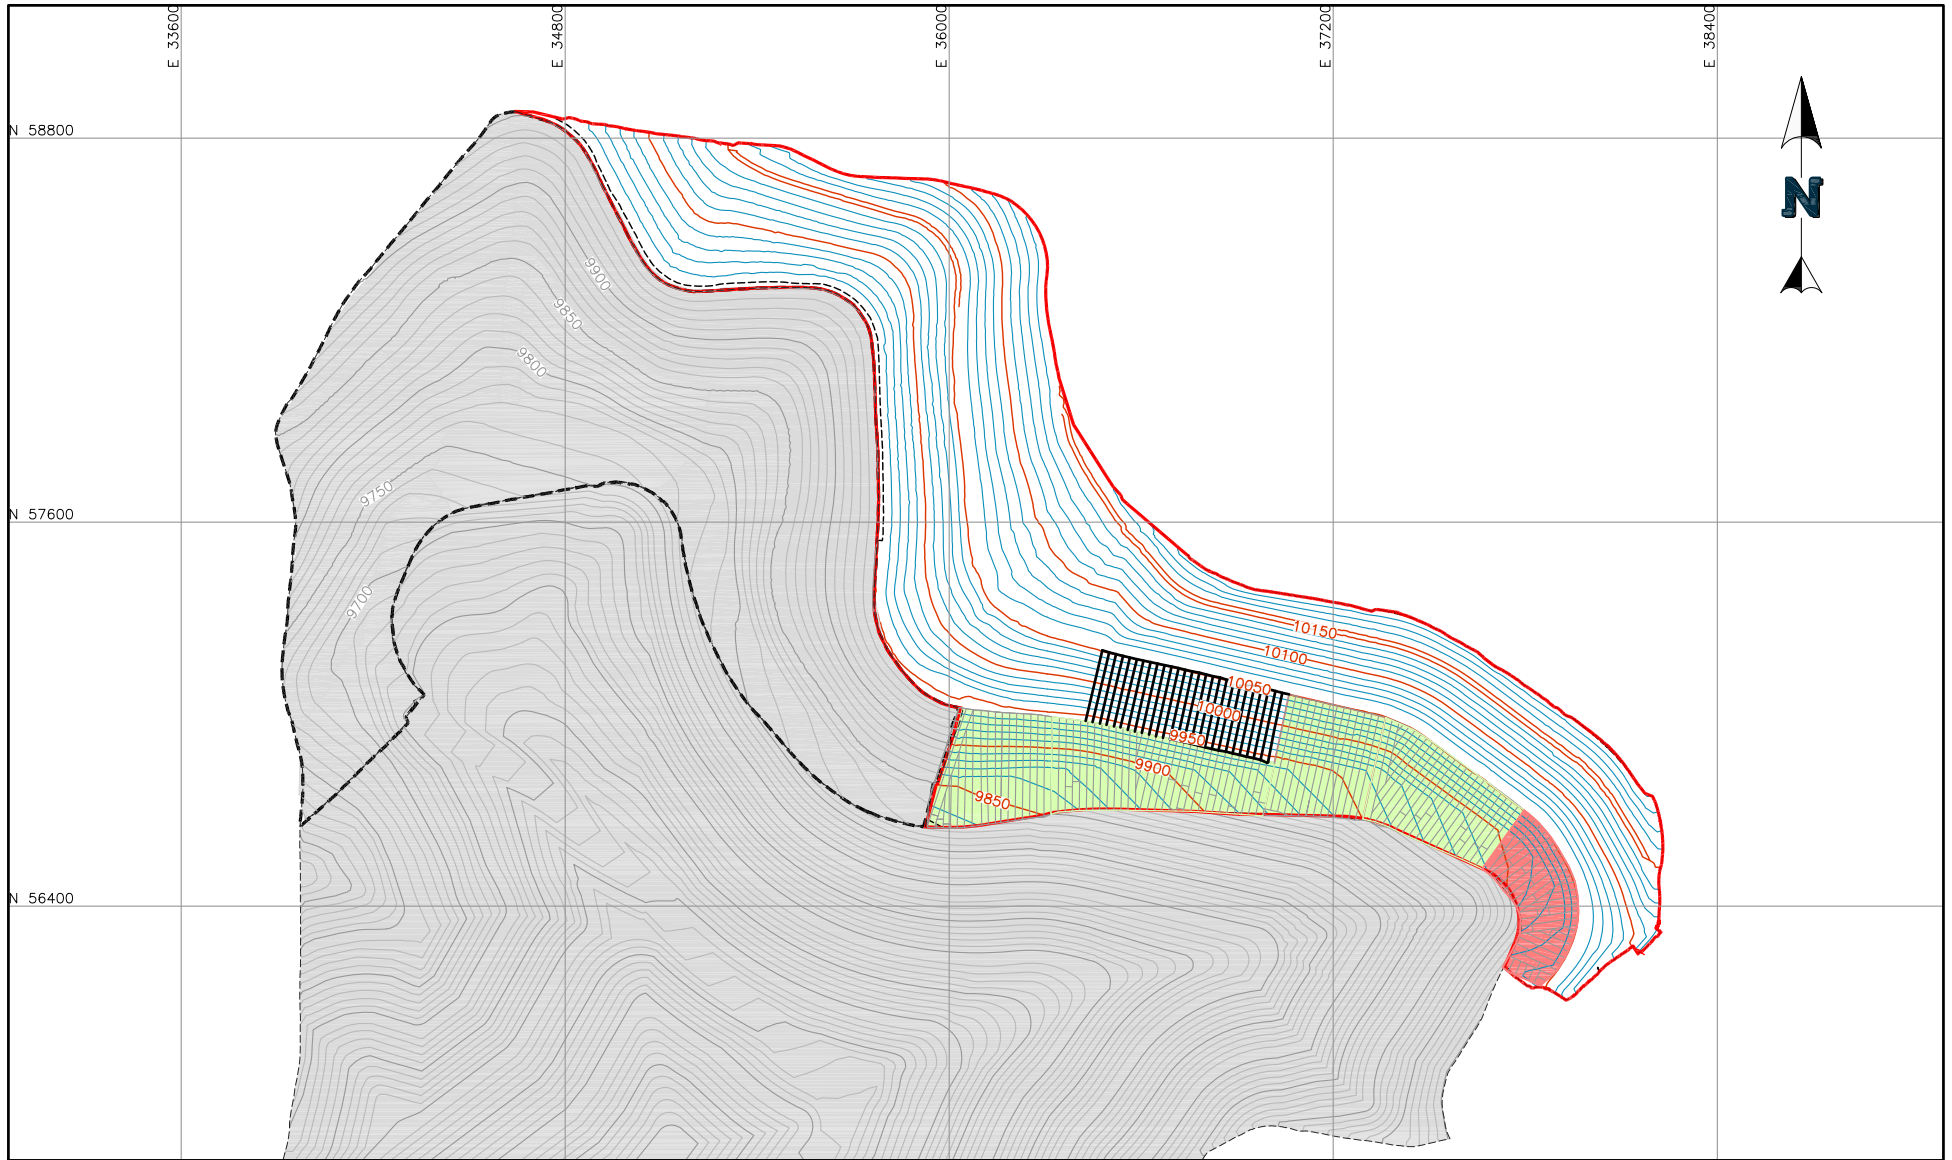
FIGURE NO.		REVISION	
3		1

Geomembrane installation continued within the Phase 2B limits as shown on Figure 3. Approximately **151,119** square feet (P-3358 to P-3384) of 80-mil LLDPE (double sided textured) was deployed. Subgrade was inspected and approved by NewFields, Tezak, Newmont and AEG

Panels P-3308 through P-3357 were accepted for drain cover fill placement. The attached Figure 3 shows the acceptance areas.

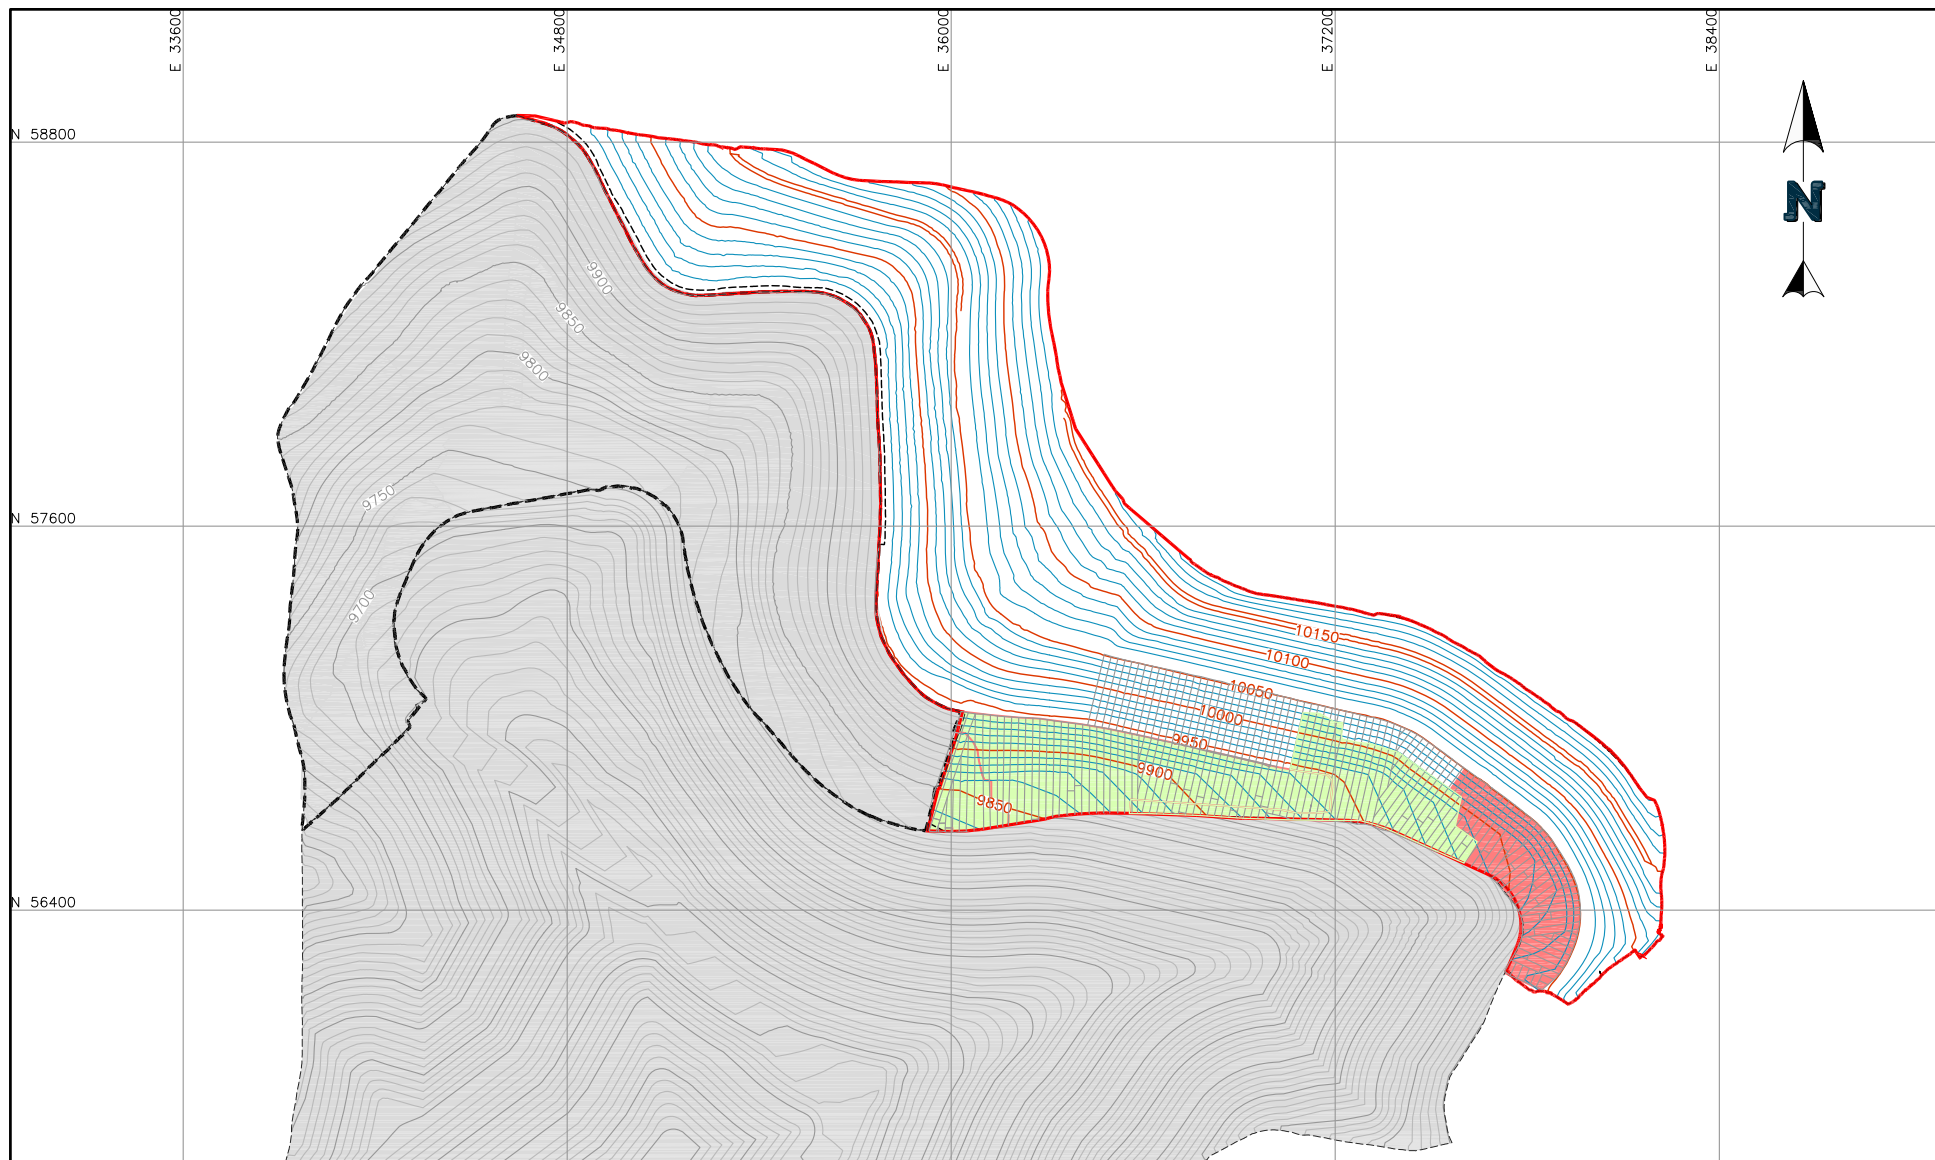
FIGURE NO. **4** REVISION **1**

Drain Cover Fill (DCF) placement was performed in the areas shown on Figure 4. The DCF was hauled from the mine's approved crushed ore stockpiles. The DCF was placed in a 2-foot lift on previously approved geomembrane by low ground pressure CAT dozers. Haul routes consisted of 4-foot lifts that will be spread into 2-foot lifts at a later date. Tezak laborers were present during placement to assist in removing debris/sandbags/large rocks, installing high volume solution collection piping, and ensuring that the lift thickness was correct. A NewFields' representative constantly monitored the DCF placement.

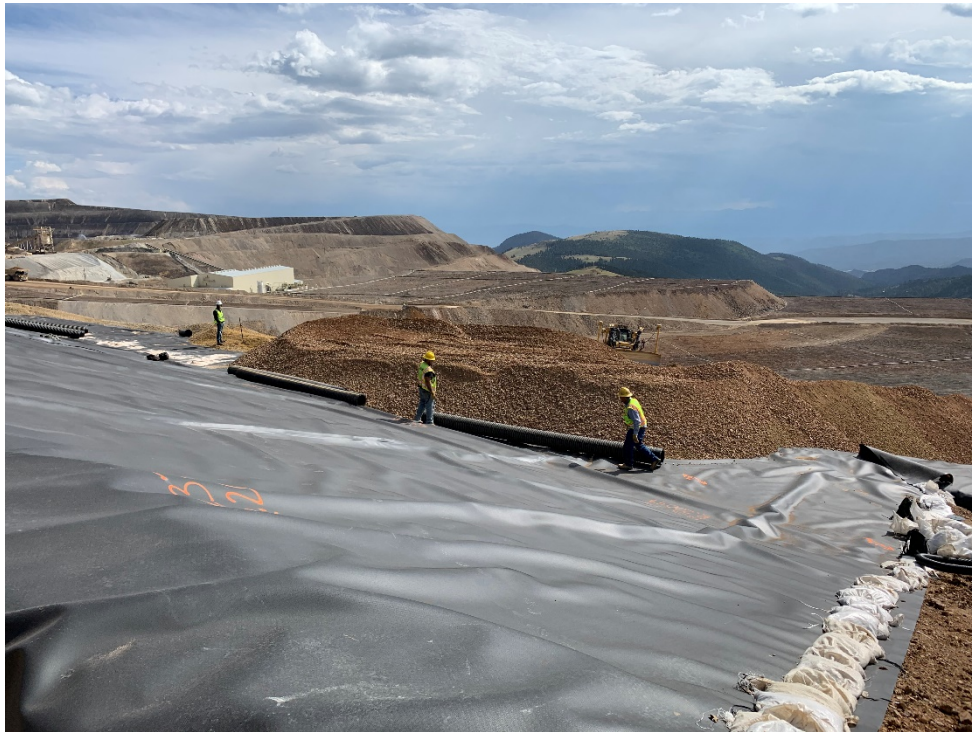
August 31, 2020 – HVSC pipe placement (TW)

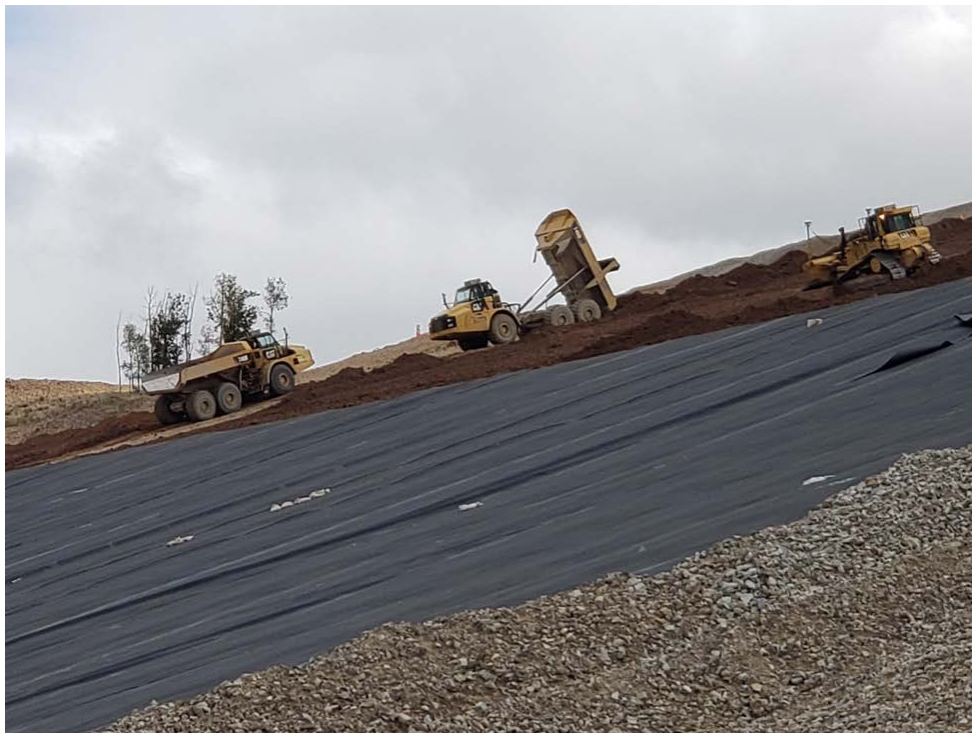
September 1, 2020 – SLF placement (BM)

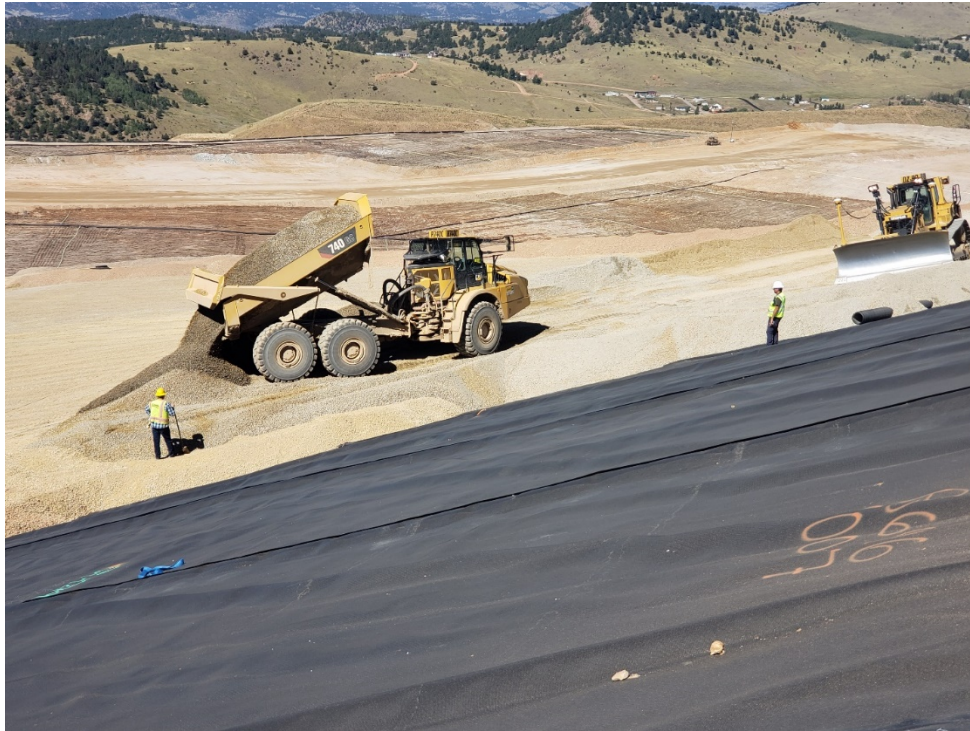
September 2, 2020 – DCF placement (BM)

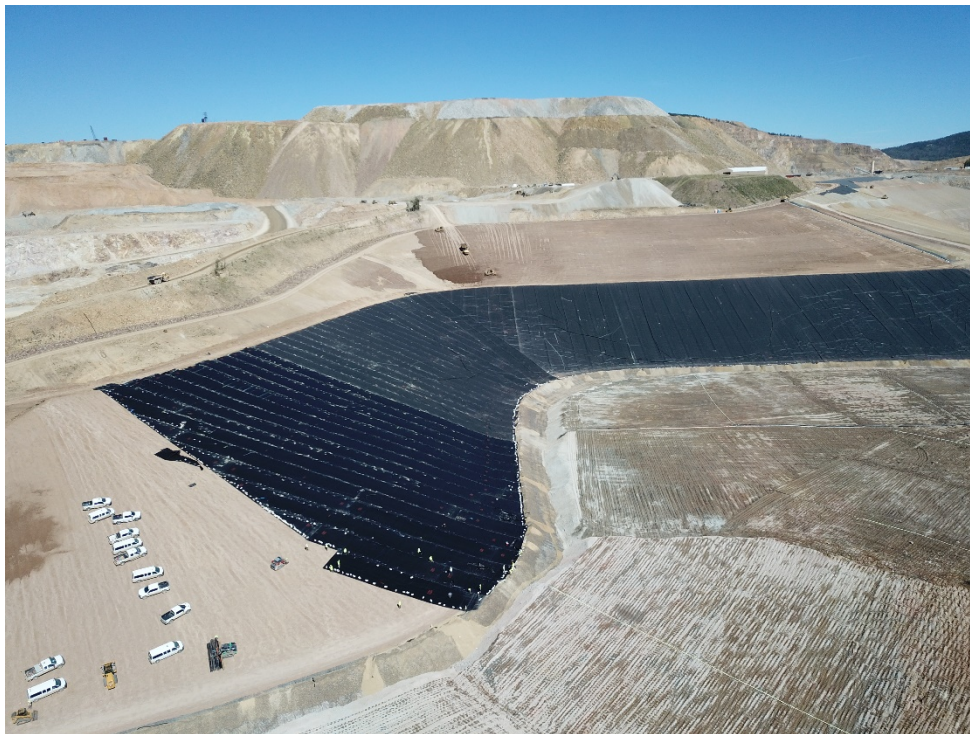
September 3, 2020 – Geomembrane and SLF placement progress (BM)

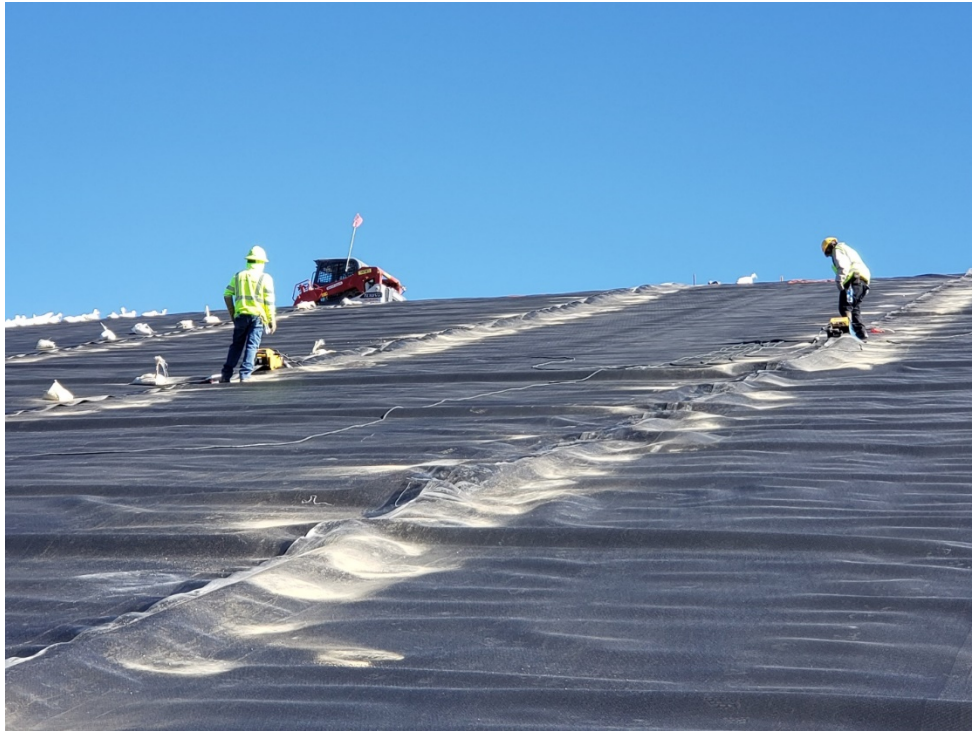
September 3, 2020 – Geomembrane fusion seaming (BM)

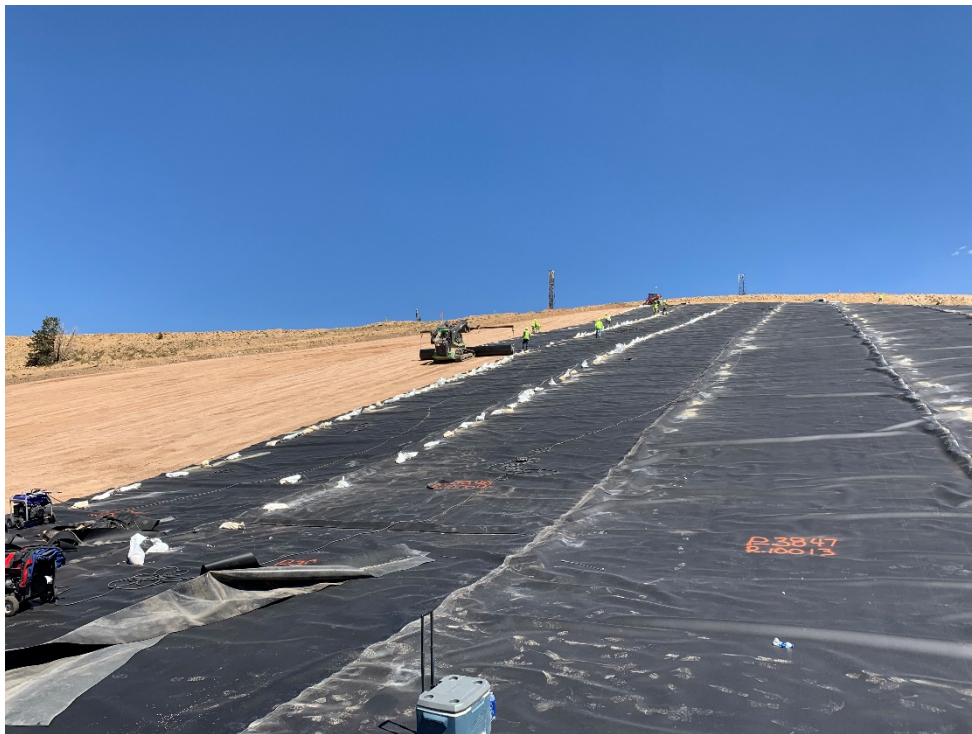
September 4, 2020 – Geomembrane deployment (BM)

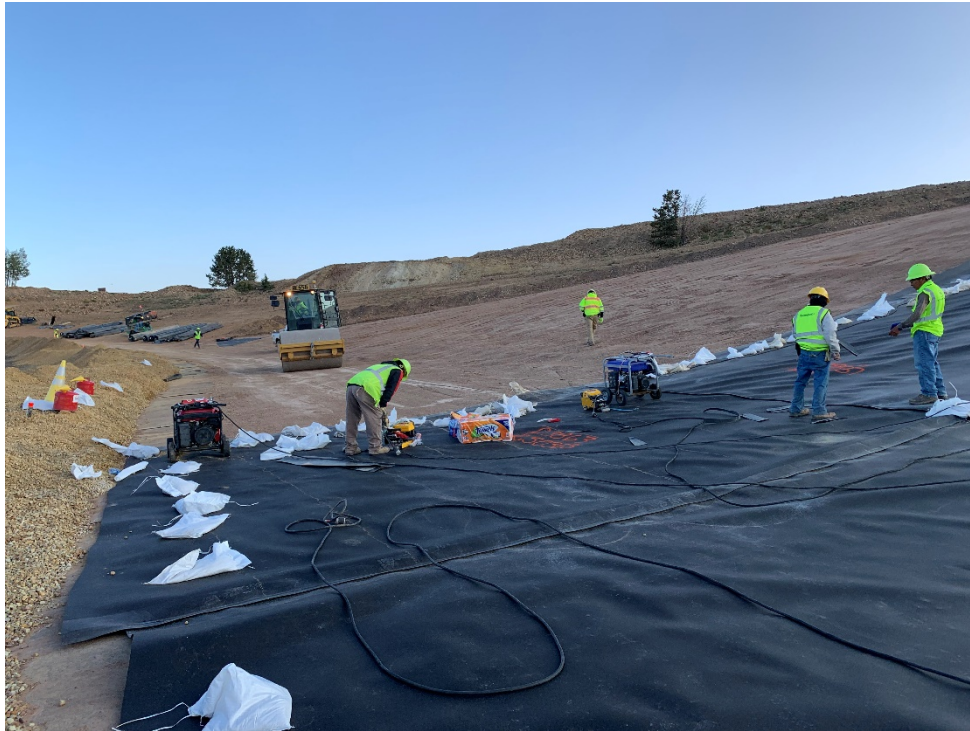
September 5, 2020 – Geomembrane trial weld (BM)

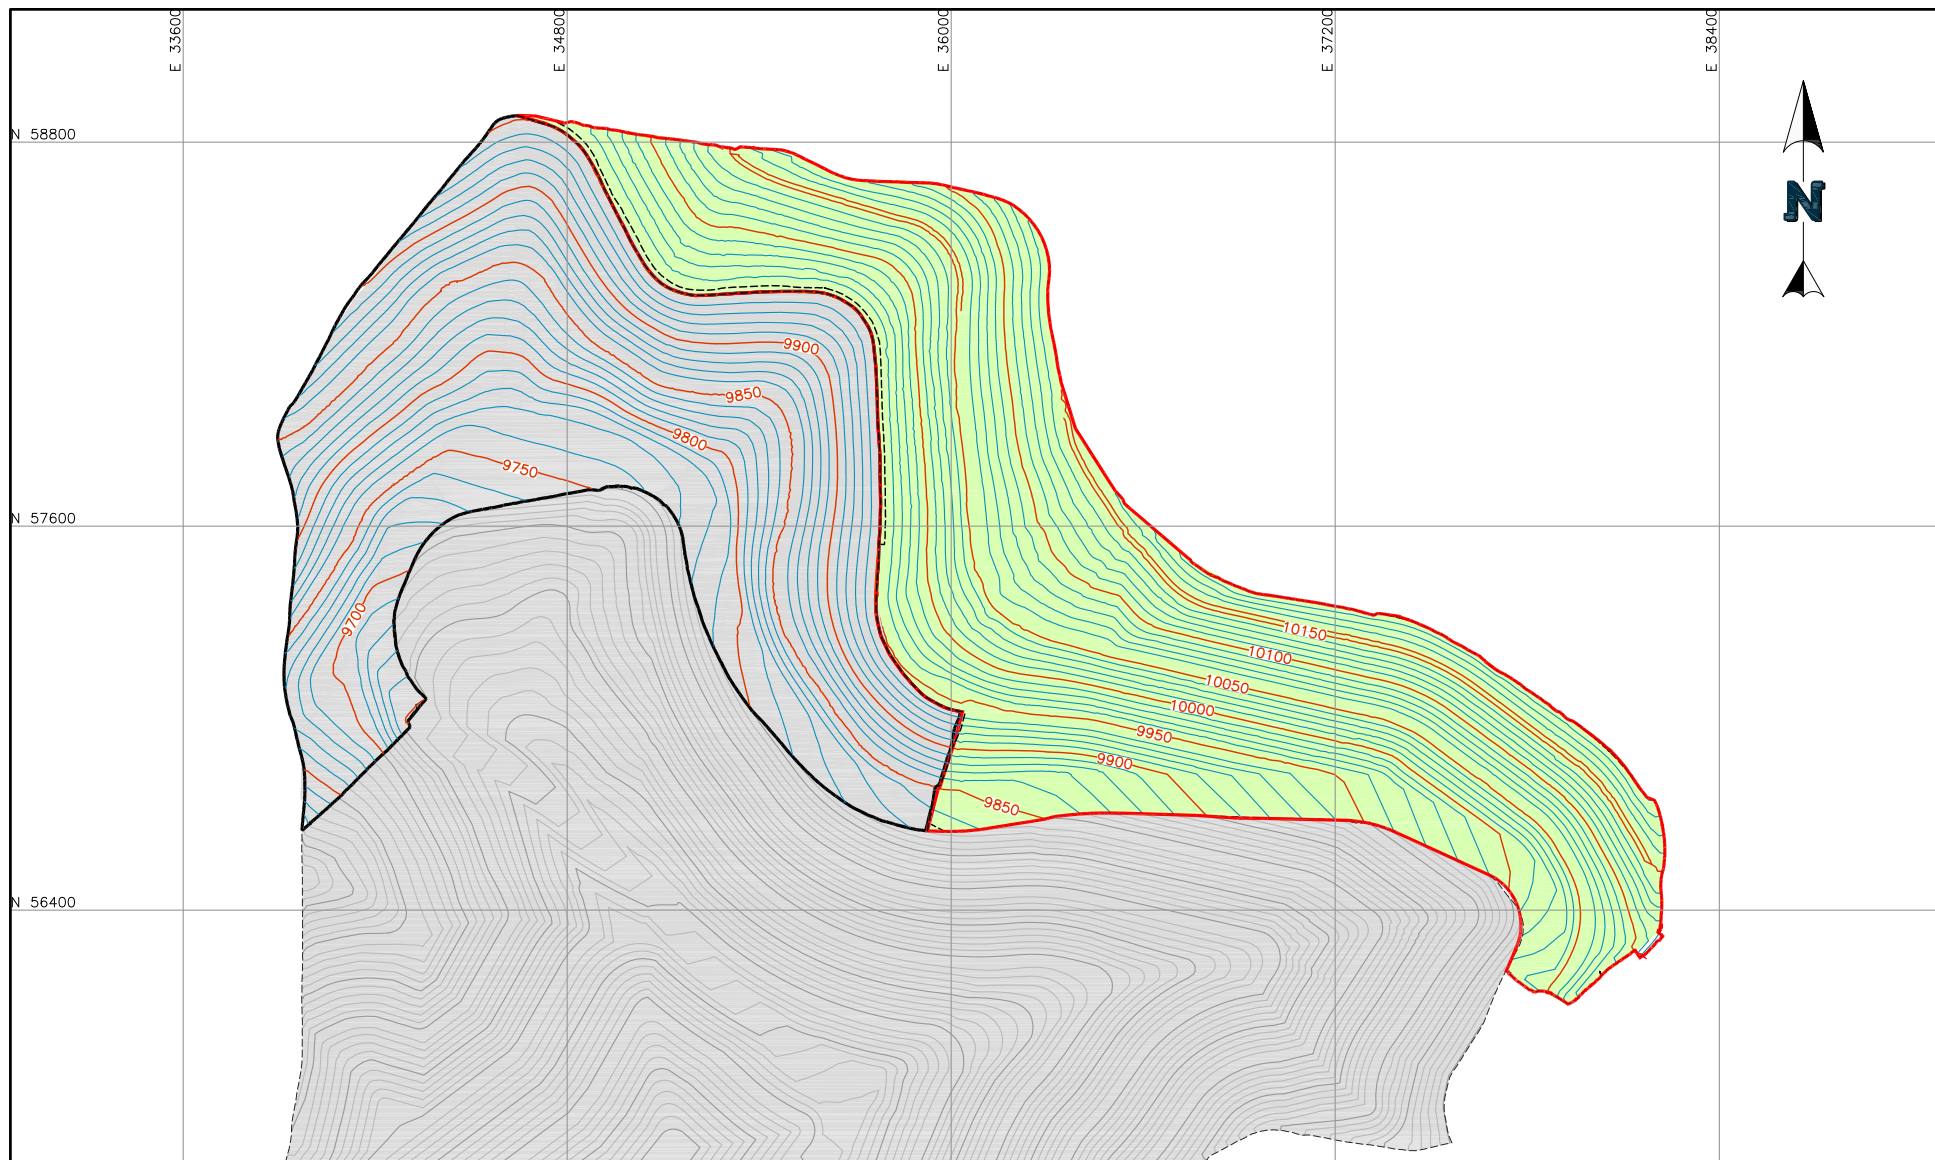
FIGURE NO.		REVISION	
1		1

All subgrade has been approved for 2020 construction. Figure 1 shows the current area of subgrade acceptance.
