FIELD WEEKLY PROGRESS REPORT

PROJECT: VALLEY LEACH FACILITY (VLF2) PHASE 2 CQA
SITE: CRIPPLE CREEK & VICTOR GOLD MINE (COLORADO)
CONTRACTOR: TEZAK HEAVY EQUIPMENT
WEEK ENDING: SATURDAY, JULY 4, 2020

REPORTING PERIOD: 06.28.2020 THROUGH 07.4.2020

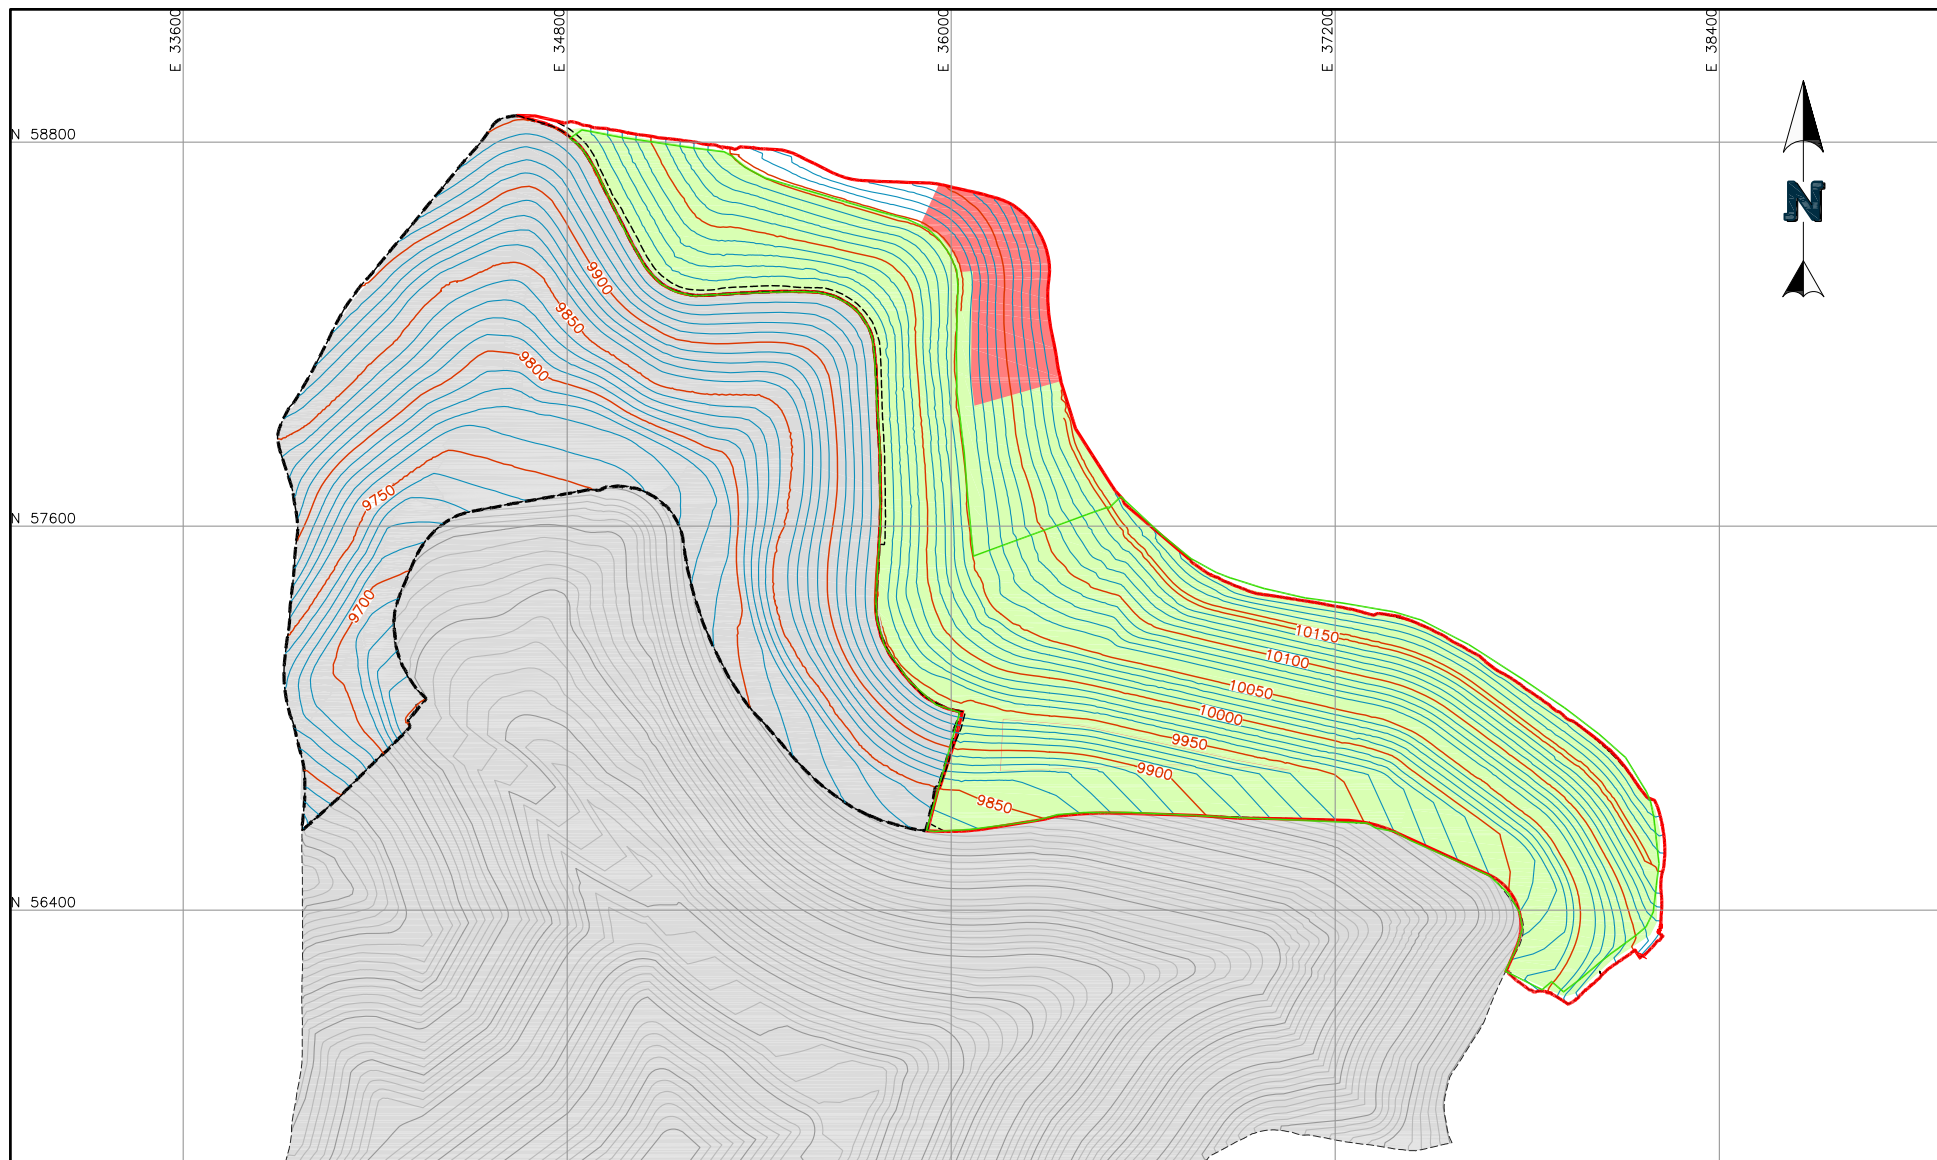
CLIENT		CRIPPLE CREEK & VICTOR GOLD MINING COMPANY	
PROJECT		VLF2 PHASE 2 CQA			
TITLE	WEEKLY SLF PLACEMENT WEEK ENDING 09-05-20			FILENAME	
				SLF WE200905	
				FIGURE NO.	REVISION
				2	1

Soil Liner Fill (SLF) placement continued in the northern portion of Phase 2B between the 10,050' and 10,150' benches. SLF material was hauled from the Dump 1 stockpile using articulating haul trucks. The material was then spread with low ground pressure CAT dozers equipped with GPS. Moisture conditioning of SLF material was performed in place using a water truck, and compaction was done using a vibratory smooth drum compactor. Figure 2 shows the area of SLF placement during this reporting period.

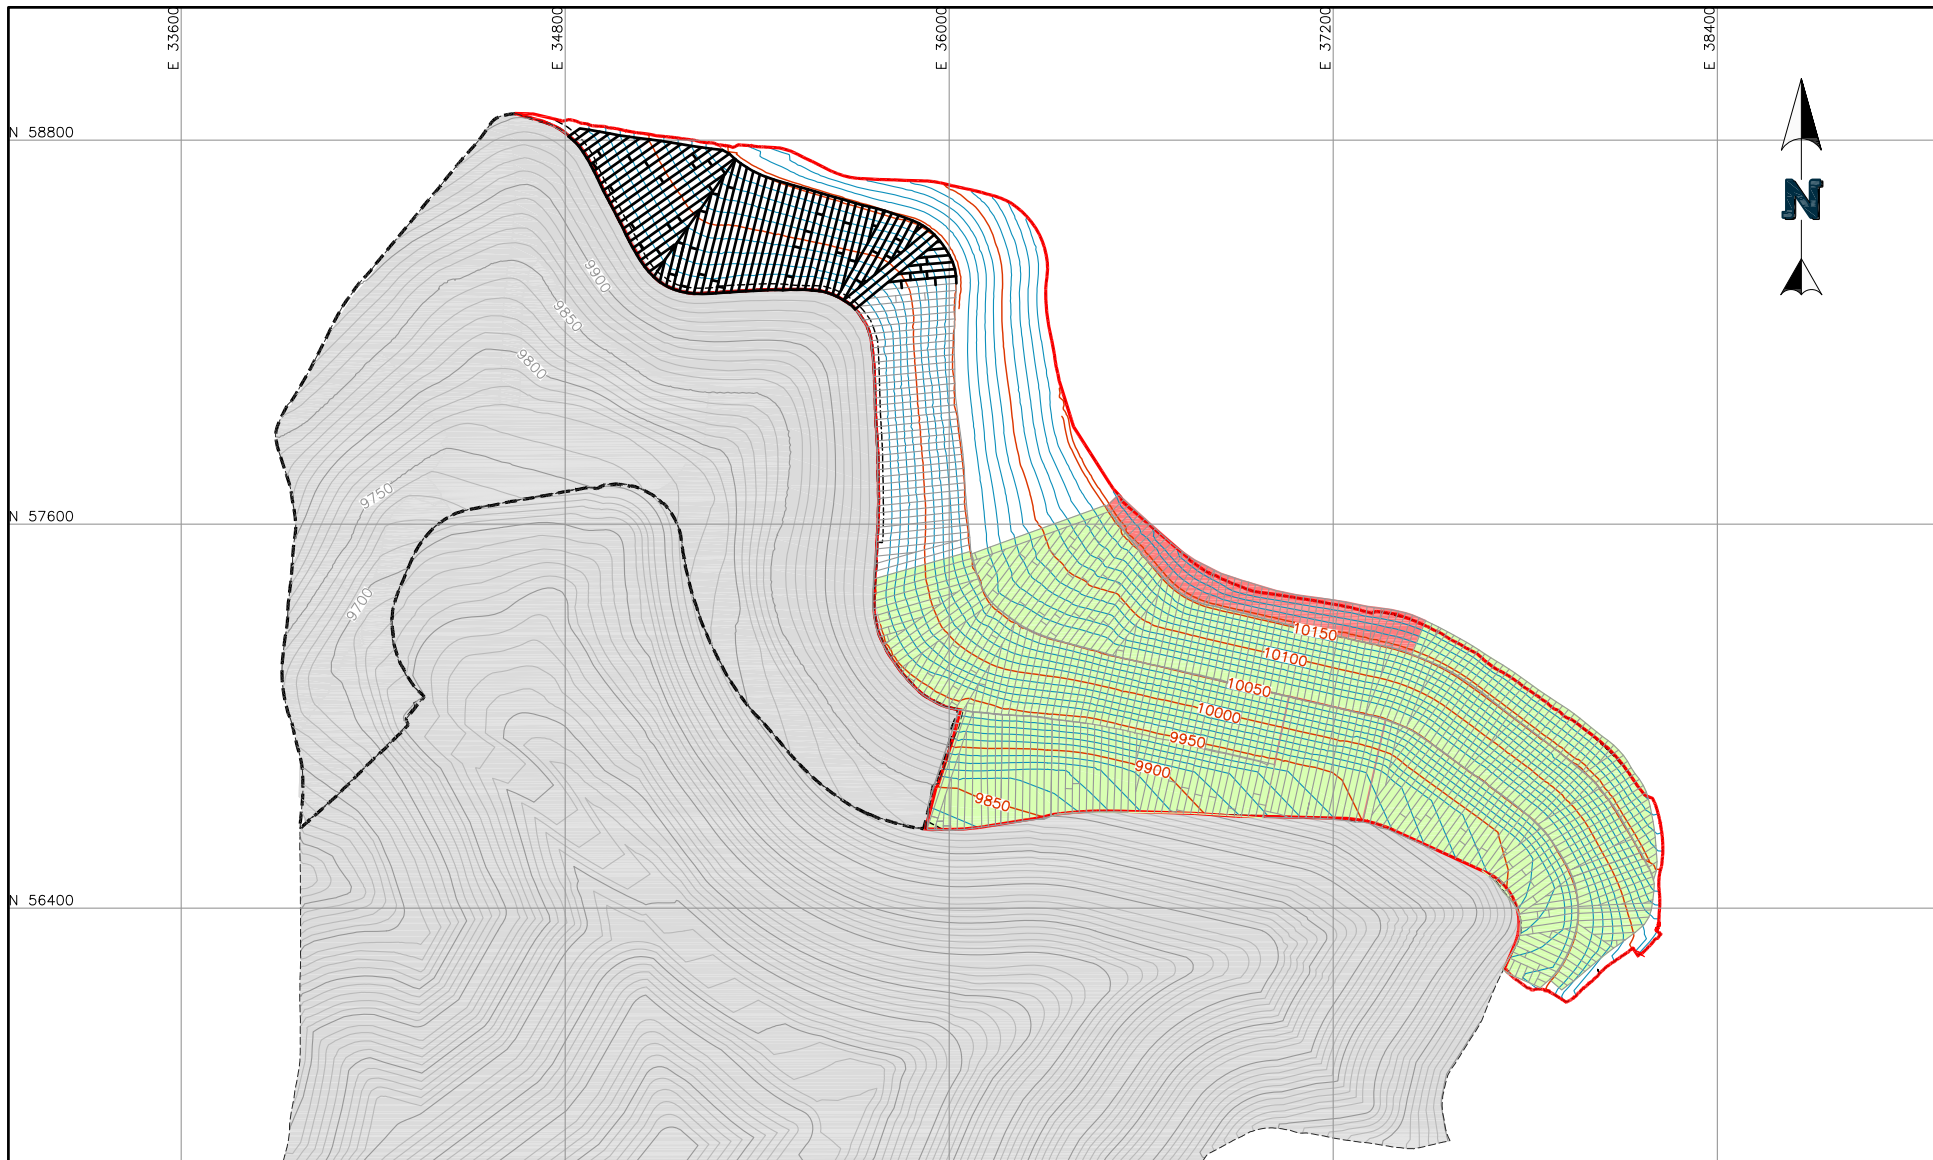
FILENAME
Liner WE200905
FIGURE NO. 3
REVISION 1

Geomembrane installation continued within the Phase 2B limits as shown on Figure 3. Approximately **391,303** square feet (P-3756 to P-3876) of 80-mil LLDPE (double sided textured) was deployed to finish liner placement in Phase 2B Part 1. Subgrade was inspected and approved by NewFields, Tezak, Newmont and AEG representatives prior to geomembrane deployment.

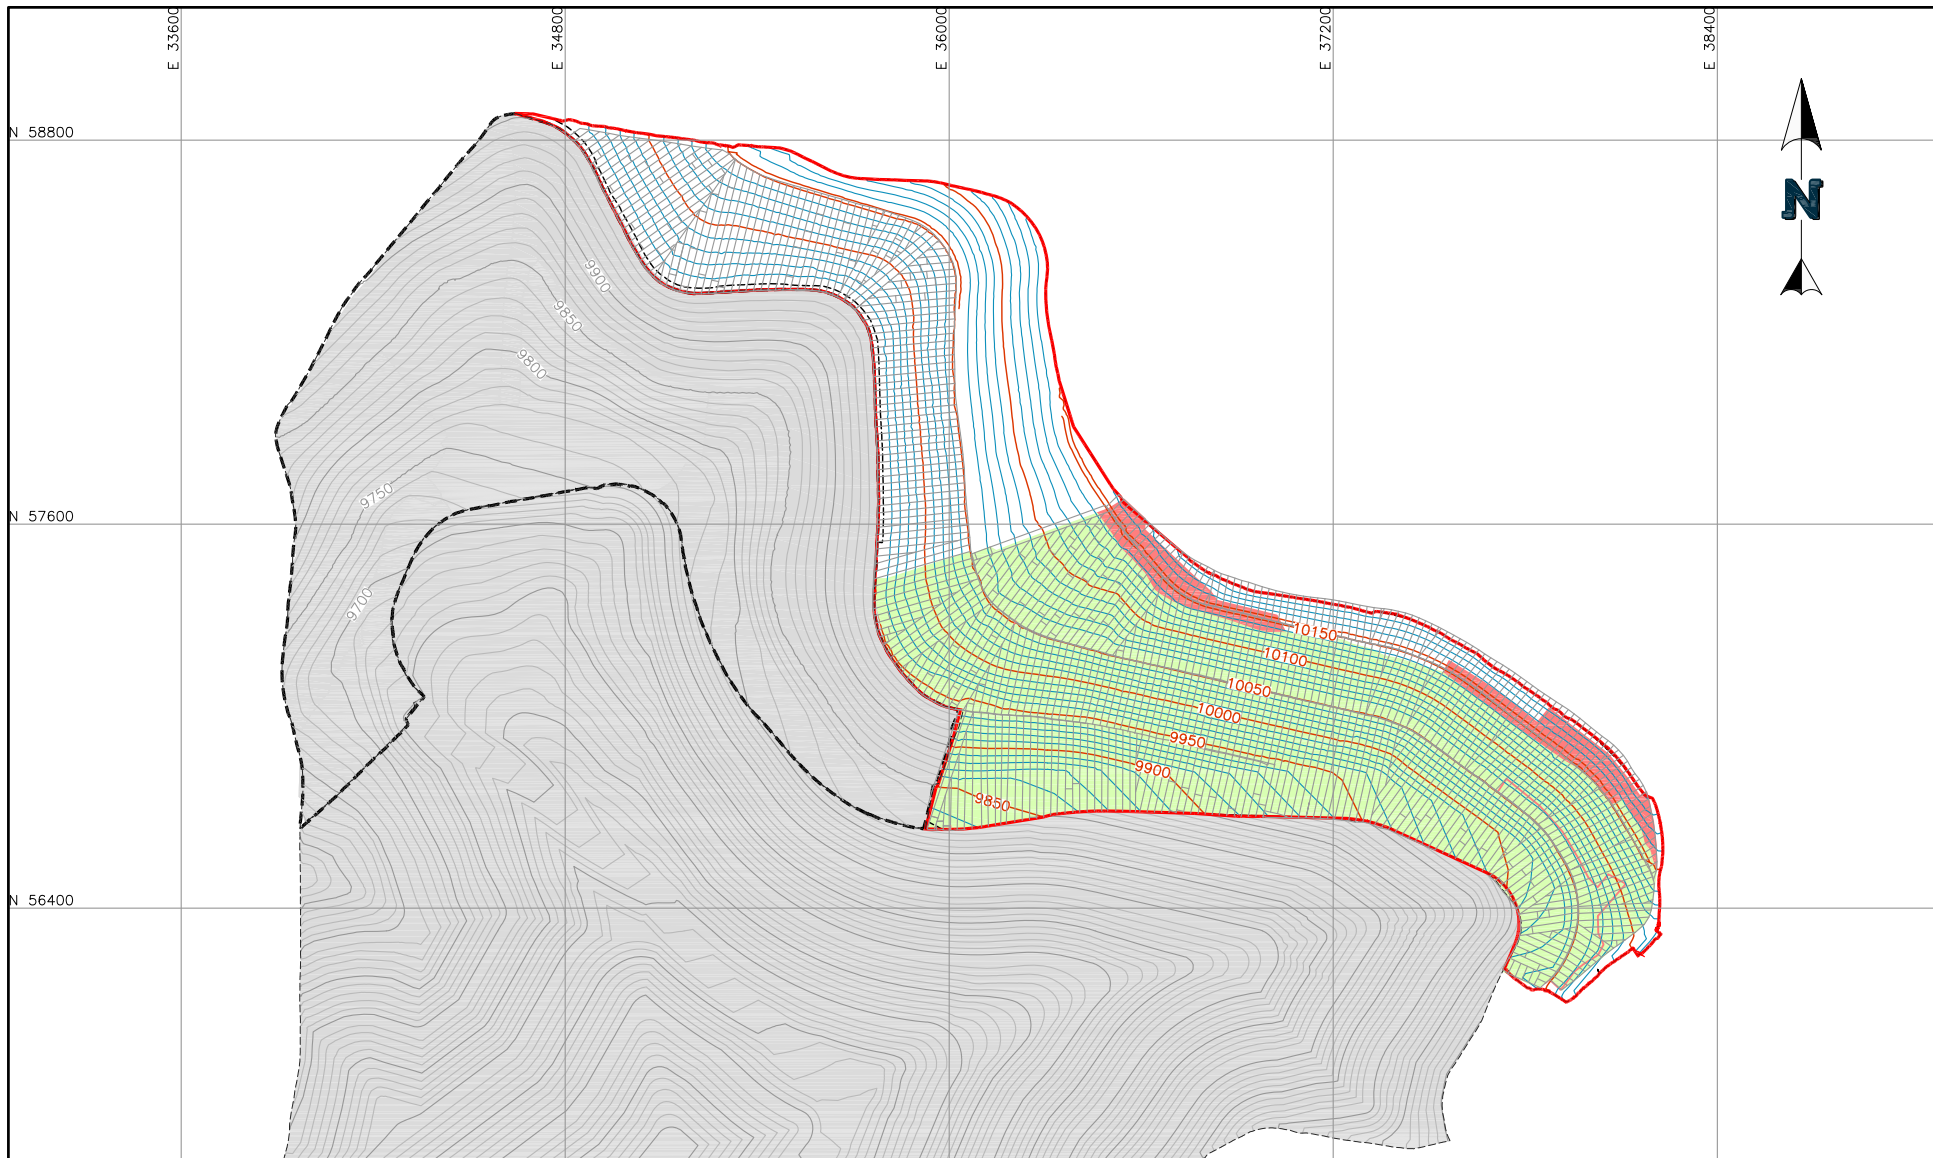
FIGURE NO. **4** REVISION **1**

Drain Cover Fill (DCF) placement was performed in the areas shown on Figure 4. The DCF was hauled from the mine's approved crushed ore stockpiles. The DCF was placed in a 2-foot lift on previously approved geomembrane by low ground pressure CAT dozers. Haul routes consisted of 4-foot lifts that will be spread into 2-foot lifts at a later date. Tezak laborers were present during placement to assist in removing debris/sandbags/large rocks, installing high volume solution collection piping, and ensuring that the lift thickness was correct. A NewFields' representative constantly monitored the DCF placement.
