STATE OF
COLORADO

Inspection report

Permit Number: C-1981-028 Mine Name: Keenesburg Strip Mine Operator: Coors Energy Company Operator Address: Mr. Ben Moline 1801 California Street Suite 4600 Denver, CO 80202	County: Weld Operation Type: Surface Permit Status: Active Ownership: Private
	Operator Representative Present: None
Operator Representative Signature: (Field Issuance Only)

Inspection Start Date: October 28, 2020 Inspection Start Time: 08:40 Inspection End Date: October 28, 2020 Inspection End Time: 09:45		Inspection Type: Coal Partial Inspection Inspection Reason: Normal I&E Program Weather: Clear	
Joint Inspection Agency: None		Joint Inspection Contacts: 	
Post Inspection Agency: None		Post Inspection Contacts: 	
Inspector(s): Robert Zuber, P.E.	Inspector's Signature:

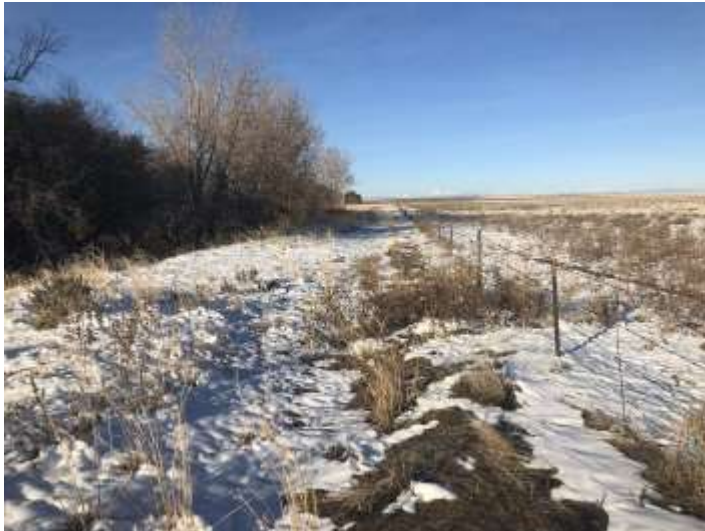
Sediment Pond 2 – north side

Only small amounts of water (if any) were in the two ponds, and neither pond was discharging during the inspection. There were no signs that they had discharged recently. As usual, they both contained large amounts of riparian vegetation. **No problems were observed with the two ponds except for a hole in the embankment at Sediment Pond 2.** The hole is approximately 24 inches by 36 inches and one foot deep. It is approximately 100 feet west of the spillway.

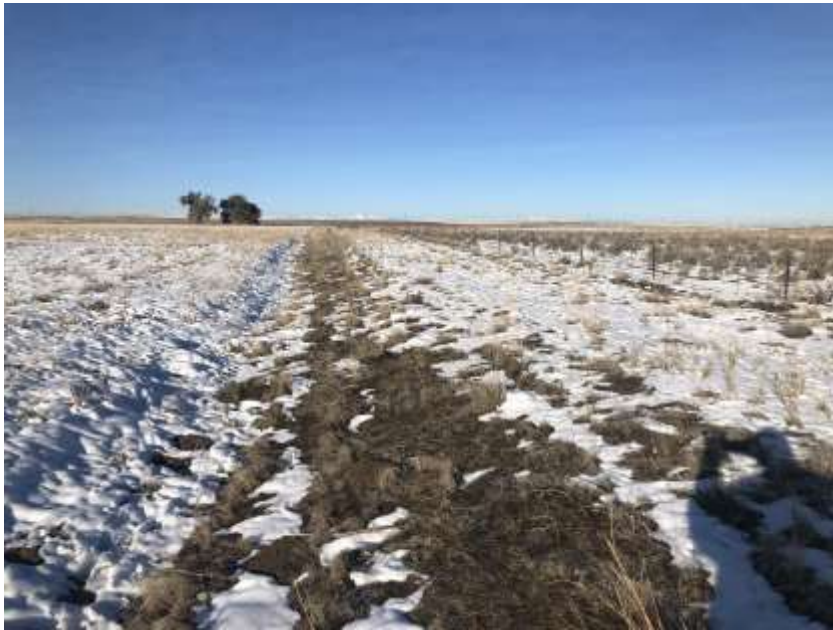
The ditch along the north side is in good condition.

Ditch along north side of site

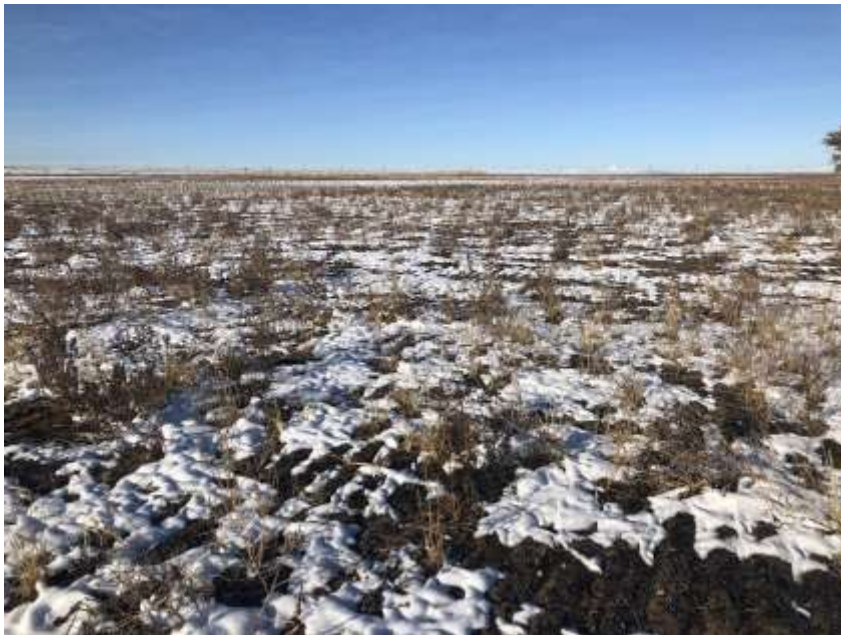
Within the Long Term Spoil area where reclamation has recently been performed, there is a large amount of Kochia (or similar plant). The Division does not consider this a problem because more desirable species should take over these areas in future years (if there is sufficient precipitation).

Reclaimed Long Term Spoil area with weeds (possibly Kochia)

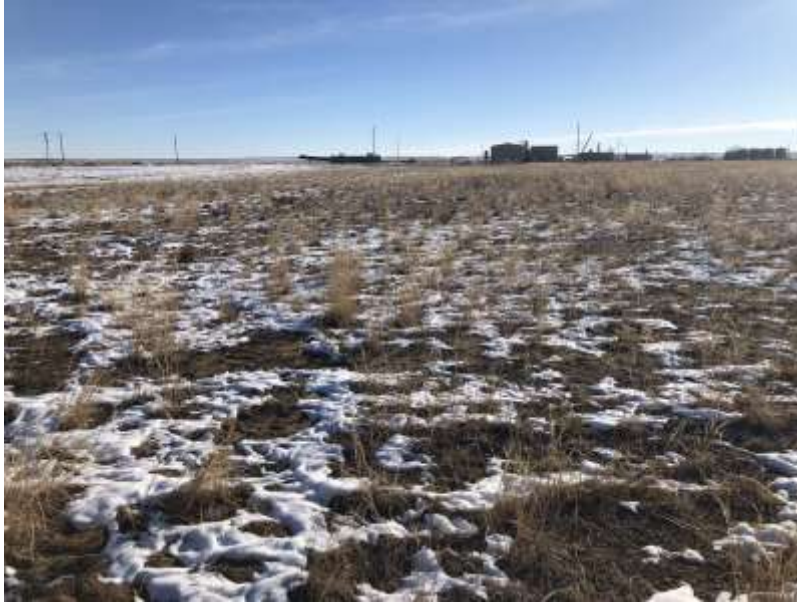
Boundary markers were observed at the north end of the site, at Parcel 34, and along the south side of the site. However, **the Division recommends that an additional boundary marker be added along the south side, namely south of Parcel 25.**

Parcel 34 (buildings in background are off of permit)

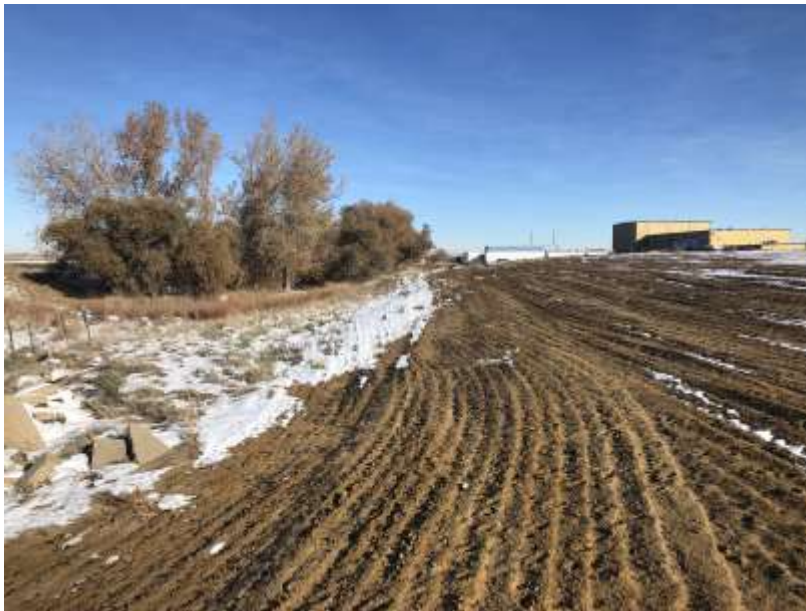
The eastern half of the site was walked, and no erosion problems were seen. This includes the area where Topsand Piles A-1 and B-1 were located prior to reclamation. However, the slope between the former topsand area and the Dugout Pond is relatively steep, and **the Division recommends that CEC place a row or two of wattles on this slope to prevent erosion.** (The wattles should be dug in at least three inches to be effective.)

**Reclaimed topsoil area and south end of Dugout Pond
(Facility area is in background on right)**
