MINERALS PROGRAM INSPECTION REPORT PHONE: (303) 866-3567

MINE NAME:		MINE/PROSPECTING ID#:	MINERAL:	COUNTY:	
Nelson Pit		M-2020-040	Sand and gravel	Washington	
INSPECTION TYPE:		INSPECTOR(S):	INSP. DATE:	INSP. TIME:	
Preoperation Inspection		Brock Bowles	October 7, 2020	10:00	
OPERATOR:		OPERATOR REPRESENTATIVE:	TYPE OF OPERATION:		
Washington County		Steve Williams	112c - Construction Regular Operation		
REASON FOR INSPECTION:		BOND CALCULATION TYPE:	BOND AMOUNT:		
Preoperation Inspection		None	No Bond Held		
DATE OF COMPLAINT:		POST INSP. CONTACTS:	JOINT INSP. AGENCY:		
NA		None	None		
WEATHER:	INSPECTOR'S SIGNATURE:		SIGNATURE DATE:		
Clear	Brok Sauls		October 30, 2020

This pre-operation inspection was conducted in response to a new 112c Reclamation Permit Application for the Nelson Pit, File No. M-2020-040. Brock Bowles of the Div. of Reclamation, Mining and Safety conducted the inspection. Steve Williams of Washington County R&B was present for the inspection. The weather during the inspection was clear, warm and the ground was dry.

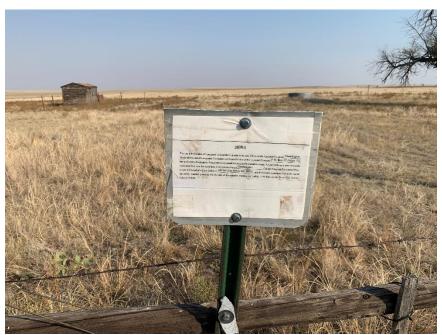
Photo 1 – Notice as seen from CR 3

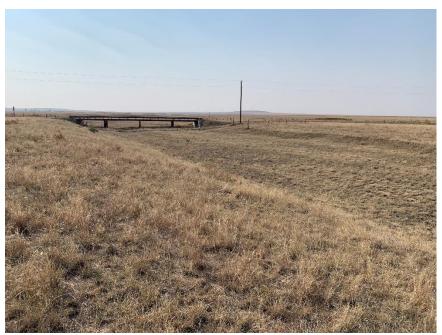
Photo 2 – Southwest corner of permit area, facing southwest

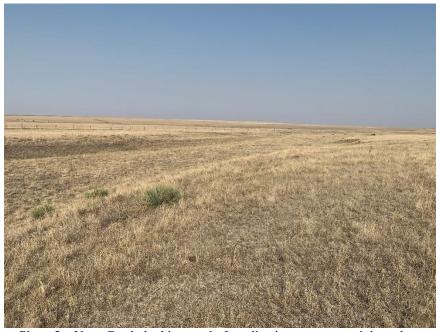
The vegetation in the creek bottom, on the creek benches, creek slopes and on the upland areas was mostly comprised of shortgrass prairie species (photo 3). Cheatgrass was scattered throughout the site but was not dominate. Some yucca pants were noted but were sparsely scattered across the site. A few prairie thistle plants (Cirsium canescens) were also noted (photo 4). This species of thistles are native to Colorado and are not noxious. There were two trees and kochia was dense in the area of the old homestead.

Photo 3 – Vega Creek, looking north, fenceline is western permit boundary

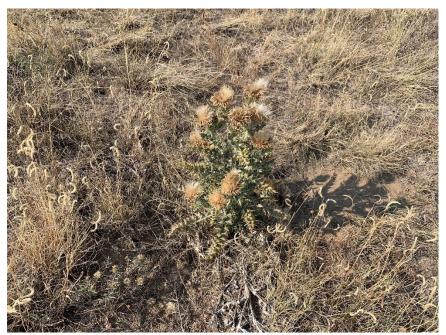
Photo 4 – Prairie thistle (Cirsium canescens)

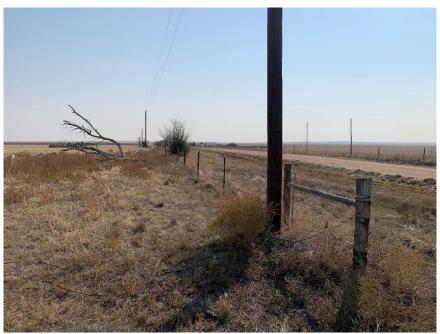
Photo 5 – Southern permit boundary, facing east

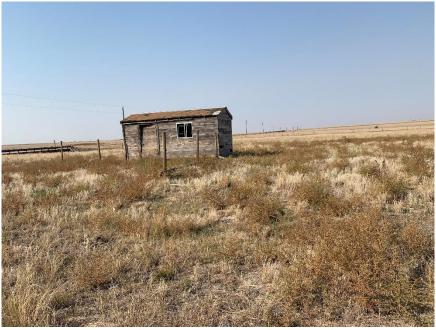
The southern part of the western permit boundary is the neighbor's fenceline. Washington County made a commitment to stay back 50 feet from the fenceline. Markers have been installed marking the 50 feet buffer. The southern permit boundary is marked by a fenceline along CR 3. Power lines run along the southern boundary (photo 5). A small building (approximately 8'x16') is located on the southern portion of the permit area. It is the only standing structure left of the old homestead (photo 6).

Photo 6 – Structure in southern part of permit area, looking southwest
