# Appendix A

## Visual Inspections

CONTINENTAL MATERIALS  
CORP.  
PIKEVIEW QUARRY SLOPE  
MONITORING

OBSERVATIONS FROM  
OCTOBER INSPECTION

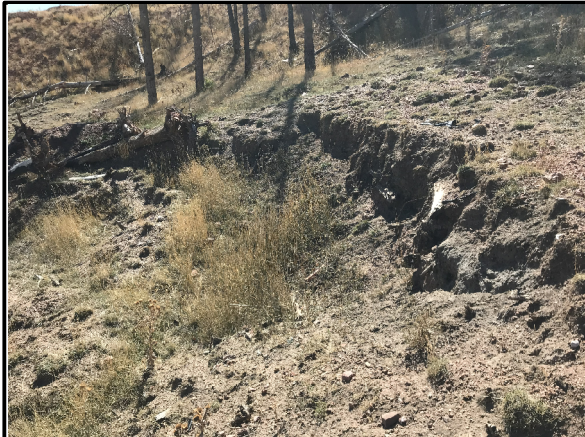
5. HEALED CRACK ABOVE SLIDE

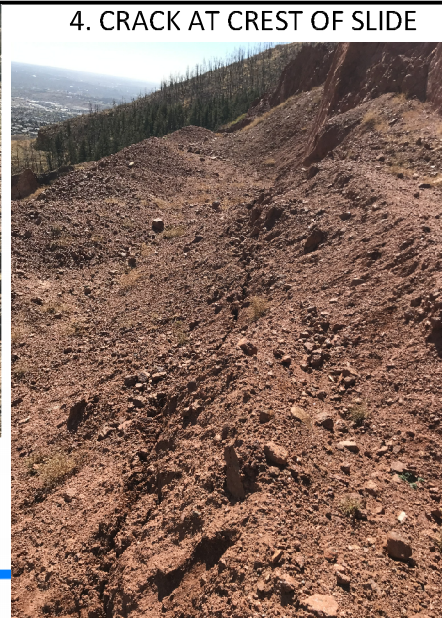
4. CRACK AT CREST OF SLIDE

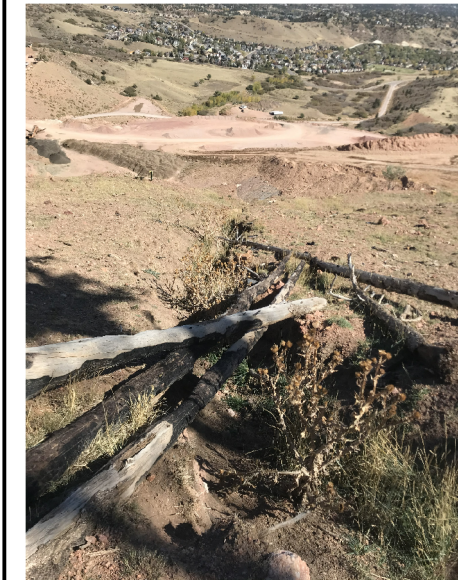
6. GULLY DIVERTS RUNOFF TO SLIDE

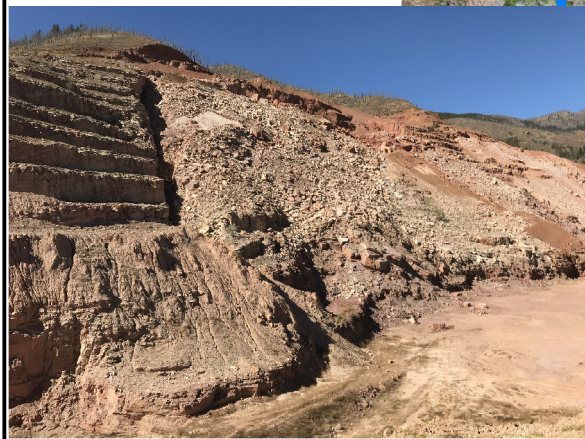
7. VIEW UP ESCARPMENT

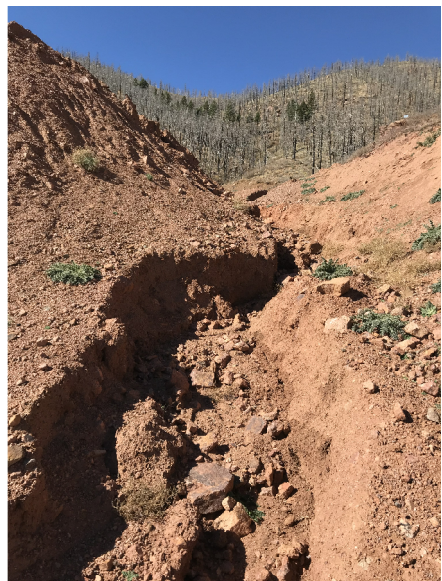
3. GULLY DIVERTS RUNOFF TO SLIDE AREA

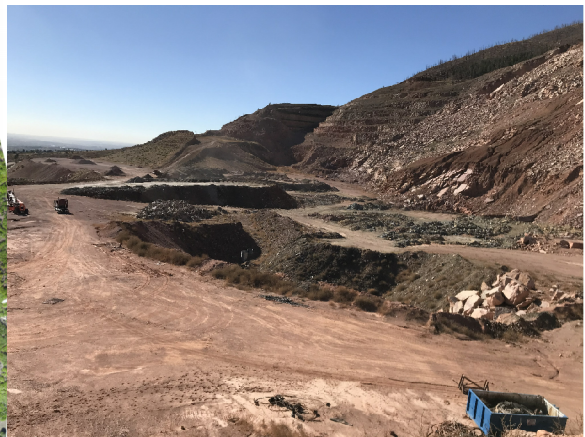
2. FILL STOCKPILED FOR FUTURE PLACEMENT

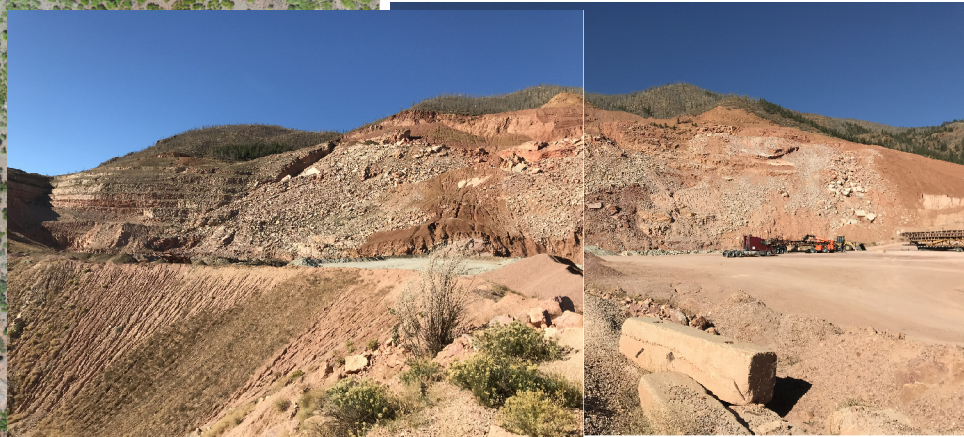
1. VIEW FROM SURVEY STATION
