MINERALS PROGRAM INSPECTION REPORT
PHONE: (303) 866-3567

| MINE NAME: Robins Rock Pit | MINE/PROSPECTING ID#: M-2009-053 | MINERAL: Volcanic materials (a | COUNTY: Conejos |
| INSPECTION TYPE: Preoperation Inspection | INSPECTOR(S): Lucas West | INSP. DATE: October 28, 2020 | INSP. TIME: 10:00 |

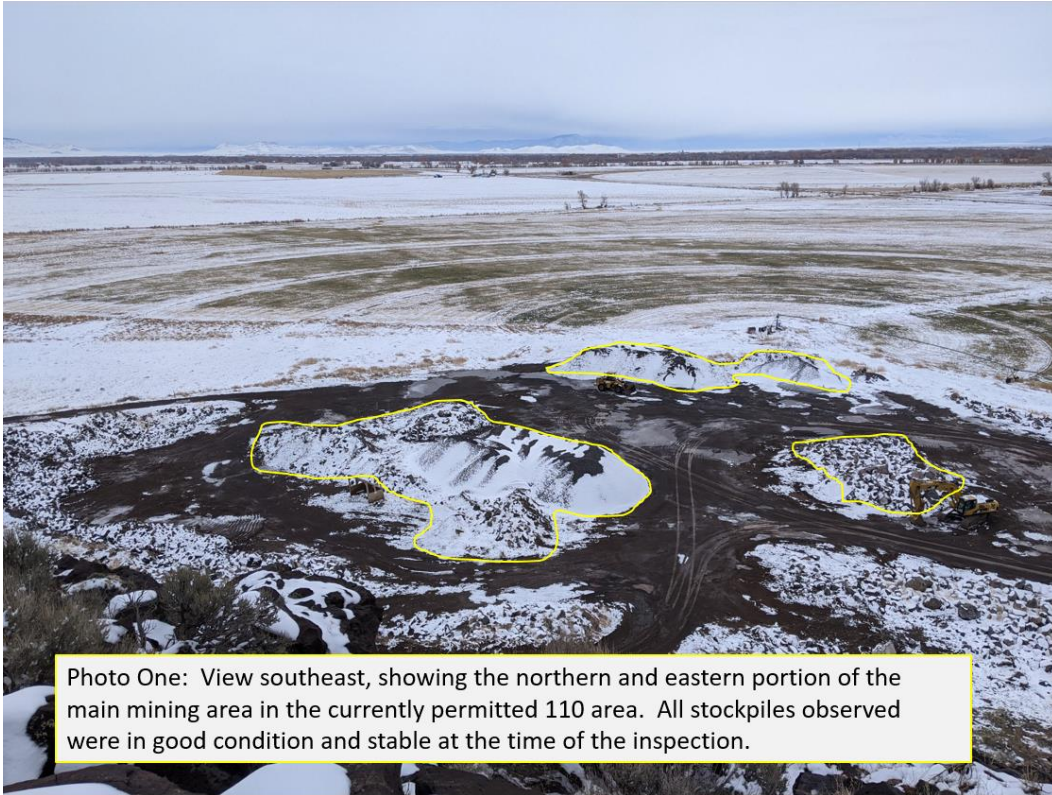
Photo One: View southeast, showing the northern and eastern portion of the main mining area in the currently permitted 110 area. All stockpiles observed were in good condition and stable at the time of the inspection.

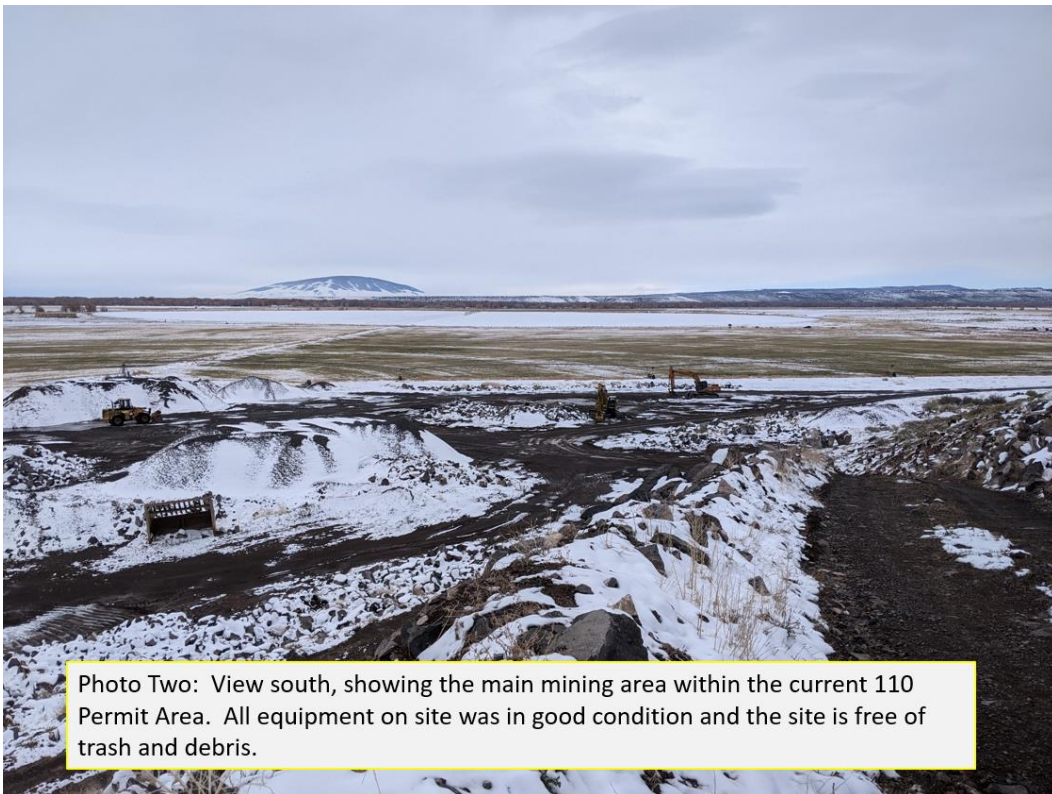
Photo Two: View south, showing the main mining area within the current 110 Permit Area. All equipment on site was in good condition and the site is free of trash and debris.
