**MINERALS PROGRAM INSPECTION REPORT**  
**PHONE: (303) 866-3567**

<b>MINE NAME:</b> Hazeltine Mine	<b>MINE/PROSPECTING ID#:</b> M-2004-031	<b>MINERAL:</b> Sand and gravel	<b>COUNTY:</b> Adams
<b>INSPECTION TYPE:</b> Monitoring	<b>INSPECTOR(S):</b> Patrick Lennberg	<b>INSP. DATE:</b> October 28, 2020	<b>INSP. TIME:</b> 11:30
<b>OPERATOR:</b> Aggregate Industries - WCR, Inc.	<b>OPERATOR REPRESENTATIVE:</b> Christine Felz	<b>TYPE OF OPERATION:</b> 112c - Construction Regular Operation	
<b>REASON FOR INSPECTION:</b> Normal I&E Program	<b>BOND CALCULATION TYPE:</b> None	<b>BOND AMOUNT:</b> \$670,602.00	
<b>DATE OF COMPLAINT:</b> NA	<b>POST INSP. CONTACTS:</b> None	<b>JOINT INSP. AGENCY:</b> None	
<b>WEATHER:</b> Clear	<b>INSPECTOR'S SIGNATURE:</b>

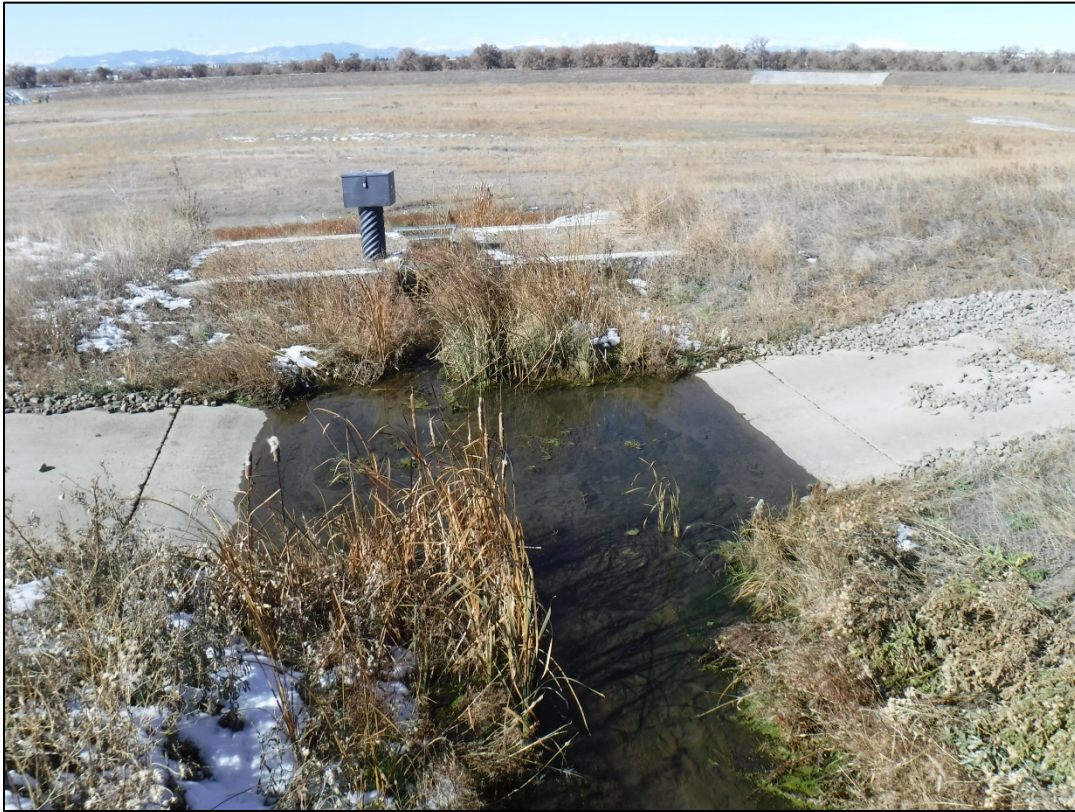
The inspection focused on the area around the Orr drain. The Orr drain was open and flowing into the lined cell. The ground in the vicinity of the drain did not appear to have any standing water on it. The drain discharges to the lined cell and conveyed to a larger ponding area in the northeast corner of the cell. The pond is then pumped down into the Platte River.

**Photo 1:** Orr drain as it crosses the road and into the cell

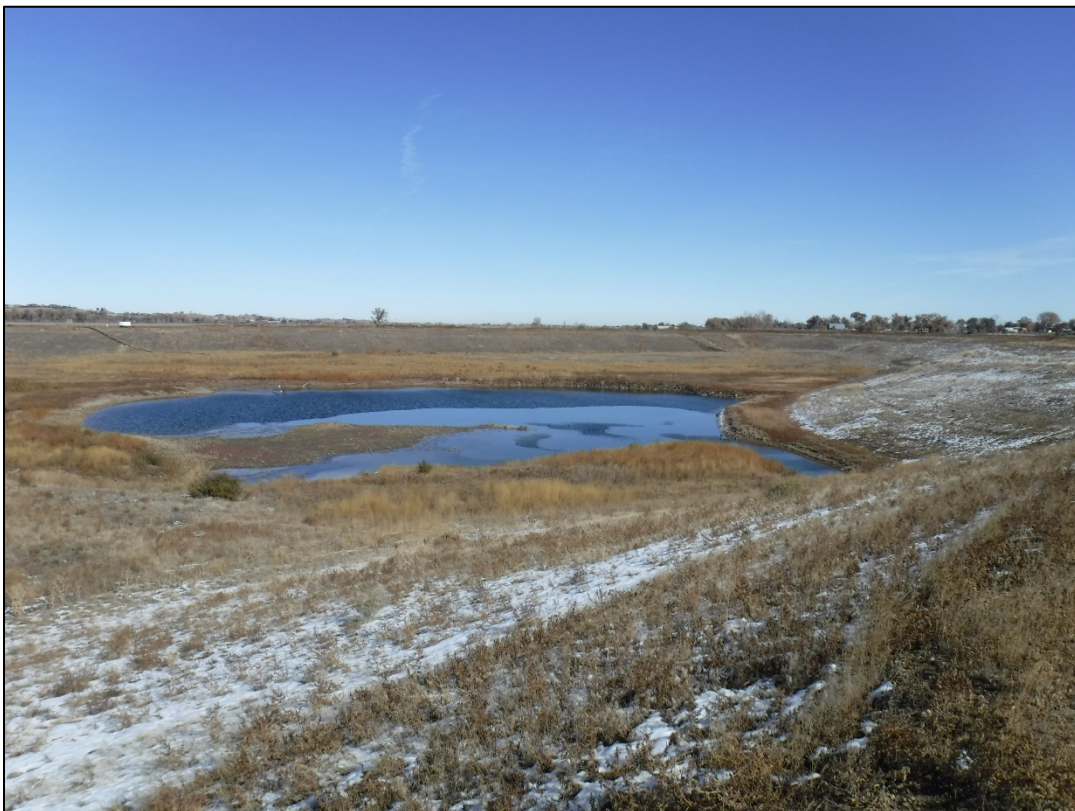
**Photo 2:** Pond in the northeast corner of cell used to pump to river

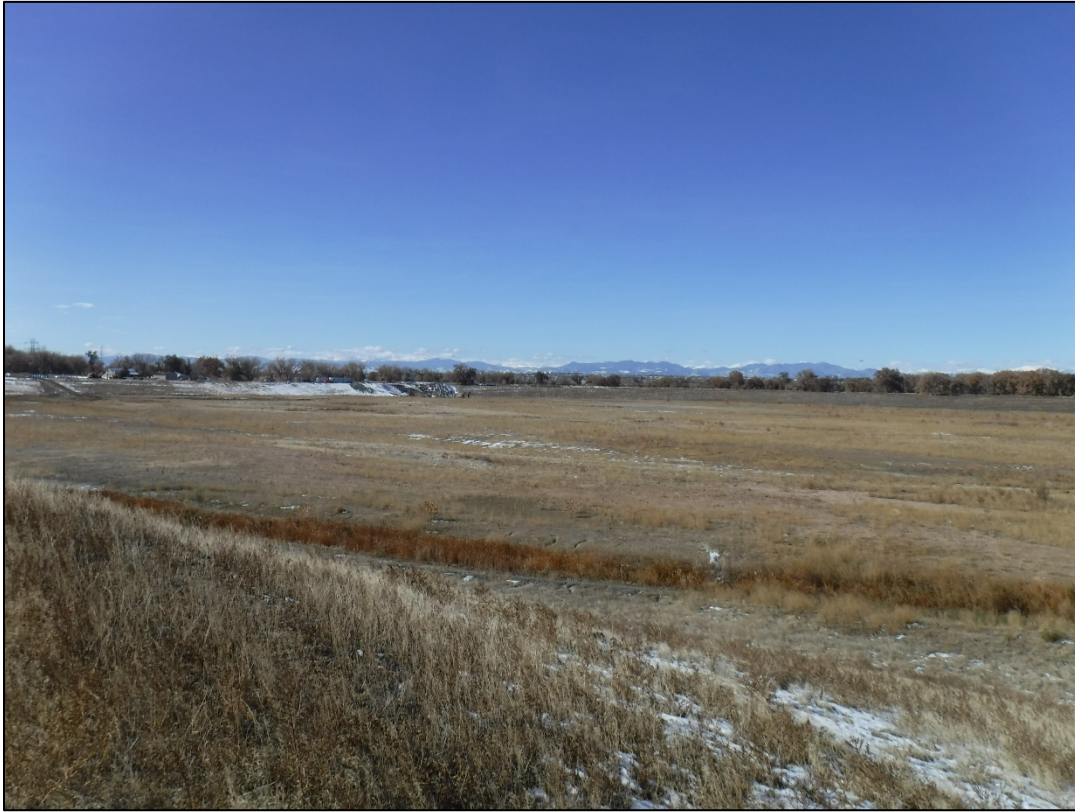
**Photo 3:** Looking southwest towards construction activities

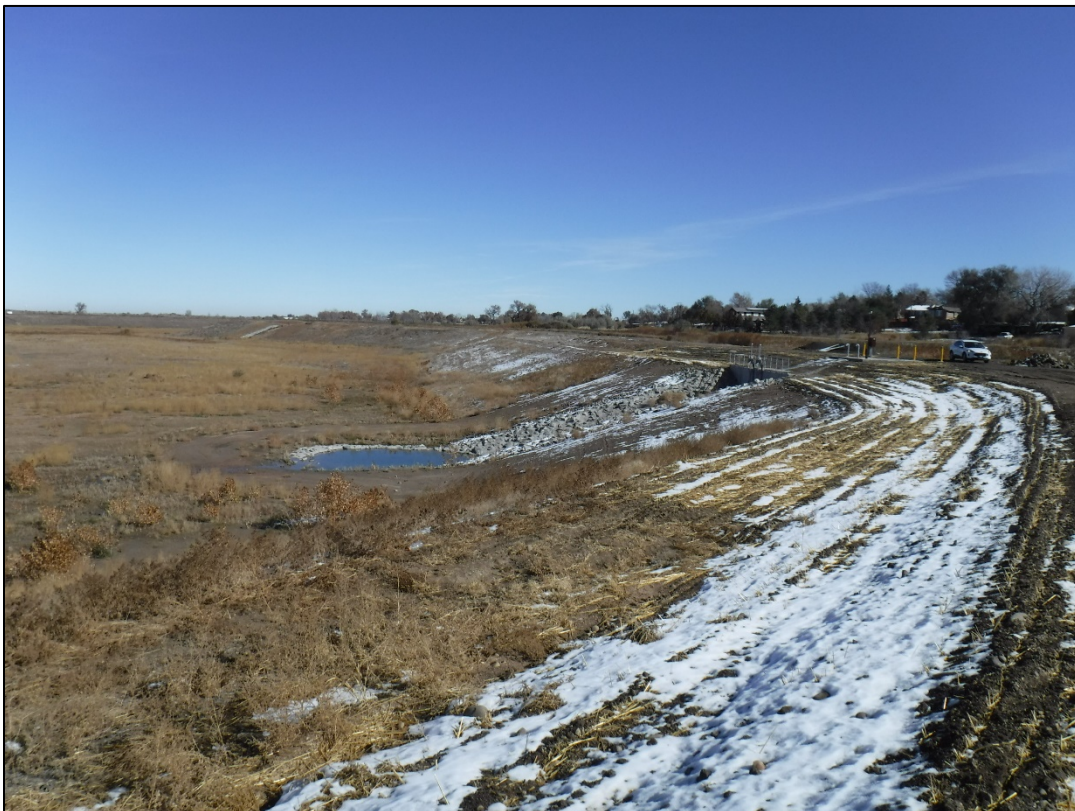
**Photo 4:** Orr drain flowing into the cell

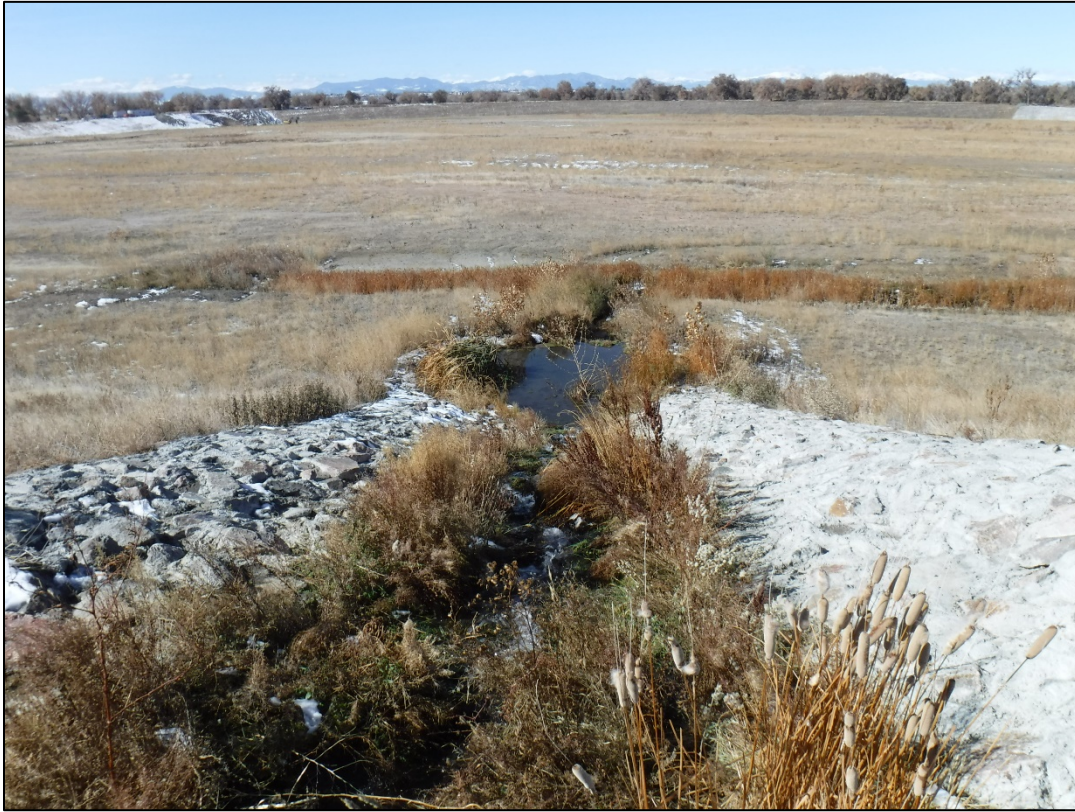
**Photo 5:** Orr drain flowing into the cell

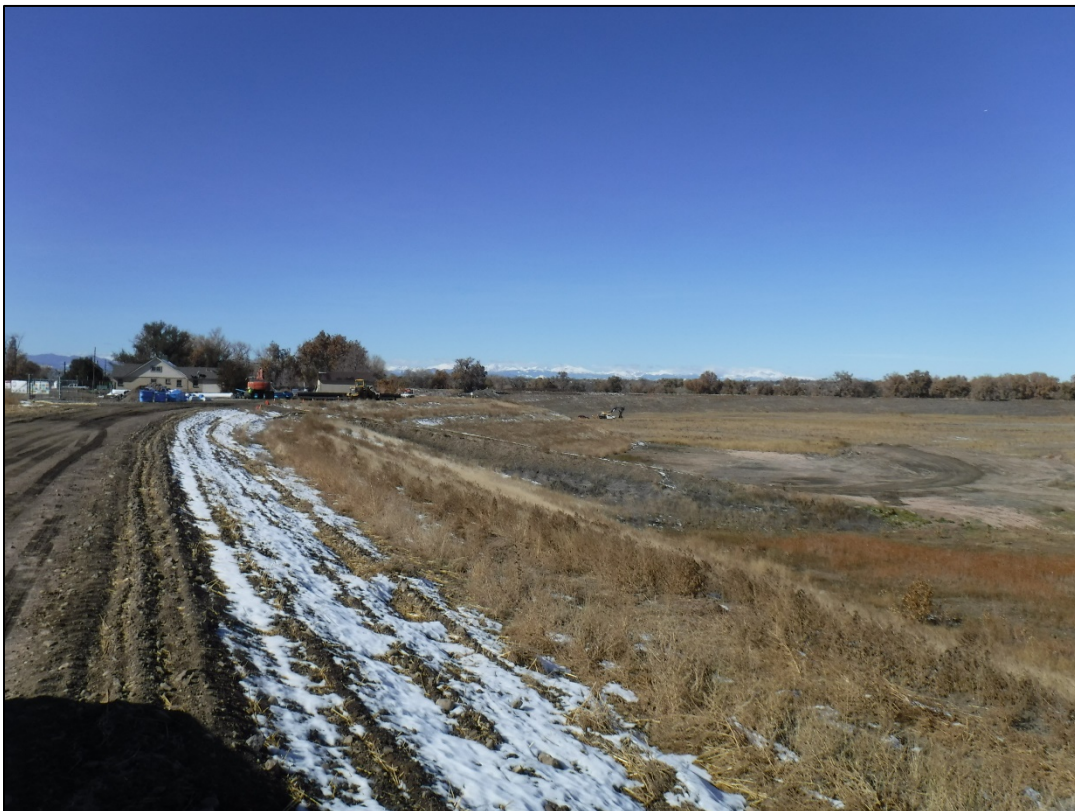
Currently, the City of Thornton has begun to construct pumps and associated pipework to allow for the cell to be filled and used as a developed water resources pond. Christine indicated that AI was anticipating that construction would be complete by early next year but a definitive schedule had not been shared by the city. Once all the piping is installed and the reservoir has begun to fill AI should submit a Technical Revision to revise the reclamation plan to show the final reservoir configuration and clearly show how water from the Orr drain can be discharged to the river. Under the currently approved plan AI will need to install culverts to get the water to the river.

**Photo 6:** Pump and pipeline infrastructure construction activities
