MINERALS PROGRAM INSPECTION REPORT
PHONE: (303) 866-3567

MINE NAME: Colo Alabaster	MINE/PROSPECTING ID#: M-1989-077	MINERAL: Alabaster	COUNTY: Larimer
INSPECTION TYPE: Monitoring	INSPECTOR(S): Brock Bowles	INSP. DATE: October 14, 2020	INSP. TIME: 13:00
OPERATOR: Colorado Alabaster Supply	OPERATOR REPRESENTATIVE: Stan Jones	TYPE OF OPERATION: 110(1) - Hard Rock Limited Impact	
REASON FOR INSPECTION: Normal I&E Program	BOND CALCULATION TYPE: None	BOND AMOUNT: \$2,250.00	
DATE OF COMPLAINT: NA	POST INSP. CONTACTS: None	JOINT INSP. AGENCY: None	
WEATHER: Clear	INSPECTOR'S SIGNATURE:

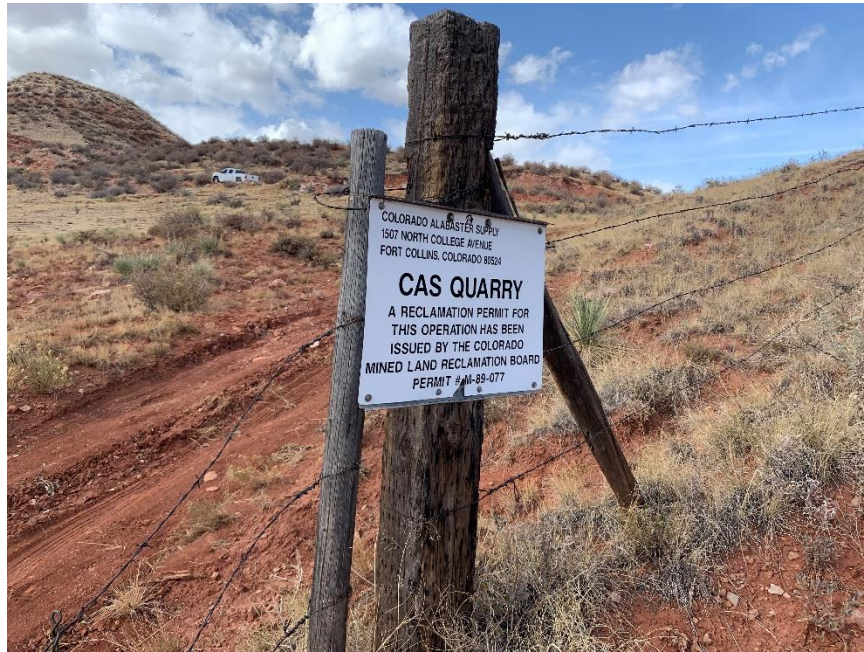
The mine entrance sign was in place (photo 1).

Photo 1 – Mine entrance sign

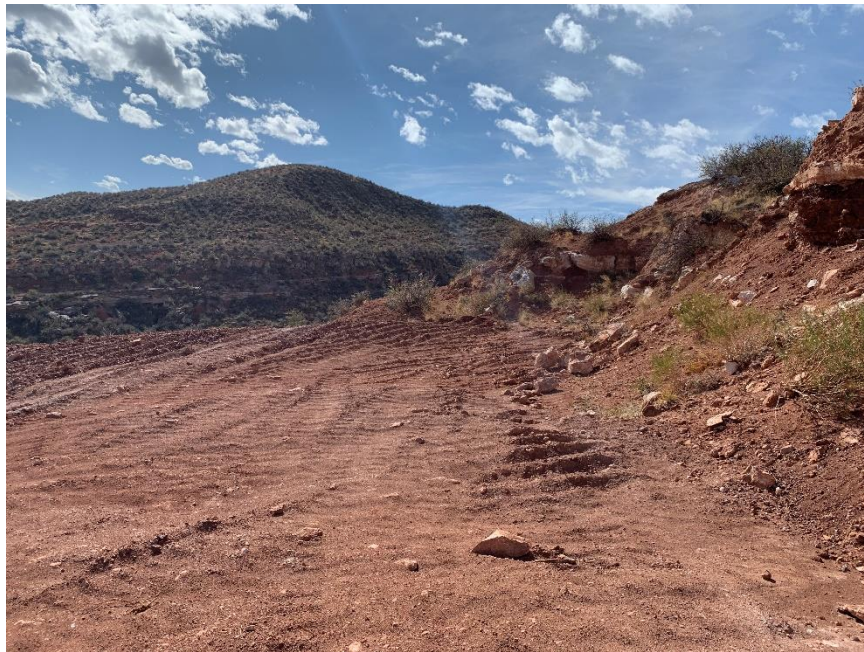
The site had recently been graded to approximate original contour. The bench areas were slightly sloped outward to promote drainage (photos 1 & 2). Seed had not been applied. The operator was preparing to seed the area this fall.

Photo 2 – Upper bench area

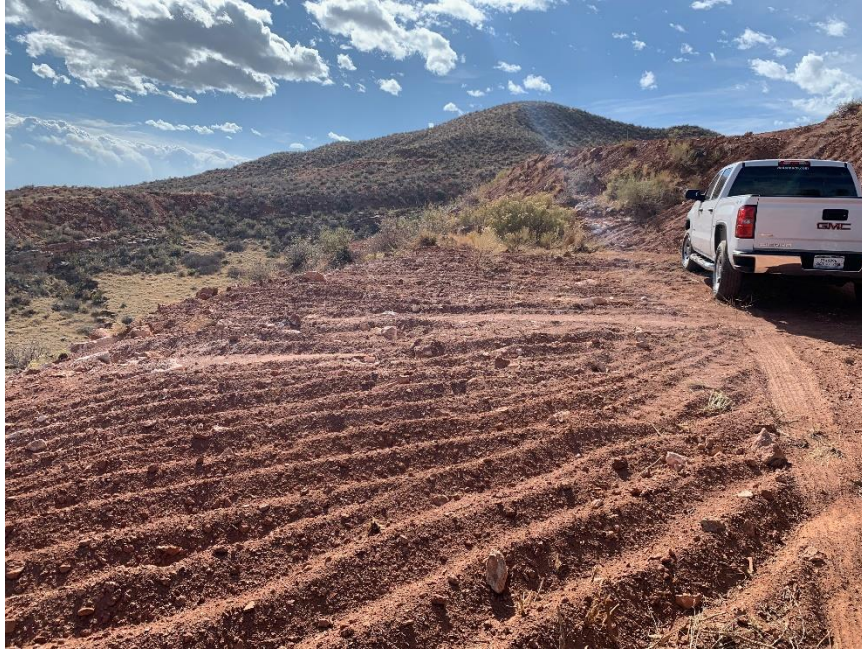
Photo 3 – Lower Bench area
