**MINERALS PROGRAM INSPECTION REPORT**  
**PHONE: (303) 866-3567**

<b>MINE NAME:</b> Friederichs Pit 112	<b>MINE/PROSPECTING ID#:</b> M-2010-080	<b>MINERAL:</b> Gravel and sand	<b>COUNTY:</b> Prowers
<b>INSPECTION TYPE:</b> Monitoring	<b>INSPECTOR(S):</b> Robert Zuber, P.E.	<b>INSP. DATE:</b> October 29, 2020	<b>INSP. TIME:</b> 13:20
<b>OPERATOR:</b> Riverside Aggregates, LLC	<b>OPERATOR REPRESENTATIVE:</b> Rudy Torres	<b>TYPE OF OPERATION:</b> 112c - Construction Regular Operation

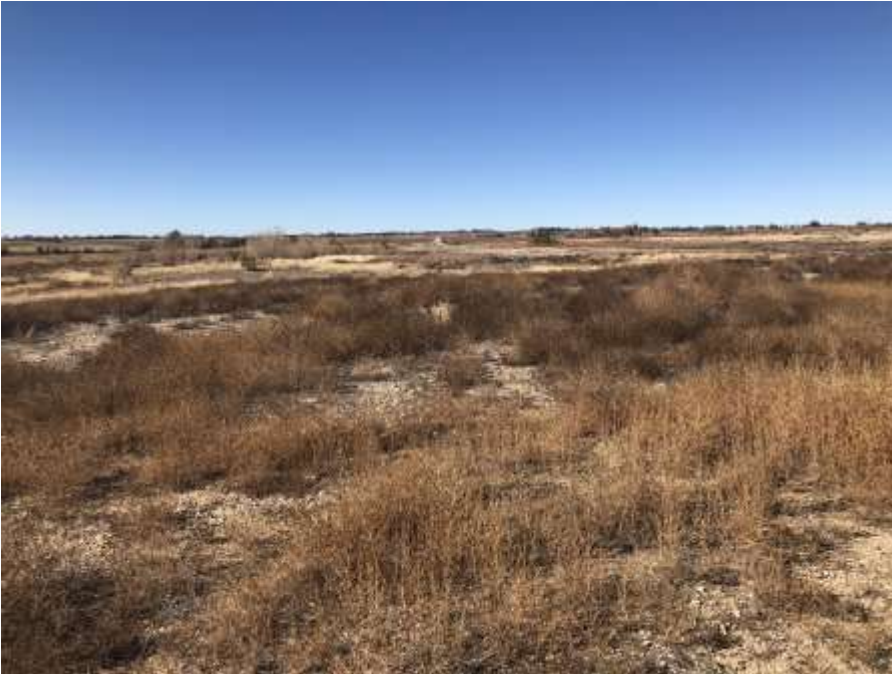
A large amount of the site has not seen good vegetation growth, with large bare spots and kochia dominating the vegetation that exists. Re-seeding will be necessary over much of the site. Initial seeding is needed at the area around the pile of road base, approximately 0.5 acre.

**Looking west from east side at large area of kochia plants**

Mr. Torres indicated that he does not want to mow the kochia because it functions to protect the soil from wind and stormwater runoff. The Division does not have a problem with this approach, as long as other measures are taken to improve future vegetation growth, such as re-seeding (possibly hydroseeding or drill seeding with mulching and crimping) and possibly other erosion prevention practices are implemented (e.g., erosion mats).

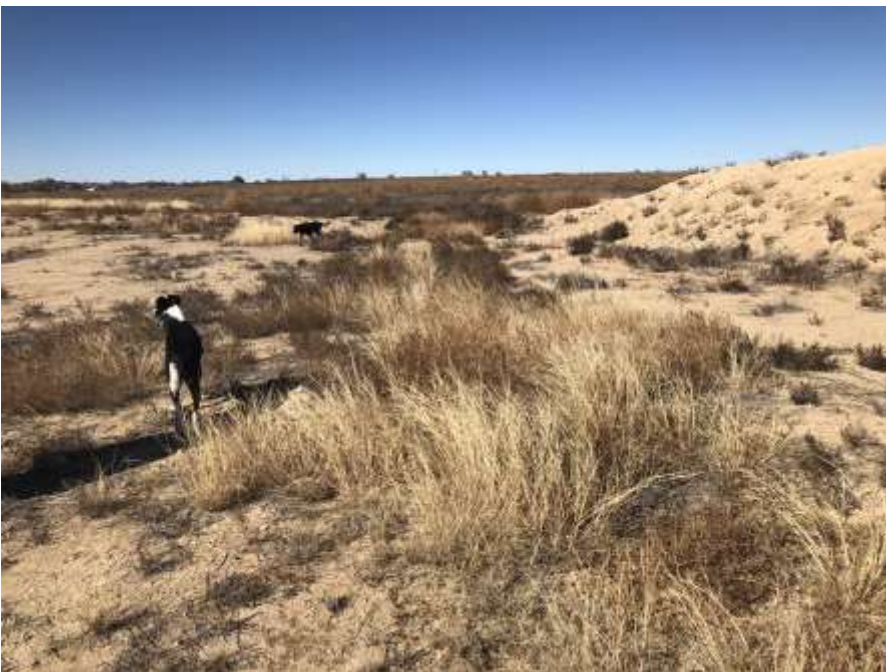
**Minimal grass was seen near the northeast part of mine (topsoil stockpile on right)**

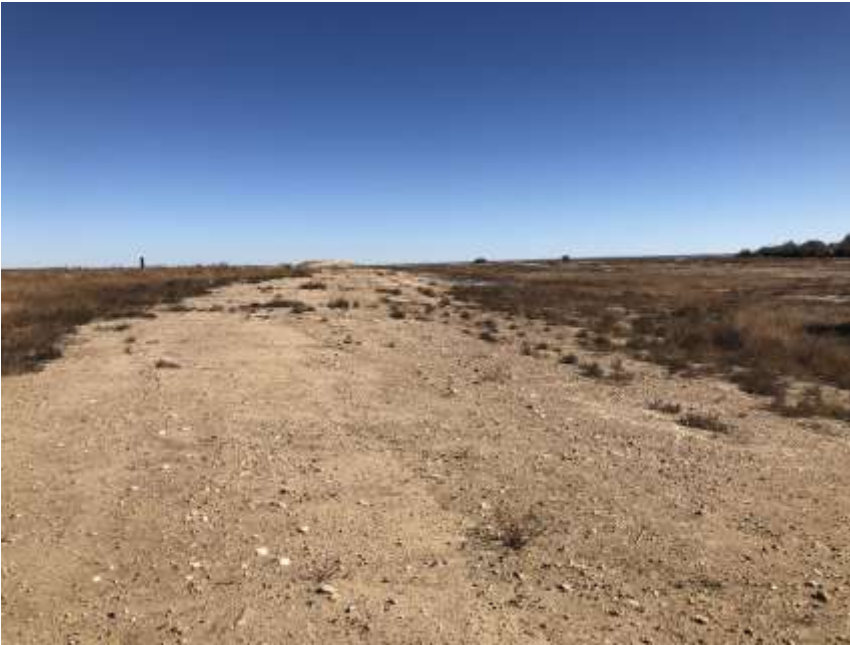
**Bare ground at north end of site**

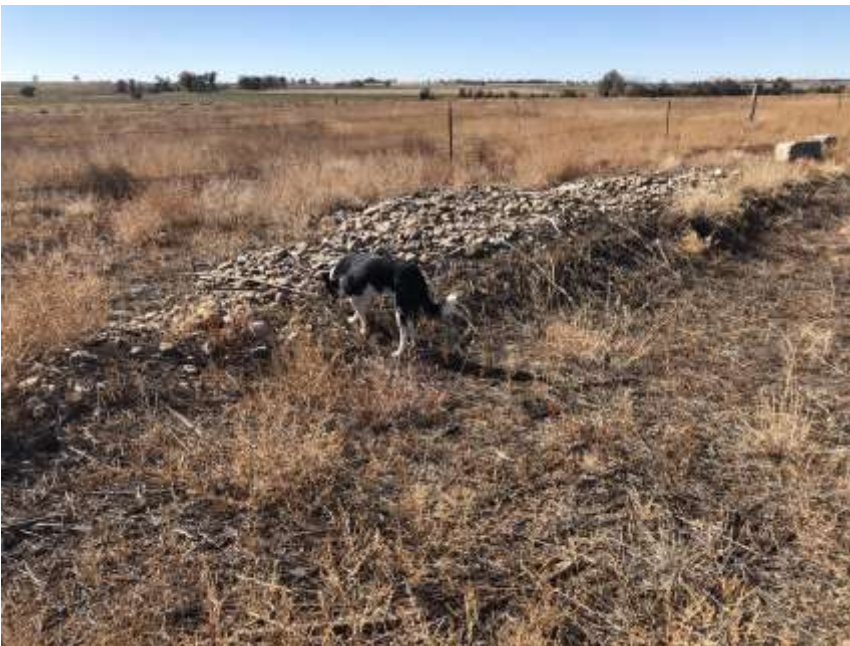
No erosion or other hydrology problems were seen at the site. The stormwater rock filter appeared stable and appeared to be functioning, with no signs of flow going around this structure.

**Stormwater rock filter**

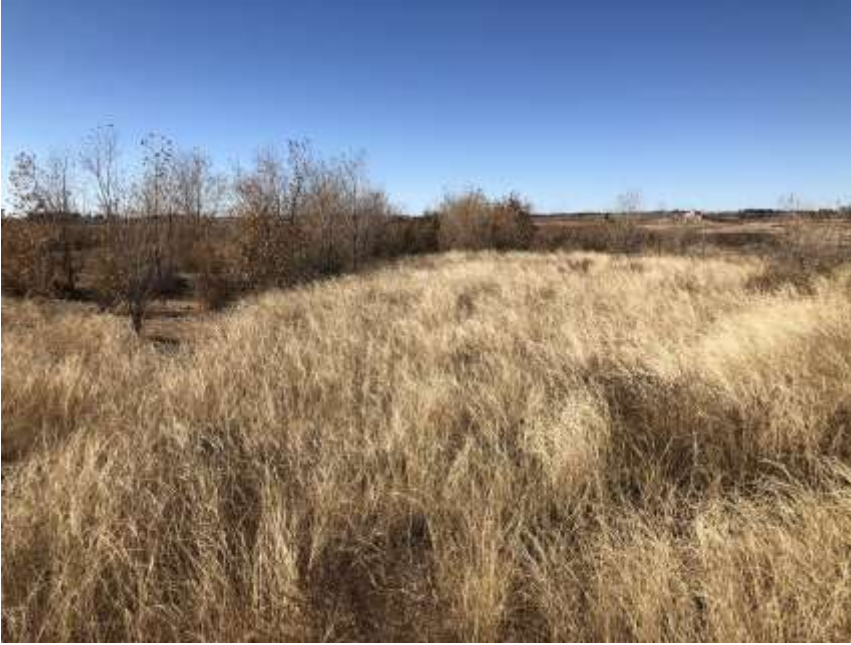
**Good stand of grass near the cottonwood patch**

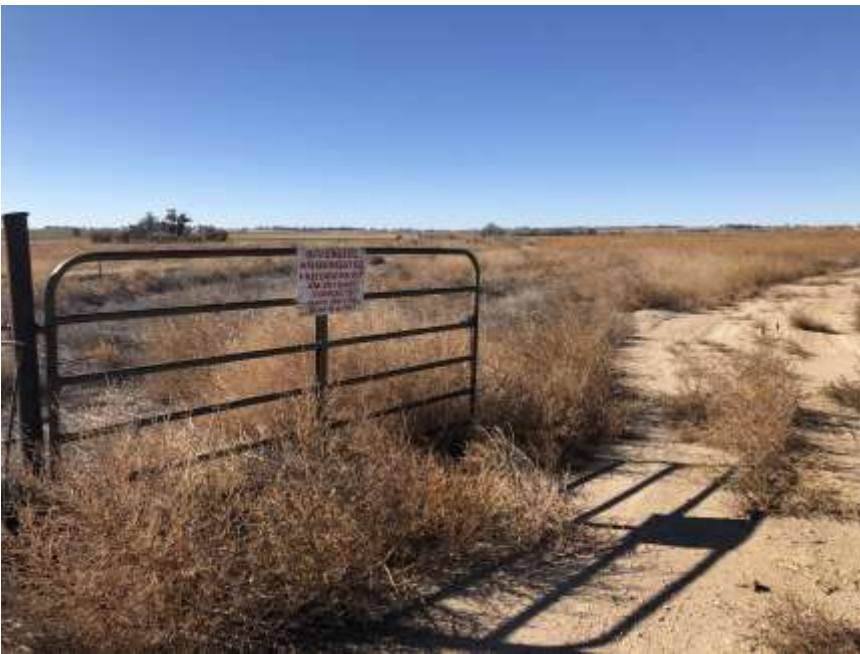
**PROBLEM/POSSIBLE VIOLATION:** Problem - The identification sign at the mine entrance did not contain any mention of the Division of Reclamation, Mining and Safety. This is a problem for failure to post an adequate mine identification sign as required by Section 3.1.12(1) of the rule. The Operator shall, at the entrance of the mine site, post a sign, which shall be clearly visible from the access road, with a minimum size equaling 187 square inches (such as 11 inches in height and 17 inches in width), with the following: the name of the Operator, a statement that a reclamation permit for the operation has been issued by the Colorado Division of Reclamation, Mining and Safety; and the permit number.

The mine entrance sign was in place. It contained the mine name, operator name, operator phone numbers, and DRMS permit number. It did not say that the permit number is associated with the Division of Reclamation, Mining, and Safety. This information should be added to the sign.

**Entrance sign lacking a reference to the Division**

**CORRECTIVE ACTIONS:** The operator shall post a sign to include all required information. The operator shall submit photo documentation that a proper sign has been posted by the corrective action date.
