MINERALS PROGRAM INSPECTION REPORT

MINE NAME: Schwartzwalder Mine	MINE/PROSPECTING ID#: M-1977-300	MINERAL: Uranium	COUNTY: Jefferson
INSPECTION TYPE: Monitoring	INSPECTOR(S): Amy Eschberger, Michael Cunningham	INSP. DATE: October 29, 2020	INSP. TIME: 13:00
OPERATOR: Colorado Legacy Land, LLC	OPERATOR REPRESENTATIVE: Liz Busby, Billy Ray, Paul Newman	TYPE OF OPERATION: 112d-2 - Designated Mining Operation	
REASON FOR INSPECTION: Normal I&E Program	BOND CALCULATION TYPE: None	BOND AMOUNT: \$8,900,000.00	
DATE OF COMPLAINT: NA	POST INSP. CONTACTS: None	JOINT INSP. AGENCY: None	
WEATHER: Clear	INSPECTOR'S SIGNATURE:

This was a pre-operation inspection of the Schwartzwalder Mine (Permit No. M-1977-300) conducted by Amy Eschberger and Michael Cunningham of the Division of Reclamation, Mining and Safety (Division) in response to the Amendment No. 5 application (AM-5) filed with our Office on September 10, 2020. The Division received three comment letters on AM-5 (from Division of Water Resources, History Colorado, and Denver Water) within the public comment period which closed on October 28, 2020. No objections were received. The operator was represented by Liz Busby, Billy Ray, and Pa

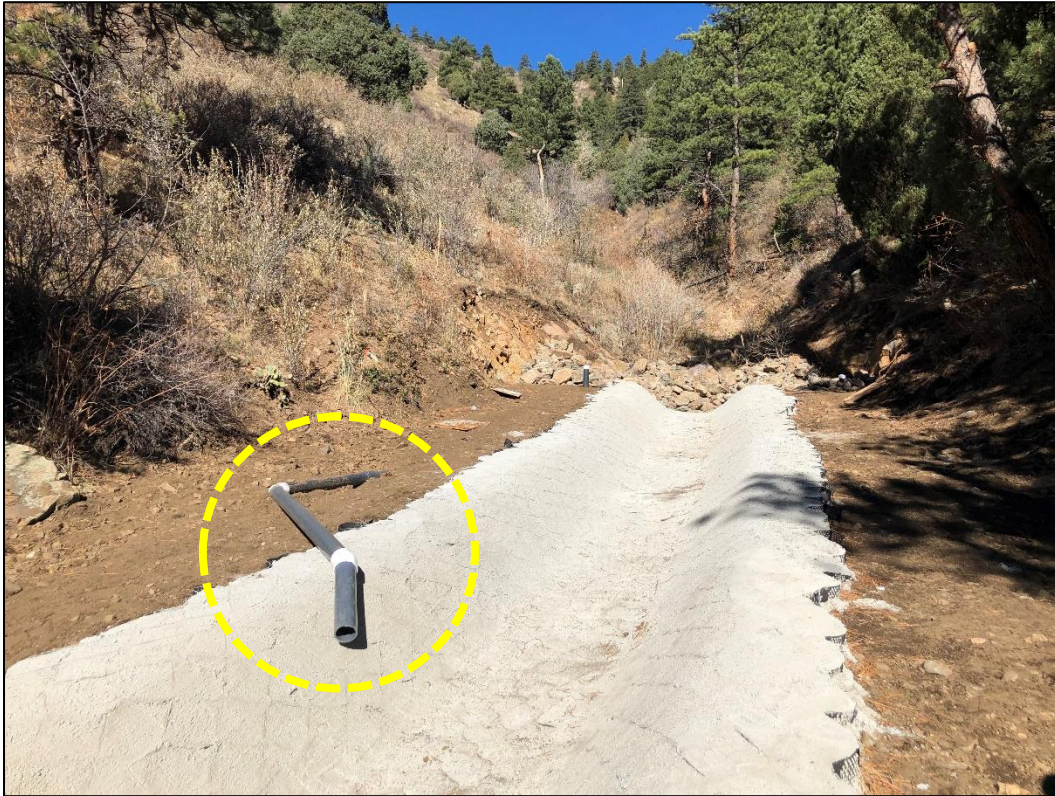
Photo 1. View looking northeast at upper end of NWRP diversion channel with concrete placement complete. Note pipeline (circled) from water intake structure daylight to discharge into ditch.

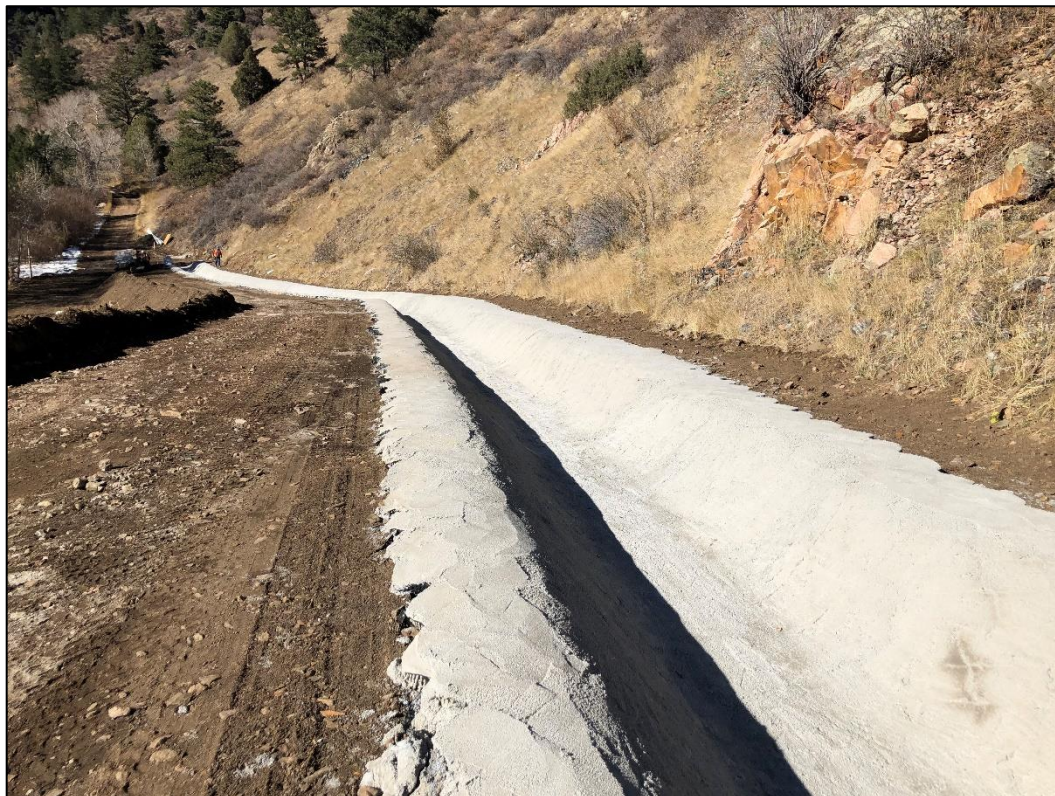
Photo 2. View looking northwest across lower section of NWRP diversion channel with concrete placement complete.

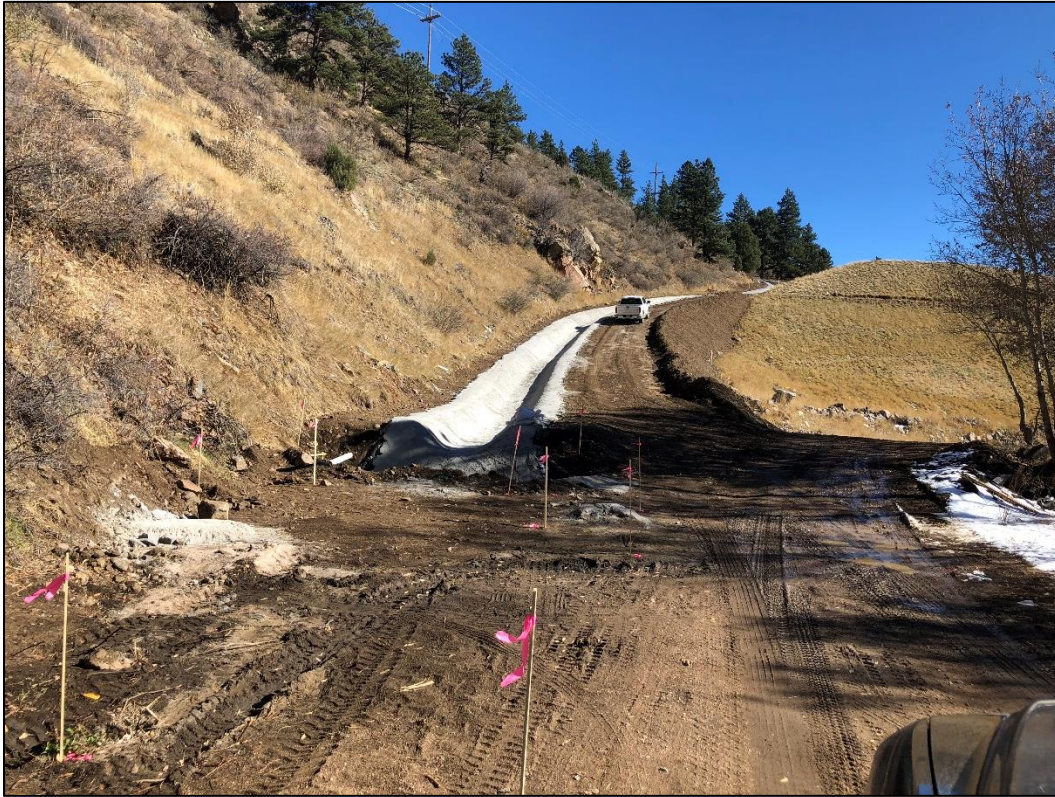
Photo 3. View looking east at lower end of NWRP diversion channel, showing location (area in foreground delineated with pink-flagged laths) where dissipation basin and road crossing will be constructed.

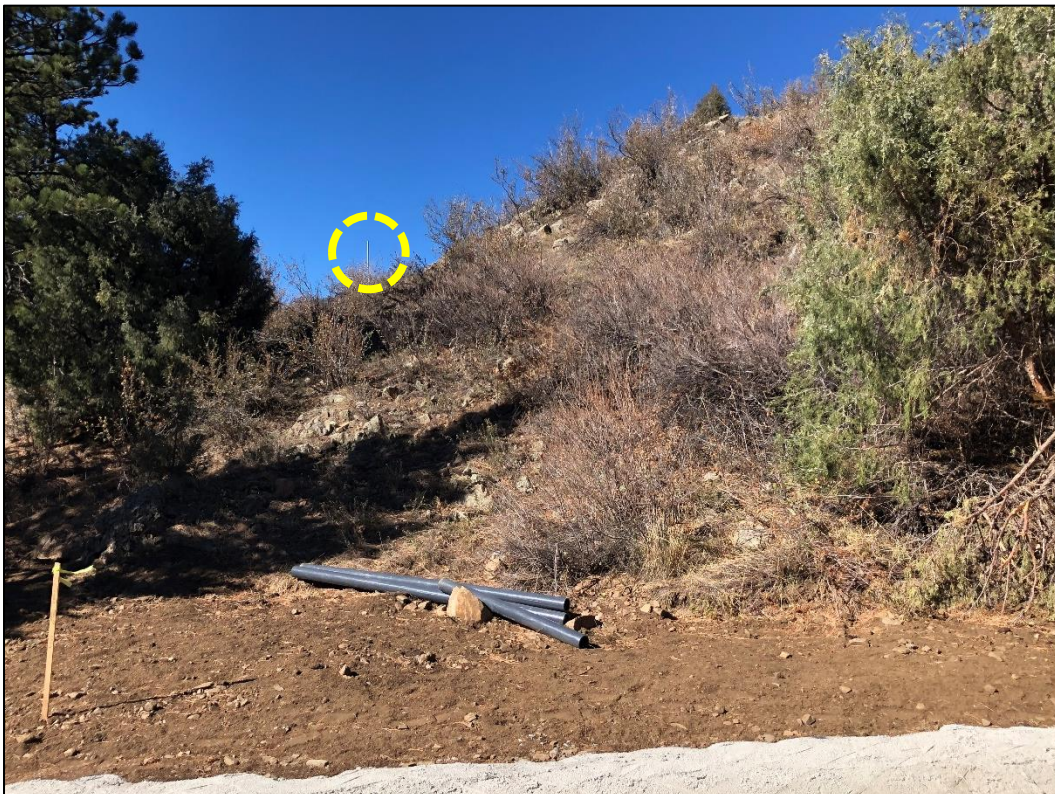
Photo 4. View looking west at slope above NWRP diversion channel where AM-5 proposed expansion area is located. Location of PVC pipe marking lower boundary of proposed 100-ft buffer zone circled in background.

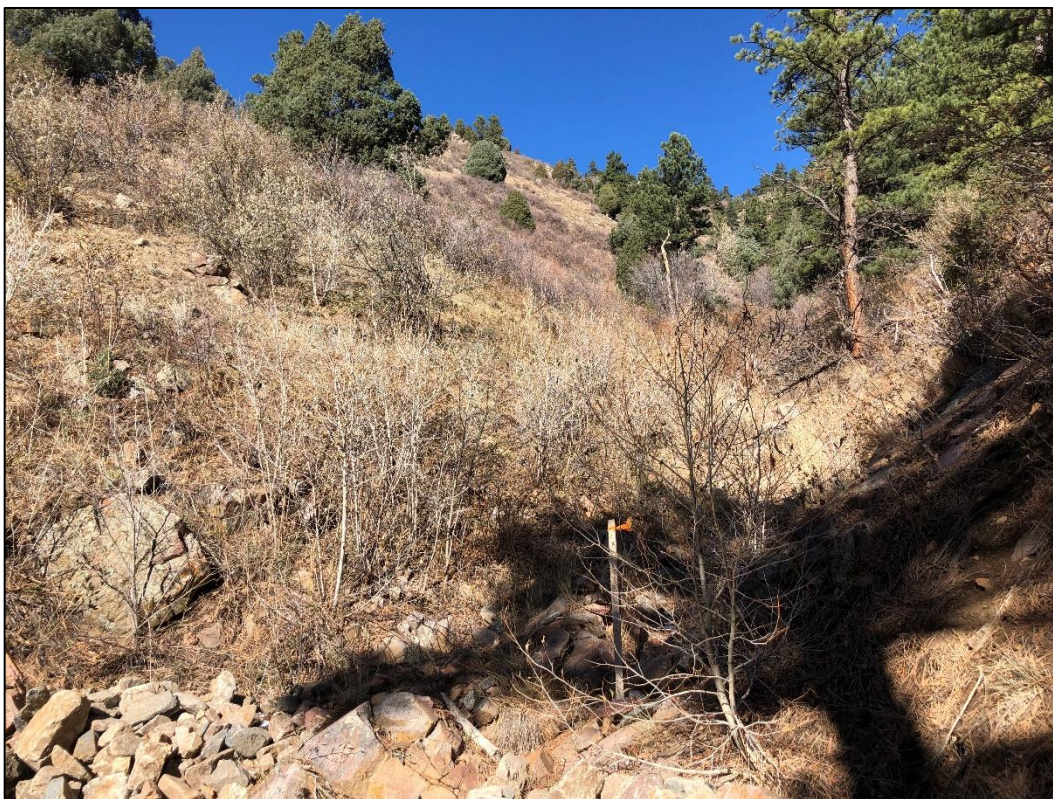
Photo 5. View looking north at slope (and drainage) above NWRP diversion channel where AM-5 proposed expansion area is located. Boundary markers not visible in photo.

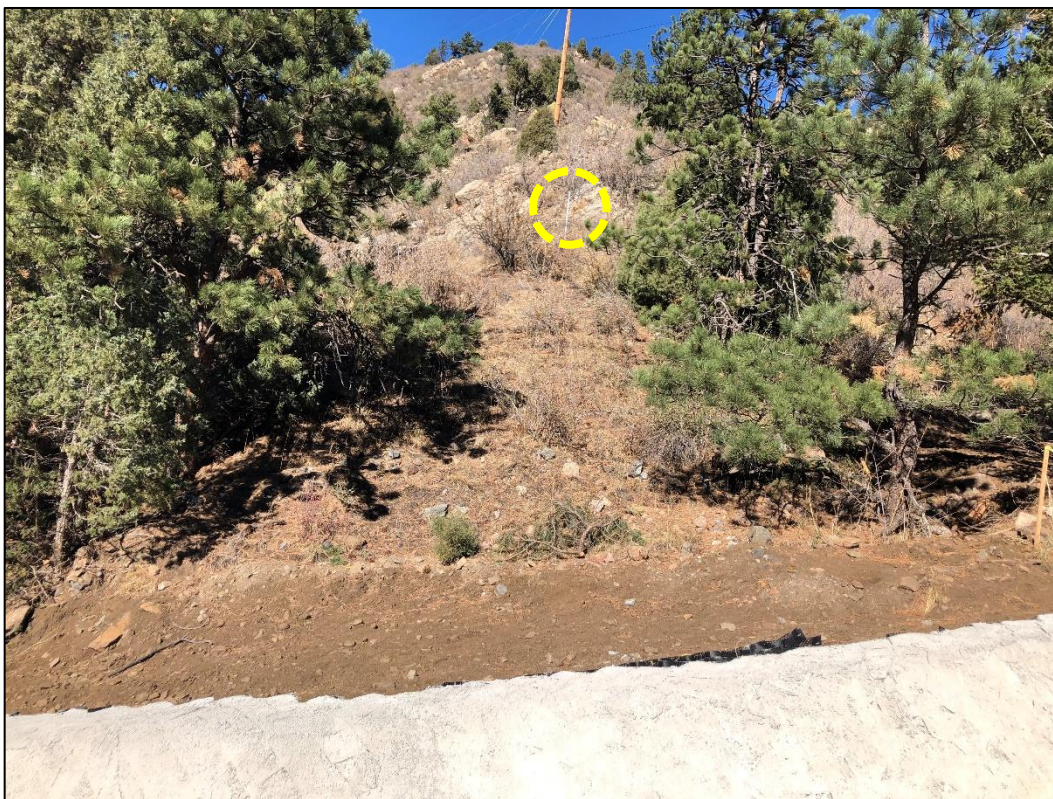
Photo 6. View looking northwest at slope above NWRP diversion channel where AM-5 proposed expansion area is located. Location of PVC pipe marking lower boundary of proposed 100-ft buffer zone circled in background.

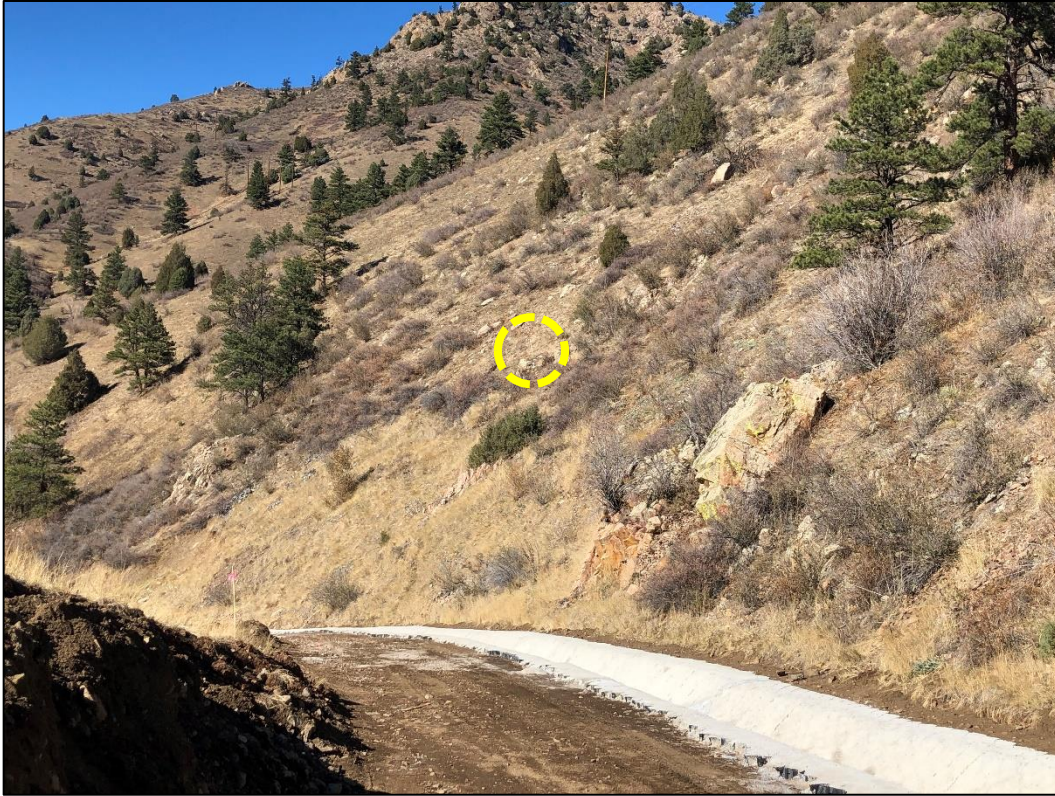
Photo 7. View looking northwest at slope above NWRP diversion channel where AM-5 proposed expansion area is located. Location of PVC pipe marking lower boundary of proposed 100-ft buffer zone circled in background.

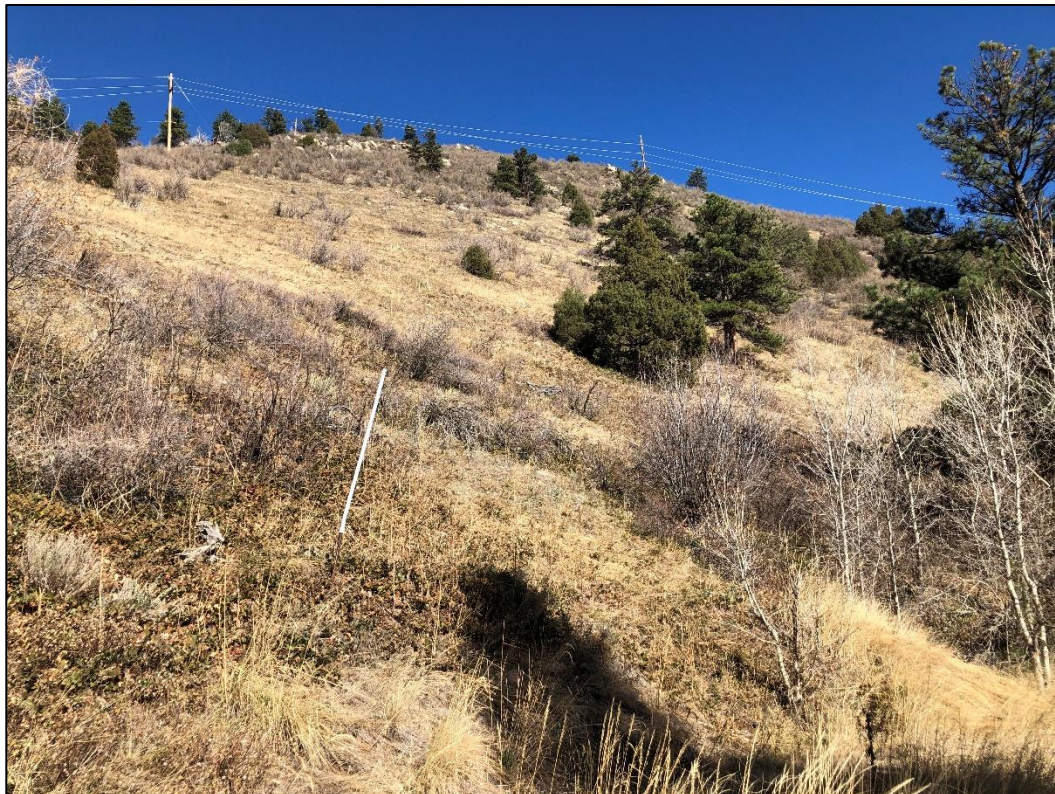
Photo 8. View looking northeast at slope above NWRP where AM-5 proposed expansion area is located. PVC pipe marking lower boundary of proposed 100-ft buffer zone visible in foreground.

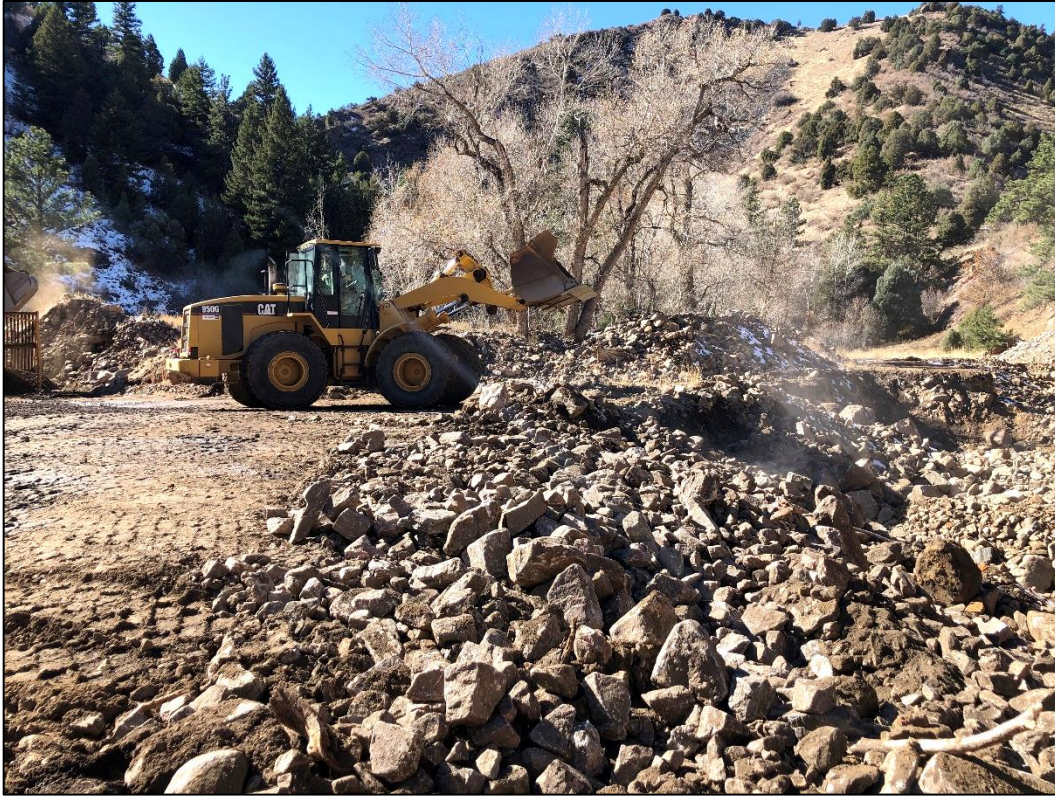
Photo 9. View looking west across borrow area located up valley from NWRP where rock and fill material is derived for diversion channel project. Construction material is excavated from an alluvial fan deposit at base of ephemeral drainage from September 2013 flood events.

an ephemeral drainage during the September 2013 flood events. This borrow area is located outside of the approved mine permit area. During the inspection, material was being screened in this area to produce soil material for backfilling the sides of the channel. While the Division does not typically require a landowner to obtain a mine permit for excavating material from their land for use on their property (e.g., maintaining roads), the nature of this particular borrow area and the use of the material for reclamation of the affected lands associated with the mine permit creates a unique situation for which additional information is needed in order for the Division to determine whether the borrow area requires permitting through our agency. According to the operator, the borrow area is included in their 404 permit held with the U.S. Army Corps of Engineers, and reclamation of this area will be completed in accordance with this permit. **Within two weeks of the date of this inspection report, the operator must provide the Division with a copy of the 404 permit and/or any other agency permits which address reclamation of the borrow area.**

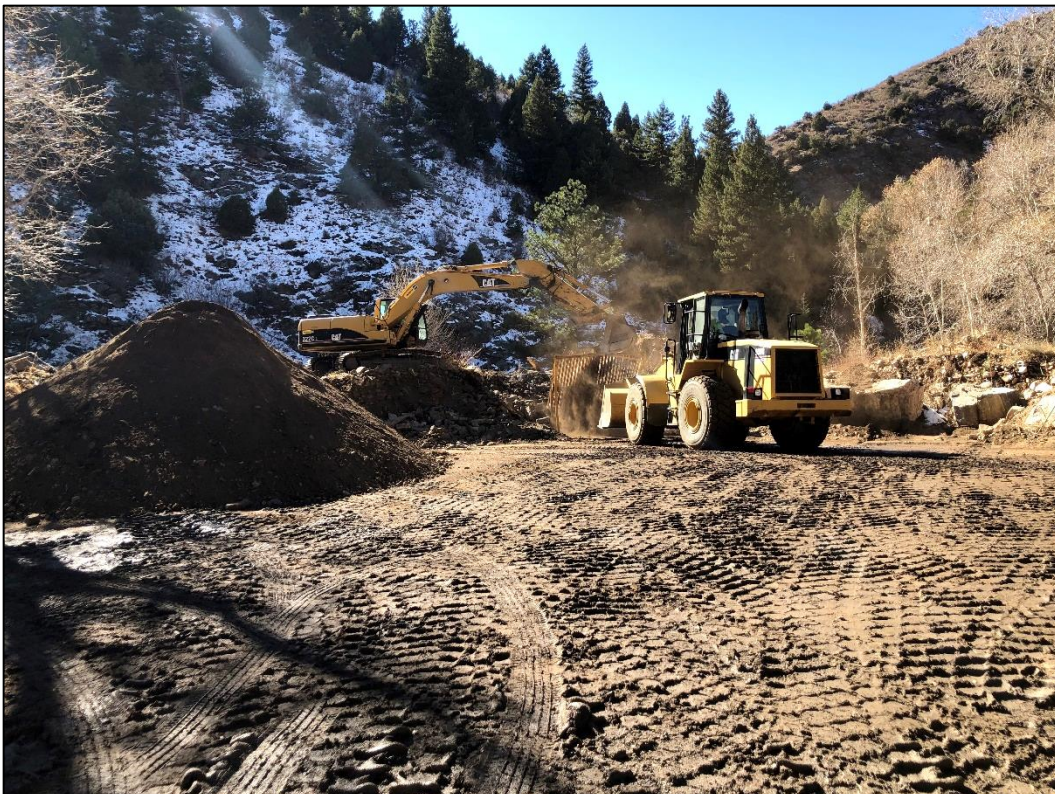
Photo 10. View looking south across borrow area located up valley from NWRP where rock and fill material is derived for diversion channel project. Excavated material was being screened during inspection.

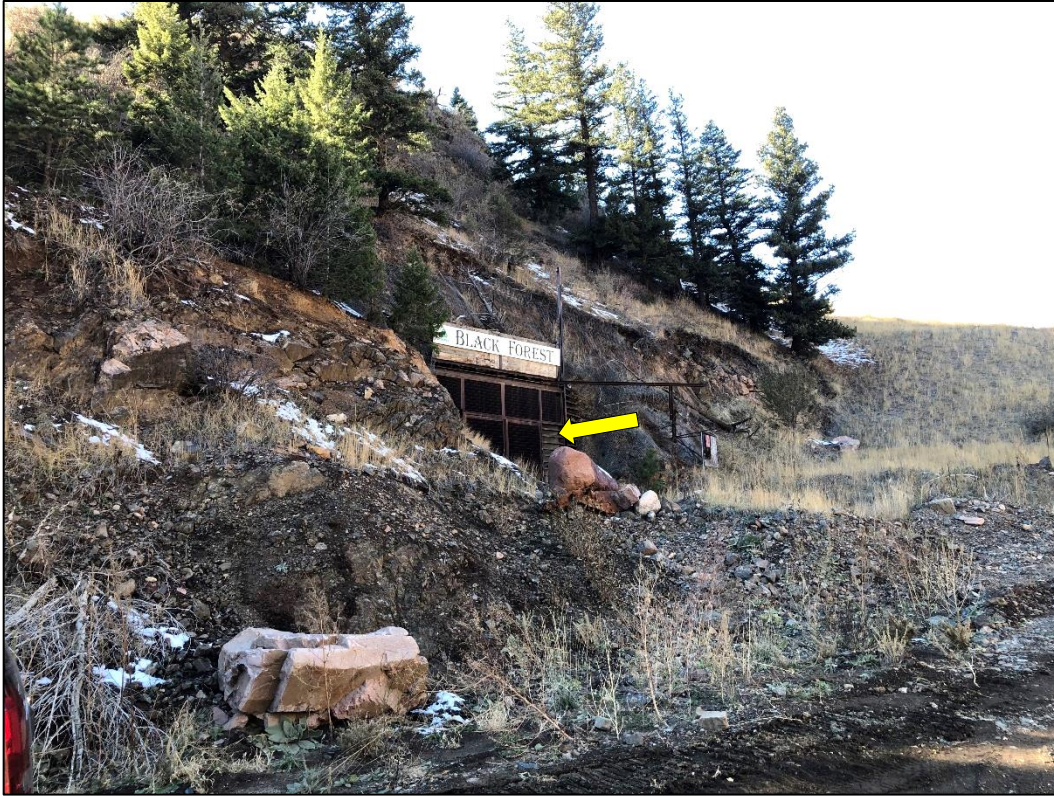
Photo 11. View looking northwest at northern portion of proposed Black Forest Mine expansion area. Note main portal in background (indicated with arrow).

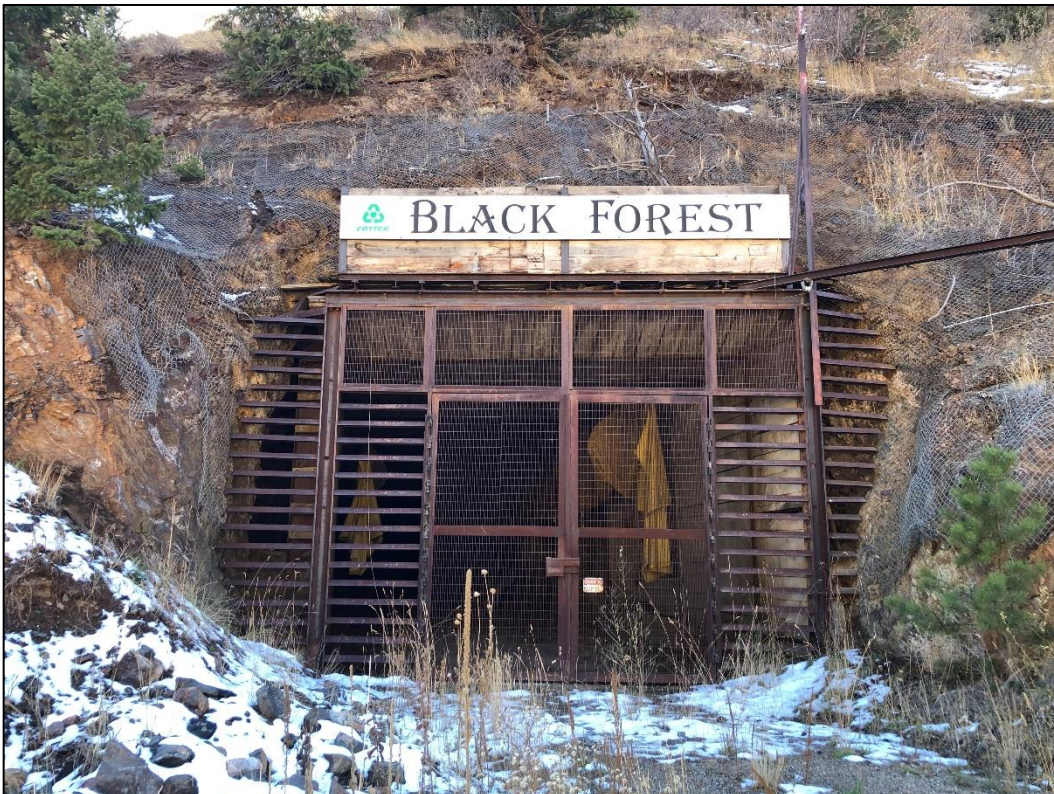
Closures have been installed on the Black Forest Mine portal and escapeway which meet the Division's Inactive Mine Reclamation Program's design specifications for underground openings. The main portal, which is approximately 11 feet x 12 feet in size, is covered by steel grating constructed of 4 inch x 4 inch angle iron with 6 inch spacing, and the gate is secured with a lock to prohibit unauthorized entry. The escapeway portal, which is approximately 7 feet in diameter and made of corrugated steel pipe, is covered by 1 inch x 4 inch steel grating, and the gate is also secured with a lock. In AM-5, the operator states that highly engineered water tight

Photo 12. Closer view of main portal to Black Forest Mine, covered with steel grating and secured with a locked gate.

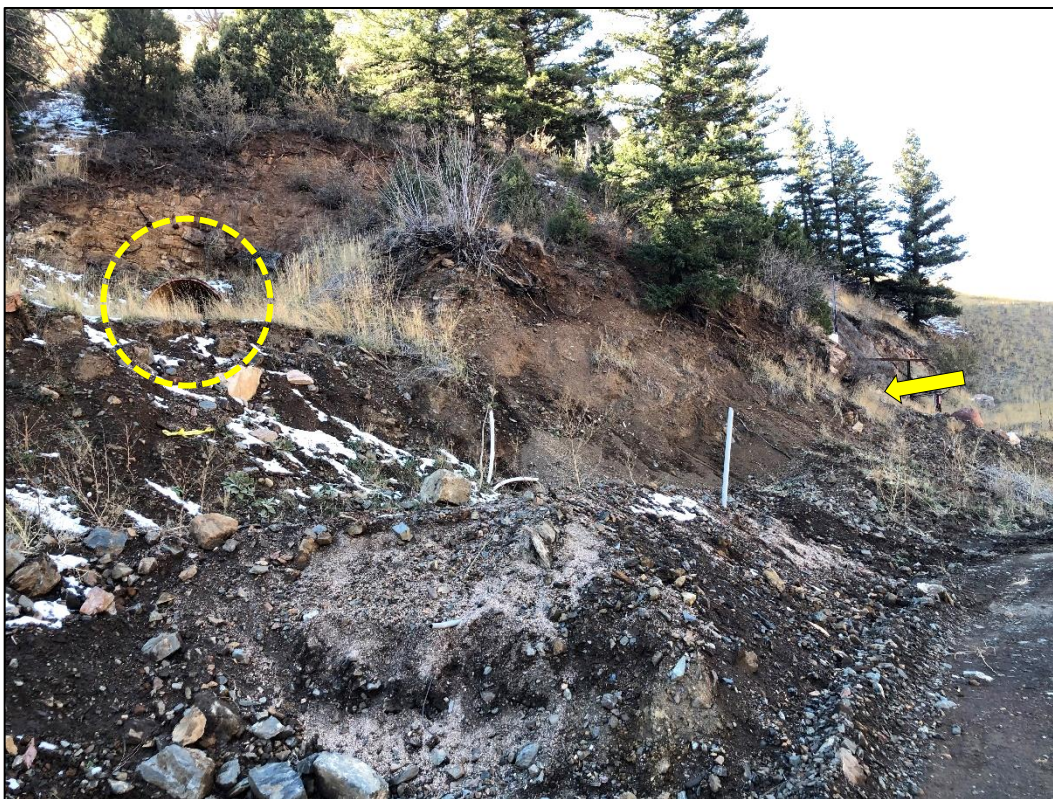
Photo 13. View looking northwest at southern portion of proposed Black Forest Mine expansion area. Note location of main portal (indicated with arrow) and escapeway (circled).

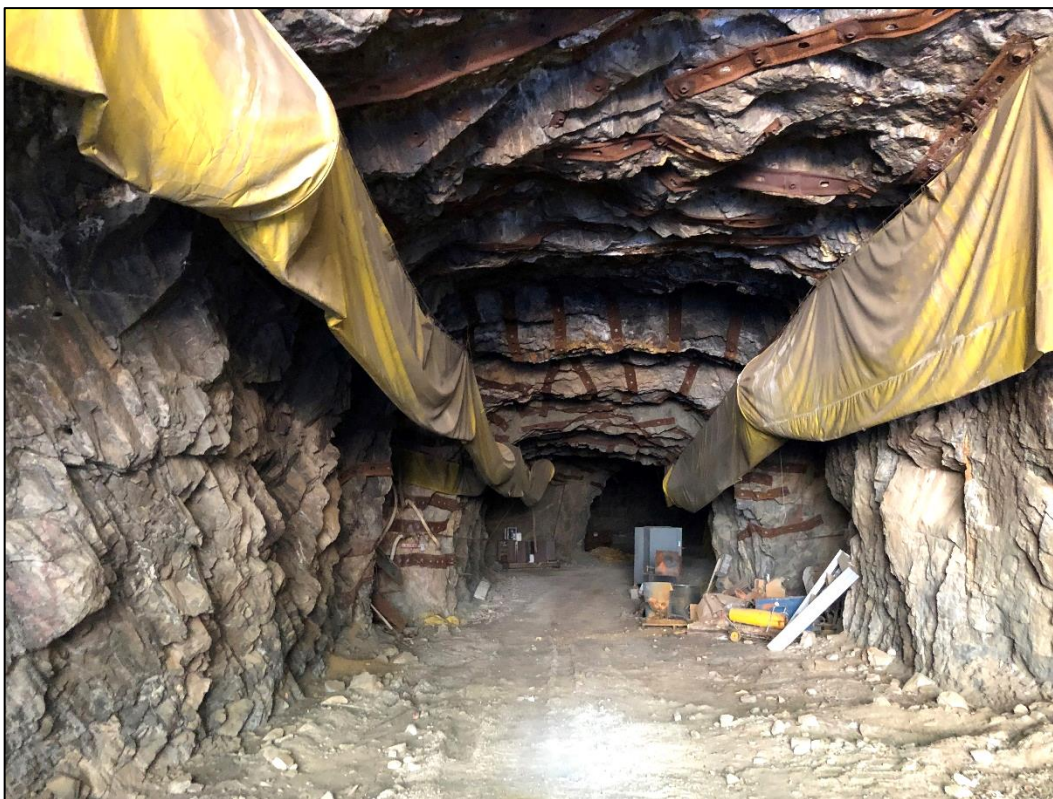
Photo 14. View looking inside Black Forest Mine from main portal. Note ventilation materials and various other pieces of equipment and materials from mining operations remain in mine per Permit No. M-2001-036.

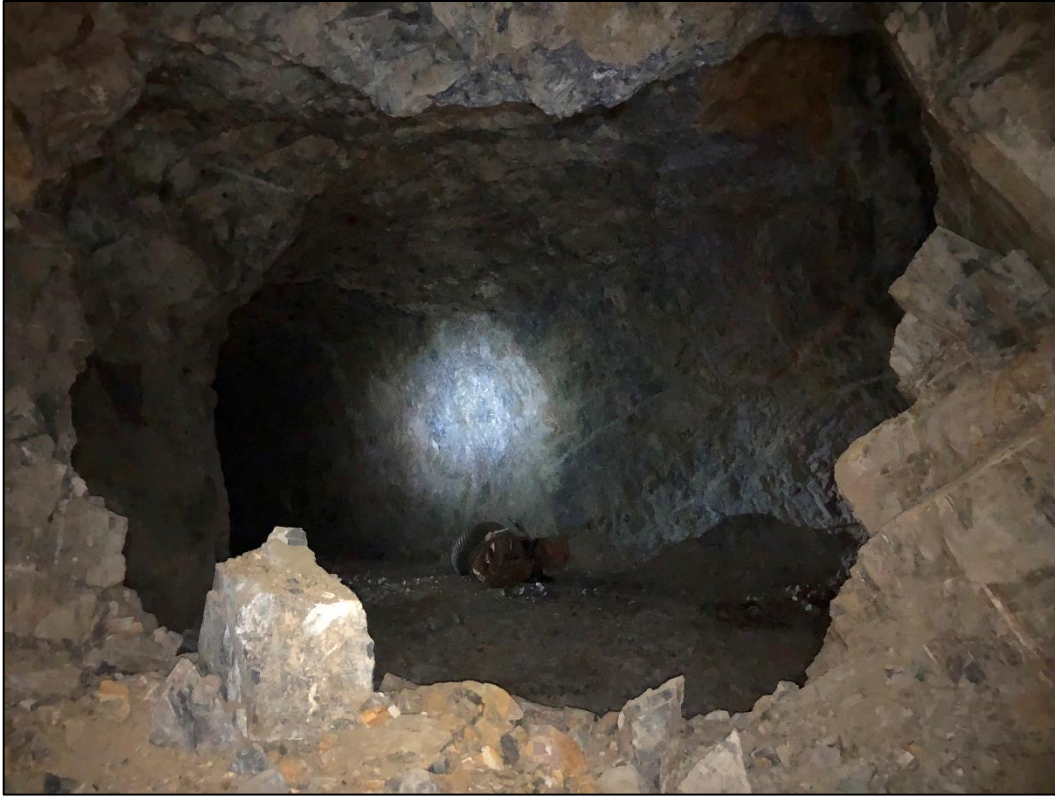
The Division inspected the inside workings of the Black Forest Mine and found no evidence of significant inflows from the walls of the workings. A few saturated areas were observed along fractures exposed at the ceiling, with minor dripping from these areas. No ponding was observed on the mine floor. The Division's observations during this inspection correlate with its observations made during previous inspections of the mine. Various pieces of old equipment and materials related to the mining operations (e.g., empty cabinets, empty tanks, ventilation-related debris, emergency equipment, decommissioned plumbing, electrical panels, concrete blocks, hoists, explosives cart) remain in the Black Forest Mine per Permit No. M-2001-036.

Photo 15. View inside Black Forest Mine. No ponding was observed on mine floor. Only a few saturated areas were observed along fractures exposed at ceiling of workings, with minor dripping from these areas.

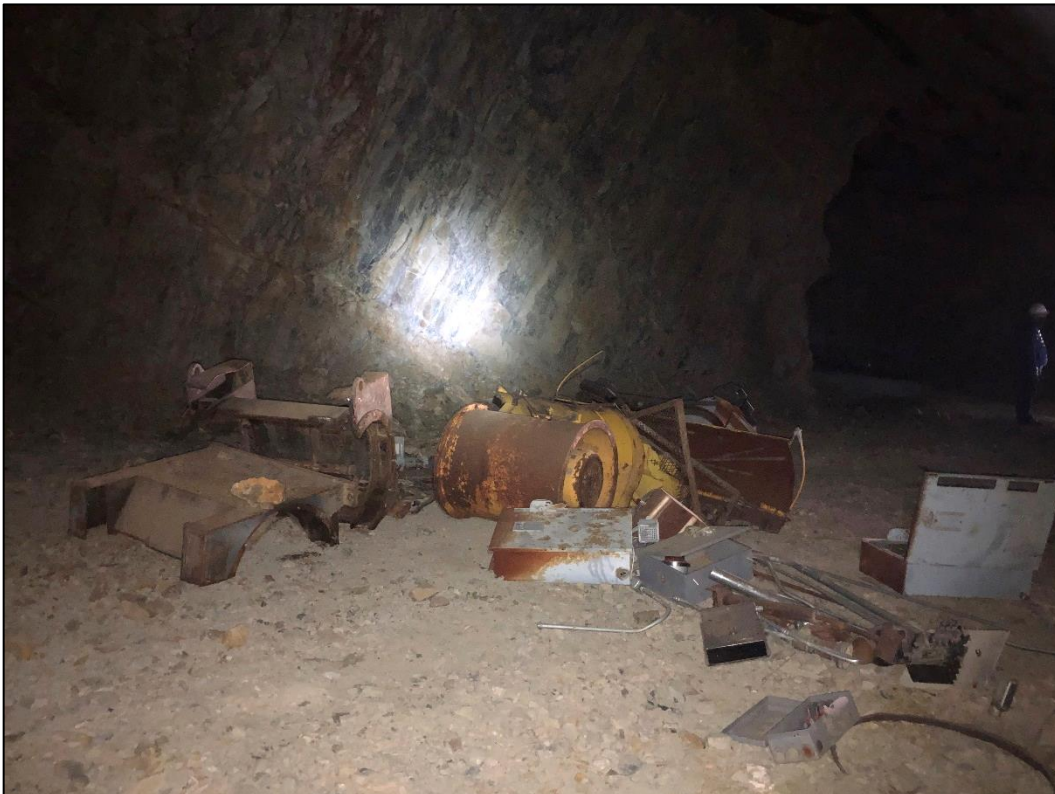
Photo 16. View inside Black Forest Mine. Note various pieces of equipment and materials from mining operations remain in mine per Permit No. M-2001-036.

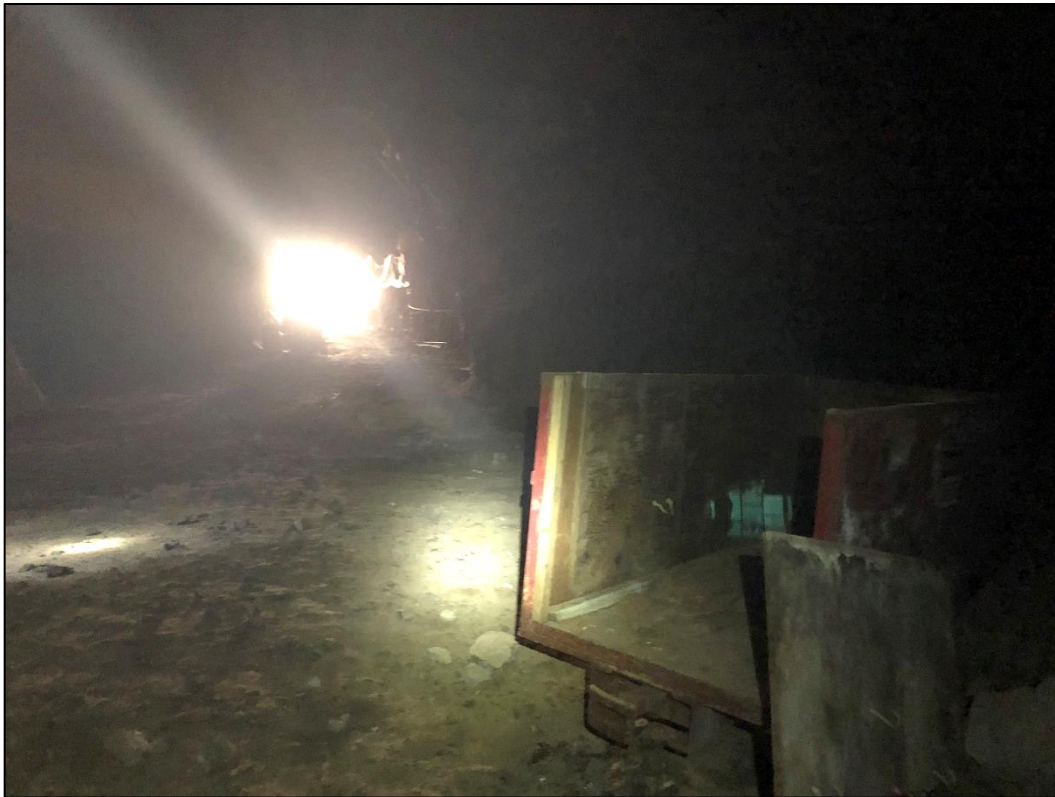
Photo 17. View inside Black Forest Mine looking toward escapeway (in background). Note explosives cart from mine operations (at right) remains in mine per Permit No. M-2001-036.

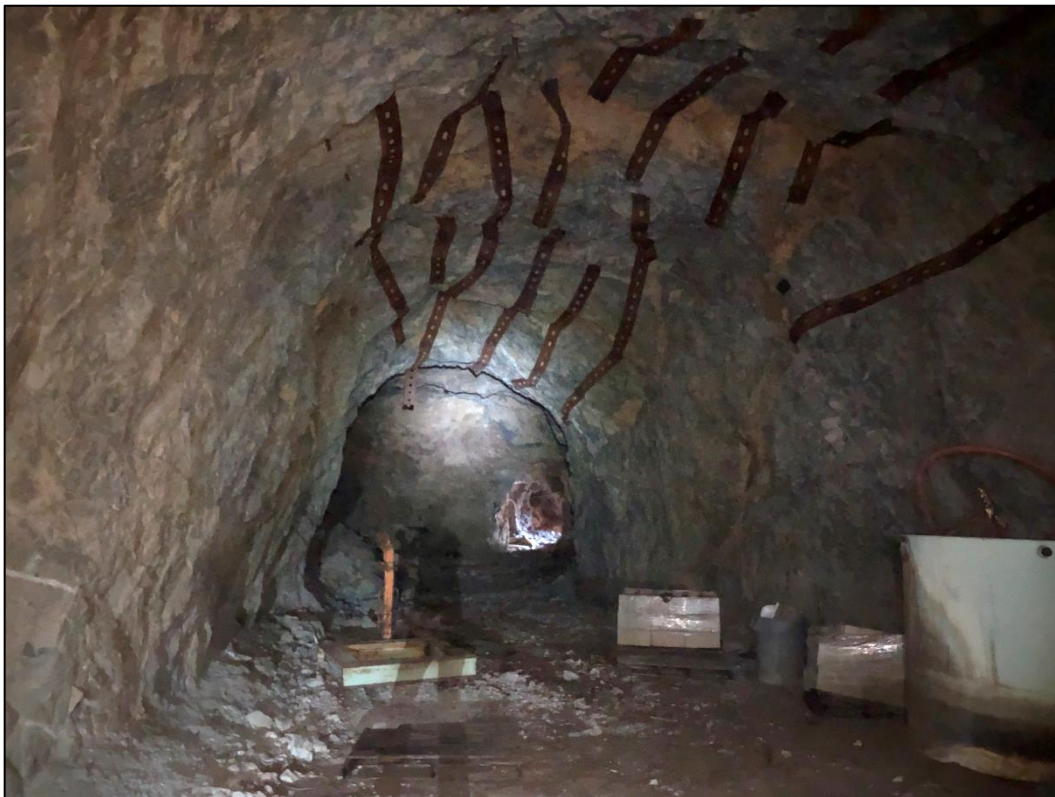
Photo 18. View inside Black Forest Mine looking toward escapeway (in background). Note various pieces of equipment and materials from mine operations remain in mine per Permit No. M-2001-036.

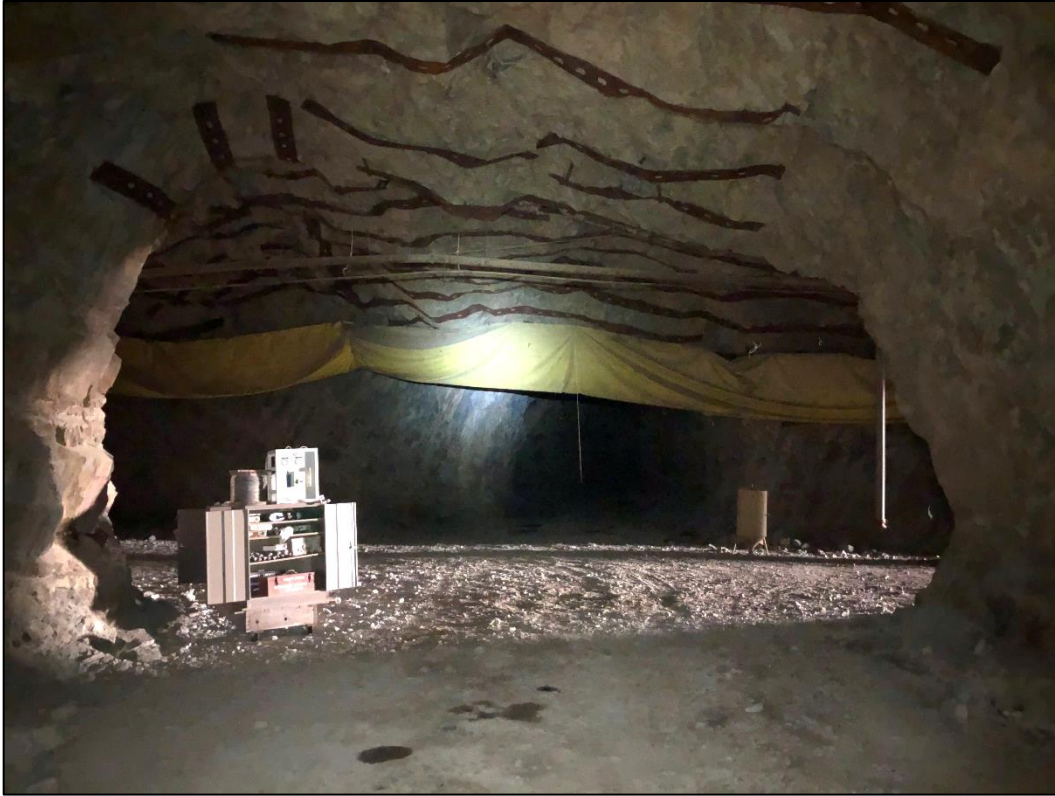
Photo 19. View inside Black Forest Mine. Note various pieces of equipment and materials from mine operations remain in mine per Permit No. M-2001-036.

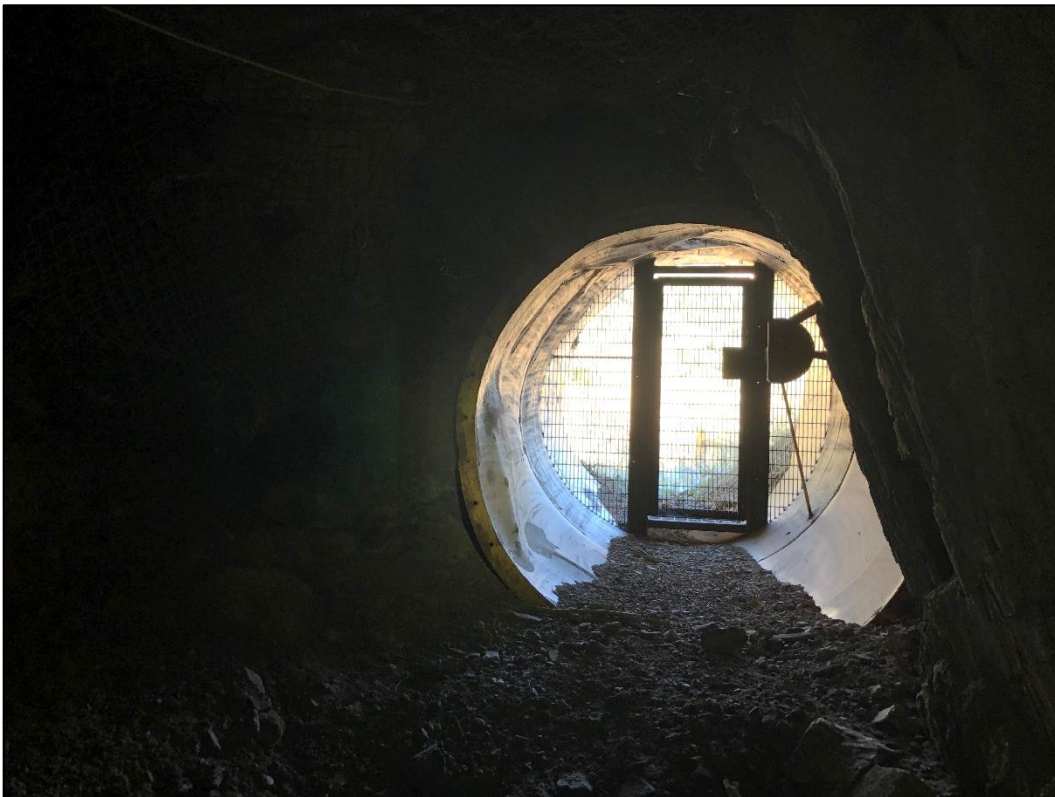
Photo 20. View inside Black Forest Mine looking at escapeway located southeast of main portal, covered with steel grating and secured with a locked gate.

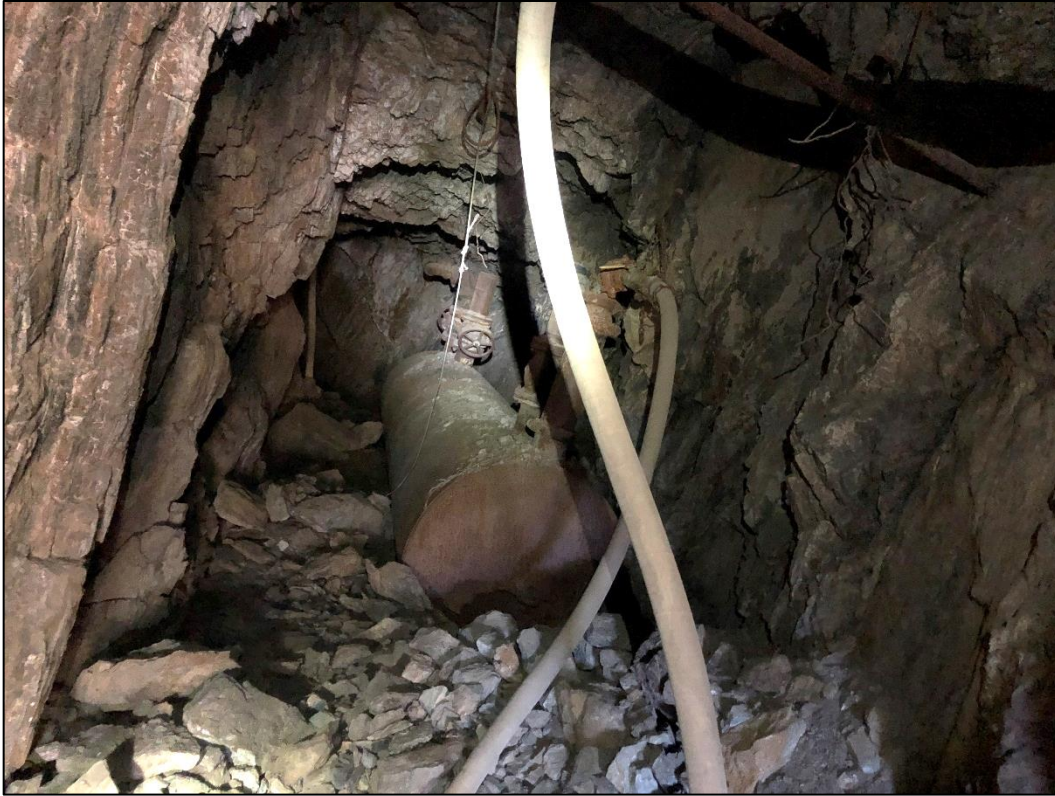
Photo 21. View inside Black Forest Mine, showing tank from mine operations left in area adjacent to escapeway.

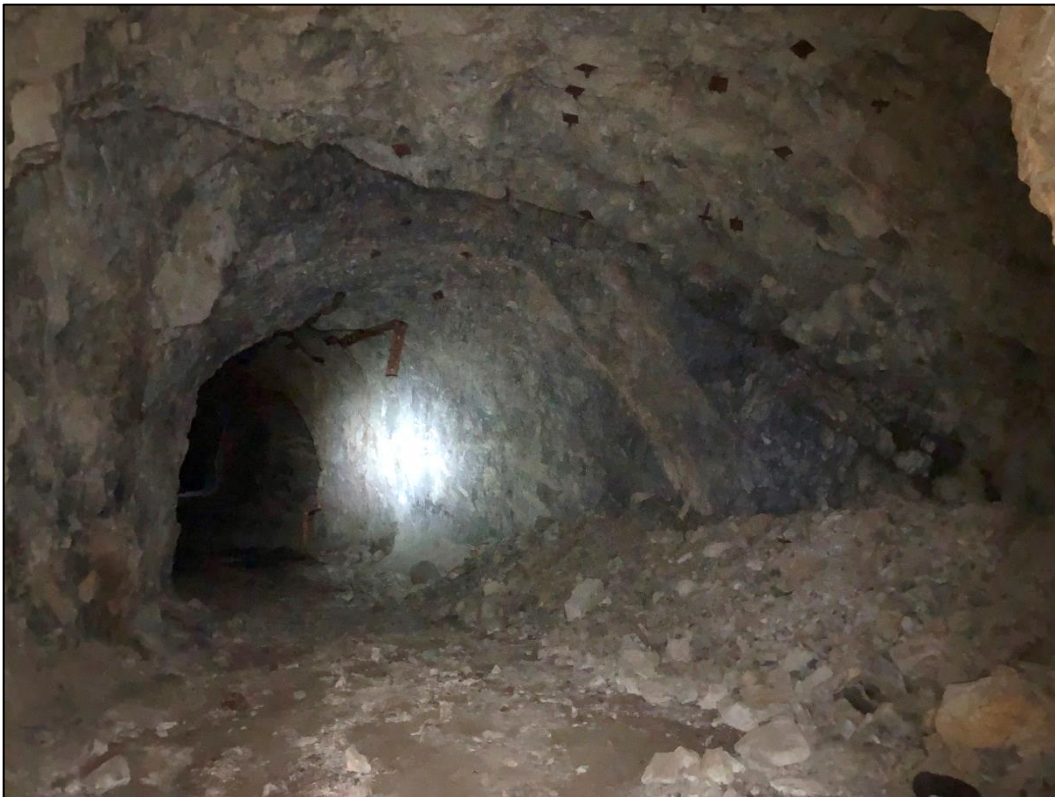
Photo 22. View inside Black Forest Mine. No ponding was observed on mine floor. Only a few saturated areas were observed along fractures exposed at ceiling of workings, with minor dripping from these areas.

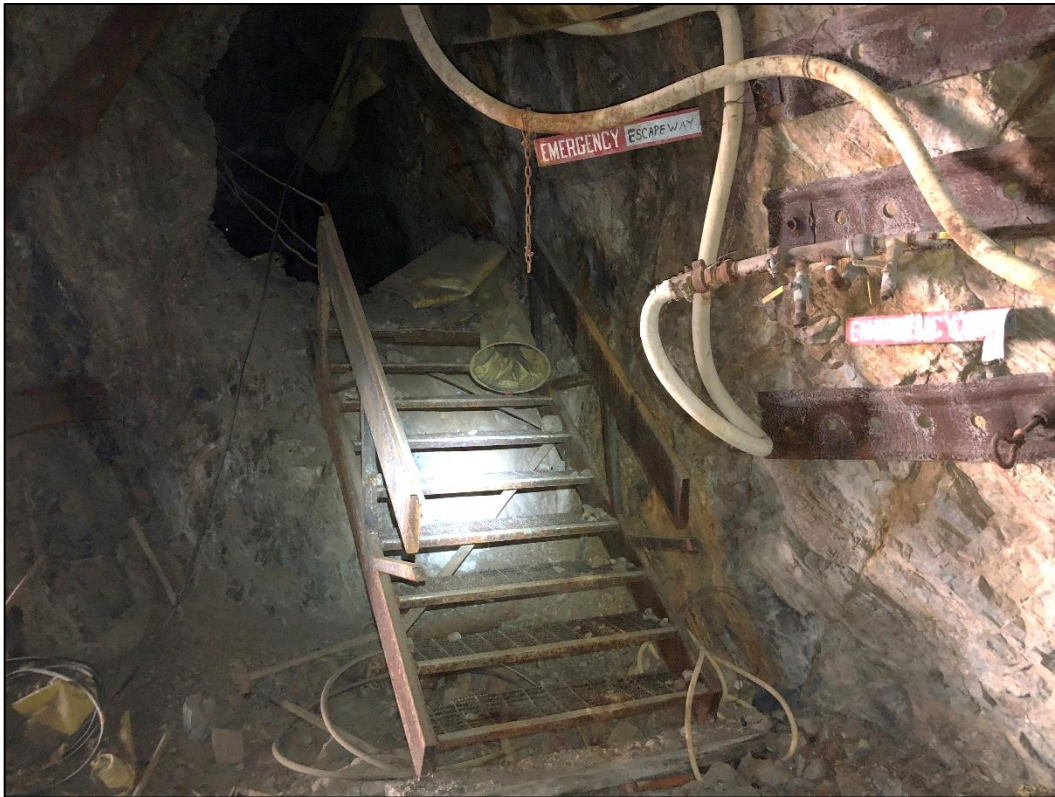
Photo 23. View inside Black Forest Mine, showing steps (to escapeway adit) and emergency equipment from mine operations left in mine.

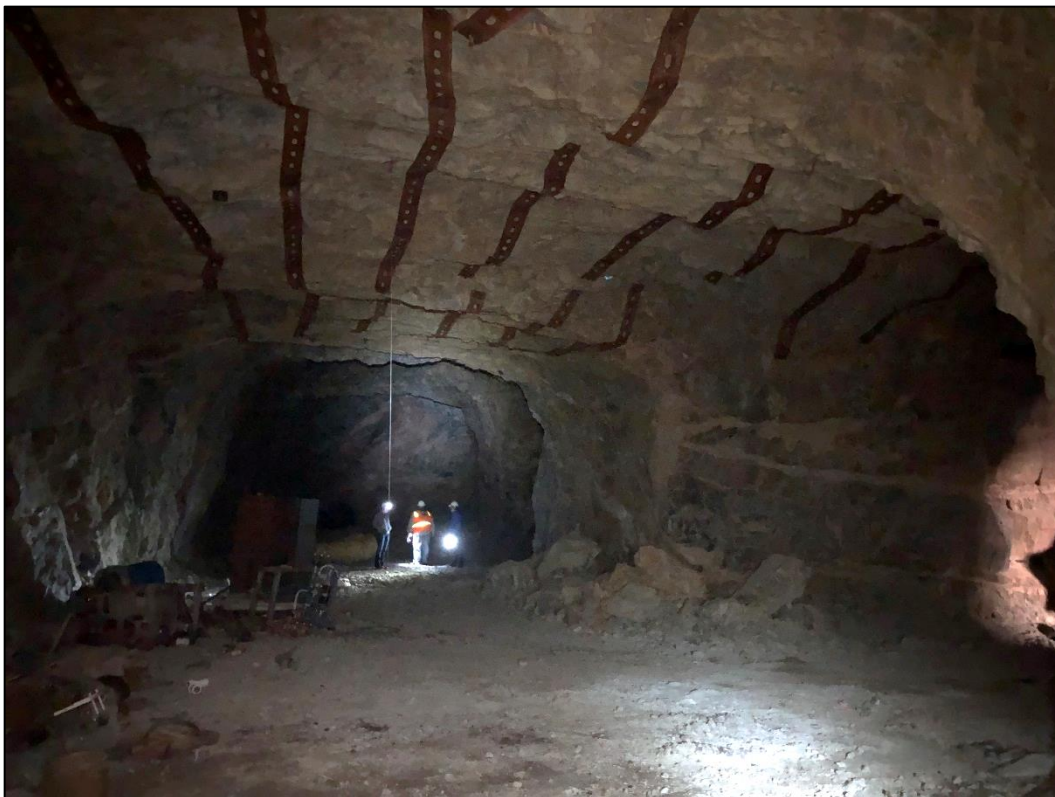
Photo 24. View inside Black Forest Mine. No ponding was observed on mine floor. Only a few saturated areas were observed along fractures exposed at ceiling of workings, with minor dripping from these areas.
