MINERALS PROGRAM INSPECTION REPORT

MINE NAME: Schwartzwalder Mine	MINE/PROSPECTING ID#: M-1977-300	MINERAL: Uranium	COUNTY: Jefferson
INSPECTION TYPE: Monitoring	INSPECTOR(S): Amy Eschberger, Michael Cunningham	INSP. DATE: October 29, 2020	INSP. TIME: 13:00
OPERATOR: Colorado Legacy Land, LLC	OPERATOR REPRESENTATIVE: Liz Busby, Billy Ray, Paul Newman	TYPE OF OPERATION: 112d-2 - Designated Mining Operation	
REASON FOR INSPECTION: Normal I&E Program	BOND CALCULATION TYPE: None	BOND AMOUNT: \$8,900,000.00	
DATE OF COMPLAINT: NA	POST INSP. CONTACTS: None	JOINT INSP. AGENCY: None	
WEATHER: Clear	INSPECTOR'S SIGNATURE:

This was a pre-operation inspection of the Schwartzwalder Mine (Permit No. M-1977-300) conducted by Amy Eschberger and Michael Cunningham of the Division of Reclamation, Mining and Safety (Division) in response to the Amendment No. 5 application (AM-5) filed with our Office on September 10, 2020. The Division received three comment letters on AM-5 (from Division of Water Resources, History Colorado, and Denver Water) within the public comment period which closed on October 28, 2020. No objections were received. The operator was represented by Liz Busby, Billy Ray, and Pa

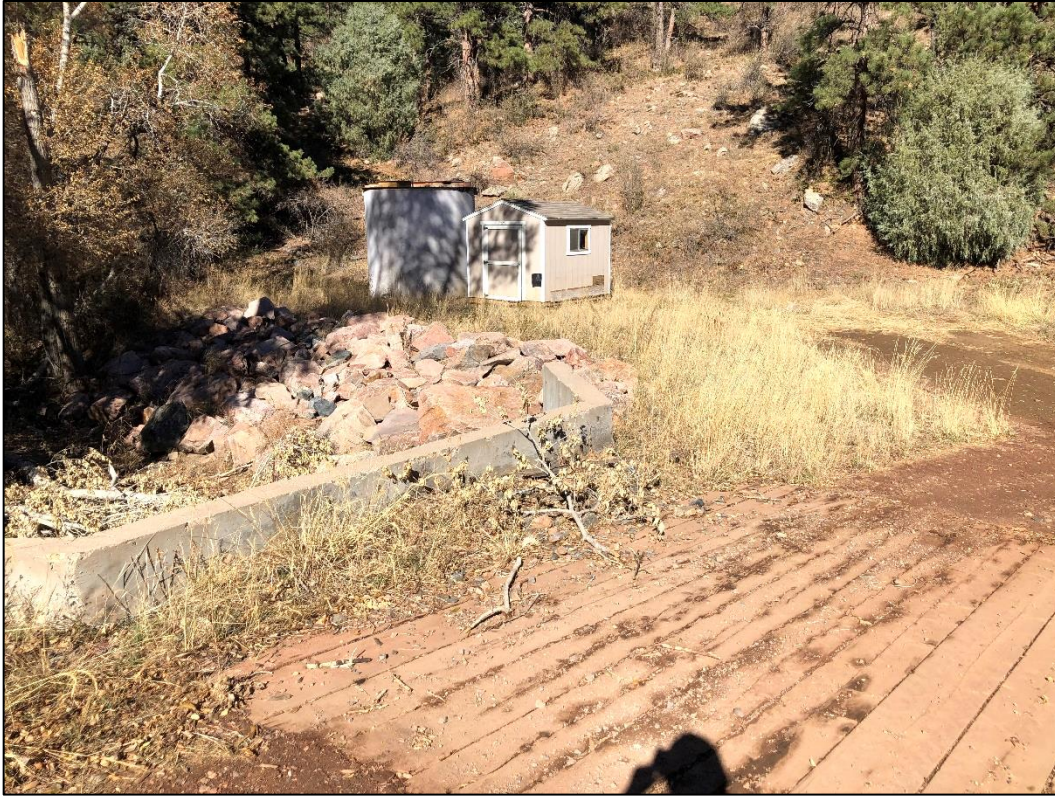
During the inspection, the Division observed the disturbed area located north/northeast of Ralston Creek (across from the Black Forest Mine) which, according to the permit file, was utilized as a waste rock storage area during mining operations. The Division estimates this area to be approximately one acre in size. The operator is currently utilizing this area for storage of equipment, tanks, slash piles, and debris piles. The operator should be sure to include costs for reclaiming this area in any future request for a surety reduction.

Photo 25. View looking north across disturbance area located northeast of Ralston Creek currently utilized for storage of equipment, slash piles, and debris piles. Note bridge (in foreground) which should be included in list of structures in Exhibit S of application.

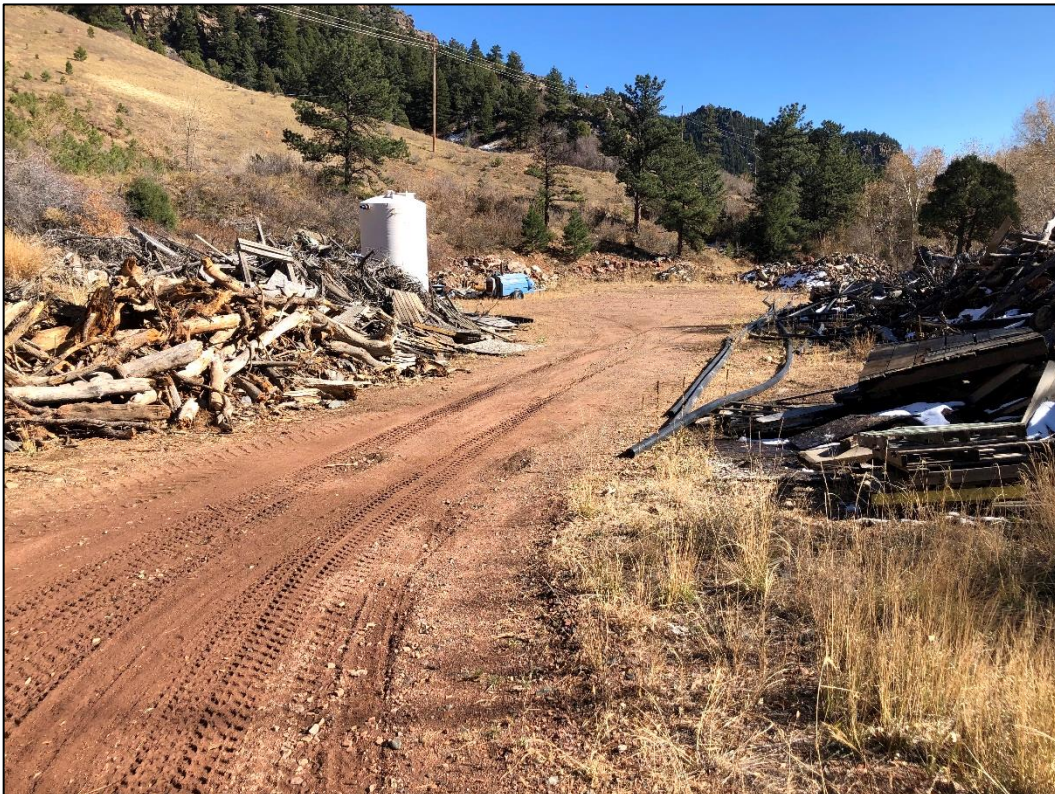
Photo 26. View looking southeast across disturbance area located northeast of Ralston Creek currently utilized for storage of equipment, slash piles, and debris piles.
