**RE: Colowyo Coal Company L.P.**  
**Permit No. C-1981-019**  
**Technical Revision No. 144**  
**West Taylor Fill Piezometer**

**To:** Brian Coates and Doug White (Colowyo)  
**From:** Samrat Mohanty (AAI)  
**Date:** October 29, 2020  
**Subject:** Geotechnical Evaluation of West Taylor Fill Piezometer

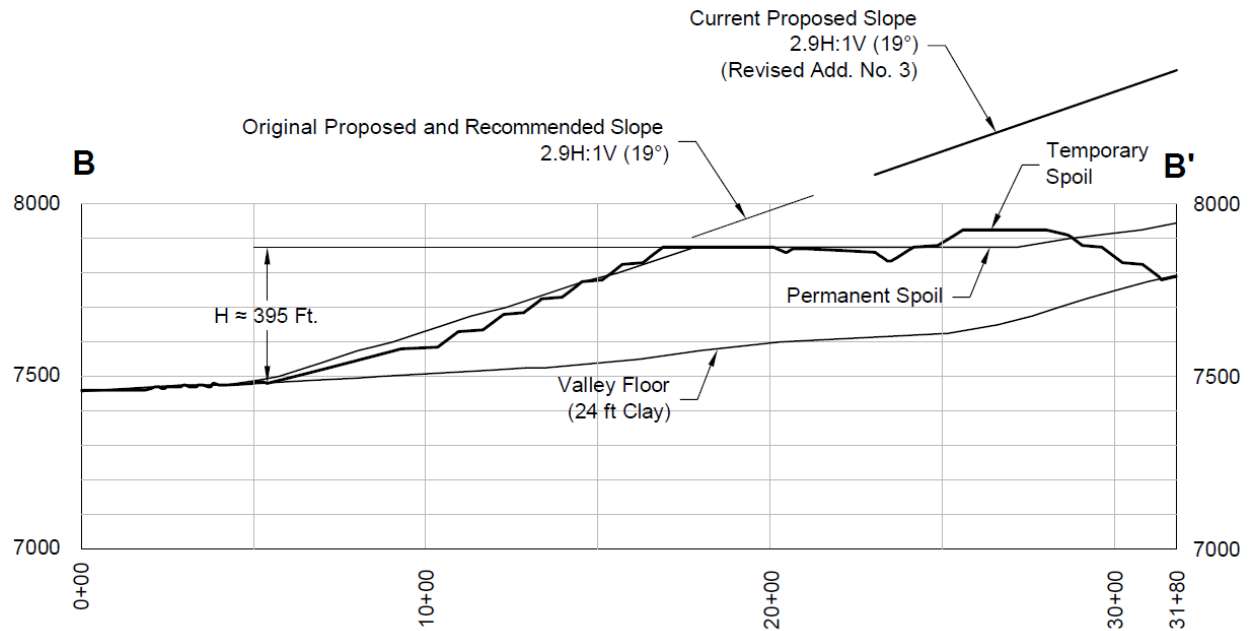
Figure 2. West Taylor Fill Schematic Section<sup>2</sup>

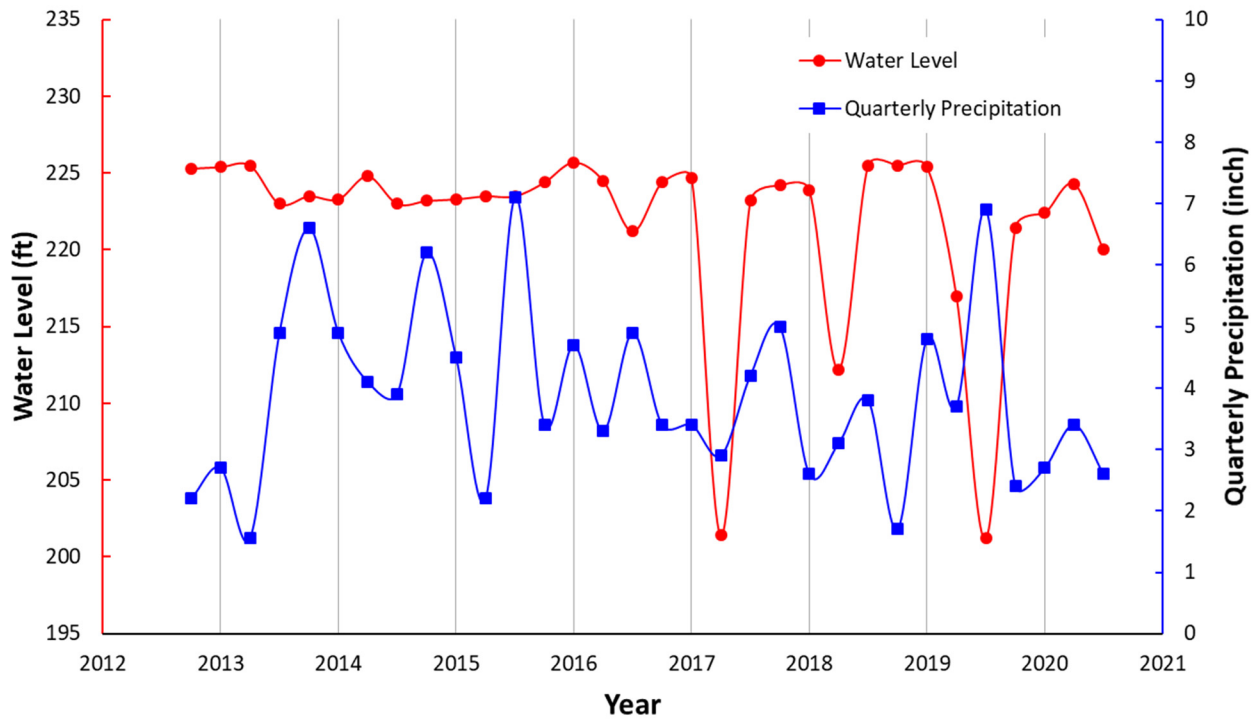
Figure 3. West Taylor Fill Piezometer Water Level Trend Since Installation

Since the first monitoring data collected in 2012, Colowyo recorded the water levels quarterly until 2018 when the piezometer well started showing signs of pinching. Colowyo has reported a total of three pinch points along the piezometer column (i.e., at approximately 90 ft, 120 ft, and 170 ft bgs). The pinch points have made measurements of the water level very difficult as the inspecting personnel need to undertake numerous attempts to maneuver the well water sounder past the pinch points. Due to the recent difficulties in accessing the groundwater level in the piezometer well, Colowyo requested that AAI ascertain if continued groundwater monitoring is required. The description of the problem prompted AAI to hypothesize that the pinching may be driven by differential displacements within the spoil matrix.

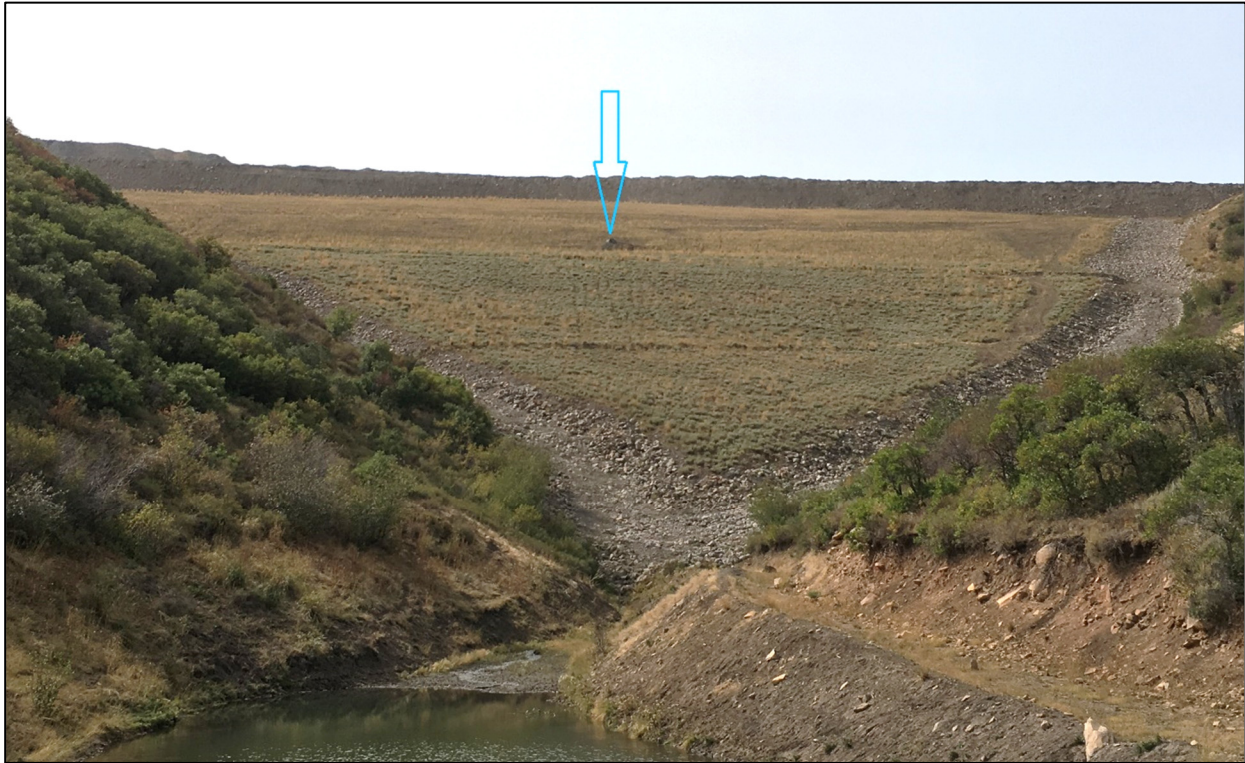
However, such behavior is not unusual and is not indicative of global instabilities deep within the spoil matrix. During site inspection, the author surveyed the fill surface, traversing from the toe to the crest level along the valley axis line, and no signs of a deeper global instability were observed (Figure 4). No tension cracks were observed close to crest, no side cracks were observed close to the east/west flanks, no heave zones were observed in the toe area, and no seeps were observed. The underdrains were observed to seep water, as intended, although the surface side drains were relatively dry.

**Figure 4. View of the West Taylor Fill, Looking South (Piezometer Location Marked)**

In light of the data review and following the visit, AAI is of the opinion that the pinching of piezometer well column will likely get worse as differential deformation between spoil zones of varying geotechnical characteristics continues. Ultimately, the collection of water level measurements is likely to become impossible in the near to medium term. Given the ground conditions observed at the site, AAI is of the opinion that an indirect monitoring approach may be utilized, such as quarterly review of fill surface topographic contours obtained from aerial drone measurements to detect large movements. In summary, AAI is of the opinion that quarterly measurement of piezometric water level in the West Taylor Fill area may be discontinued given the data collection challenges, which can be more effectively substituted by study of remotely monitored topographic contours in addition to quarterly monitoring of general ground conditions of the fill.
