MINERALS PROGRAM INSPECTION REPORT

MINE NAME: Nahcolite Project	MINE/PROSPECTING ID#: M-1983-194	MINERAL: Carbonates	COUNTY: Rio Blanco
INSPECTION TYPE: Monitoring	INSPECTOR(S): Amy Yeldell	INSP. DATE: October 22, 2020	INSP. TIME: 10:30
OPERATOR: Natural Soda LLC	OPERATOR REPRESENTATIVE: Kirk Daehling	TYPE OF OPERATION: 112d-3 - Designated Mining Operation	
REASON FOR INSPECTION: Normal I&E Program	BOND CALCULATION TYPE: None	BOND AMOUNT: \$3,671,965.00	
DATE OF COMPLAINT: NA	POST INSP. CONTACTS: DRMS	JOINT INSP. AGENCY: U.S.BLM	
WEATHER: Clear	INSPECTOR'S SIGNATURE:

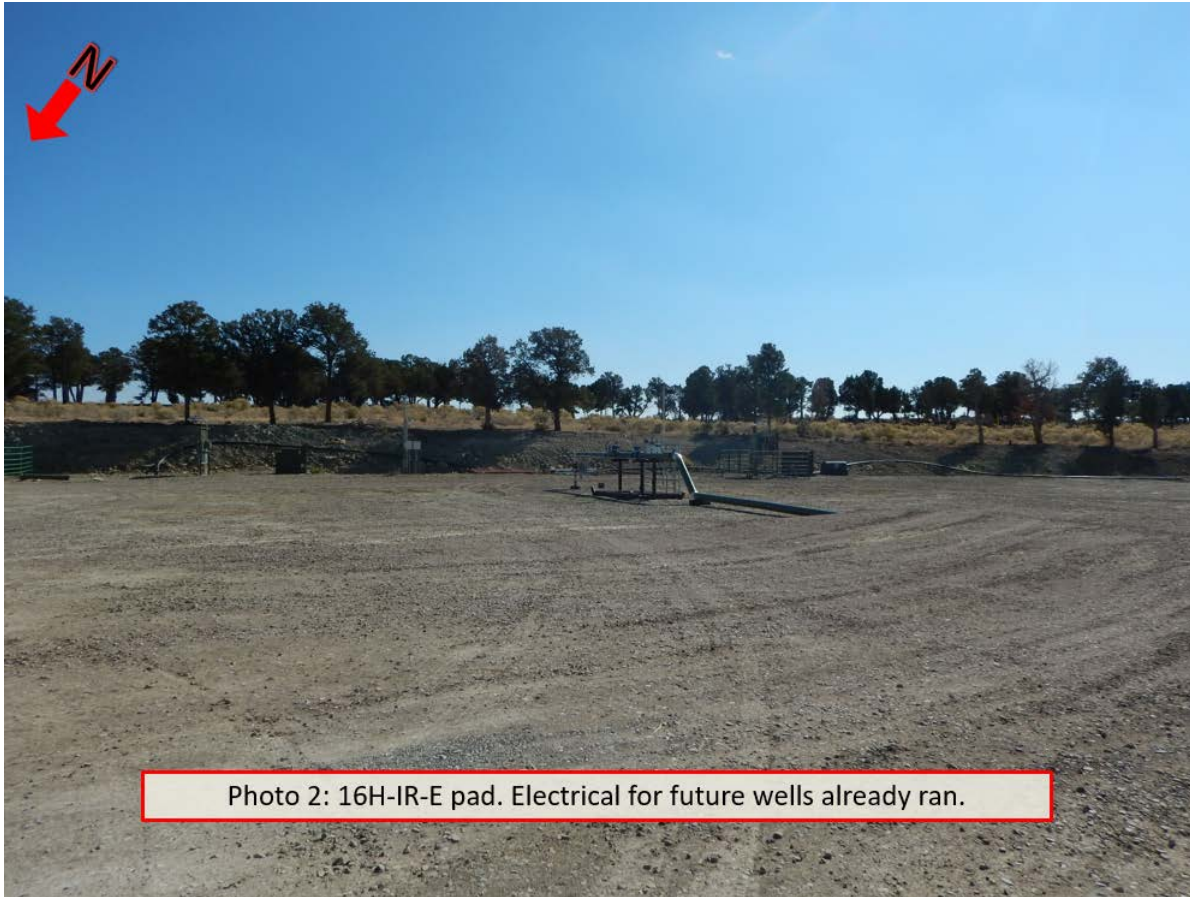
The Division also inspected the 16H-IR-E pad. The 16H-IR-E well is now online. NSI anticipates drilling 17H-IR-E in 2022.

Photo 2: 16H-IR-E pad. Electrical for future wells already ran.

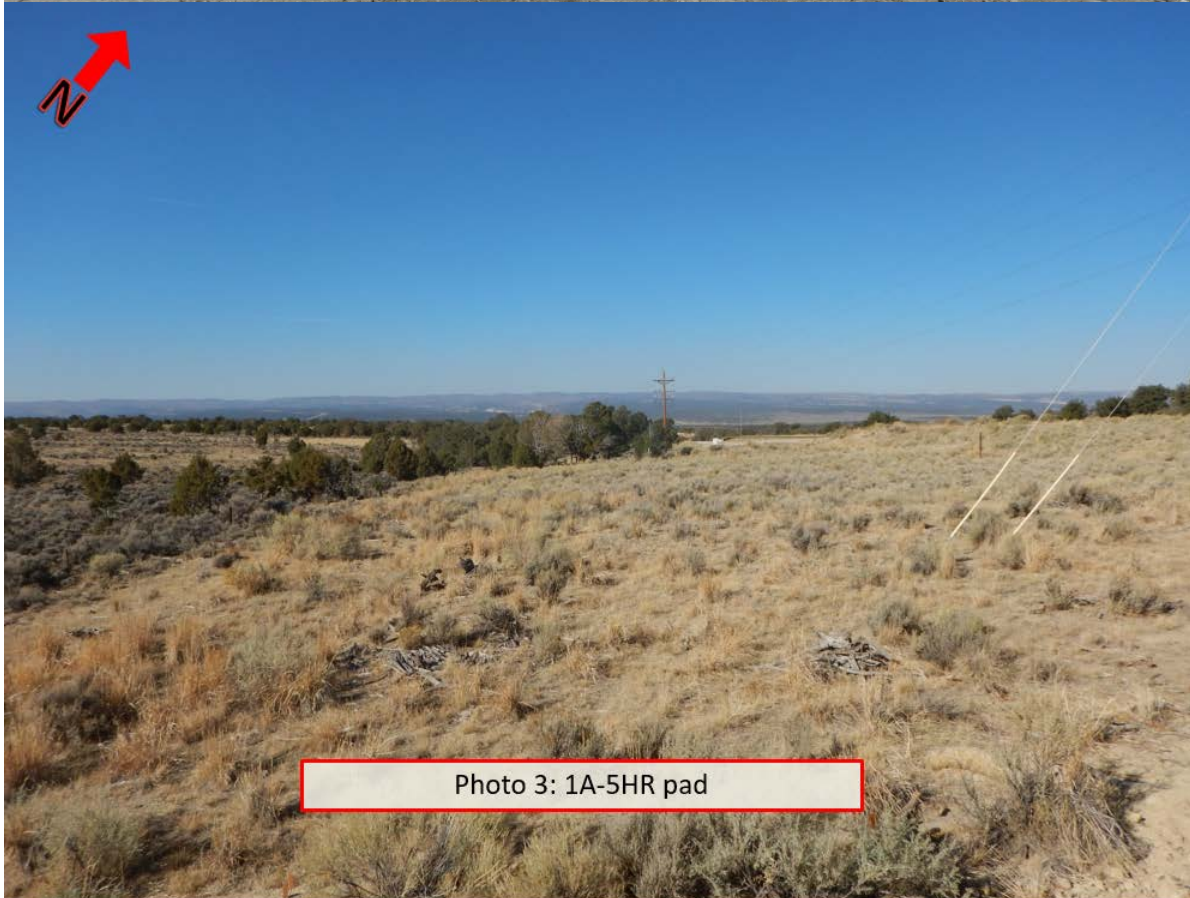
The field between the 16H-1V pad and 8 pad known as the 1A-5HR pad has been completely reclaimed. Plugged wells in this area include 1A-4HI, 3A-5V, 1A-5HR. Above ground well markers remain in place. Grasses are well established with approximately 30% shrub-sage cover.

Photo 3: 1A-5HR pad

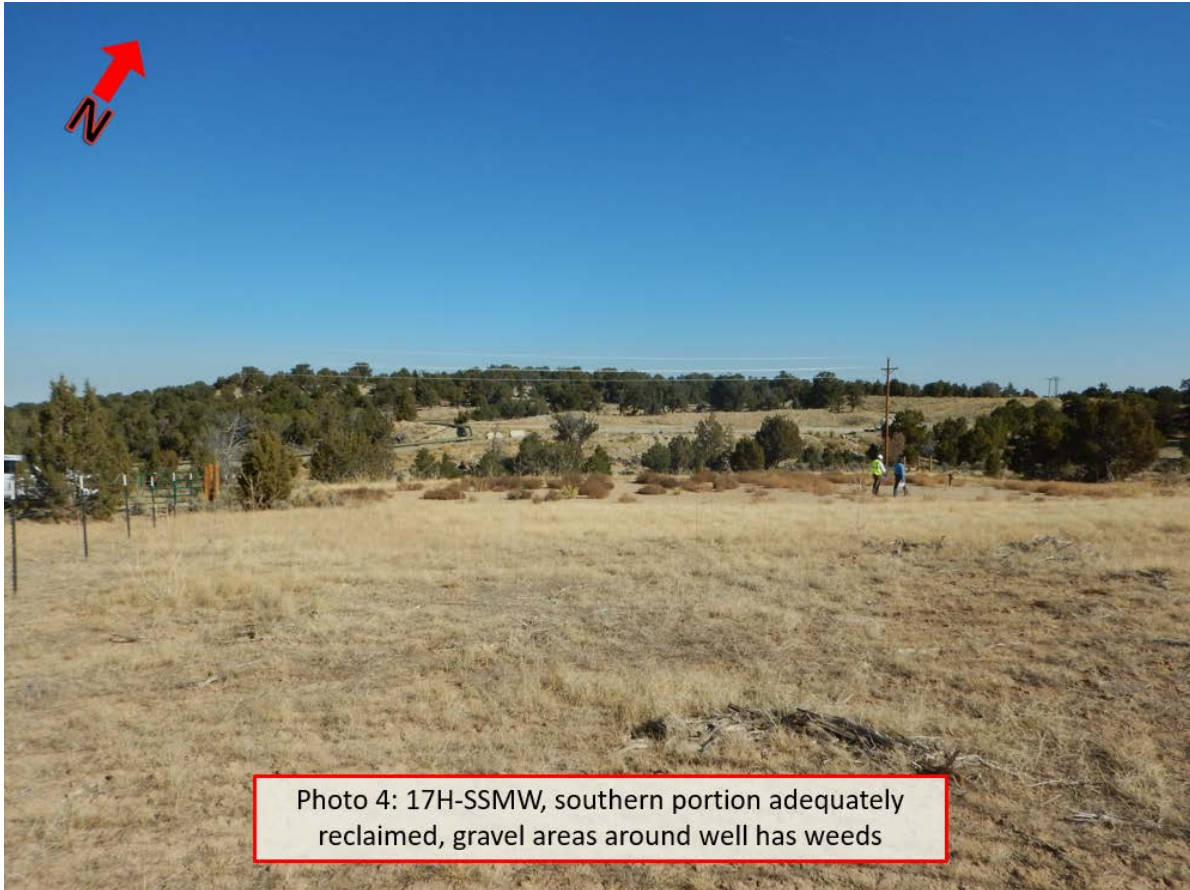
The 17H-SSMW pad has been interim reclaimed. Only a small area around the well is graveled. The remainder of the pad has been sloped, topsoiled and revegetated. Excess topsoil was placed at the toe of the slope to be pulled back for final reclamation once the well is abandoned. The pad is primarily perennial grasses with some annual flowers. The northern graveled portion of the pad had large amounts of Russian Thistle. This area is small enough that mechanical treatments may be more effective than chemical.

Photo 4: 17H-SSMW, southern portion adequately reclaimed, gravel areas around well has weeds

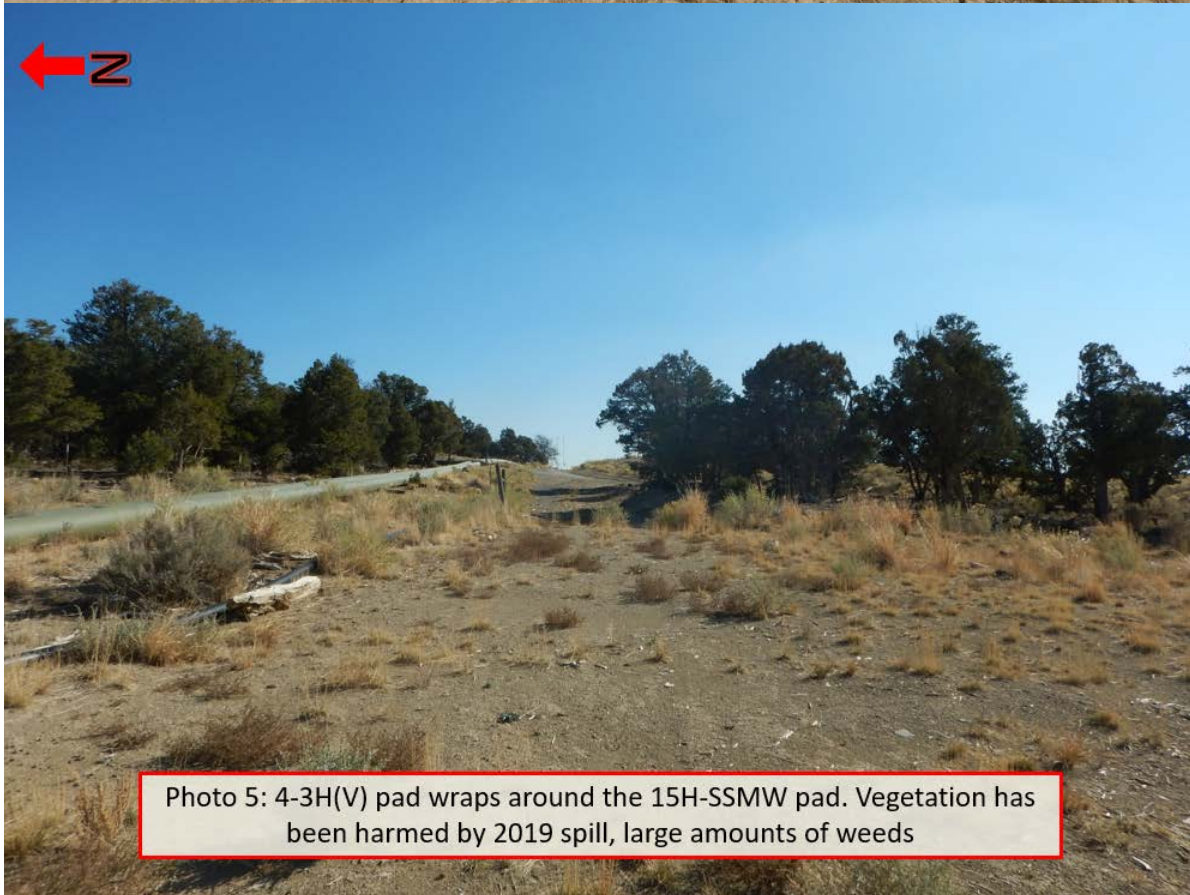
The 4-3H(V) pad wraps around the 15H-SSMW pad. On May 13, 2019 a spill occurred in this area which resulted in a portion of this pad to be re-reclaimed. Evidence of the spill is still visible as recently reclaimed areas have poor success. Reclamation of this pad is very 'hit or miss'. Areas are either well established, diverse and lush or nearly nonexistent with a large amount of noxious weeds. This area has a large amount of Halogeton. This pad has not been successfully reclaimed.

Photo 5: 4-3H(V) pad wraps around the 15H-SSMW pad. Vegetation has been harmed by 2019 spill, large amounts of weeds

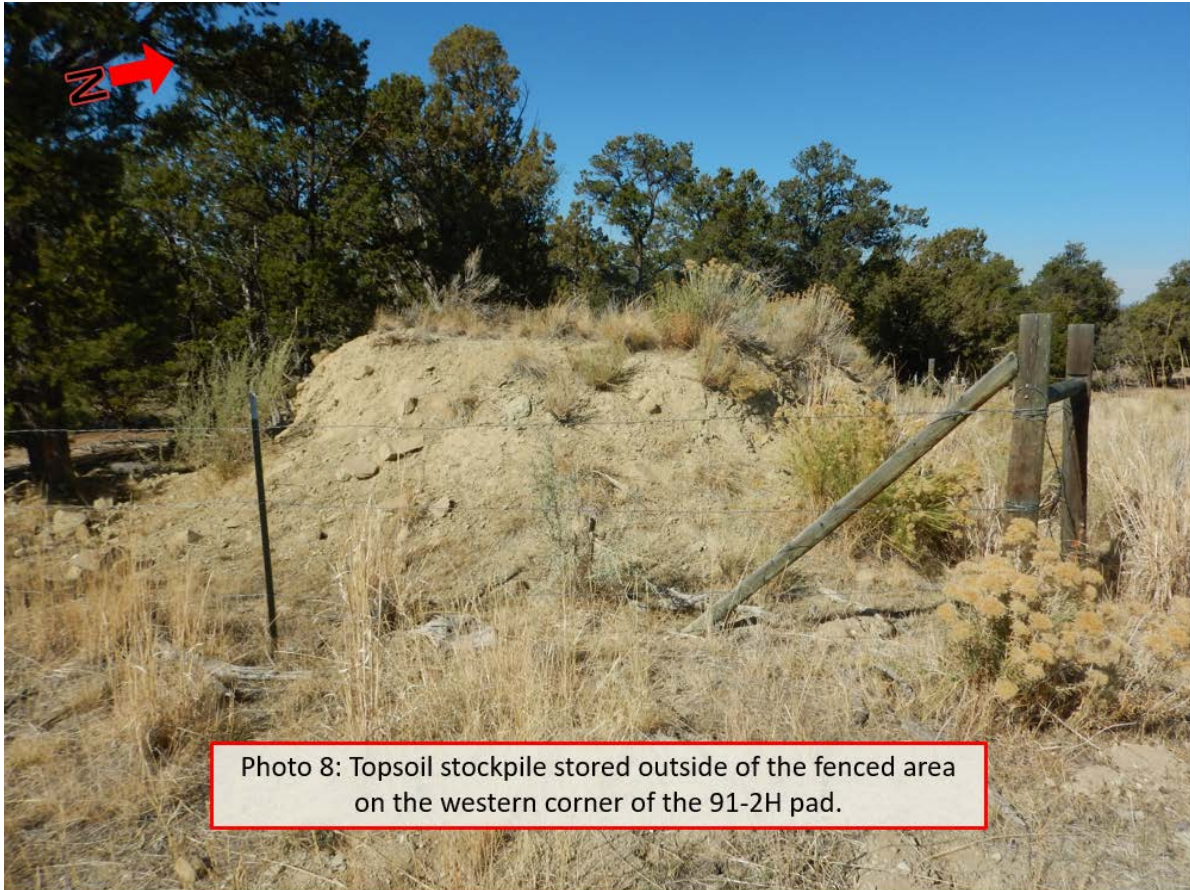
91-2H pad, includes wells 4A-1V, 4A-4V, 93-4H and 91-2H all of which have been abandoned. Overall this pad has good grass cover with established rabbit brush. On the northwest side of the pad is some cheatgrass clusters that will need additional spraying. Desirable vegetation in the cheatgrass areas is sparse and should be monitored, spot seeding may be necessary. The entire pad is enclosed by a fence. Just outside of the fence on the northwest corner is a topsoil pile that will need to be removed and reclaimed.

Photo 8: Topsoil stockpile stored outside of the fenced area on the western corner of the 91-2H pad.

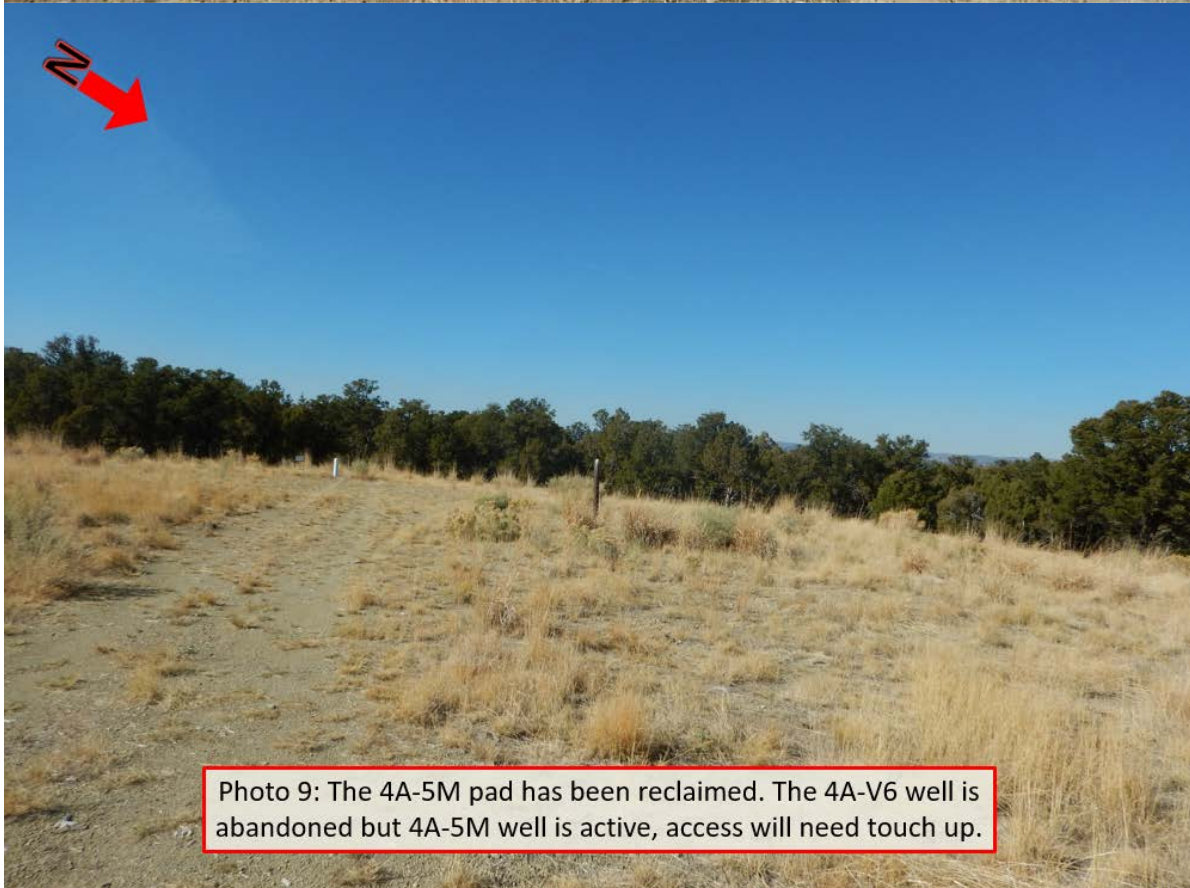
The 4A-5M pad has been reclaimed. The 4A-V6 well is abandoned and 4A-5M well is active. The entire pad is fenced in with an access gate on the northeast side. Grasses are well established with some shrub species. Given the active well on site there are tire two tracks to the monitoring well. Additional reclamation measures will be required upon abandonment of that well. A disconnected electrical panel was observed on site but has since been removed. No reclamation of the access road has taken place.

Photo 9: The 4A-5M pad has been reclaimed. The 4A-V6 well is abandoned but 4A-5M well is active, access will need touch up.

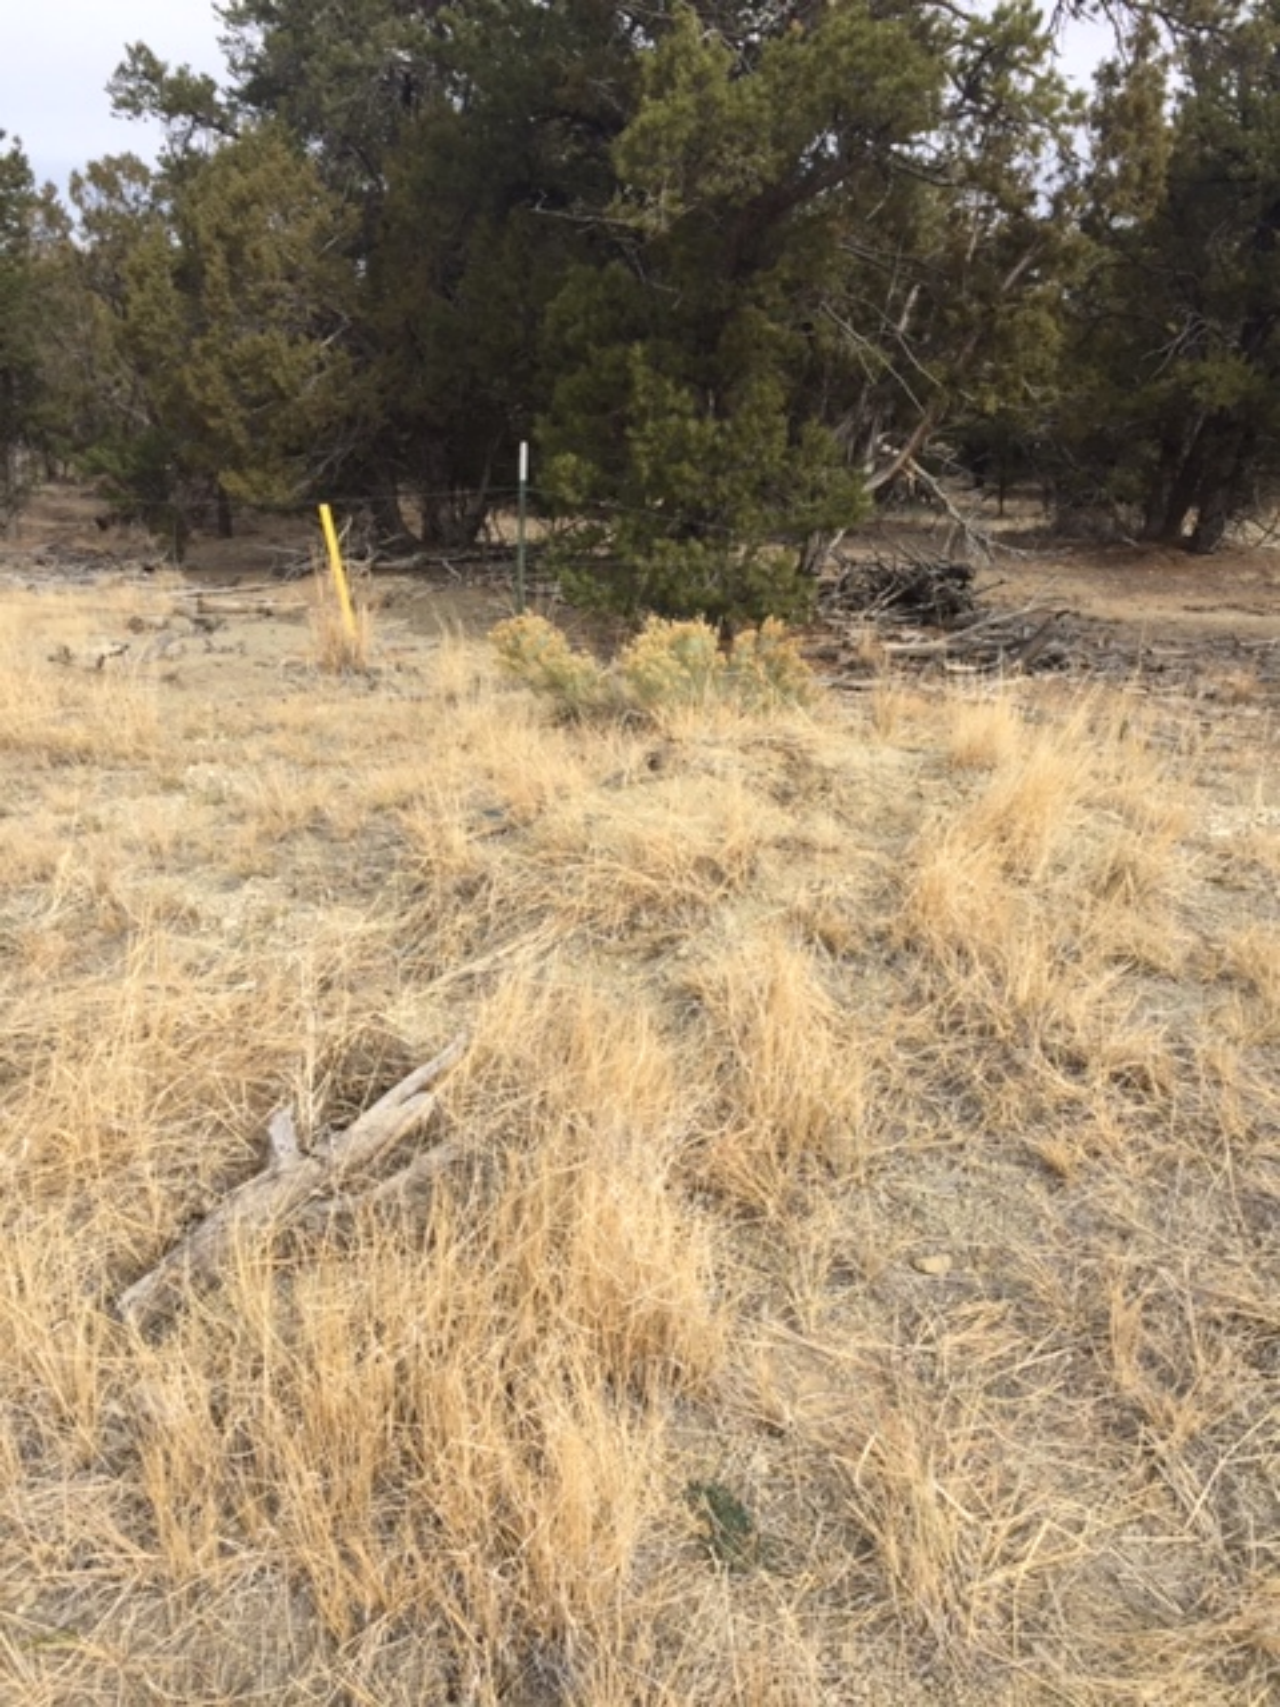
PAD E 10/23/20

Photos of the remote pads E, H, N, P and R were provided after the inspection via email. The report and photos are attached. Based on the photos provided the pads appear to be adequately reclaimed. Given that only one picture per pad was provided it's difficult to determine if vegetation is uniform throughout the pad or if the photo is representative. Prior to a formal release of these pads the Division will need to personally inspect each pad.
