MINERALS PROGRAM INSPECTION REPORT
PHONE: (303) 866-3567

MINE NAME: Climax Mine	MINE/PROSPECTING ID#: M-1977-493	MINERAL: Molybdenum	COUNTY: Lake, Summit
INSPECTION TYPE: Monitoring	INSPECTOR(S): Dustin Czaplá	INSP. DATE: October 21, 2020	INSP. TIME: 13:00
OPERATOR: Climax Molybdenum Company	OPERATOR REPRESENTATIVE: Diana Kelts	TYPE OF OPERATION: 112d-3 - Designated Mining Operation	
REASON FOR INSPECTION: Normal I&E Program	BOND CALCULATION TYPE: None	BOND AMOUNT: \$91,011,850.00	
DATE OF COMPLAINT: NA	POST INSP. CONTACTS: None	JOINT INSP. AGENCY: None	
WEATHER: Clear	INSPECTOR'S SIGNATURE:

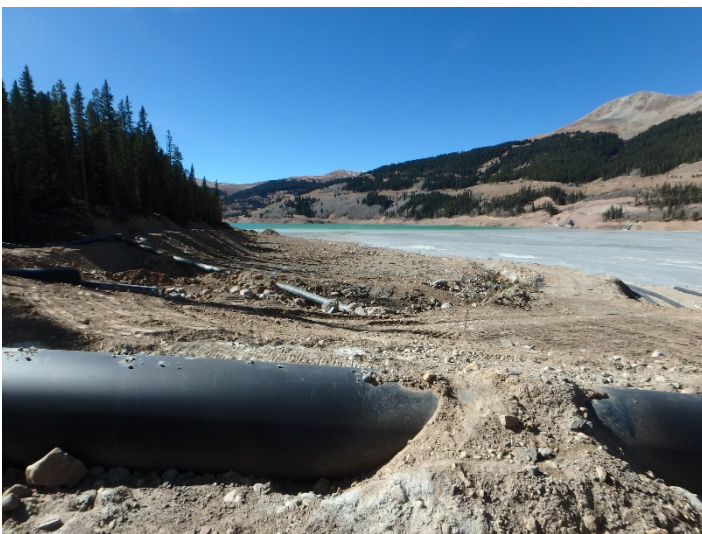
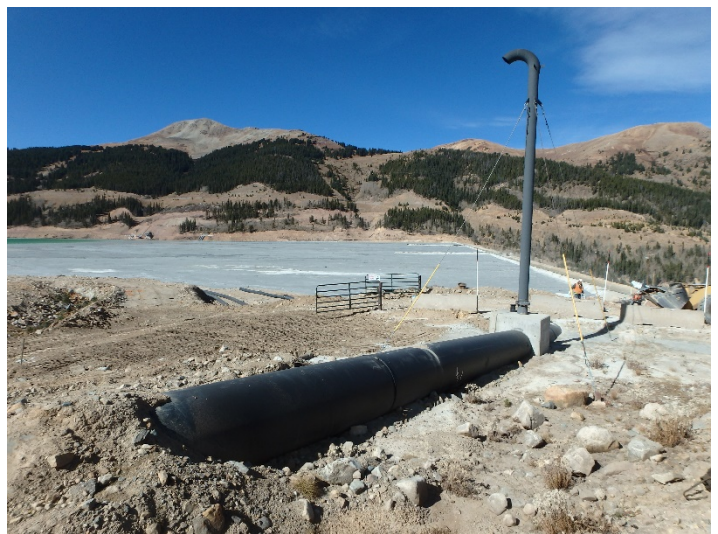
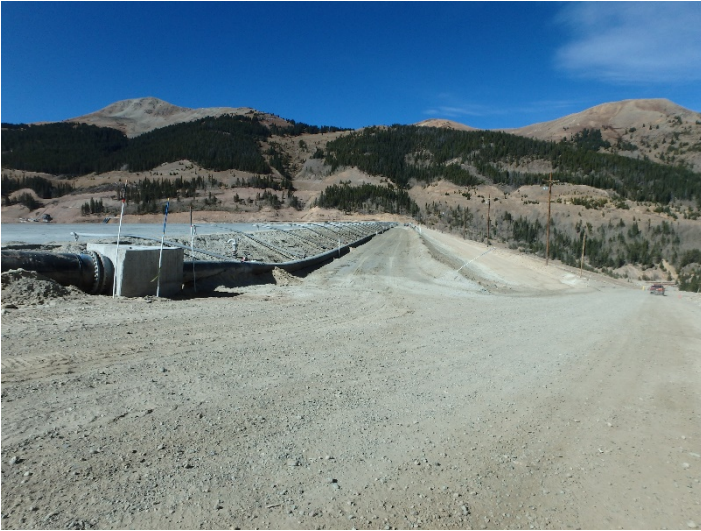
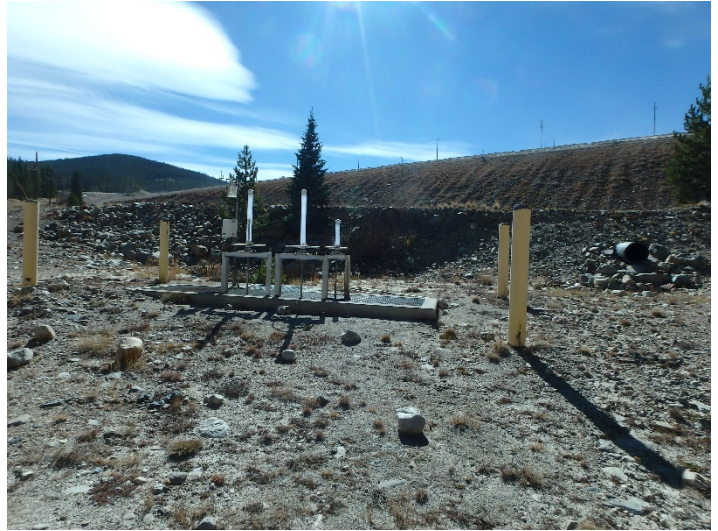
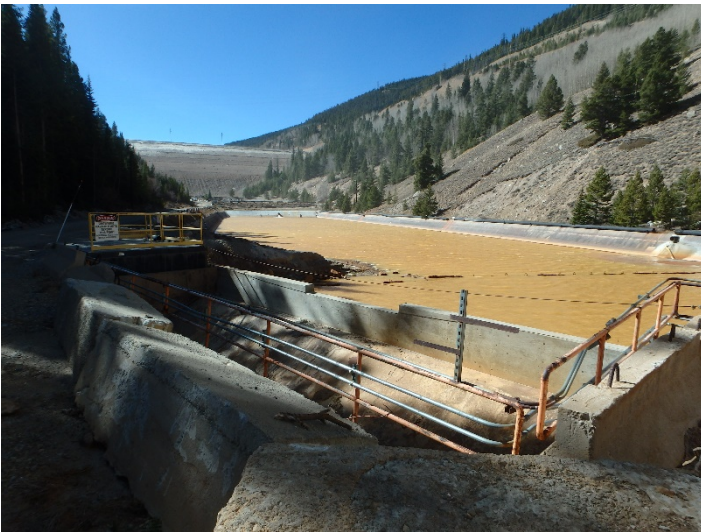
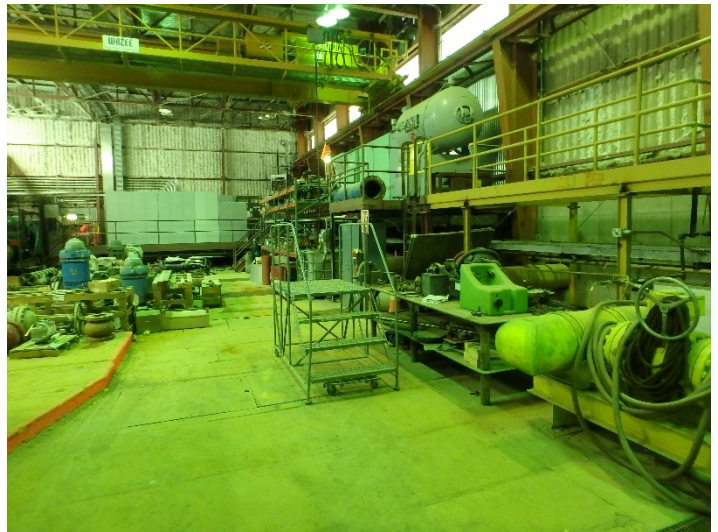
Mayflower Tailings Storage Facility, 5 Dam and Seepwater Pump System

The Mayflower TSF is the furthest downstream TSF in the Tenmile watershed. The TSF provides critical containment of acid producing tailing, as well as providing a place for containment of contaminated materials or designated chemicals in case of accidental release up-gradient of the TSF. Additionally, the Mayflower TSF contains, mixes, and treats impacted waters from several historic mines and smelter sites as well as non-point run-off waters which contact mine wastes within a large portion of the historic Consolidated Tenmile Mining District. During this inspection it appeared that operations of the Mayflower TSF are in accordance with the approved plan. No seepage or instability issues were visibly observed on 5 Dam.

The 5 Dam seepwater pump system is located within the Mayflower Pump Station below 5 Dam. Seepage from the dam is routed to concrete ponds. Collected seepage is pumped back by vertical turbine pumps to the 3 Dam Pump Station or the water pool on the Mayflower TSF. No problems were noted with the 5 Dam pump system.

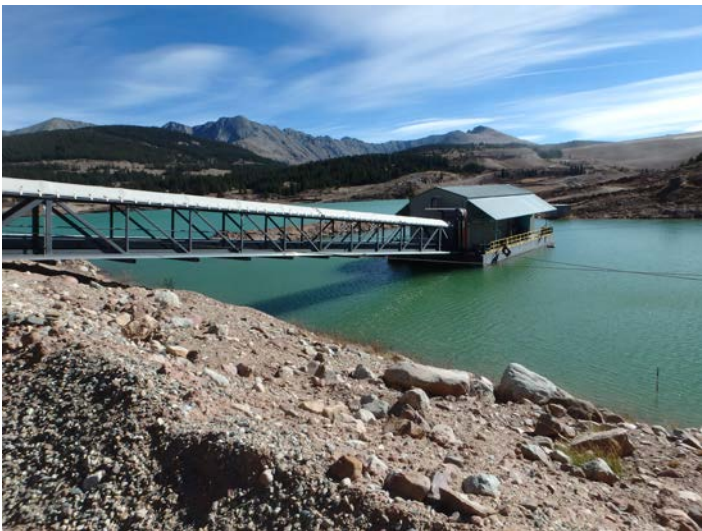
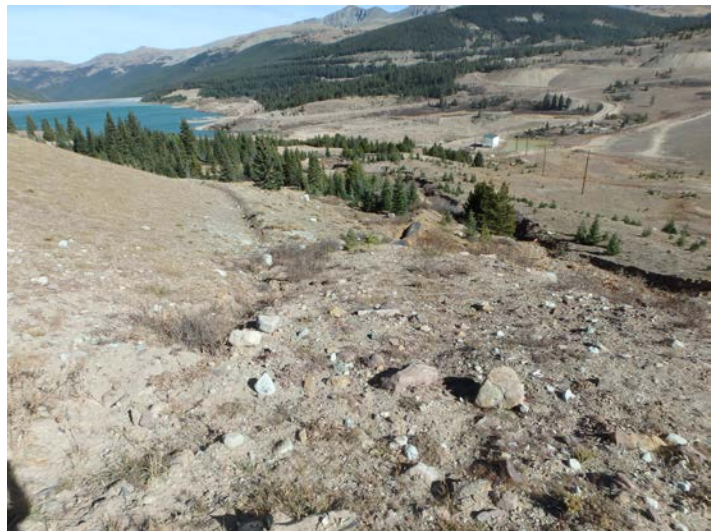
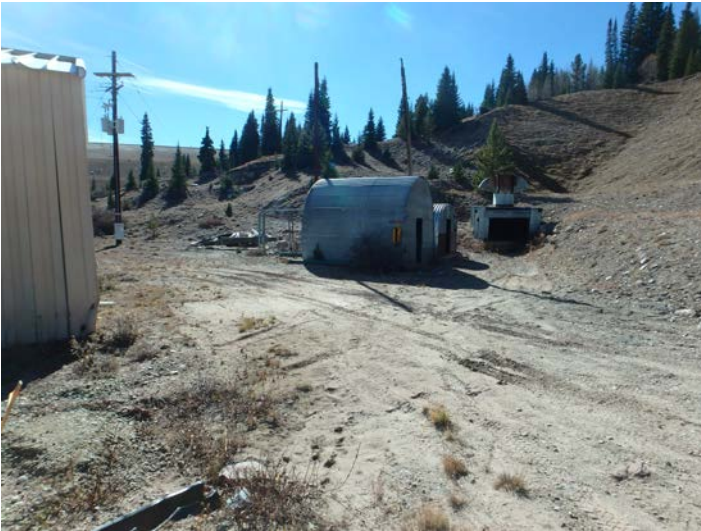
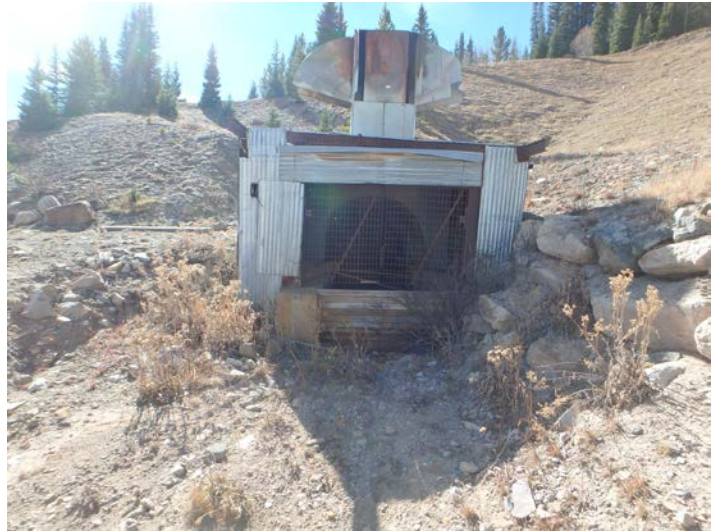
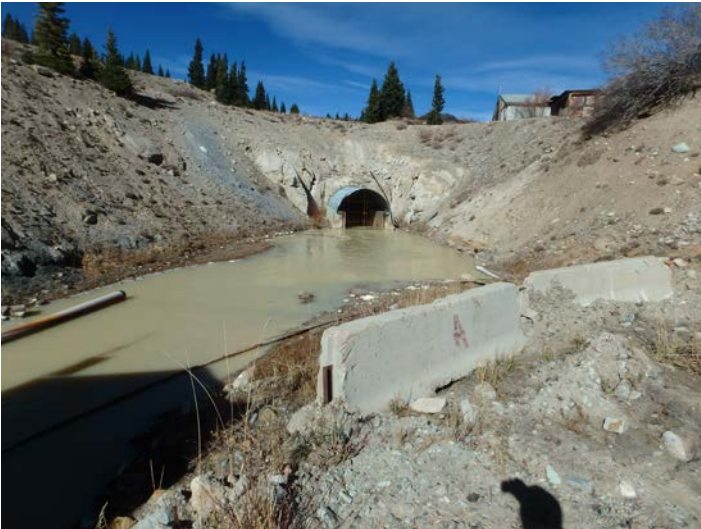
The Tenmile Tunnel is a water conveyance feature running from the west side of 3 Dam on the north, to Robinson Lake on the south. Water can be directed to Robinson Lake or Mayflower TSF by operating valves at a bulkhead within the tunnel. The tunnel is part of the mill water reclaim system. There is a process water barge located in the Mayflower TSF water pool that delivers water from the pool to the north portal of Tenmile Tunnel. No problems were noted with Tenmile Tunnel.

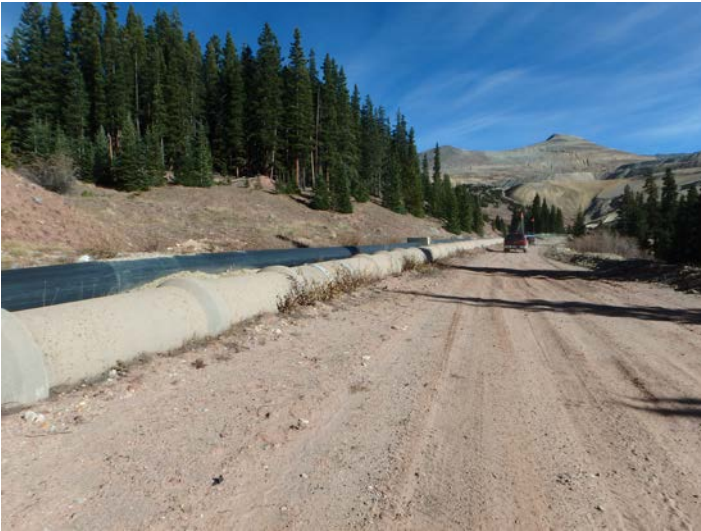
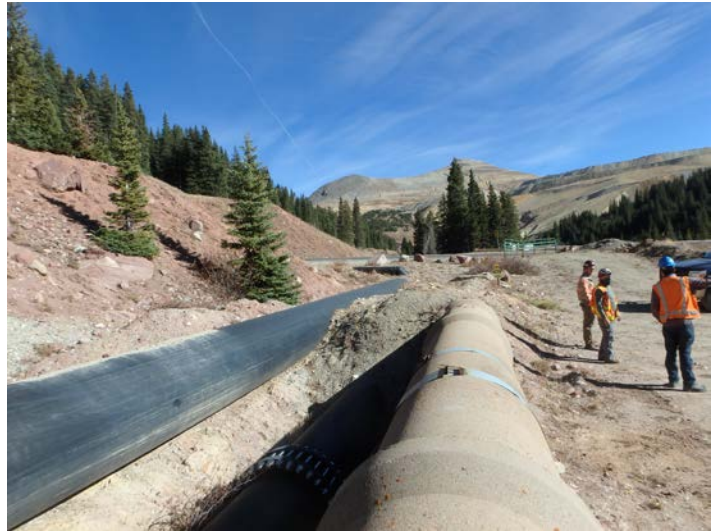
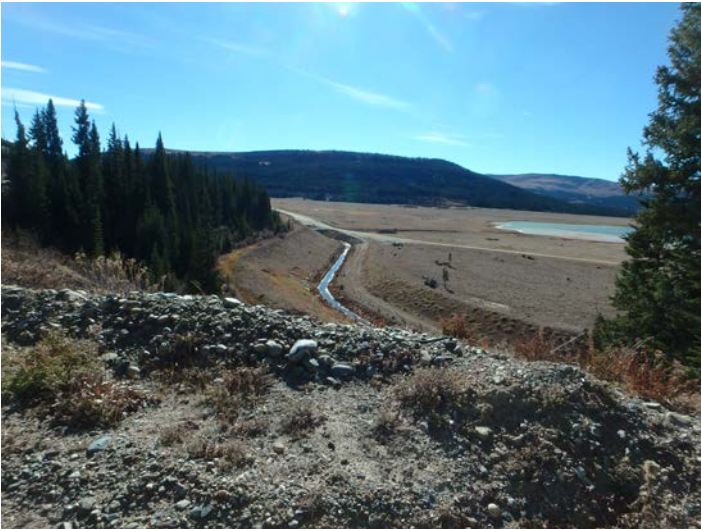
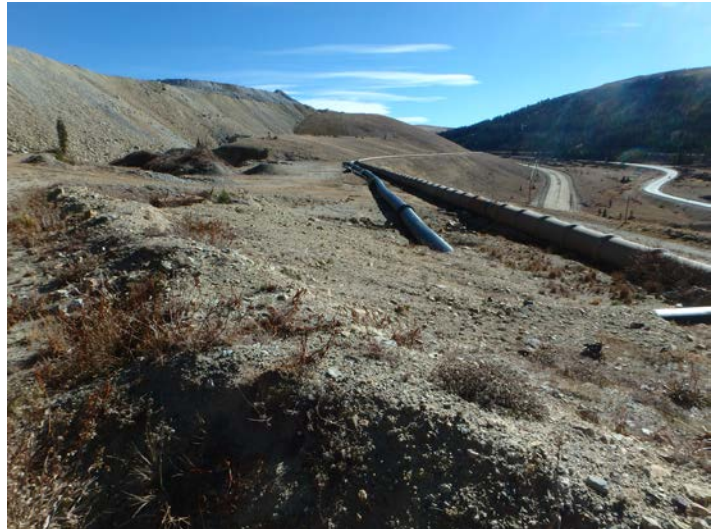
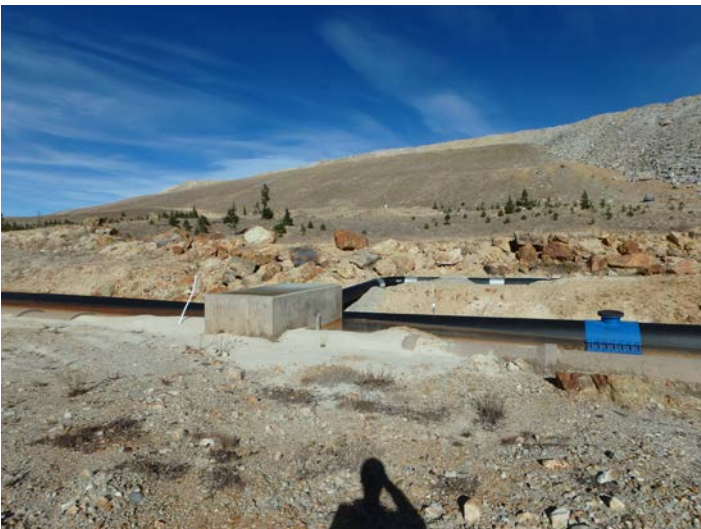
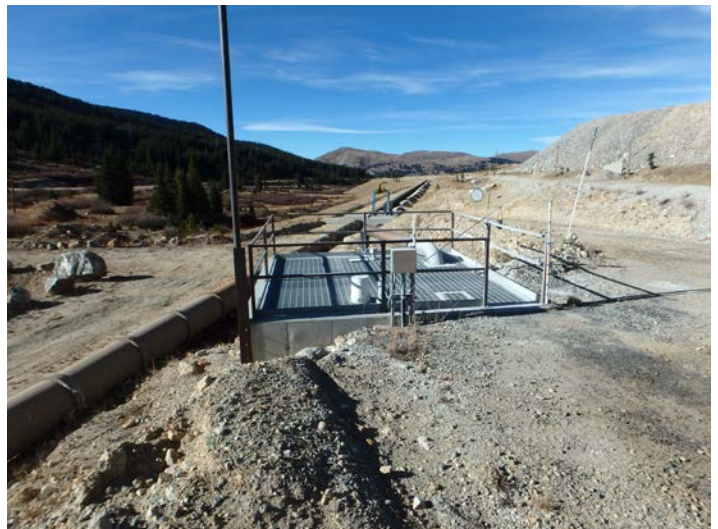
East Tailing Delivery Line, Eastside Channel-Robinson Section, DSM Interceptors

The ETDL conveys impacted water to the SDP and serves as an emergency tailing conveyance line should the main delivery line from the Mill to the first discharge point be taken out of service for short periods. The line is constructed of 36-inch and 42-inch reinforced concrete pipe that isolates the impacted water from the environment until it is delivered to the SDP or deposited in one of the TSFs. No problems were noted with the ETDL.

The Robinson Section of the East Side Channel conveys water from the Robinson Pond water pool and areas tributary to the Robinson Pond through the 2 Dam Spillway to Tenmile TSF. No problems were noted with Eastside Channel-Robinson Section.

The DSM Interceptors are several separate interceptor systems that collect process water from impacted areas and discharge into the ETDL. System includes South Camp Interceptor, North Camp Interceptor, Ore Dump Interceptor, and the McNulty Interceptor. No problems were noted with the DSM interceptors.
