MINERALS PROGRAM INSPECTION REPORT
PHONE: (303) 866-3567

MINE NAME: Henderson Mine	MINE/PROSPECTING ID#: M-1977-342	MINERAL: Molybdenum	COUNTY: Clear Creek, Grand
INSPECTION TYPE: Monitoring	INSPECTOR(S): Peter Hays	INSP. DATE: November 5, 2020	INSP. TIME: 10:00
OPERATOR: Climax Molybdenum Company	OPERATOR REPRESENTATIVE: Miguel Hamarat	TYPE OF OPERATION: 112d-3 - Designated Mining Operation	
REASON FOR INSPECTION: Normal I&E Program	BOND CALCULATION TYPE: None	BOND AMOUNT: \$49,690,538.00	
DATE OF COMPLAINT: NA	POST INSP. CONTACTS: None	JOINT INSP. AGENCY: None	
WEATHER: Clear	INSPECTOR'S SIGNATURE:

The Henderson Mill was inspected by Peter Hays with the Division of Reclamation, Mining and Safety (Division/DRMS) as part of the Division's monitoring inspection program. Mr. Miguel Hamarat with Climax Molybdenum - Henderson Operations (Henderson) was present during the inspection.

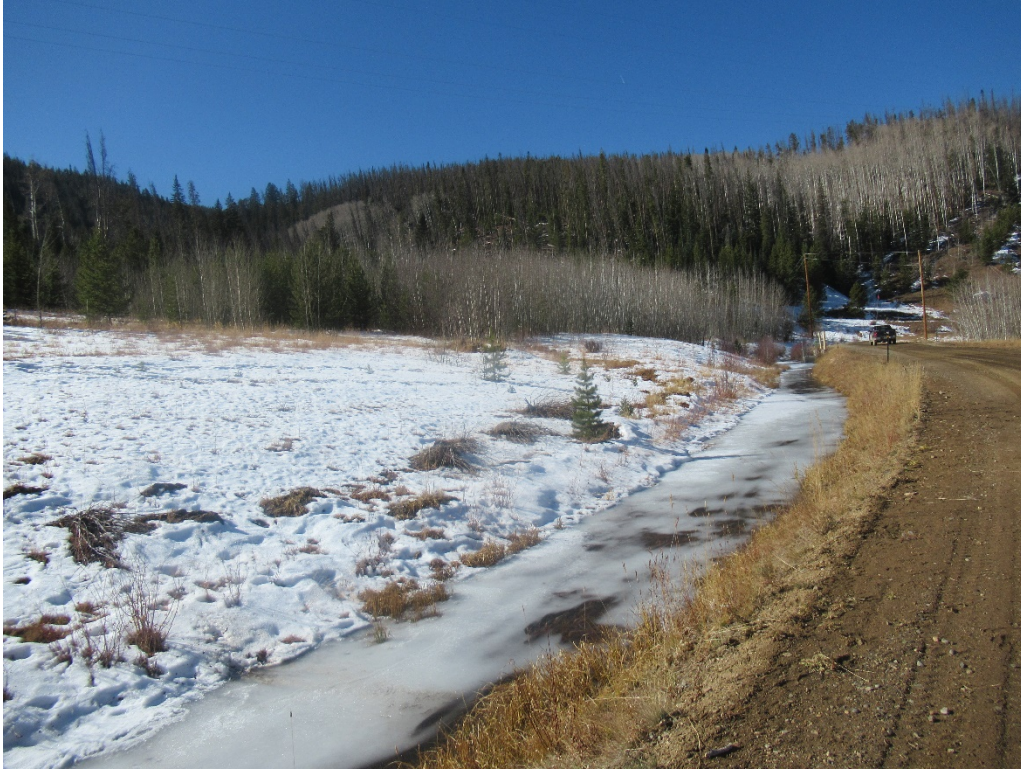
The Ultimate Canal is included in Mill EPF 3.1 - Storm Water Diversion System. The canal diverts un-impacted storm water from the west and north ends of the tailings storage facility (TSF) around the north end of the property to the Williams Fork River. The canal was inspected from south to north during the inspection. The canal surface was partially ice covered at the time of the inspection, however sections of the canal were ice free and water was flowing freely. The gabion structures, culverts and inlet structures were observed and appeared to be working as designed.

Ice covered section of the Ultimate Canal

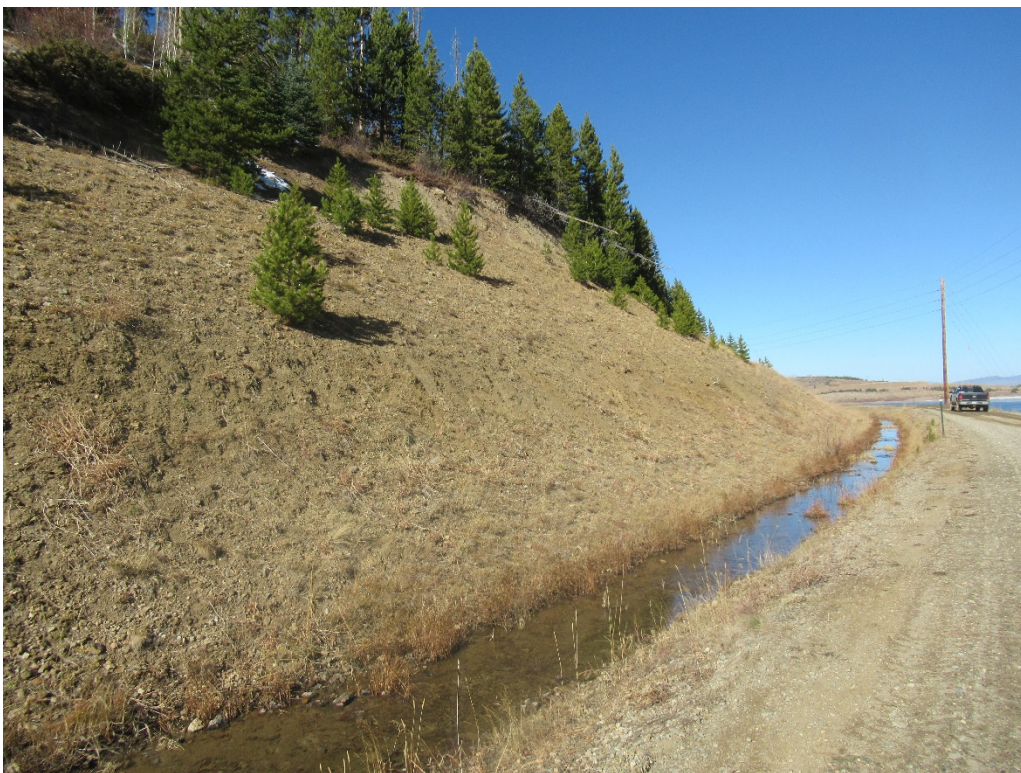
Open section of the Ultimate Canal

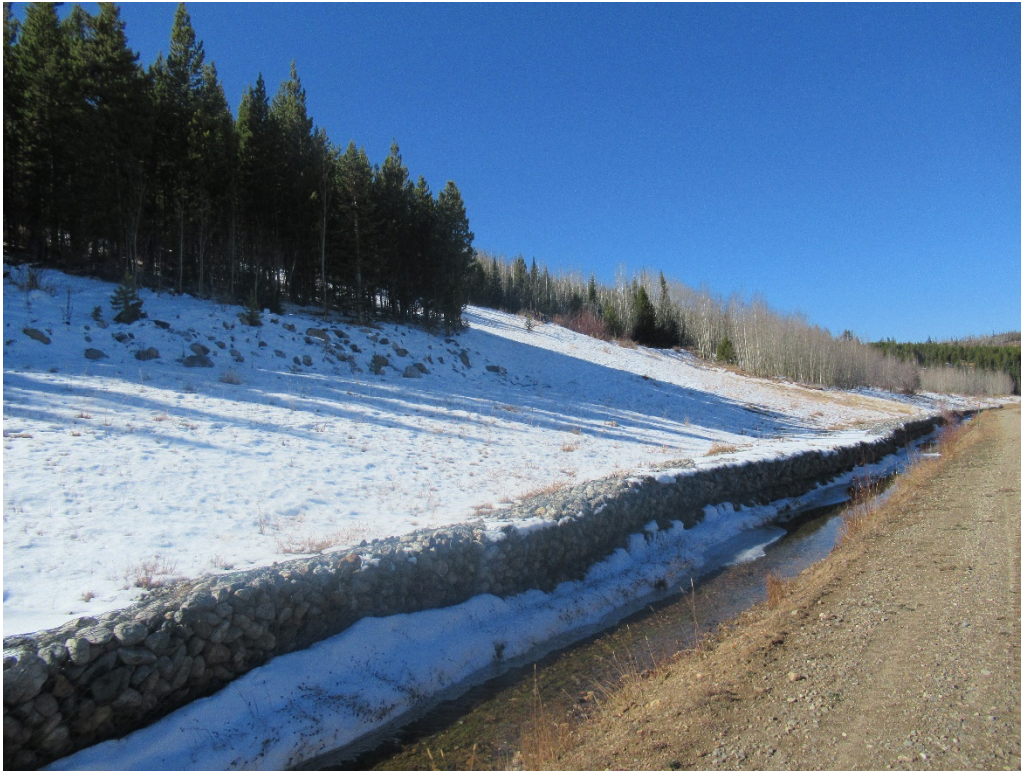
Gabion structure along the Ultimate Canal

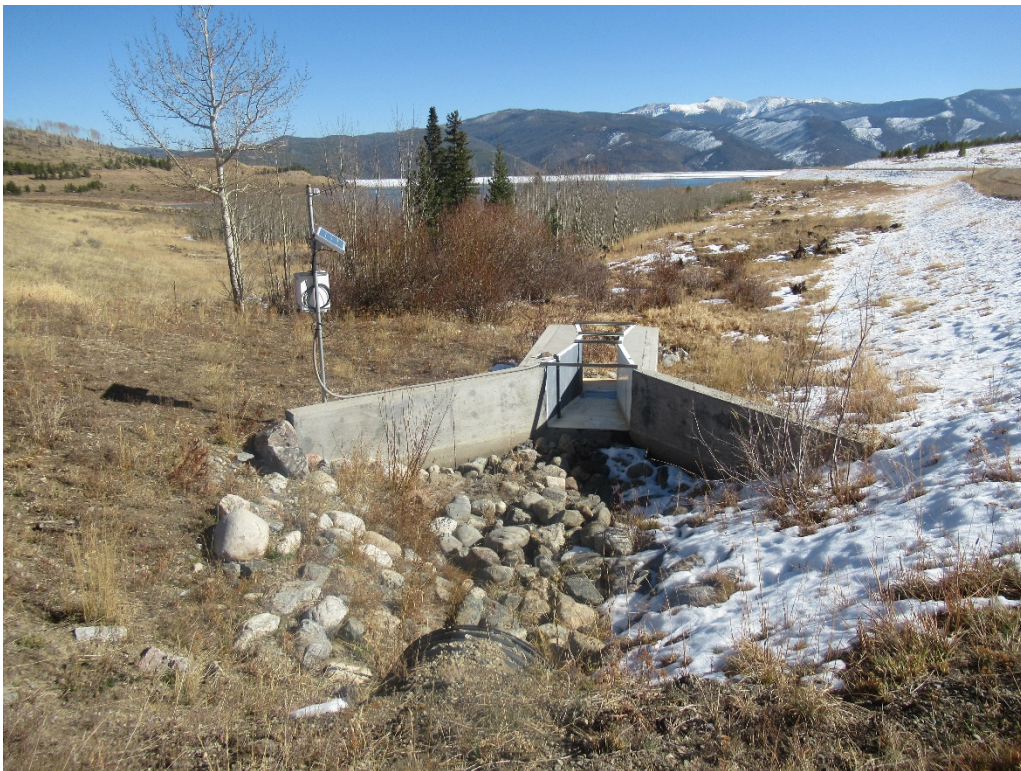
Inlet weir from the Ultimate Canal to the tailings impoundment

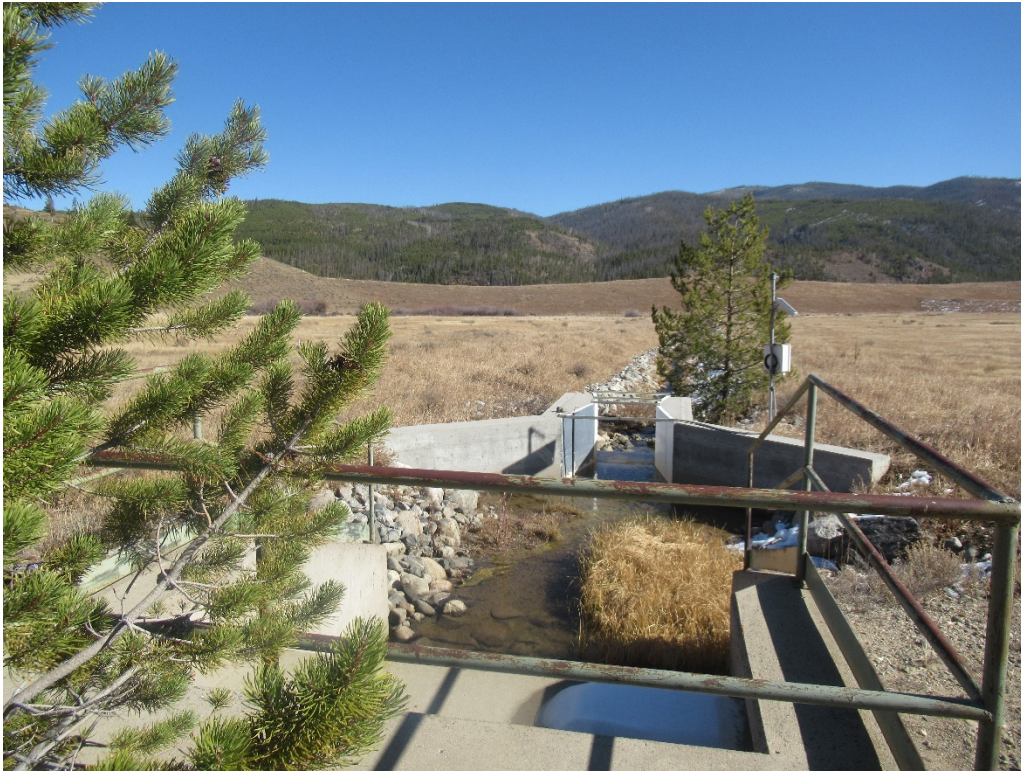
View of the final outlet structure for the Ultimate Canal

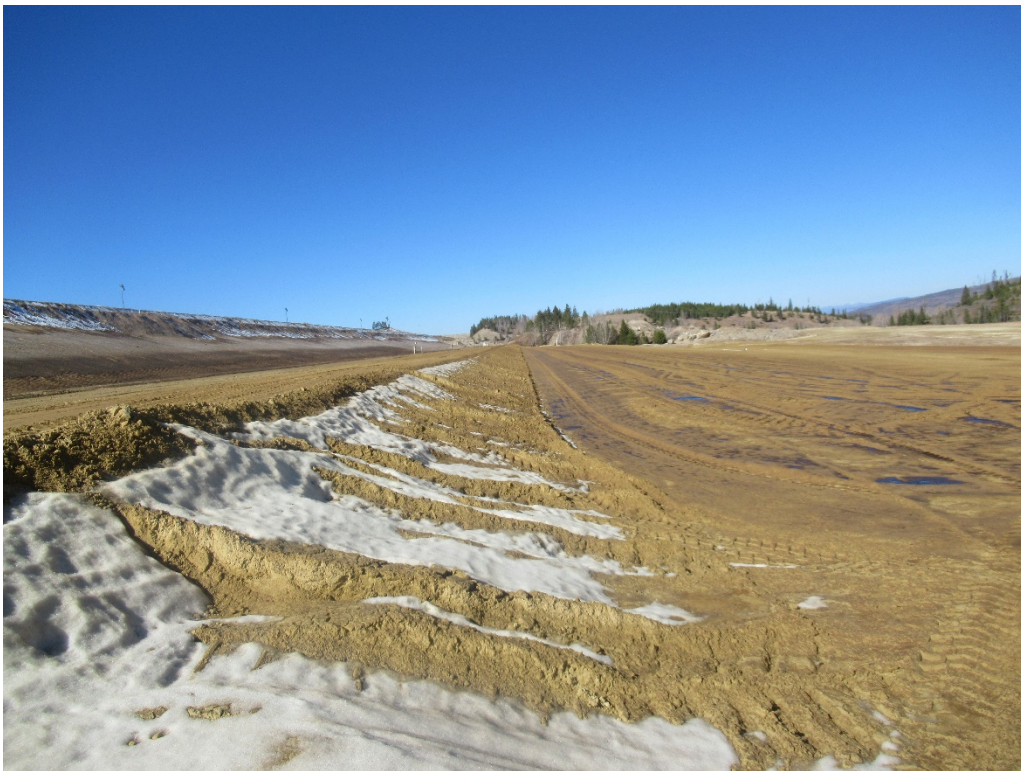
The Phase 2 buttress construction is complete for the south and north areas of 3-Dam. The Operator estimates 80,000 cubic yards of material was placed during the Phase 2 buttress construction. The two upper buttress benches of the north area were combined into one bench with the extension of the lower bench into the upper bench. The modification was approved by AECOM and will be incorporated into the as-built drawings for the project. The 3-Dam buttress area was surveyed last week according to the Operator. All of the buttress benches were treated with coherex and the toe of all the benches have been graded to a 3H:1V slope and compacted with a sheepsfoot compactor perpendicular to the slope to prevent erosion. All instrumentation affected by the project has been raised according to the Operator.

View of the upper bench of the upper face of the 3-Dam south area buttress

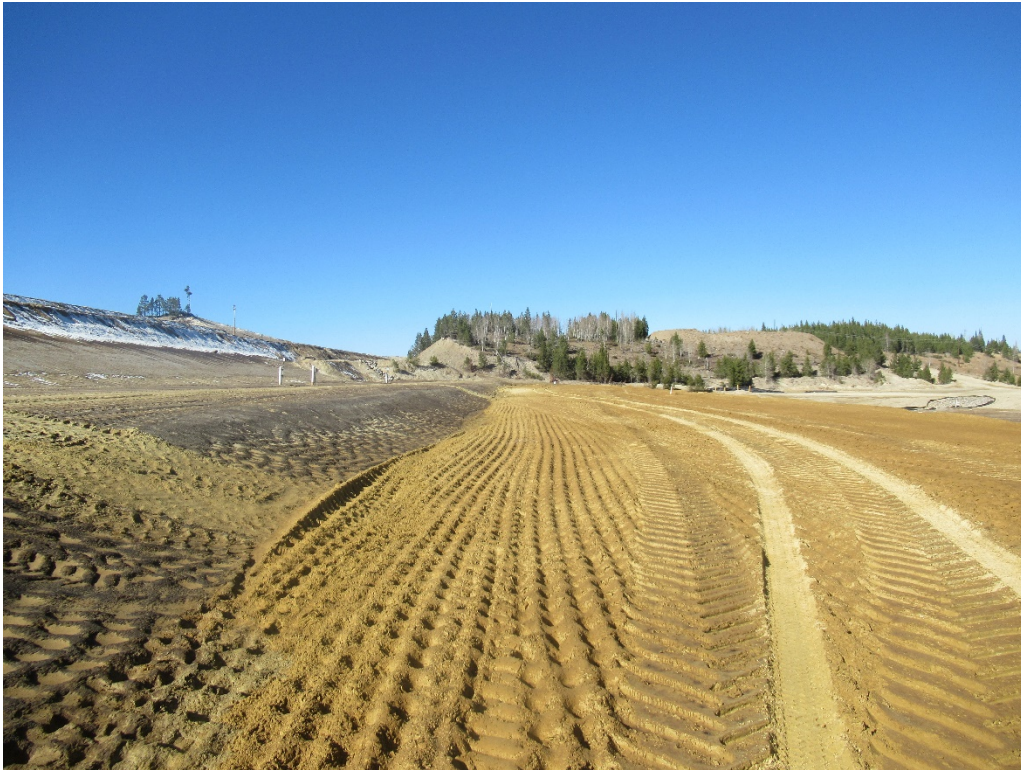
View of the upper bench of the upper face of the 3-Dam north area buttress

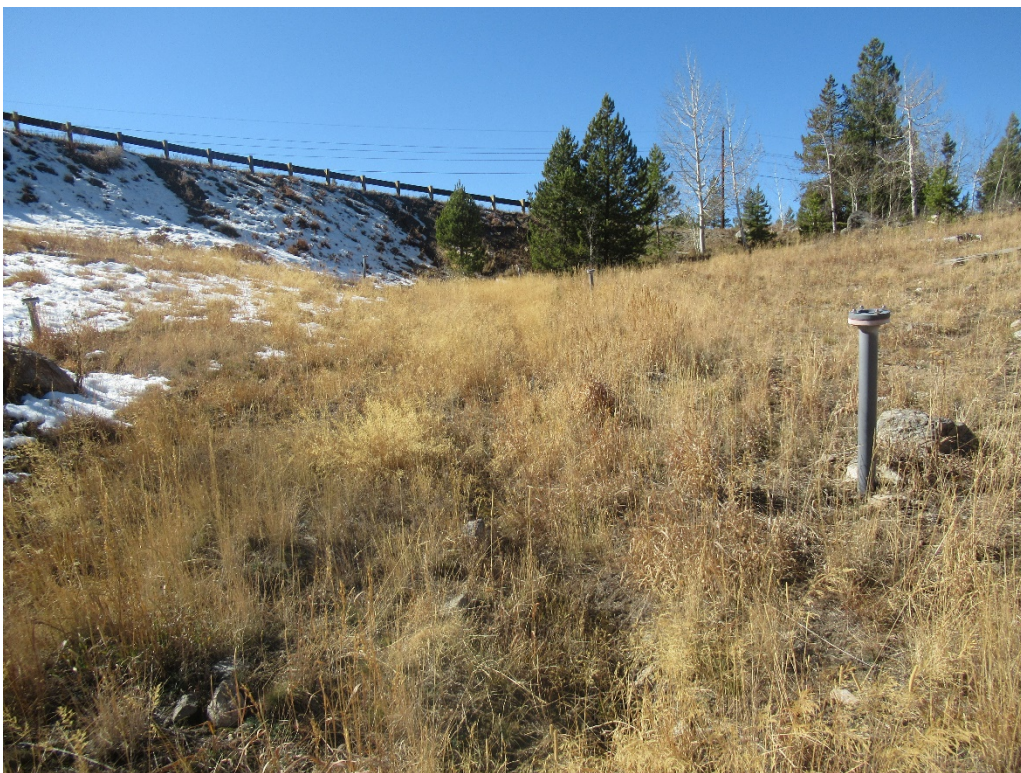
The 3-Dam Seepwater Collection and Pumpback System were observed during the inspection. The vegetation in the collection area was well-established and no erosion features were observed during the inspection. The pumpback system, which consists of two pipelines, vaults and pumps was operational at the time of the inspection.

View of the vegetation in the 3-Dam seepwater collection area

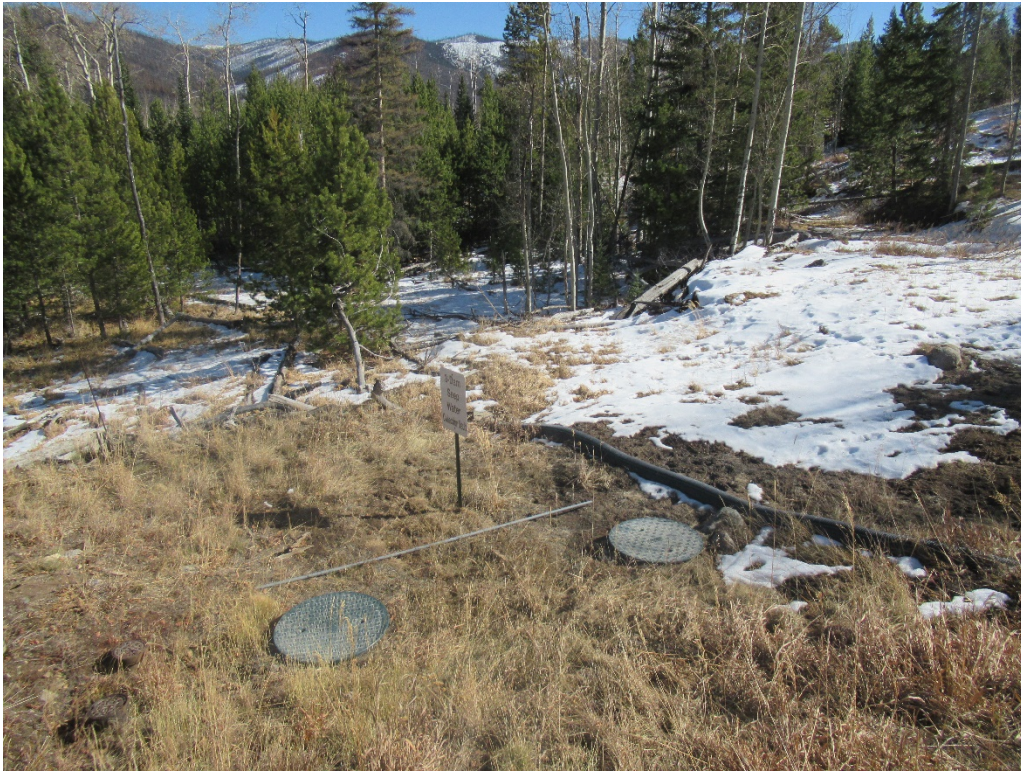
View of the 3-Dam seepwater collection vault covers
