MINERALS PROGRAM INSPECTION REPORT
PHONE: (303) 866-3567

MINE NAME: Kiowa Clay Mine	MINE/PROSPECTING ID#: M-2007-009	MINERAL: Clay (general)	COUNTY: Elbert
INSPECTION TYPE: Monitoring	INSPECTOR(S): Elliott Russell	INSP. DATE: September 11, 2020	INSP. TIME: 12:45
OPERATOR: The Denver Brick Company	OPERATOR REPRESENTATIVE: Richard Murphy	TYPE OF OPERATION: 112c - Construction Regular Operation	
REASON FOR INSPECTION: Normal I&E Program	BOND CALCULATION TYPE: None	BOND AMOUNT: \$244,932.00	
DATE OF COMPLAINT: NA	POST INSP. CONTACTS: None	JOINT INSP. AGENCY: None	
WEATHER: Clear	INSPECTOR'S SIGNATURE:

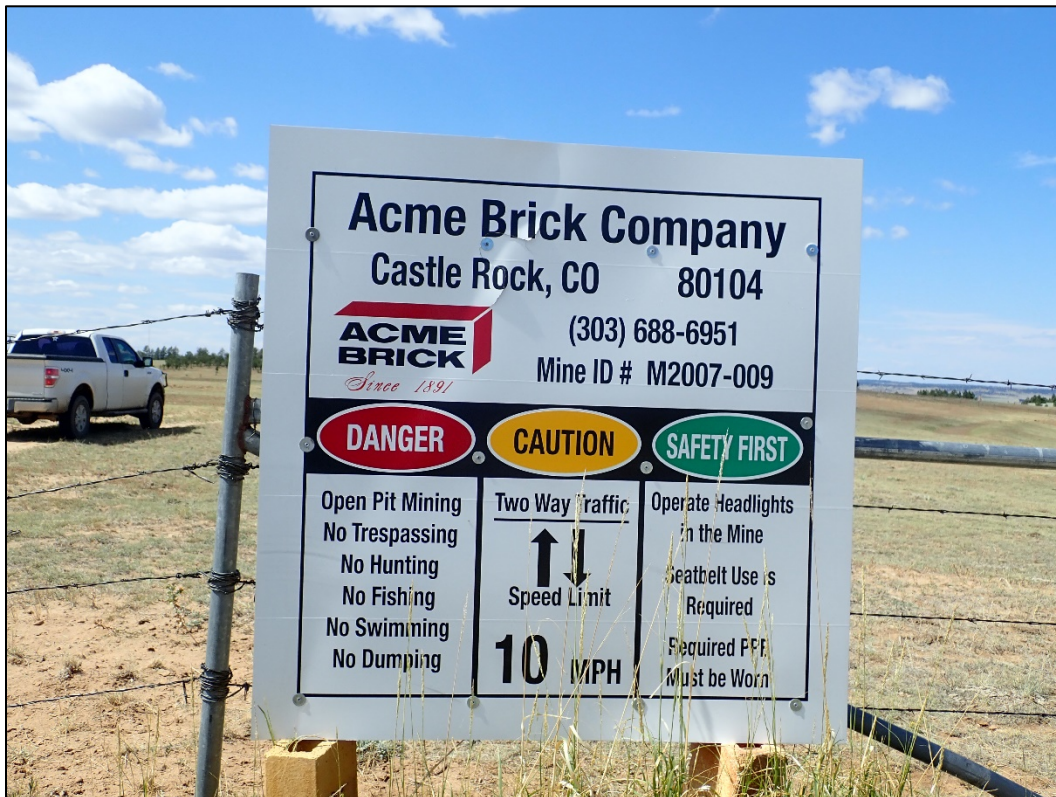
Photo 1. Mine site identification sign; looking west.

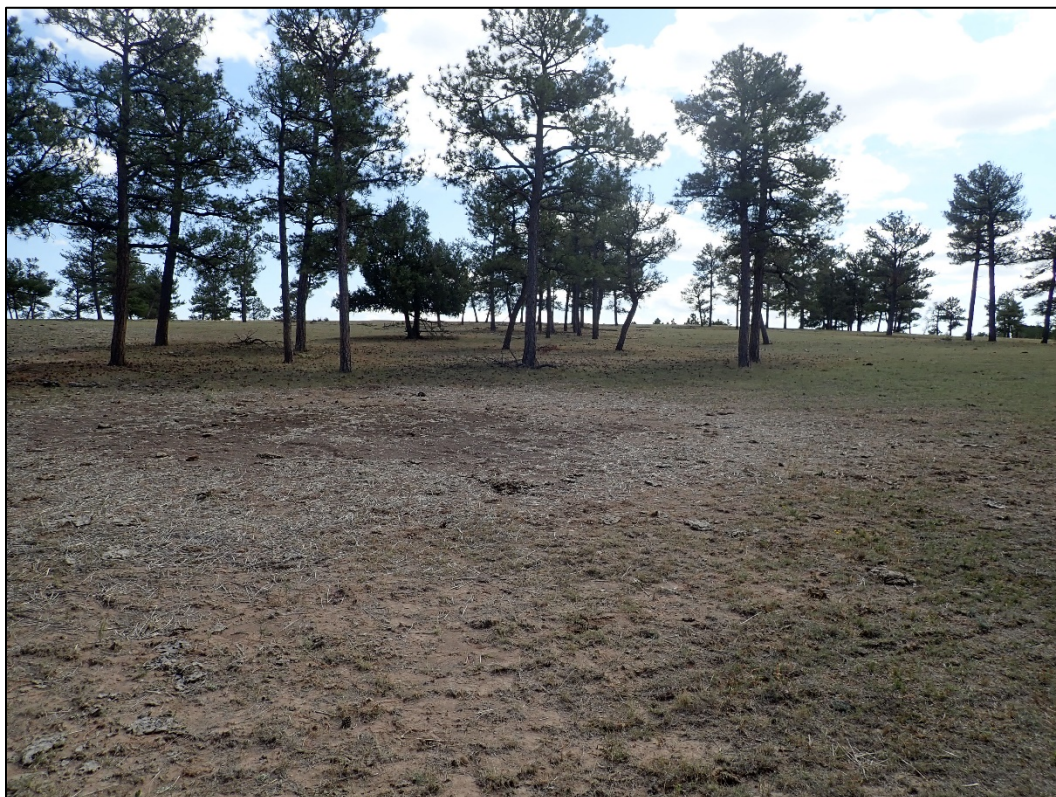
Backfilling and Grading: The small test trench appeared to be appropriately backfilled and/or graded. The Division and the Operator had difficulty determining where the exact location of the trench had been as the reclaimed topography matched the surrounding areas very well.

Sediment Control: The slopes of the small reclaimed test trench appeared stable and showed no signs of erosion.

Revegetation: The affected lands were starting to become revegetated grasses. Vegetative cover had already appeared to match adjacent off-site areas. No noxious weed infestations were observed. The Division recommended that prior to submitting a release request, the Operator should reseed and rake the reclaimed area to ensure the best chance of grass reestablishment. On October 8, 2020, the Operator submitted photographs demonstrating the small reclaimed area had been reseeded.

Photo 2. Sample photo of the reclaimed test trench; looking southwest.

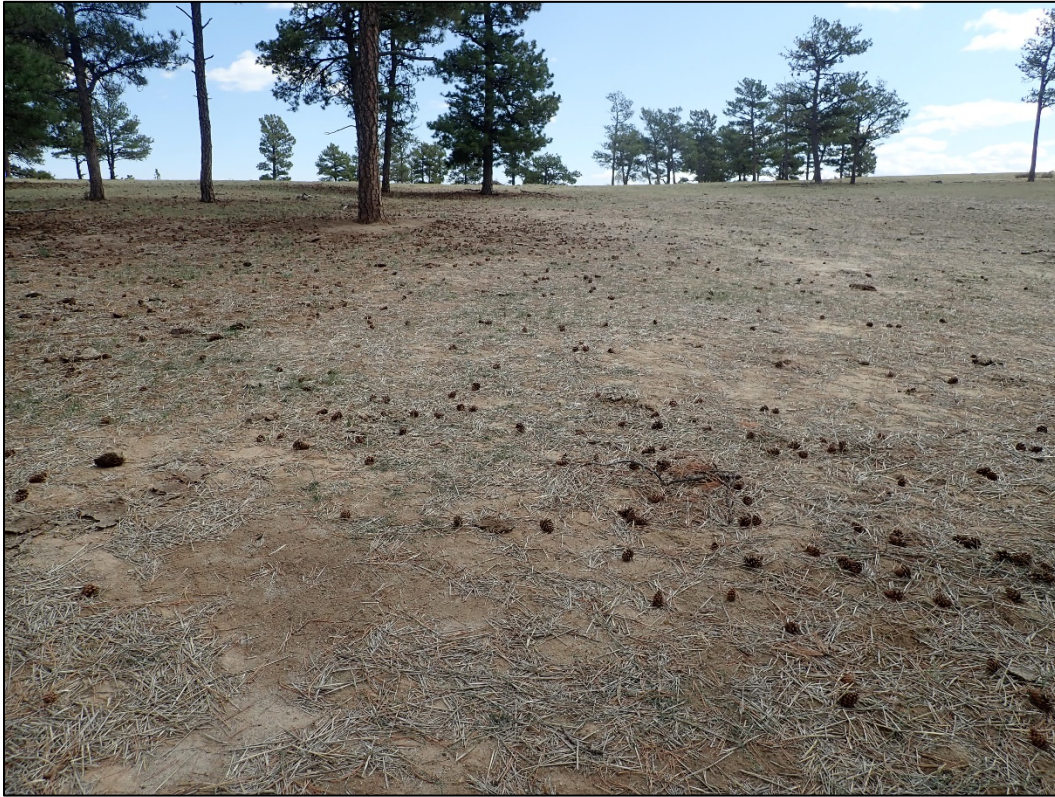
Photo 3. Sample photo of the reclaimed test trench; looking south.

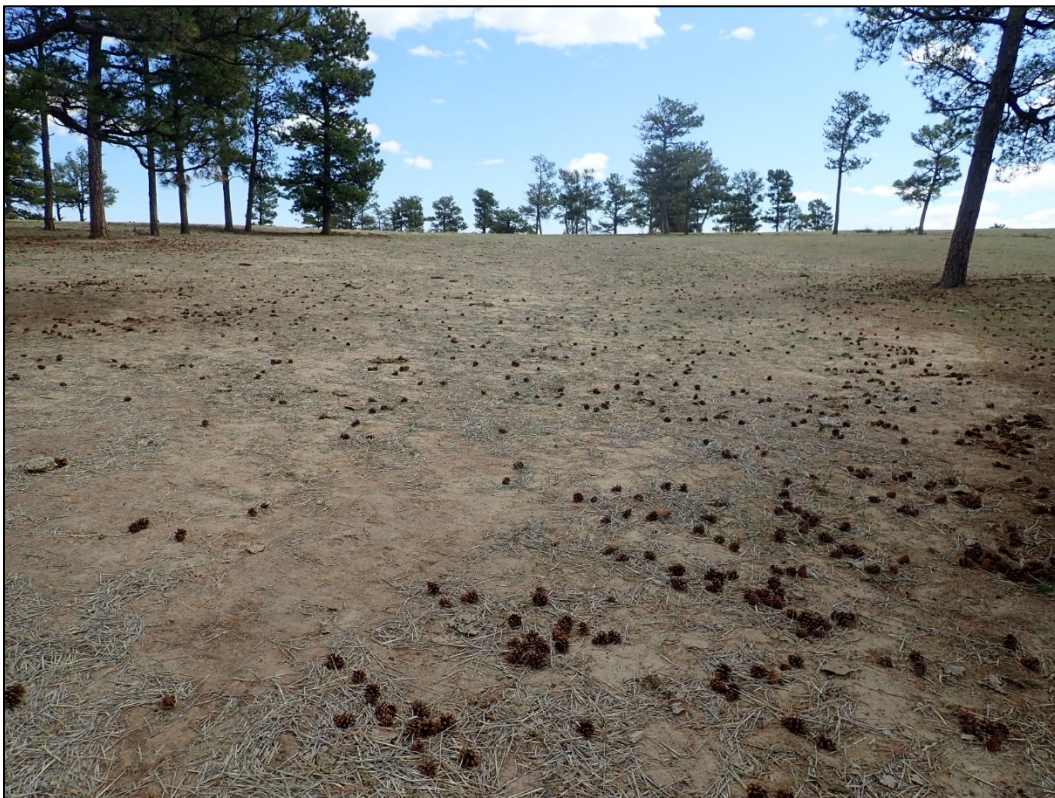
Photo 4. Sample photo of the reclaimed test trench; looking southeast.

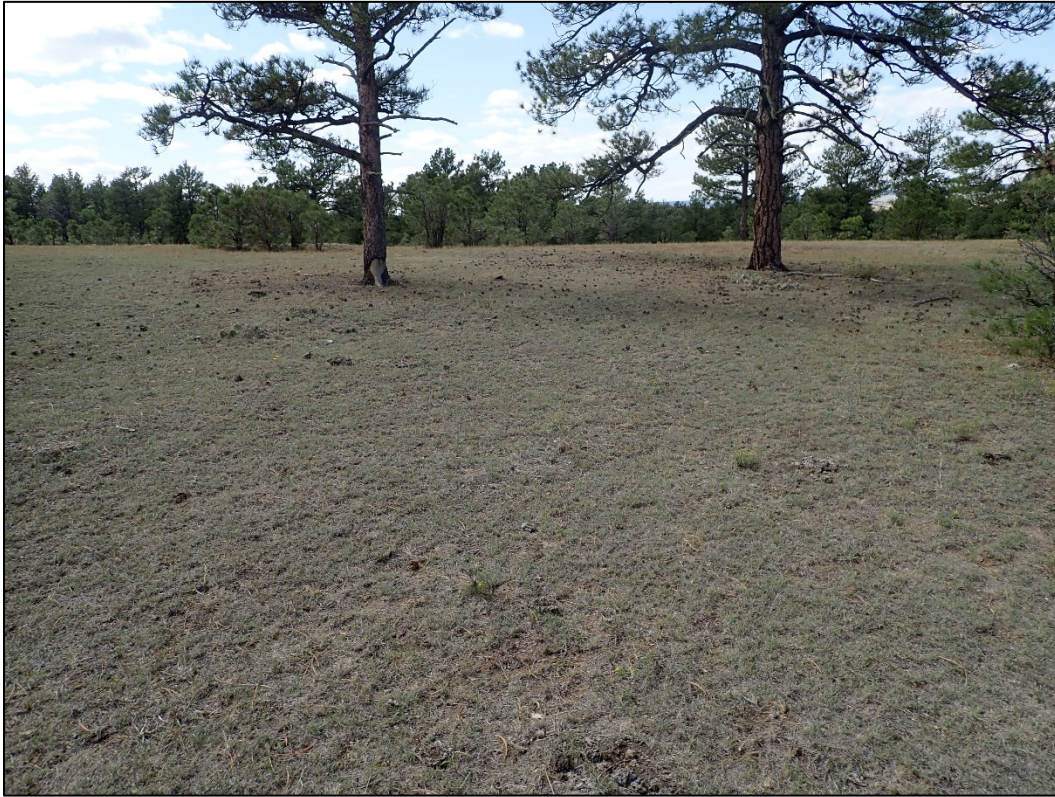
Photo 5. Sample photo of adjacent undisturbed lands; looking east.
