South Taylor Fill Inspection Certification

INSPECTION REPORT ~ SOUTH TAYLOR FILL
(Including Both the East Taylor and West Taylor Fill Segments)

INDICATE QUARTER → 1ST ☐ 2ND ☐ 3RD ☐ 4TH ☒ 2020
YEAR

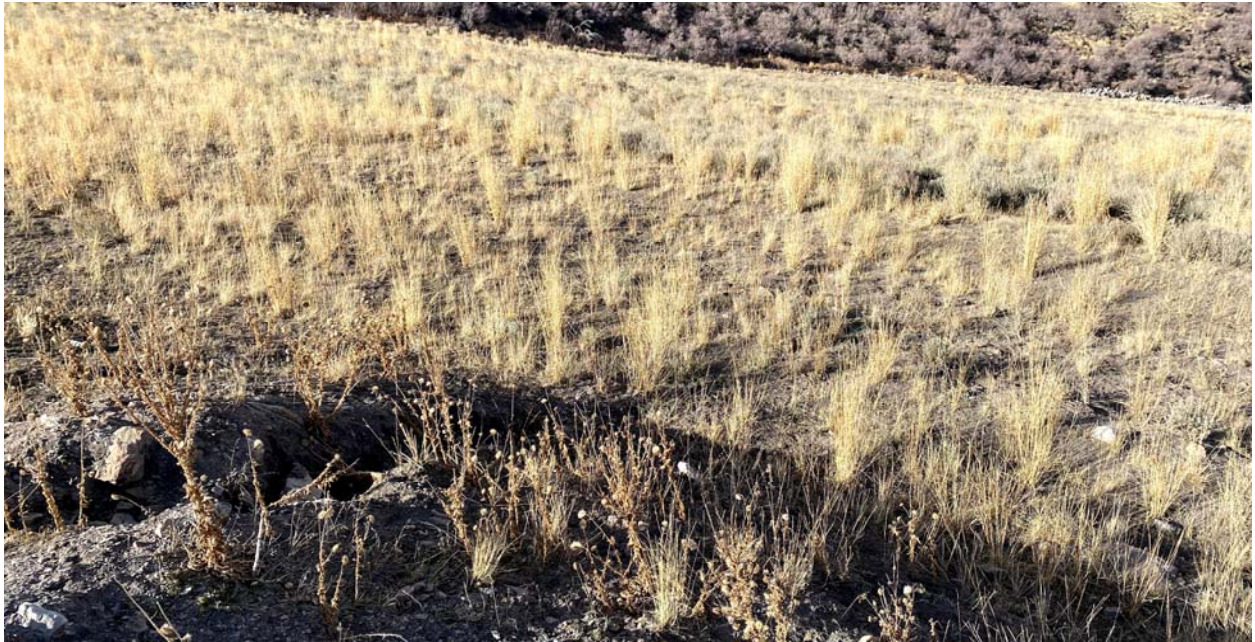
11-04-20 - West Taylor fill looking northwest from monitoring well location

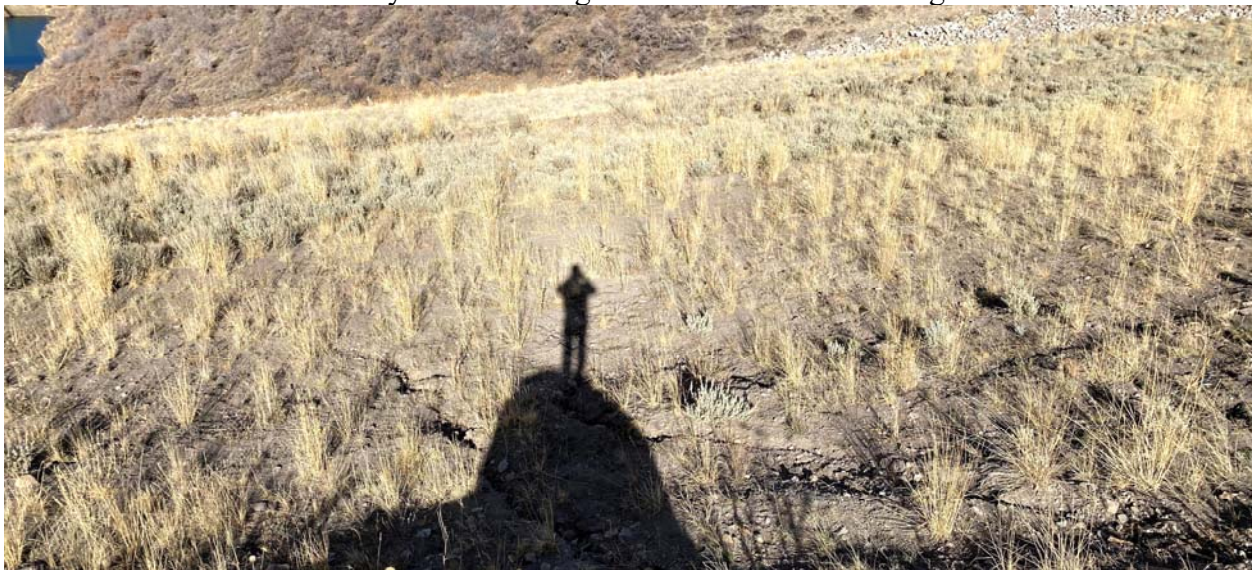
11-04-20 - West Taylor fill looking northeast from monitoring well location

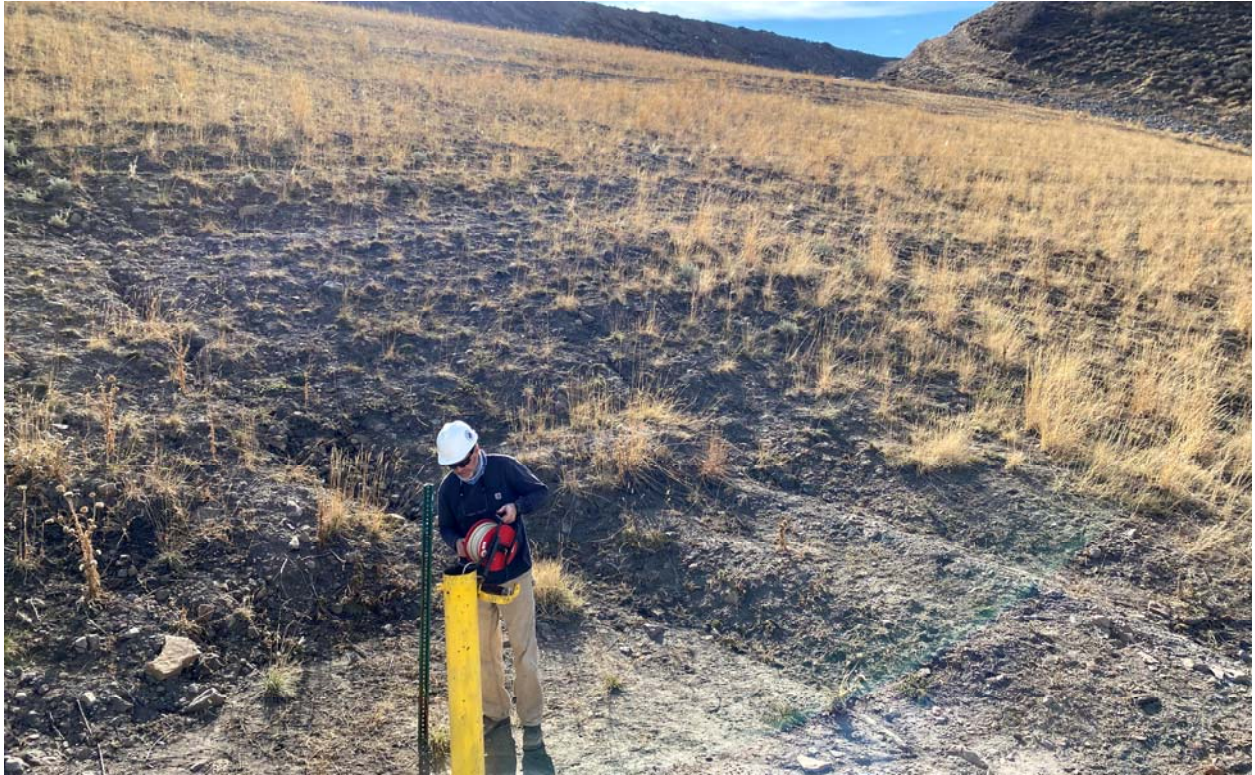
11-04-20 - West Taylor Fill West Flank from monitoring well location

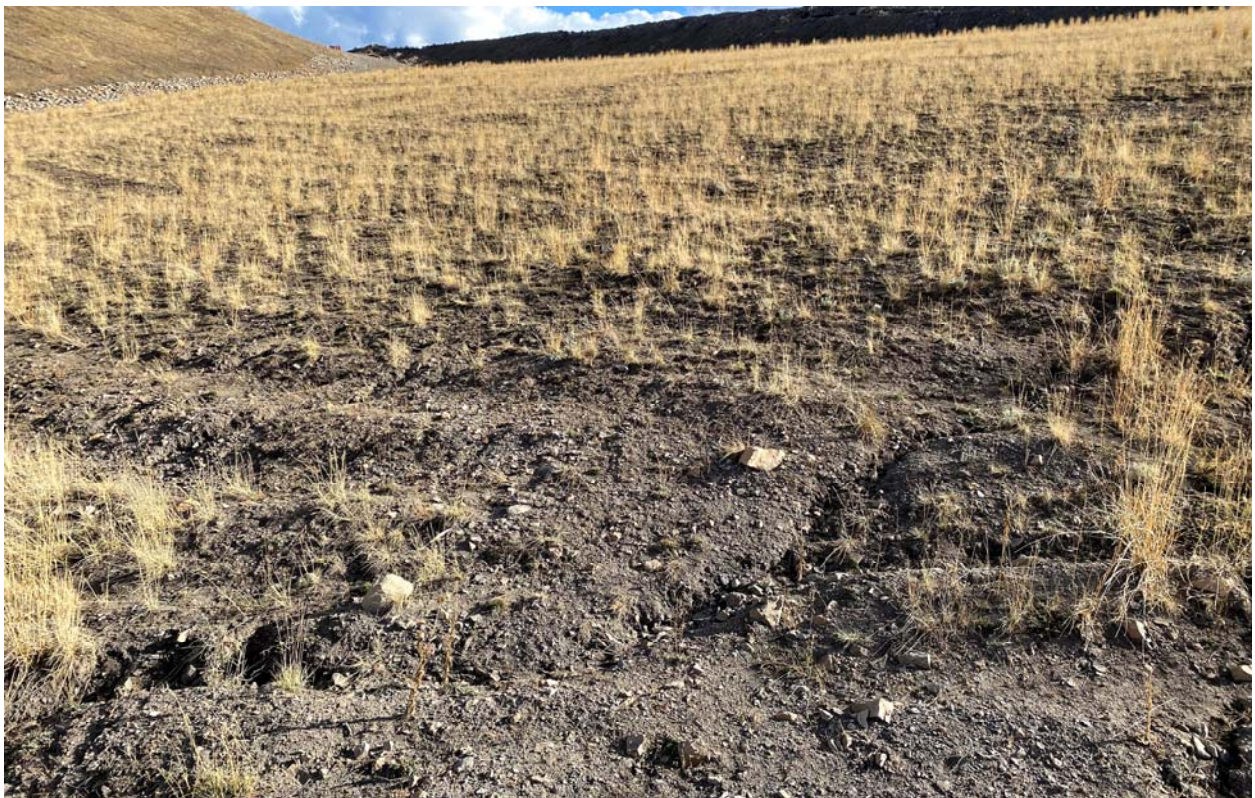
11-04-20 - West Taylor Fill East Flank from monitoring well location

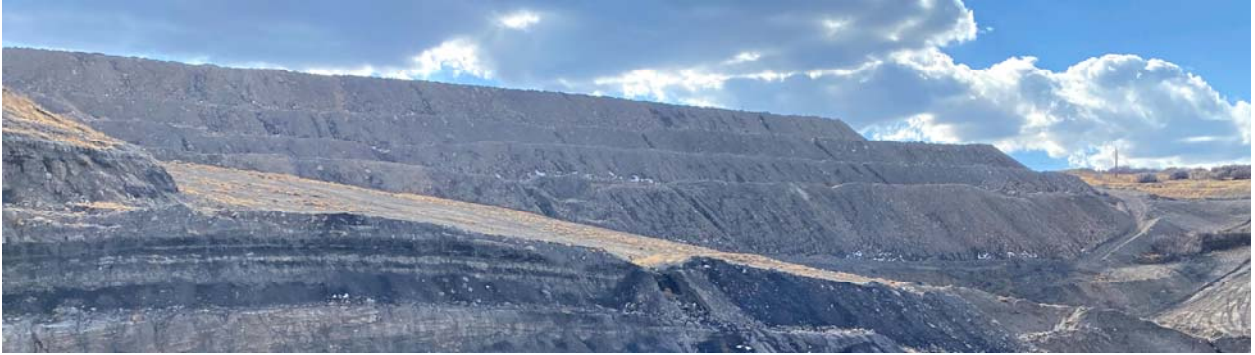
East Taylor Fill with C-C' Underdrain Area: Reclamation activity including removal of material from the top of the fill area have taken place within the East Taylor fill during this quarter. The rock crusher has been relocated away from this fill.

No structural weakness, signs of instability, or other hazards were noted at the time of inspection.

11-04-20 - East Taylor Fill looking southwest from the West Pit reclamation
