**PERMIT INFORMATION**

<b>Permit Number:</b> C-1982-056 <b>Mine Name:</b> Foidel Creek Mine <b>Operator:</b> Twentymile Coal, LLC <b>Operator Address:</b> Ms Miranda Kawcak 29515 Routt County Road No. 27 Oak Creek, CO 80467	<b>County:</b> Routt <b>Operation Type:</b> Underground <b>Permit Status:</b> Active <b>Ownership:</b> Private
	<b>Operator Representative Present:</b>  Kevin Copeland
<b>Operator Representative Signature:</b> (Field Issuance Only)

**INSPECTION INFORMATION**

This was coal partial inspection conducted at the Foidel Creek Mine by Tabetha Lynch with DRMS. Miranda Kawcak was present during the inspection. This inspection focused no following up on maintenance items from the complete inspection conducted in October.

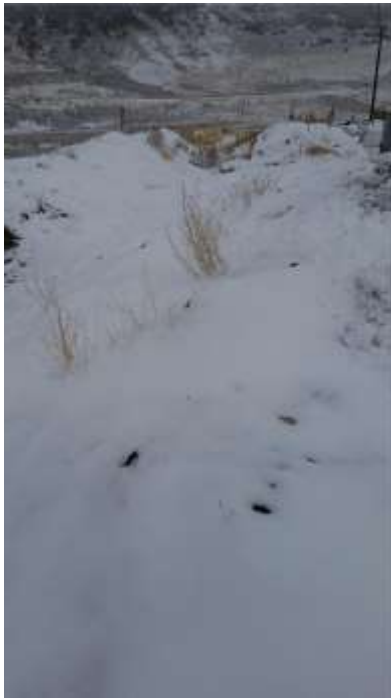
Ditches appear to have been cleaned but were covered in snow during the inspection.

Cleared ditch

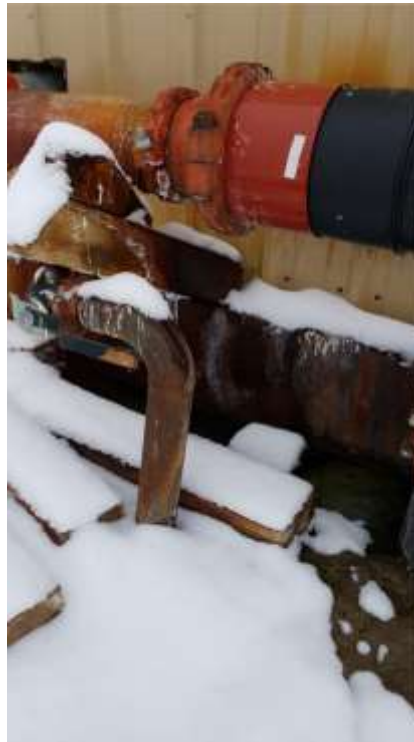
Leaking pipe a the fish creek borehole is still in the process of being repaired. Per the operator a part has been ordered to seal the leak.

Location of leak at pump house
