MINERALS PROGRAM INSPECTION REPORT

MINE NAME: Jenkins Site	MINE/PROSPECTING ID#: M-1977-393	MINERAL: Sand and gravel	COUNTY: Boulder
INSPECTION TYPE: Monitoring	INSPECTOR(S): Amy Eschberger	INSP. DATE: October 29, 2020	INSP. TIME: 09:00
OPERATOR: City of Boulder	OPERATOR REPRESENTATIVE: Chris Lawlor	TYPE OF OPERATION: 112c - Construction Regular Operation	
REASON FOR INSPECTION: Normal I&E Program	BOND CALCULATION TYPE: None	BOND AMOUNT: \$0.00	
DATE OF COMPLAINT: NA	POST INSP. CONTACTS: None	JOINT INSP. AGENCY: None	
WEATHER: Clear	INSPECTOR'S SIGNATURE:

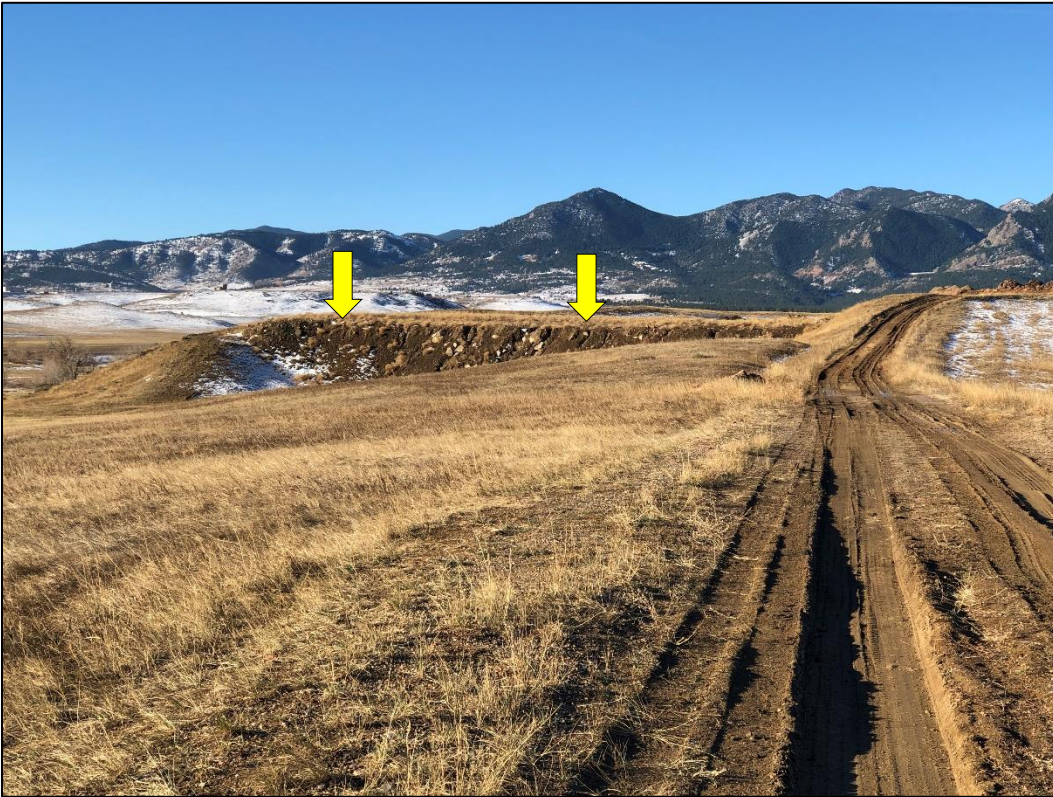
Photo 1. View looking southwest from main access road at eastern edge of lower lift (indicated) placed inside pit in north mining area.

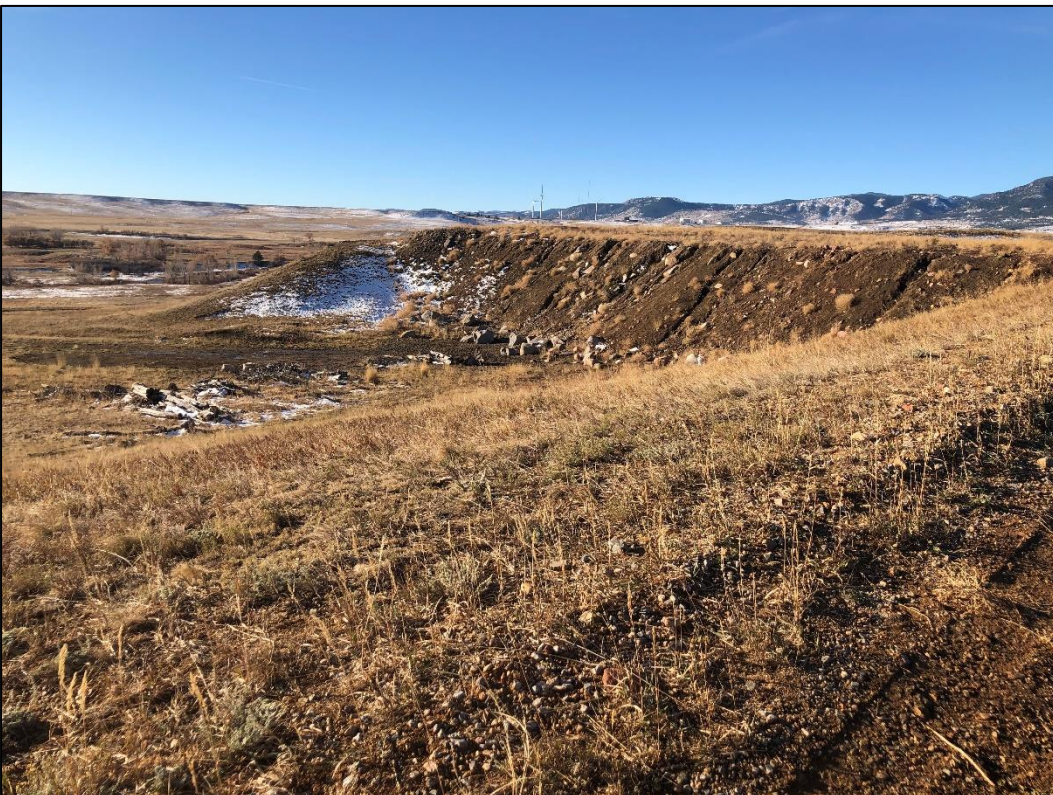
Photo 2. Closer view of eastern edge of lower lift placed inside pit in north mining area. Side slopes of this lift are at ~1.5H:1V.

The Division estimates remaining reclamation of the north mining area (in its current condition) to include grading the sides of the backfill lifts to 3H:1V or flatter (approximately 530 feet for the upper lift and approximately 260 feet for the lower lift), replacing 6-10 inches of growth medium on approximately 8 acres, and revegetating the land with the approved rangeland grass mixture. Considering the area is currently used for livestock grazing (cattle were seen grazing just west of the pit during the inspection), the operator will most likely need to install fencing to protect areas undergoing revegetation from livestock disturbance.

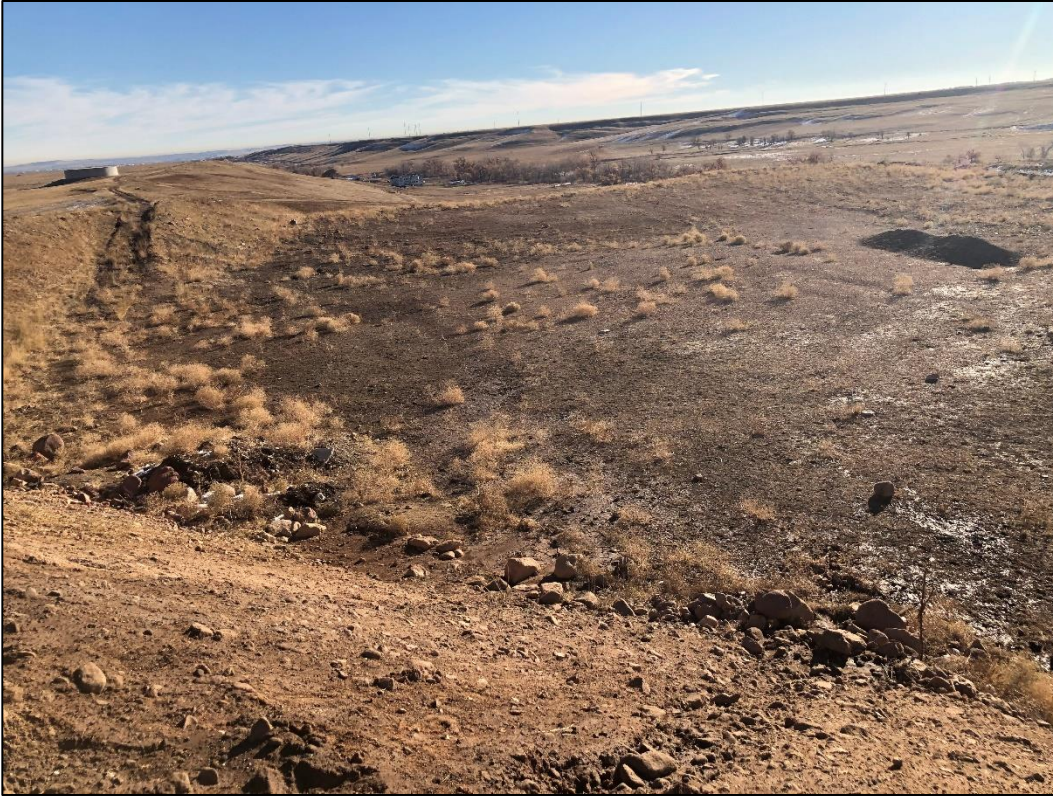
Photo 3. View looking east across top of lower lift placed inside pit in north mining area.

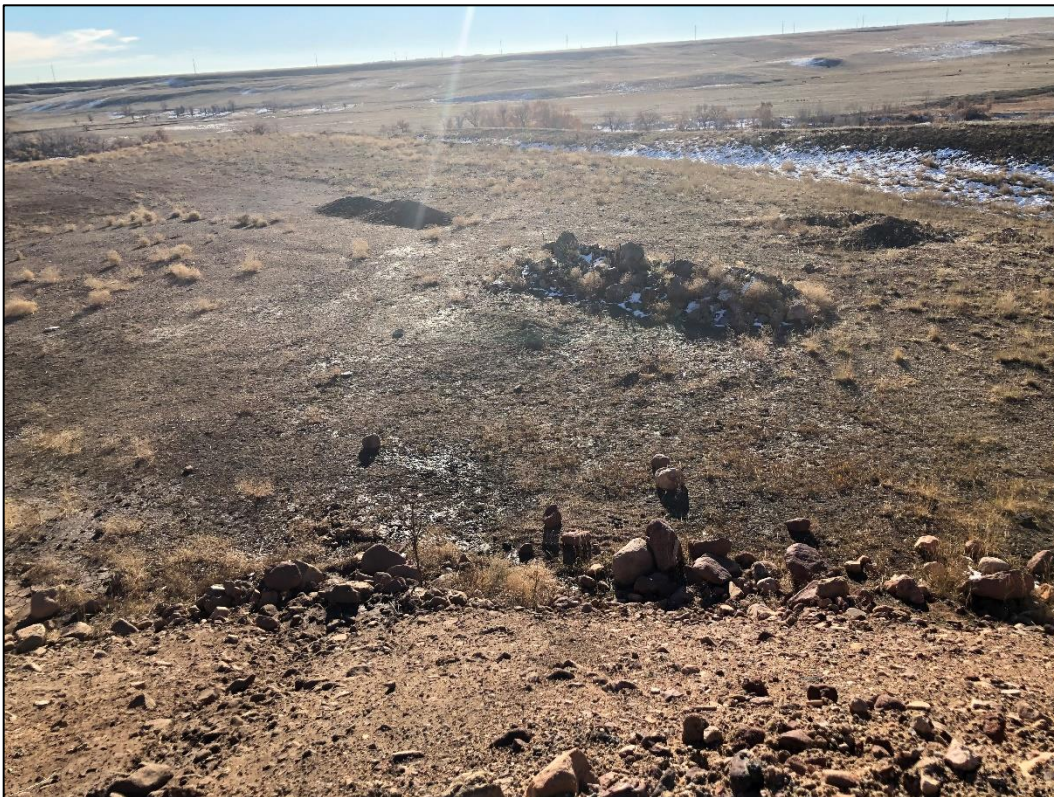
Photo 4. View looking southeast across top of lower lift placed inside pit in north mining area.

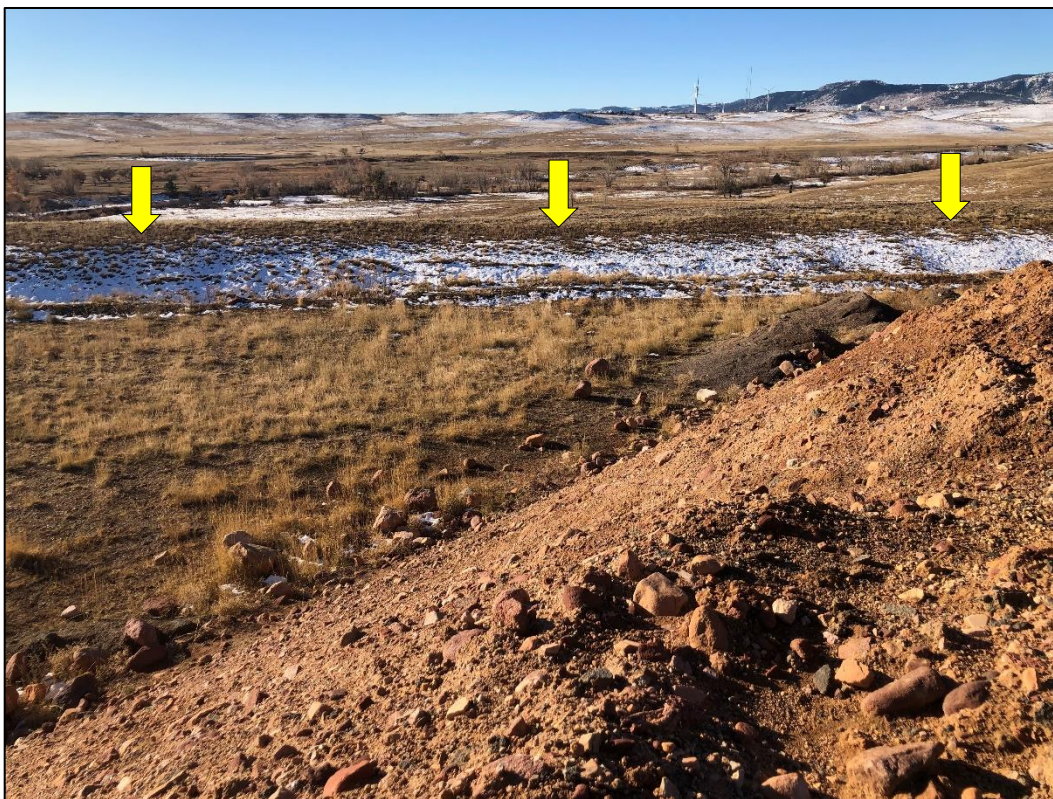
Photo 5. View looking south across top of lower lift placed inside pit in north mining area. Note side slope of upper lift (in foreground) at ~1.5H:1V. Also note southern rim of pit (indicated in background).

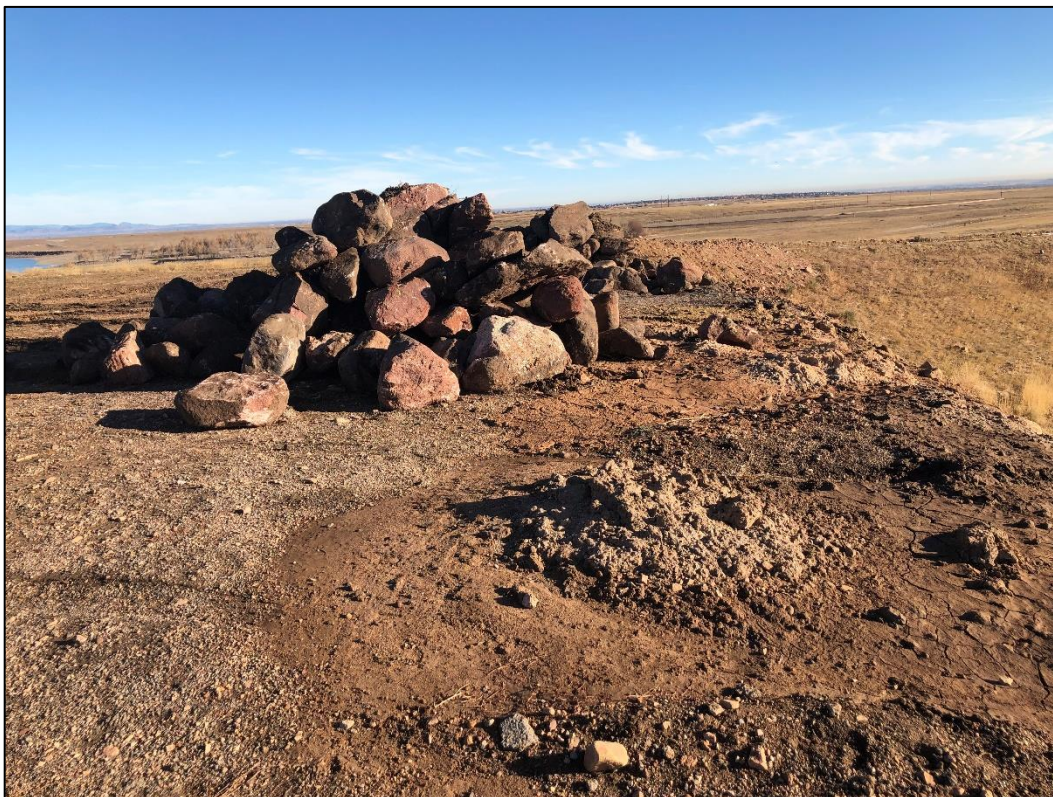
Photo 6. View looking northeast at boulders stockpiled at eastern edge of upper lift.

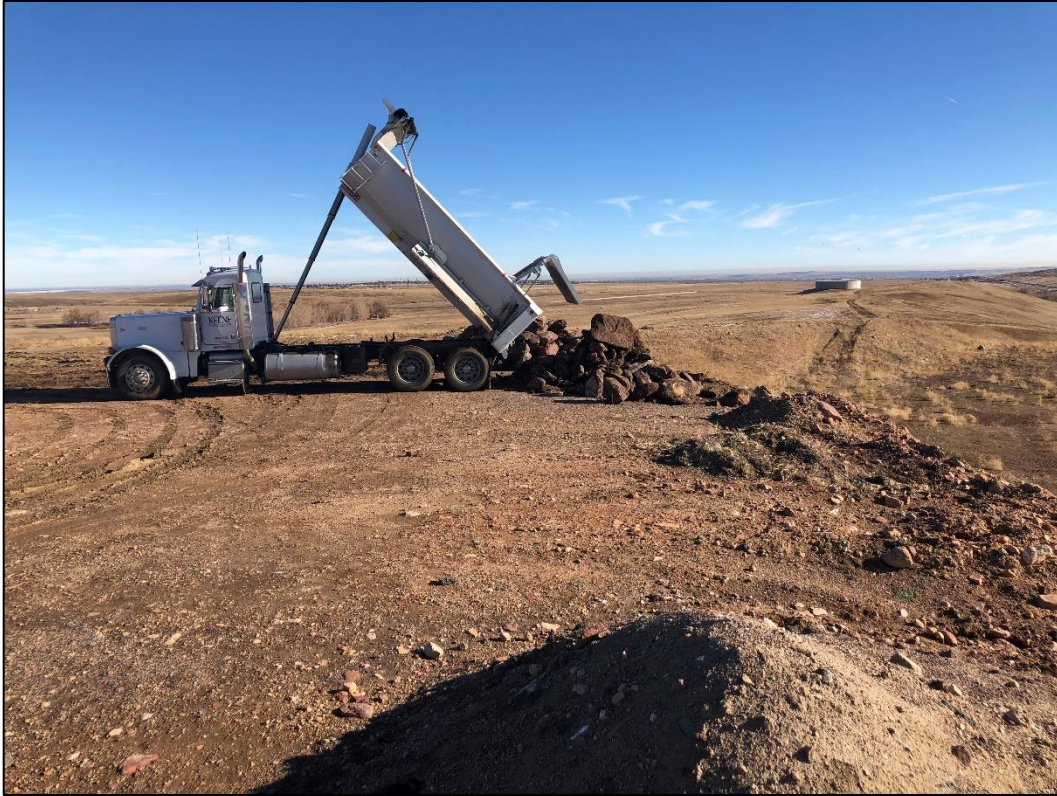
Photo 7. View looking northeast showing haul truck dumping additional boulders at eastern edge of upper lift during inspection.

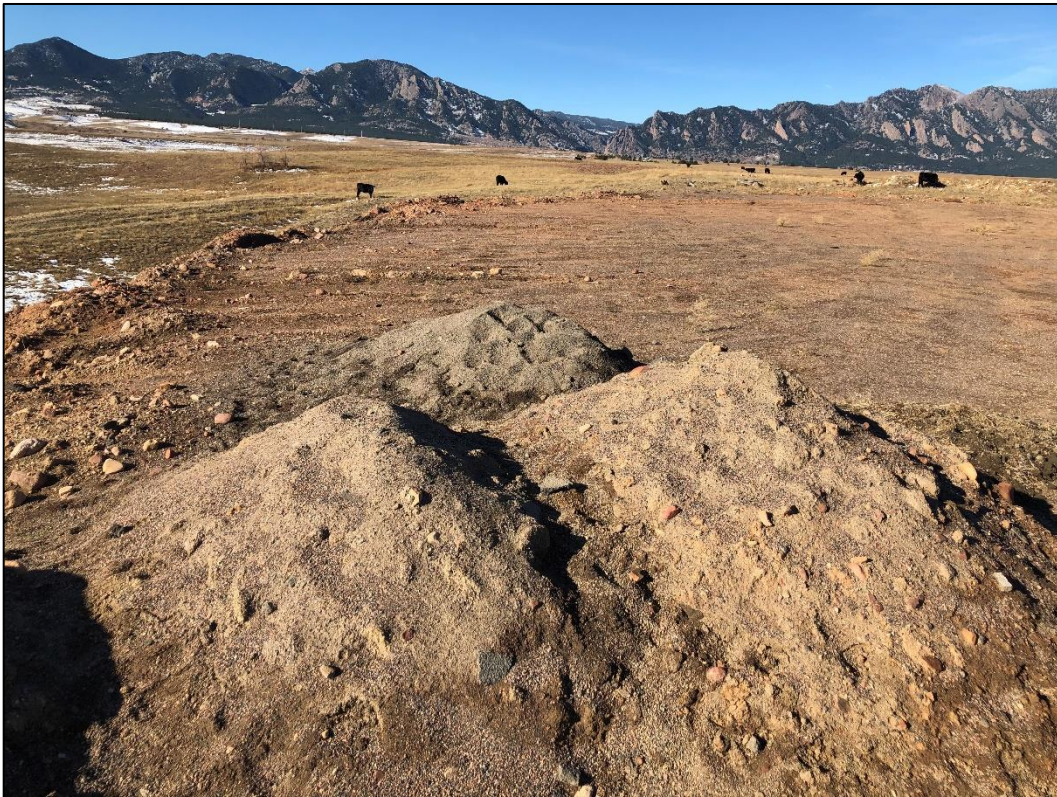
Photo 8. View looking west at small stockpiles of imported material stored at southern edge of upper lift.

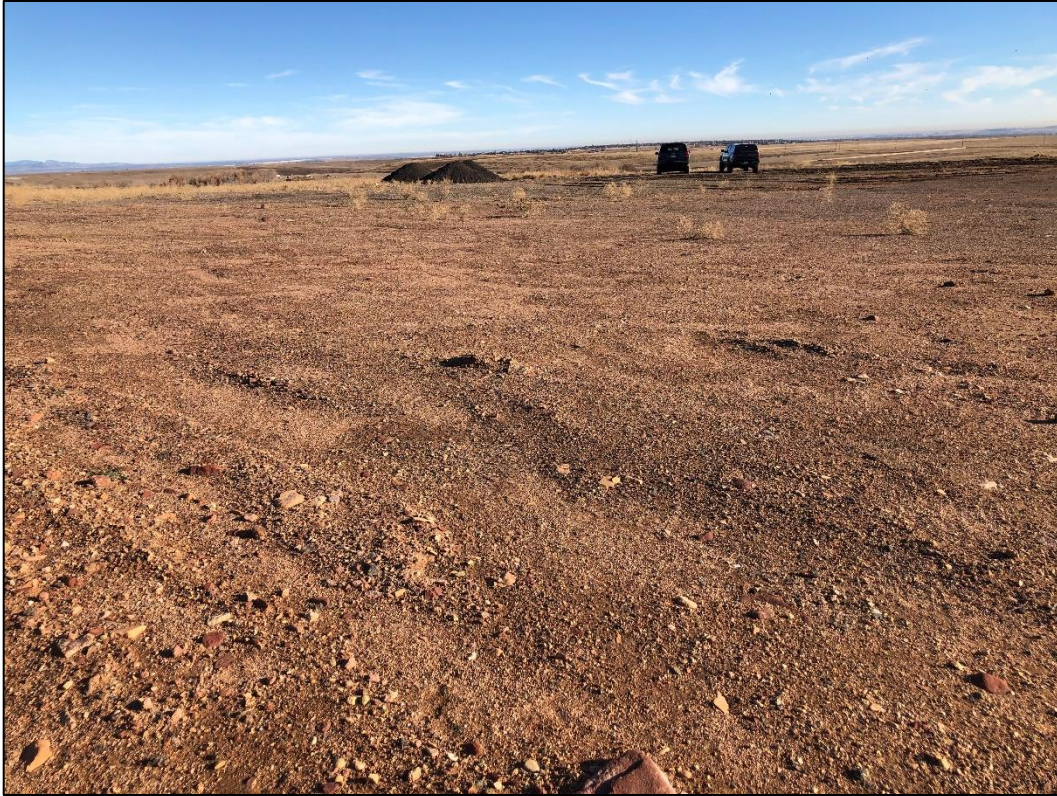
Photo 9. View looking northeast across top of upper lift placed inside pit in north mining area.

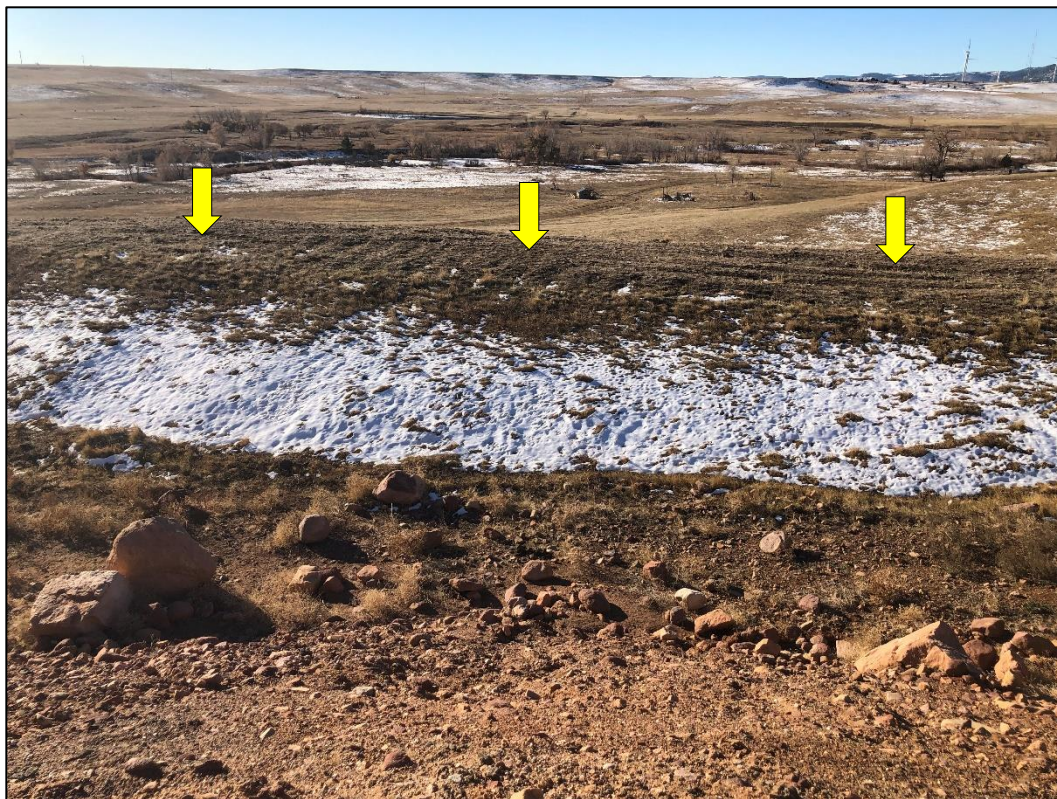
Photo 10. View looking south from top of upper lift placed inside pit in north mining area. Note southern rim of pit (indicated in background).

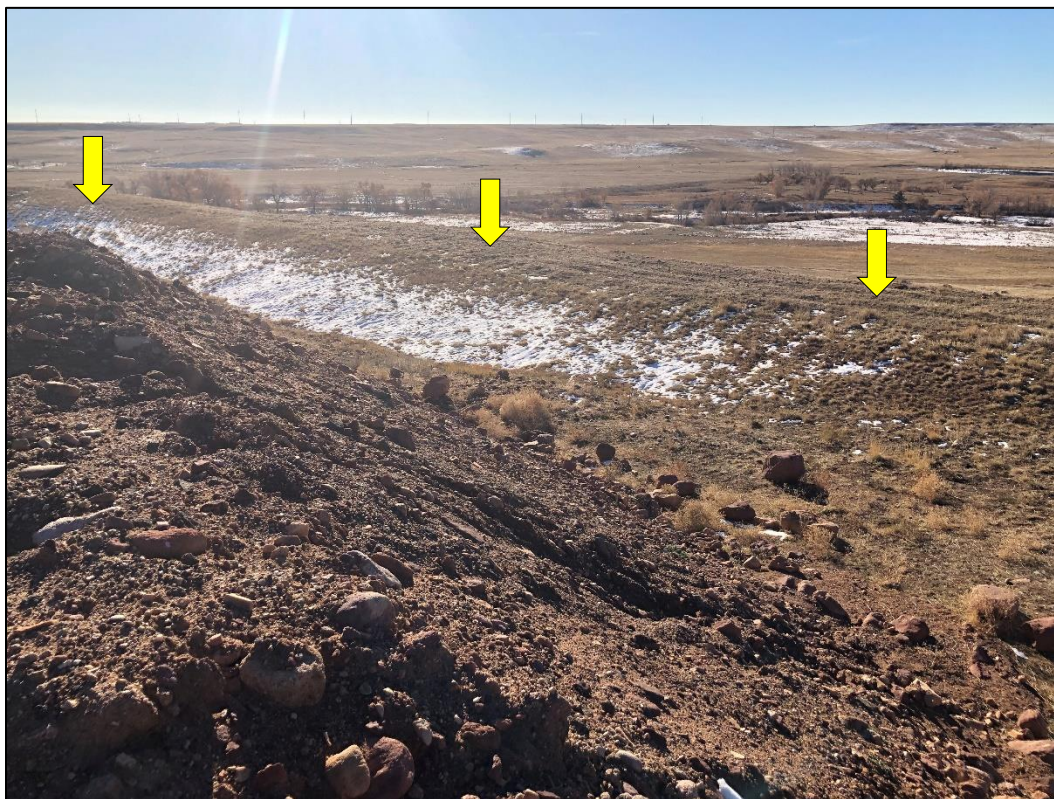
Photo 11. View looking southeast from top of upper lift placed inside pit in north mining area. Note side slope of upper lift (in foreground) at $\sim 1.5H:1V$. Also note southern rim of pit (indicated in background).

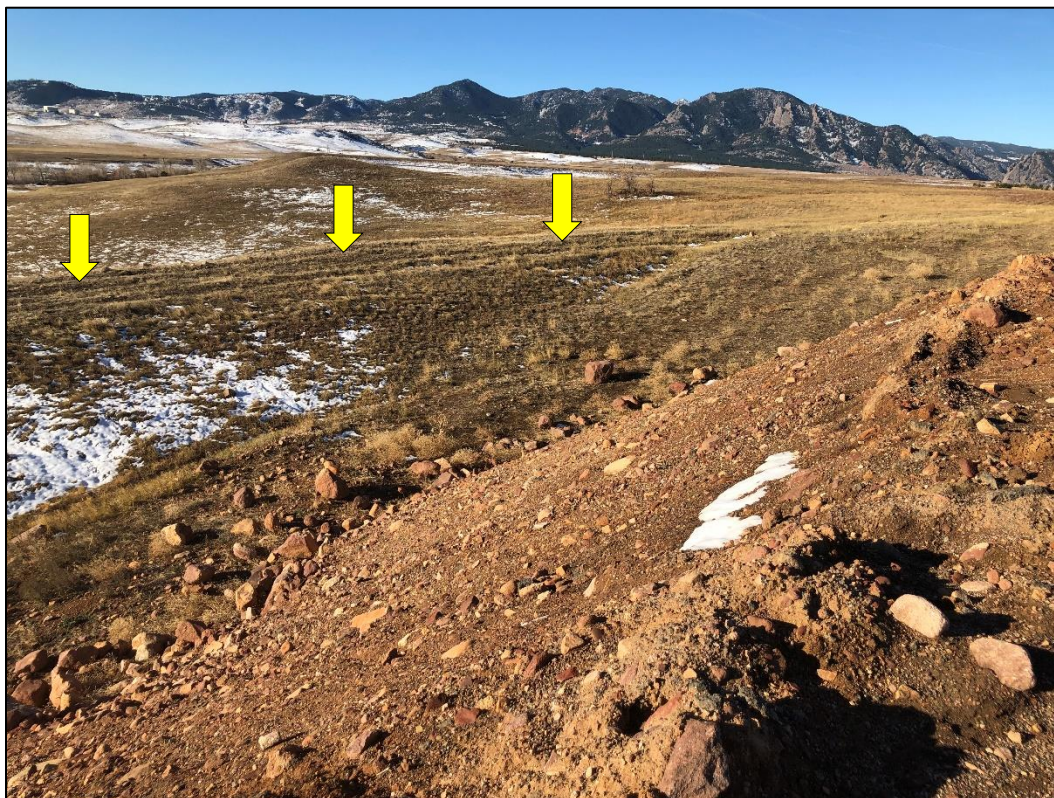
Photo 12. View looking west from top of upper lift placed inside pit in north mining area. Note side slope of upper lift (in foreground) at $\sim 1.5H:1V$. Also note southern rim of pit (indicated in background).

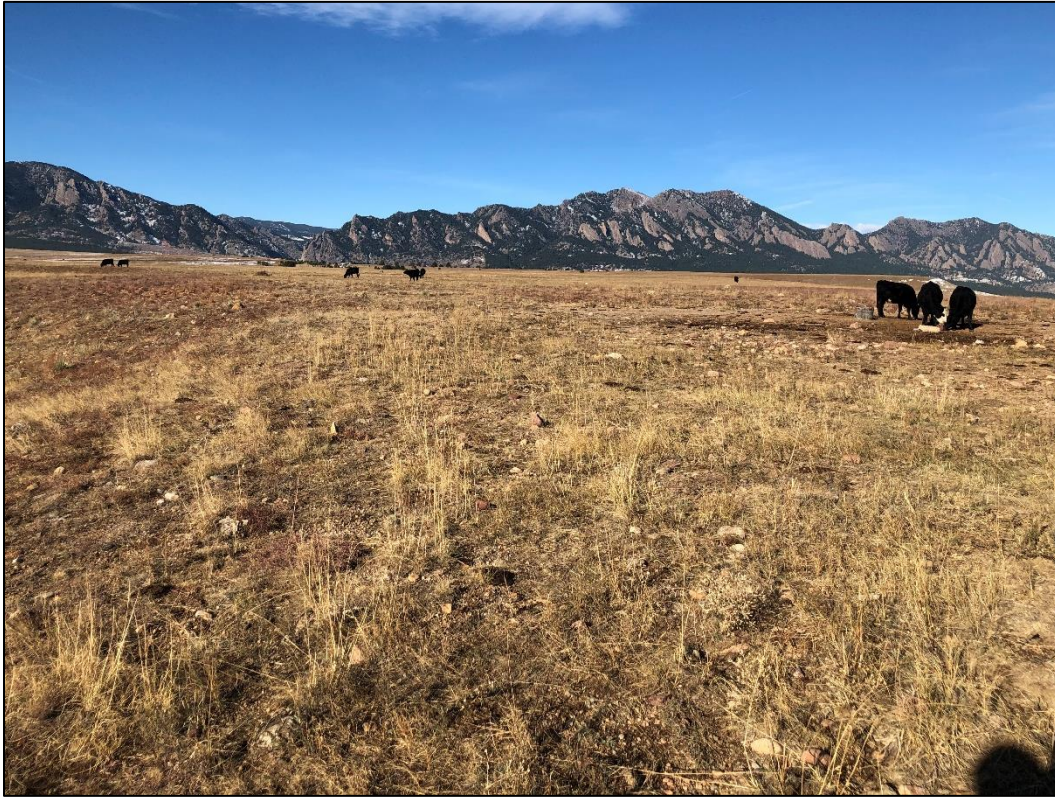
Photo 13. View looking west across reclaimed area located west of pit where cattle were grazing during inspection.

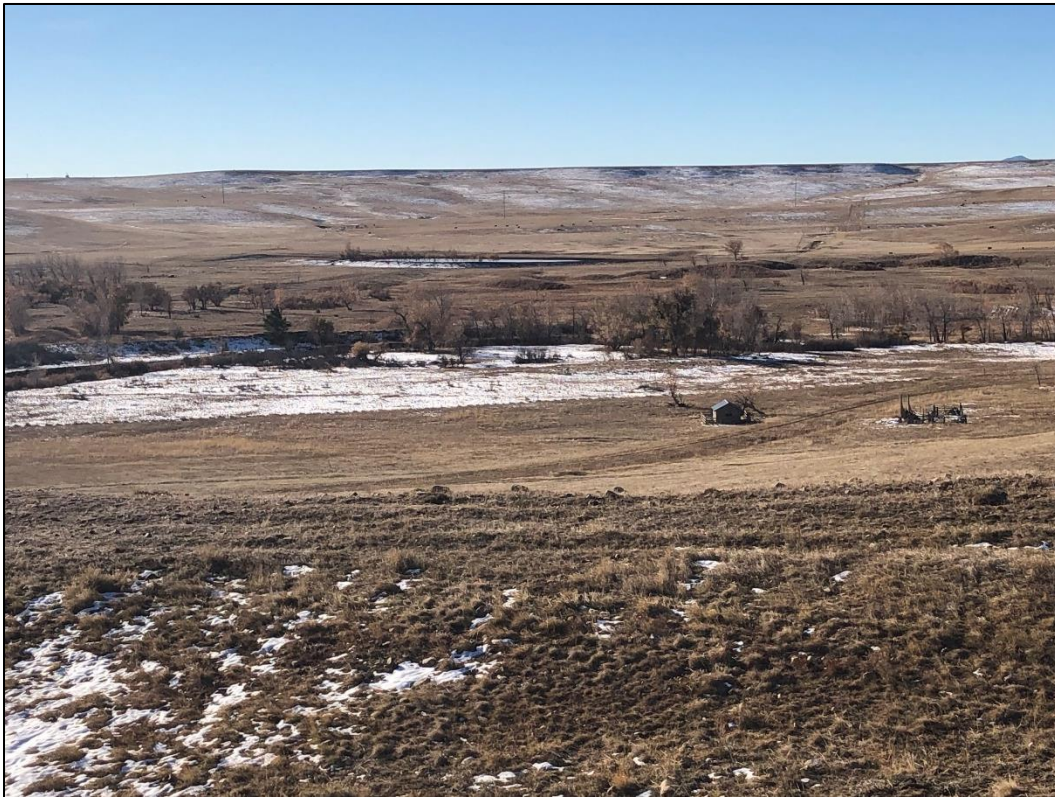
Photo 14. View looking south across permit area from top of upper lift. Coal Creek (lined by trees in background) bisects permit area.

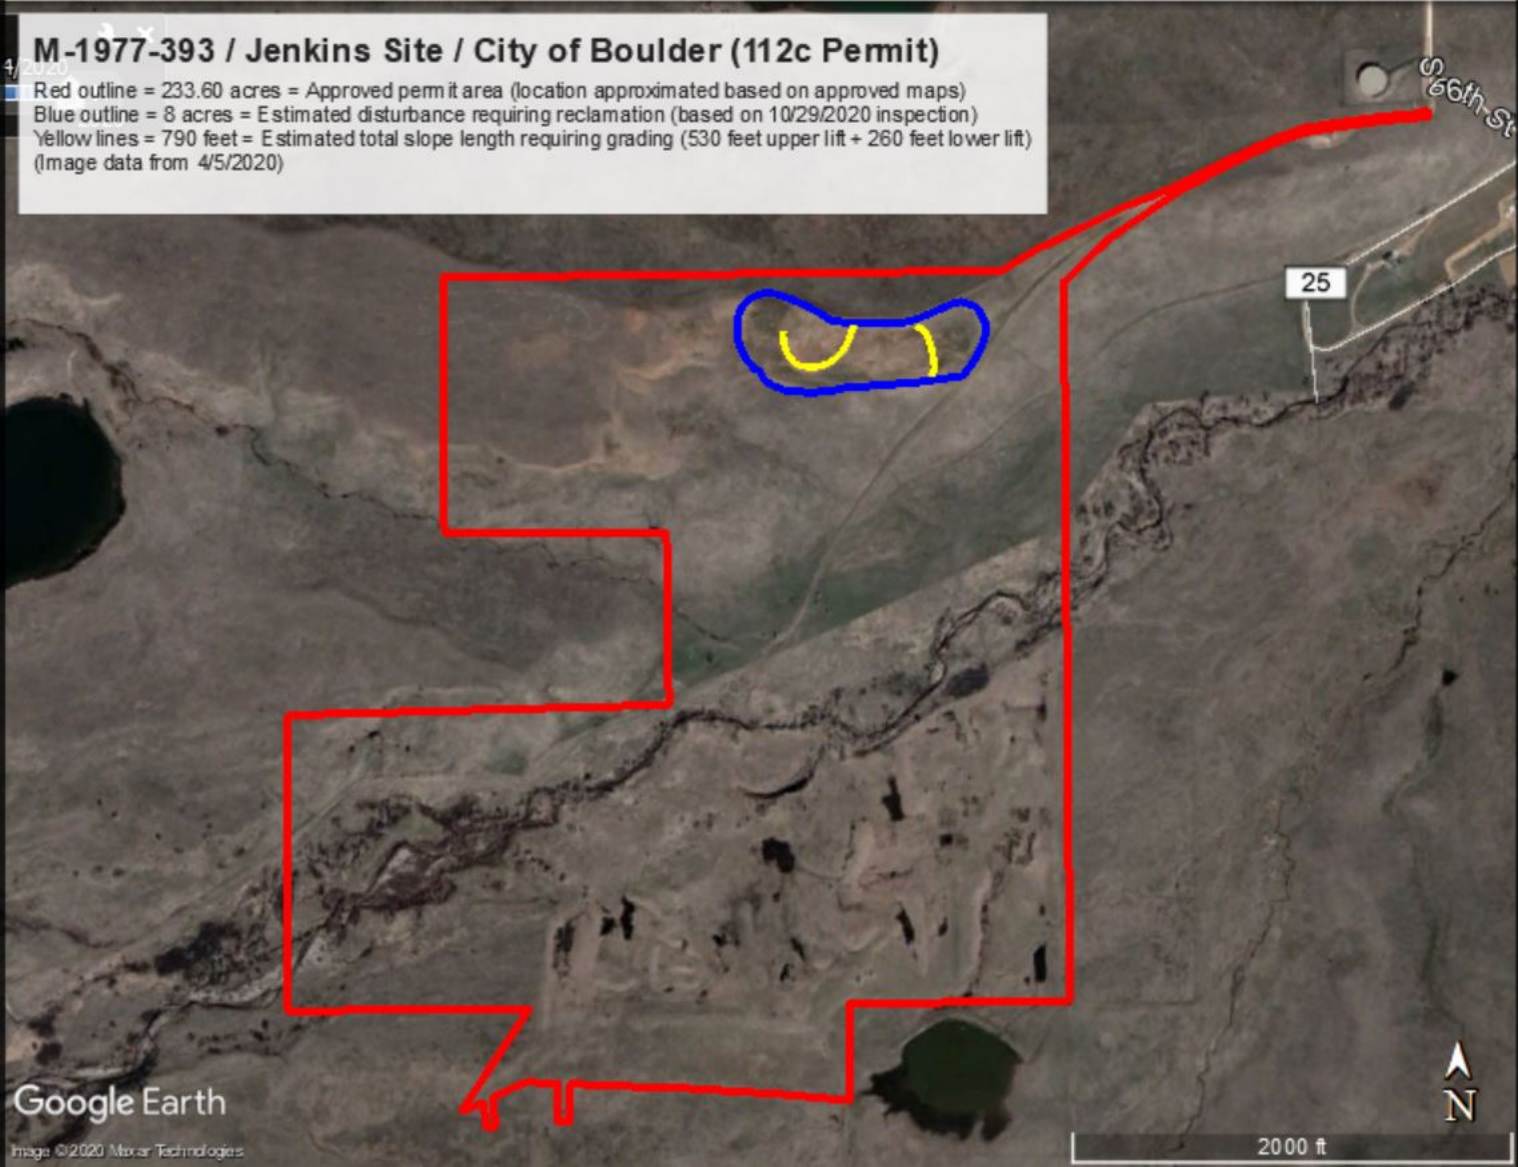
Red outline = 233.60 acres = Approved permit area (location approximated based on approved maps)
Blue outline = 8 acres = Estimated disturbance requiring reclamation (based on 10/29/2020 inspection)
Yellow lines = 790 feet = Estimated total slope length requiring grading (530 feet upper lift + 260 feet lower lift)
(Image data from 4/5/2020)

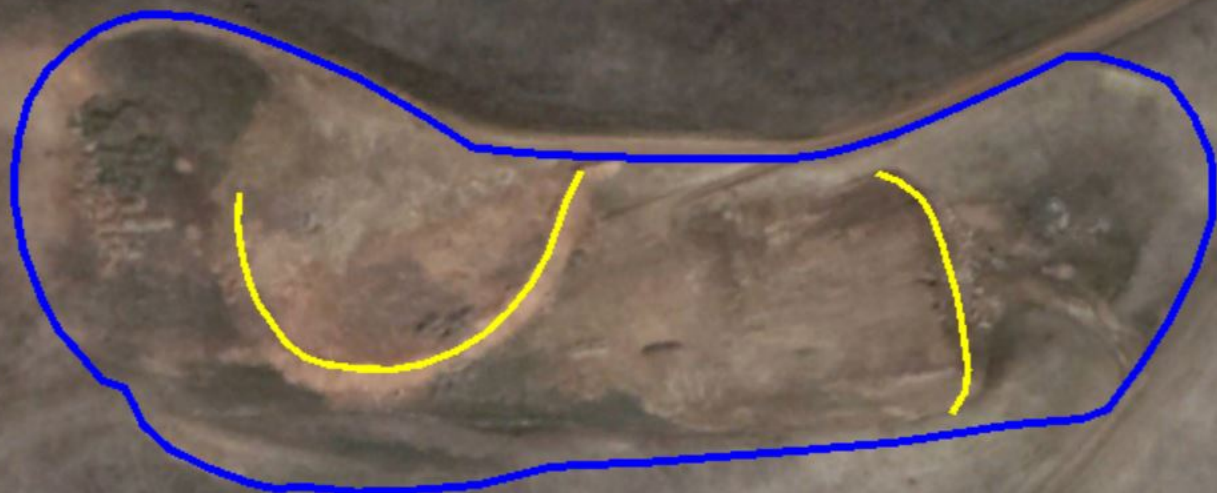
4/2020
2020
Closer view of disturbed area.

Red outline = 233.60 acres = Approved permit area (location approximated based on approved maps)
Blue outline = 8 acres = Estimated disturbance requiring reclamation (based on 10/29/2020 inspection)
Yellow lines = 790 feet = Estimated total slope length requiring grading (530 feet upper lift + 260 feet lower lift)
(Image data from 4/5/2020)
