C1980007, West Elk Mine, October Inspection Report and NOV CV-2020-001

COLORADO
Division of Reclamation,
Mining and Safety
Department of Natural Resources

Permit Number: C-1980-007 Mine Name: West Elk Mine Operator: Mountain Coal Company, LLC Operator Address: Ms Kathleen G Welt 5174 Highway 133 Somerset, CO 81434	County: Delta, Gunnison Operation Type: Underground Permit Status: Active Ownership: Private
	Operator Representative Present: John Poulos, Kathy Welt
Operator Representative Signature: (Field Issuance Only)

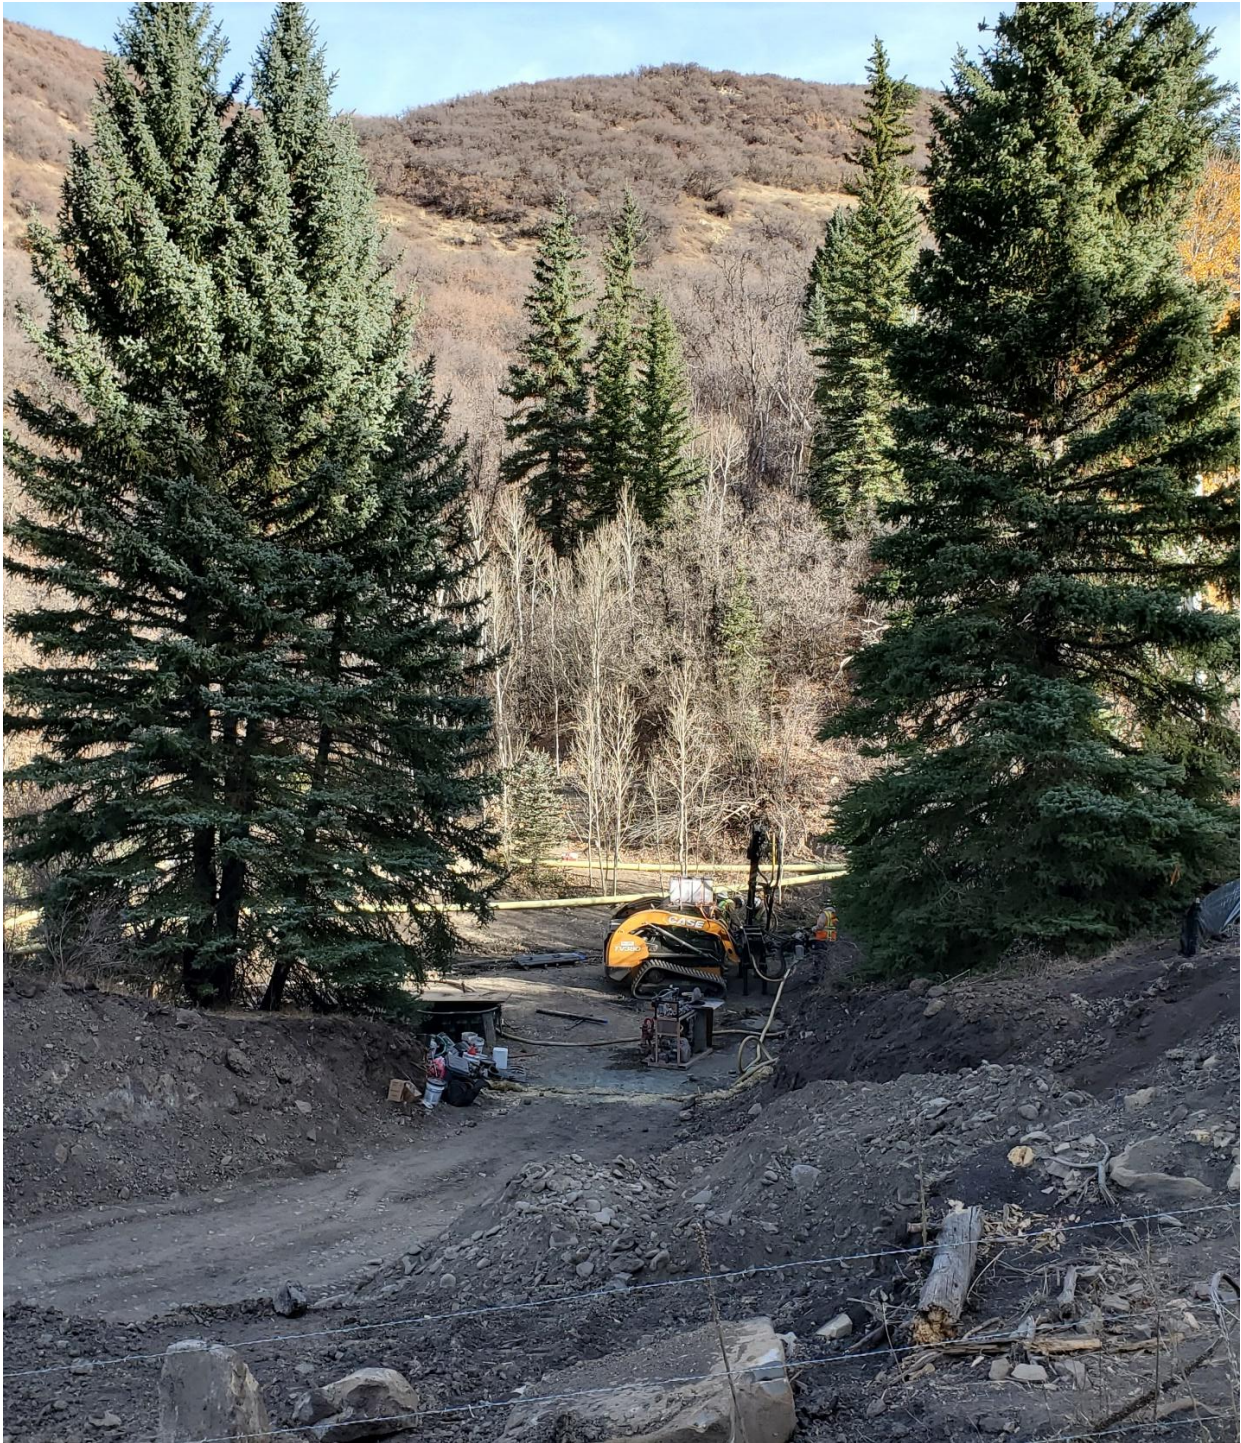
MCC had previously notified the Division of subsidence that had occurred during the afternoon of Monday October 13th, as a result of development mining under South Prong Creek. A hole, approximately 40' across, had opened up on the surface, just upstream of the confluence with the North Fork of South Prong Creek, causing water from the creek to flow into the mine workings. MCC staff had responded immediately, setting up pumps and a temporary diversion during the night. Stream flow was initially estimated at 100 gallons per minute (0.22 cfs), and later measured at 160 gallons per minute (0.36 cfs). The stream flow had been successfully diverted around the subsidence hole by the morning of Tuesday October 14th.

According to Mr. Poulos, the subsidence of the creek had occurred when the roof of the western-most of five entries in the Sunset Mains South had caved, as development was progressing from north to south. The entries

are approximately 100' apart. The fifth, fourth and third entries had been or were being backfilled at the time of the inspection, and would be sealed - the final design of the bulkhead seals will require MSHA approval. The second entry had not yet progressed as far south as those to the west, and the first had already been dropped as it was no longer required to satisfy ventilation requirements.

Figure 1: Overview of subsidence at South Prong Creek

The operator, Mountain Coal Company (MCC), had previously notified the Division of subsidence that had occurred during the afternoon of Monday October 13th, as a result of development mining under South Prong Creek. During the inspection it was apparent that the depth of cover at the location where the subsidence had occurred was extremely shallow, on the order of 30' (thirty feet).

The actual depth of cover at the location where subsidence occurred under South Prong Creek was an order of magnitude less than the minimum depth of cover contemplated by the authors of the approved subsidence evaluation study in Exhibit 60E. As the subsidence predictions made in Exhibit 60E were not valid for the actual mining conditions, the predictions of hydrologic impacts made in Exhibit 55B were also not valid.

Abatement Description: Submit a technical revision to: (1) reconcile the mine plan with the subsidence survey and include the information in an updated subsidence control plan as required by 2.05.6(6)(i); (2) update predictions of probable hydrologic consequences as necessary

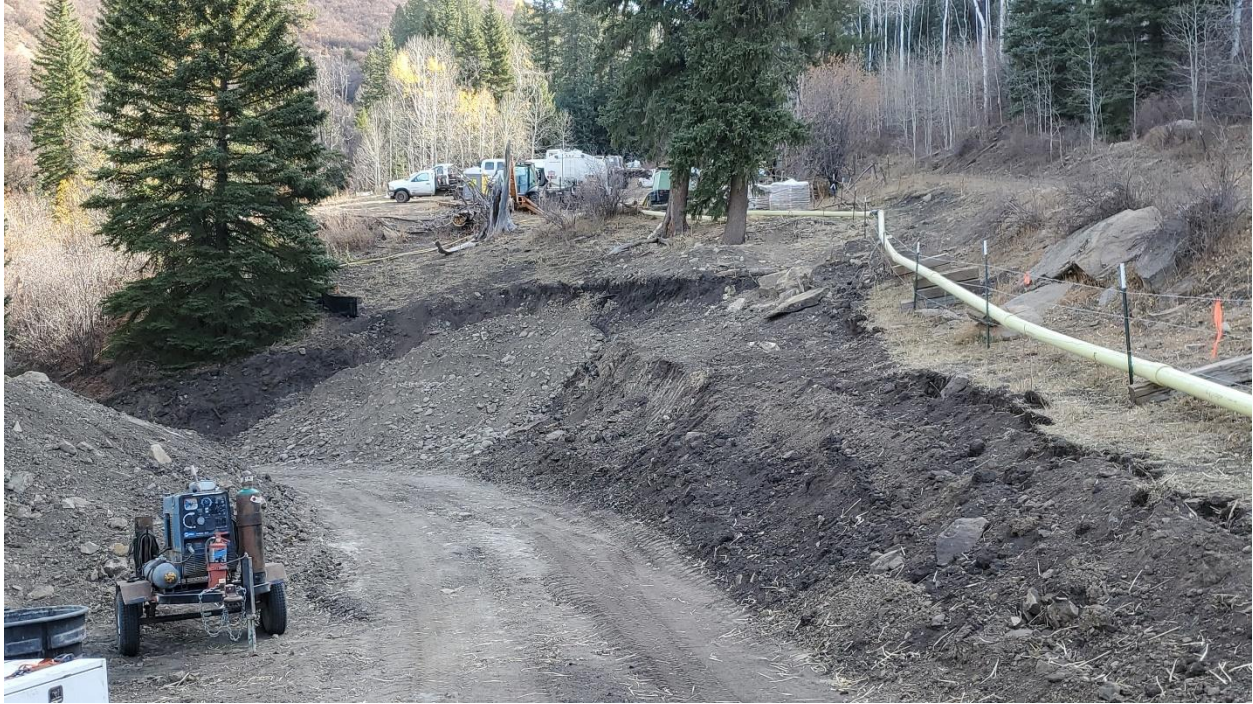
Figure 2: Access to work area, protected by fence

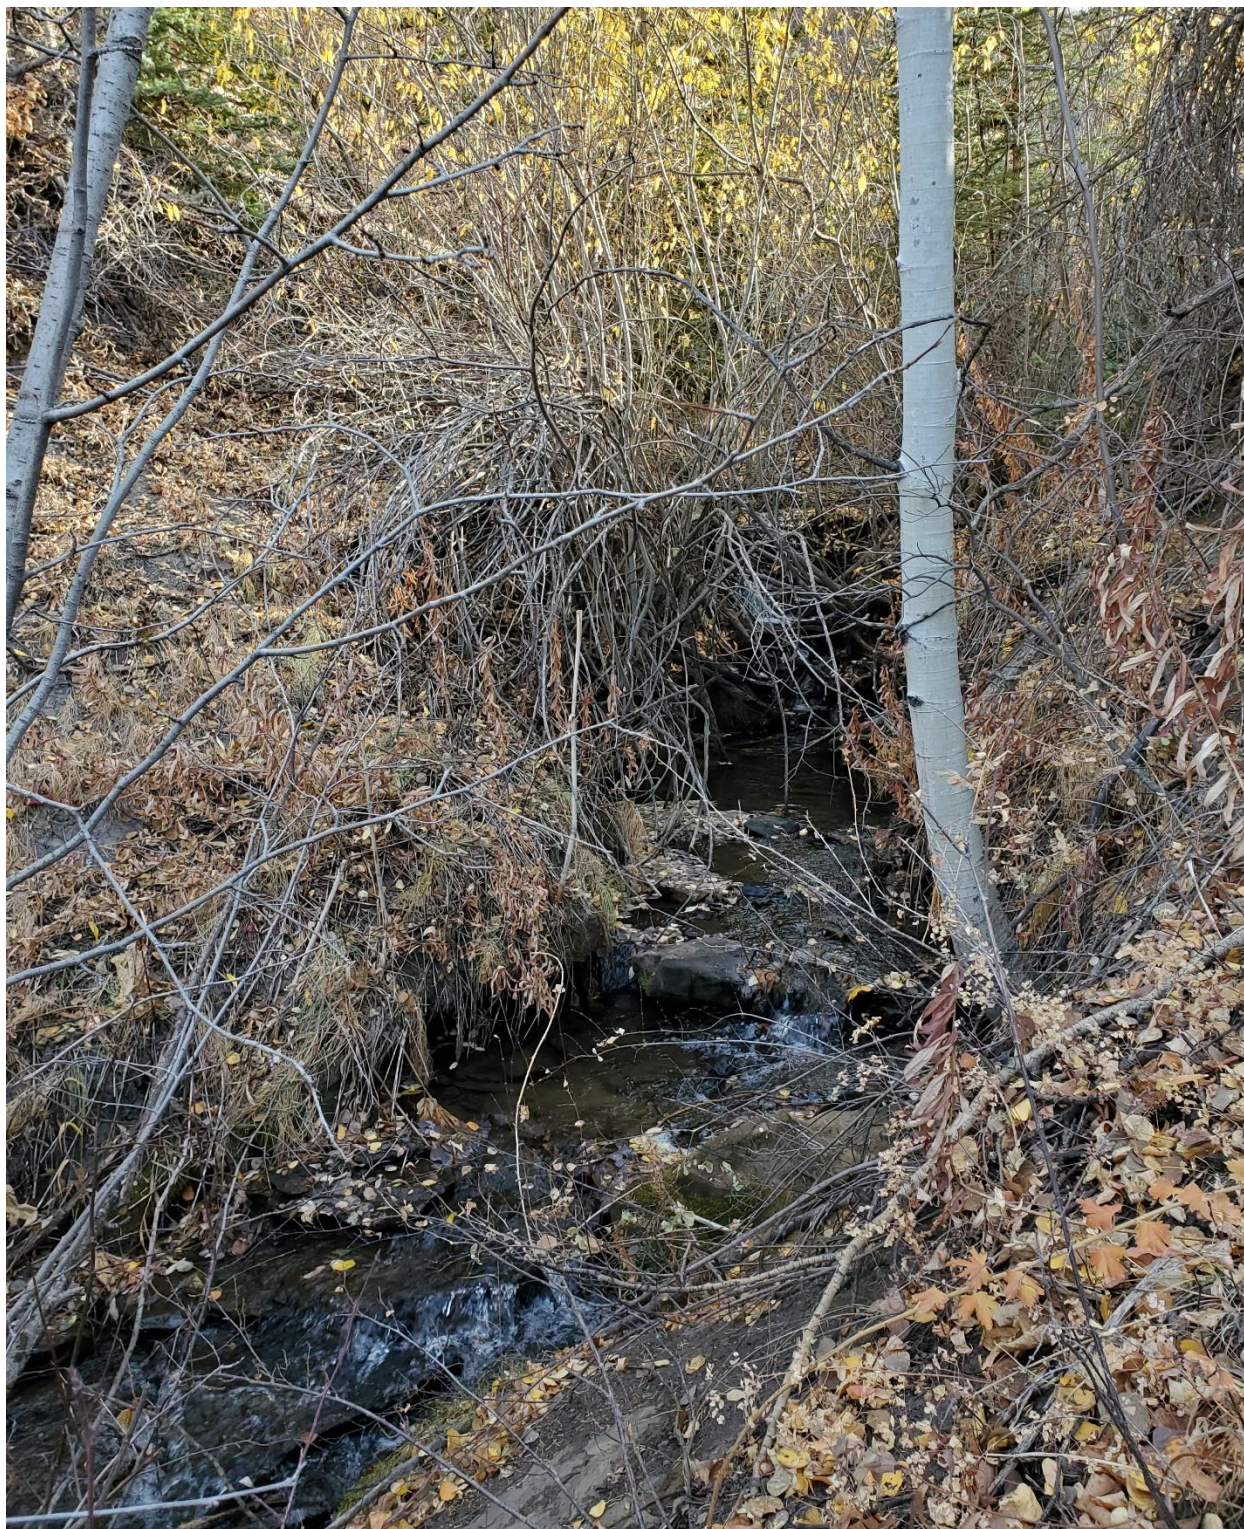
Figure 3: South Prong Creek upstream of subsidence

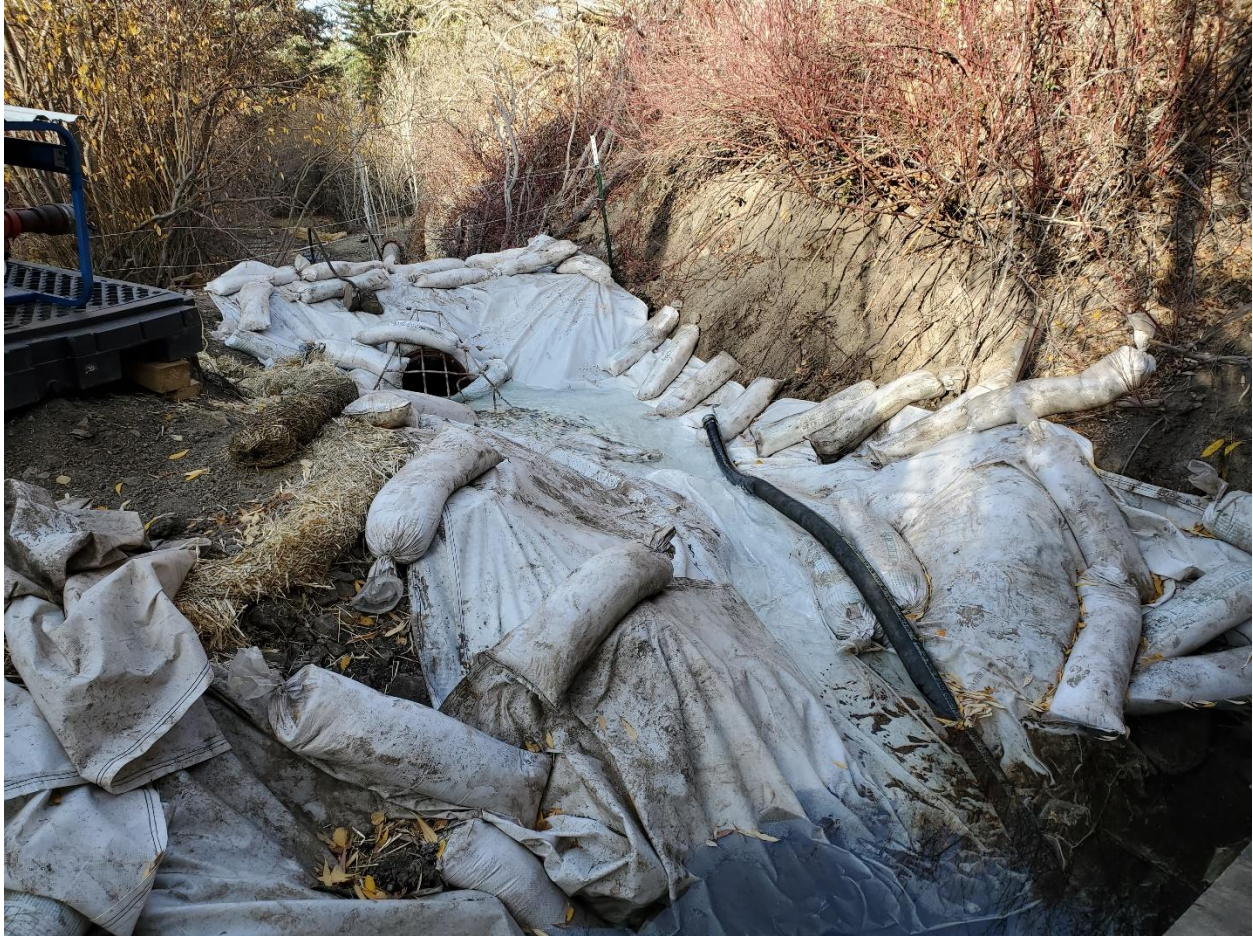
The main focus of the inspection was the damaged area, the associated disturbance, and the ongoing repairs. At the time of the inspection the water in the creek had been directed into a lined sump, which gravity drained into a 16" pipe. The 16" pipe split into two 6" pipes, only one of which was in use. The other pipe was available to provide capacity in case of increased stream flows. A second sump had been constructed just downstream of the first, which allowed a small electric pump to be used to pump the small amount of water that ran under the lining to be pumped back up to the first sump through a hosepipe as necessary.

Figure 4: Sump at inlet to temporary diversion

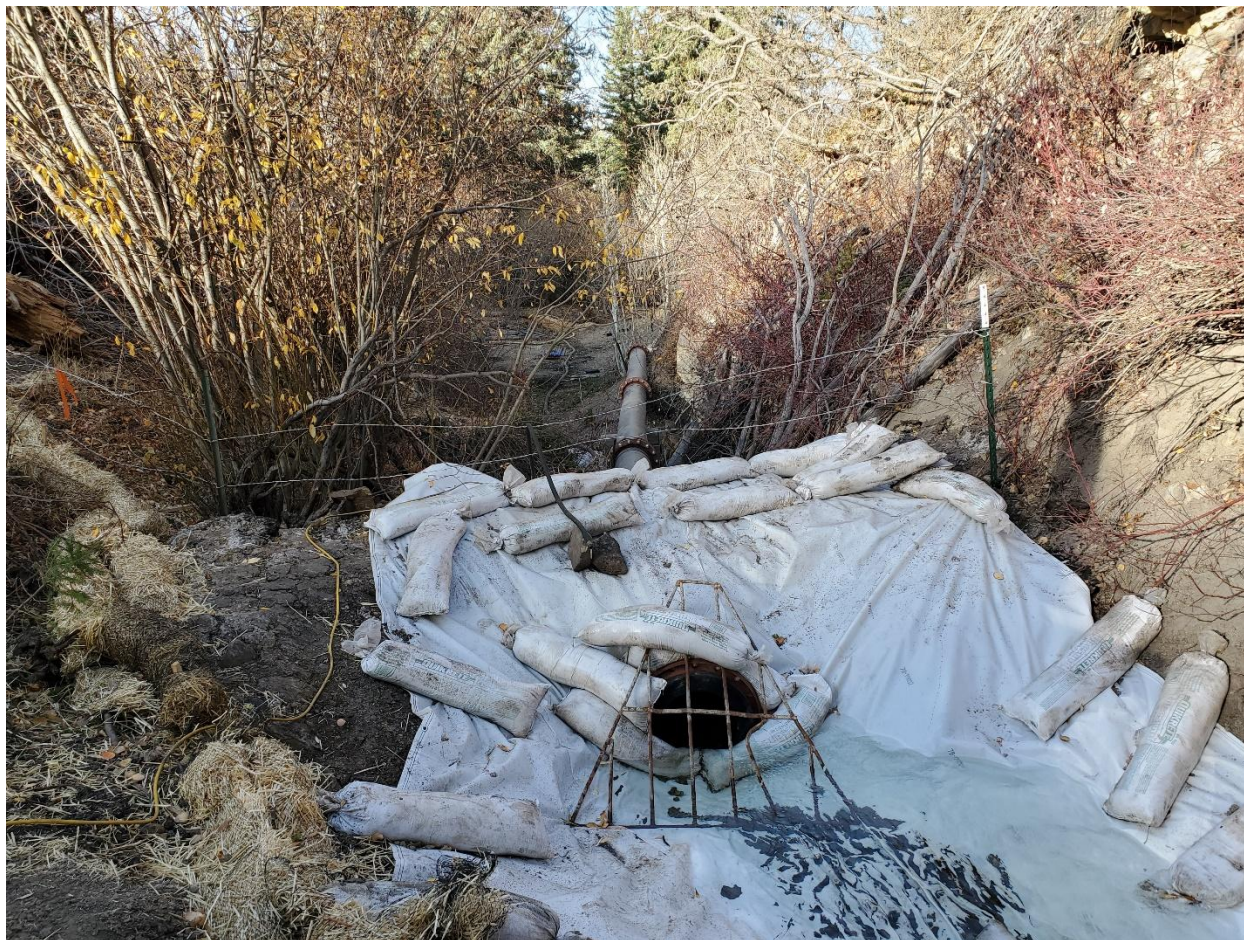
Figure 5: Temporary diversion

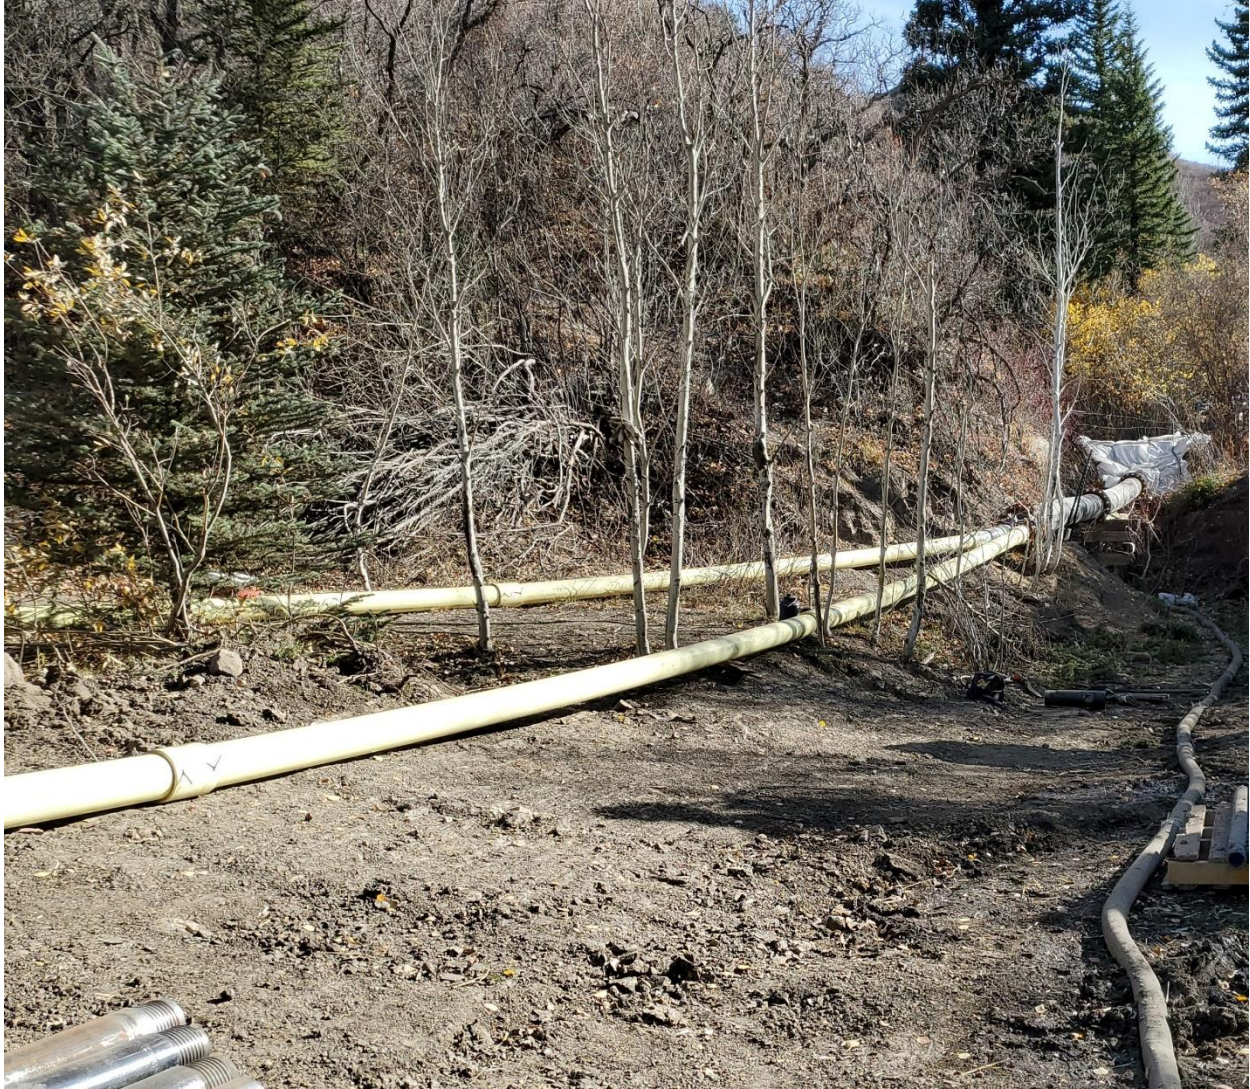
Figure 6: 16" pipe splits into two 6" pipes, one in use the other for surge capacity

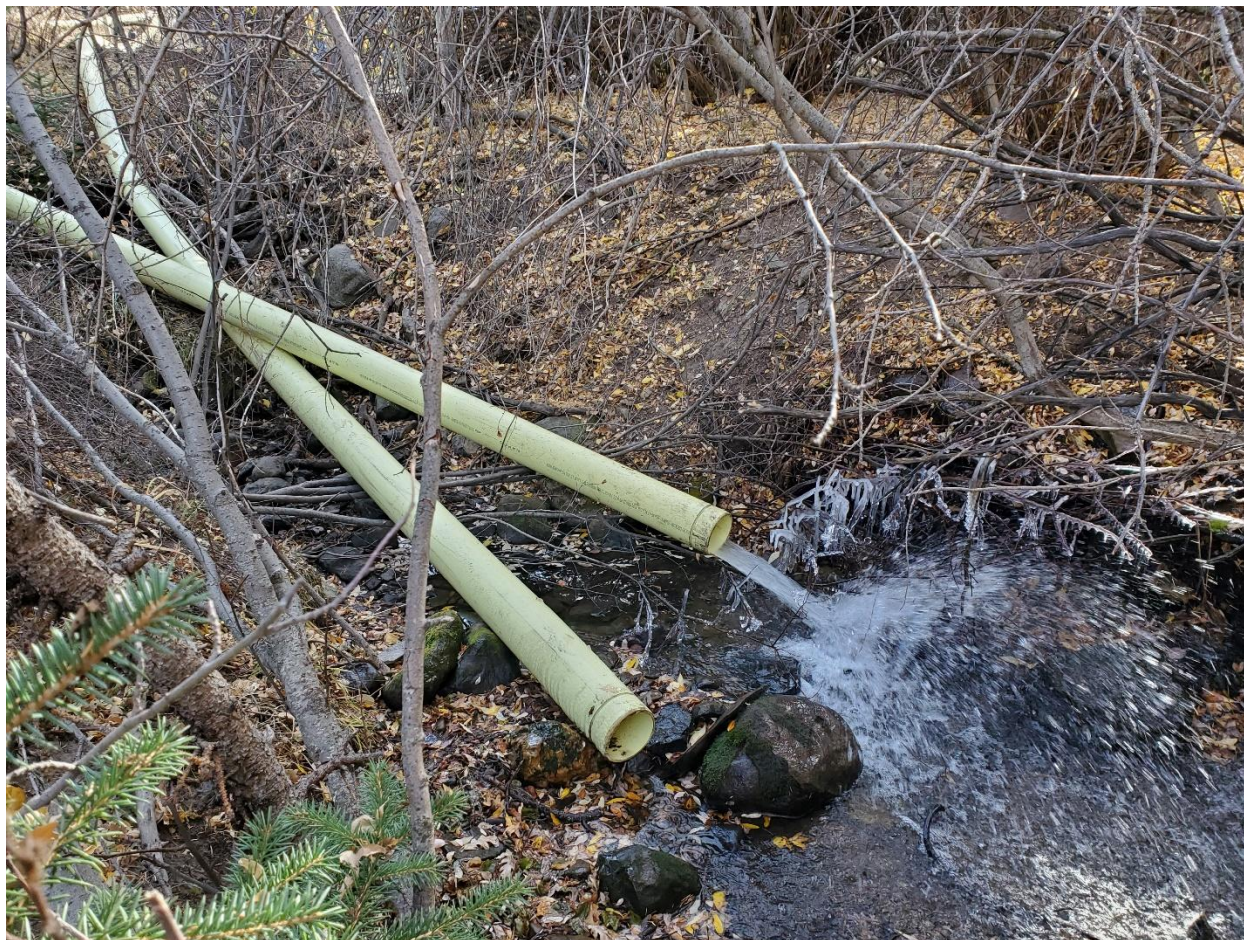
Figure 7: Outlet of temporary diversion

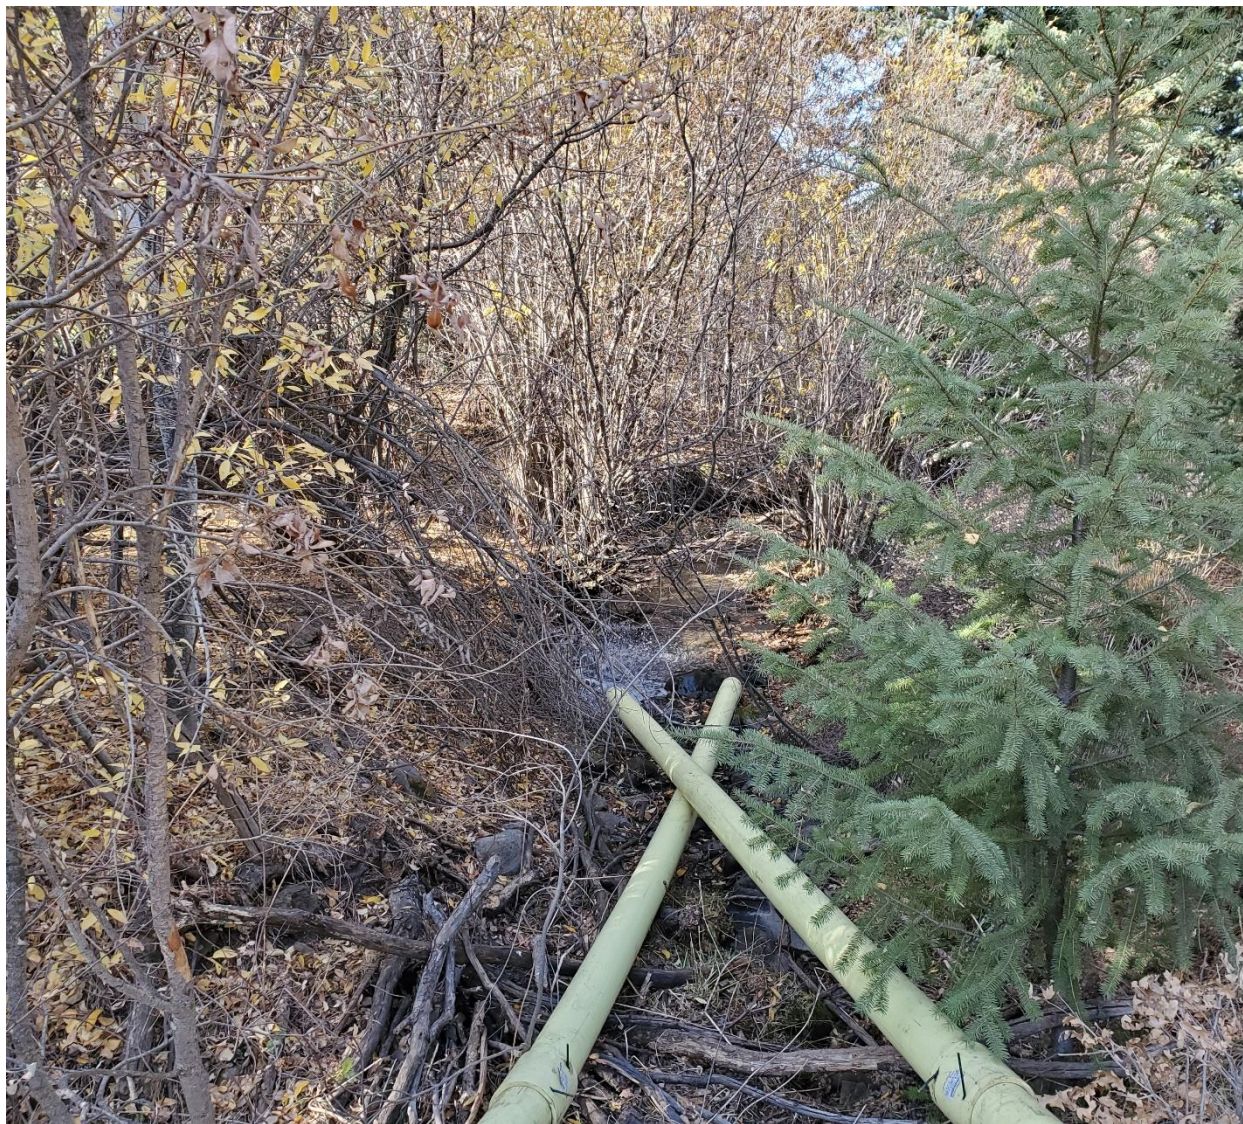
Figure 8: South Prong Creek downstream of temporary diversion

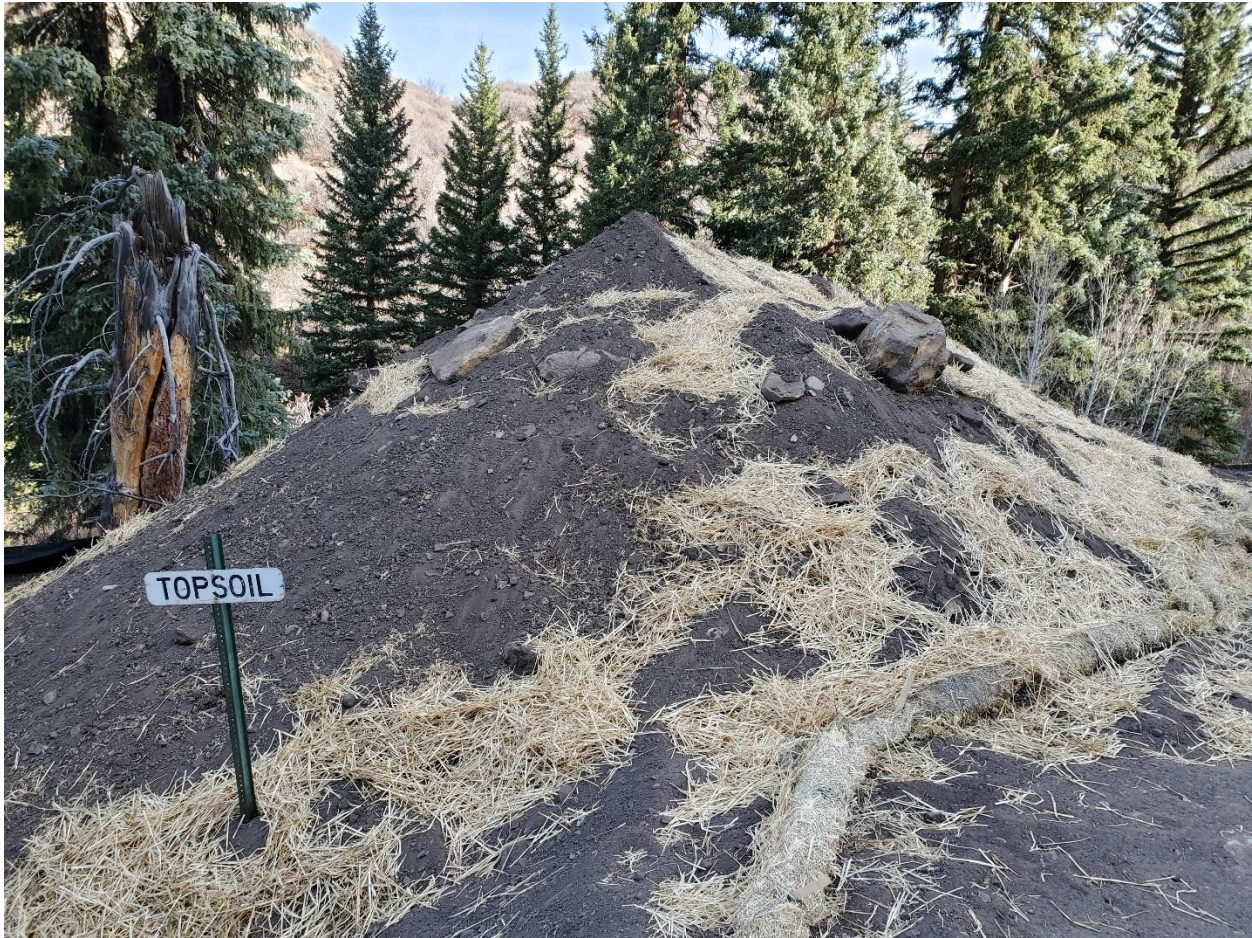
Figure 9: Salvaged topsoil, signposted, mulched, and protected with straw wattle

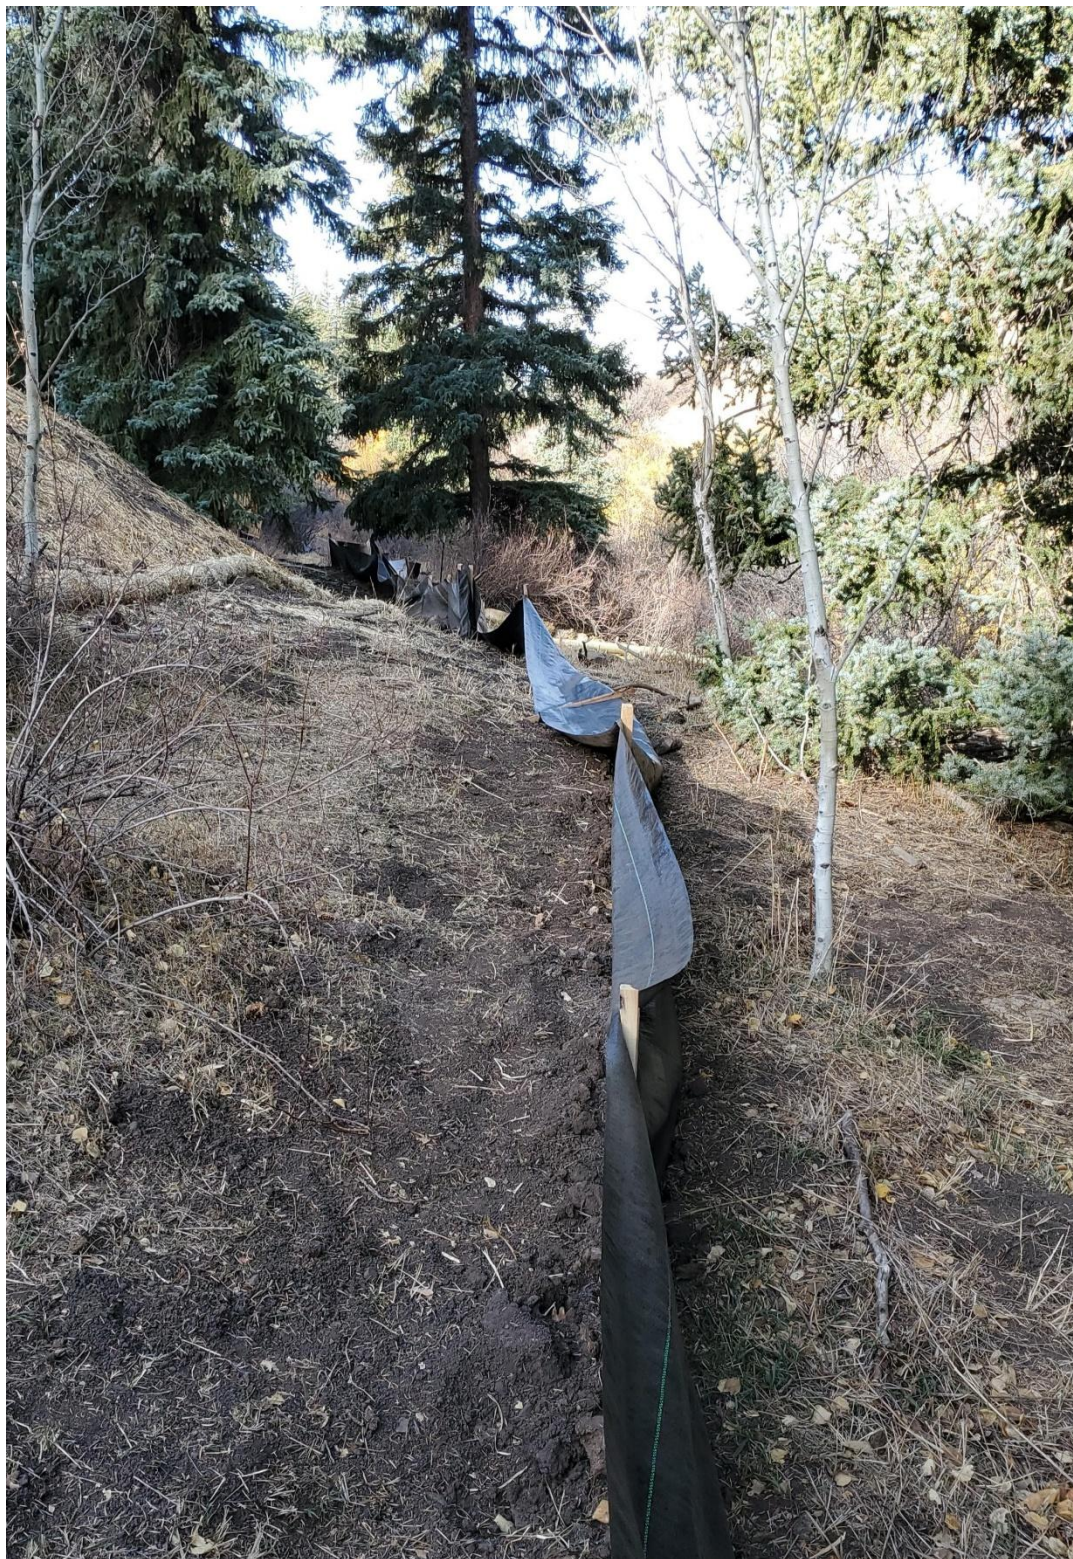
Figure 10: Disturbed area run-off controlled by silt fence (1)

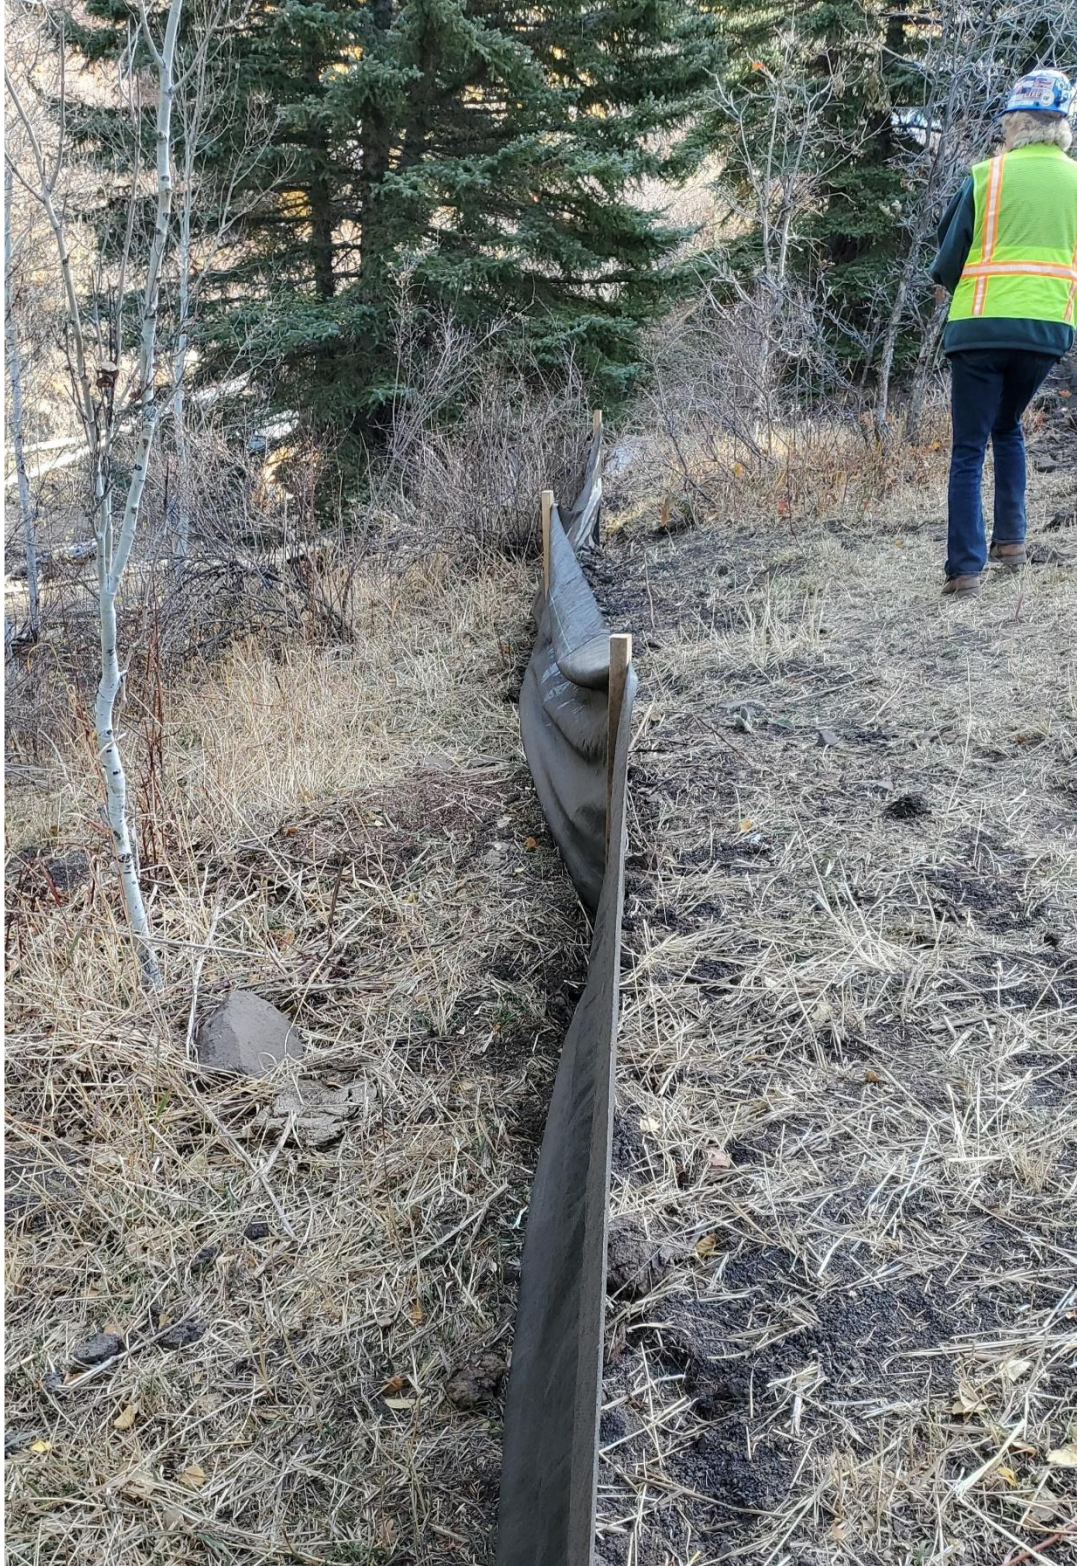
Figure 11: Disturbed area run-off controlled by silt fence (2)

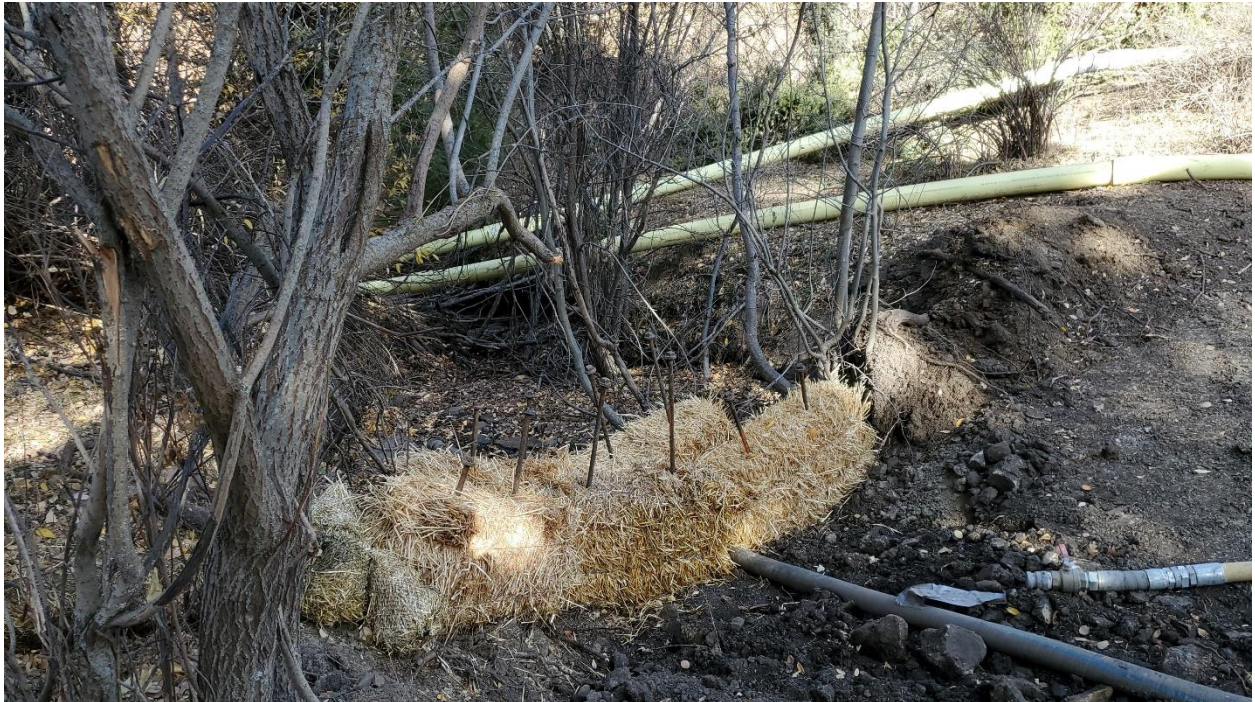
Figure 12: South Prong Creek channel protected from disturbed area run-off with straw bales

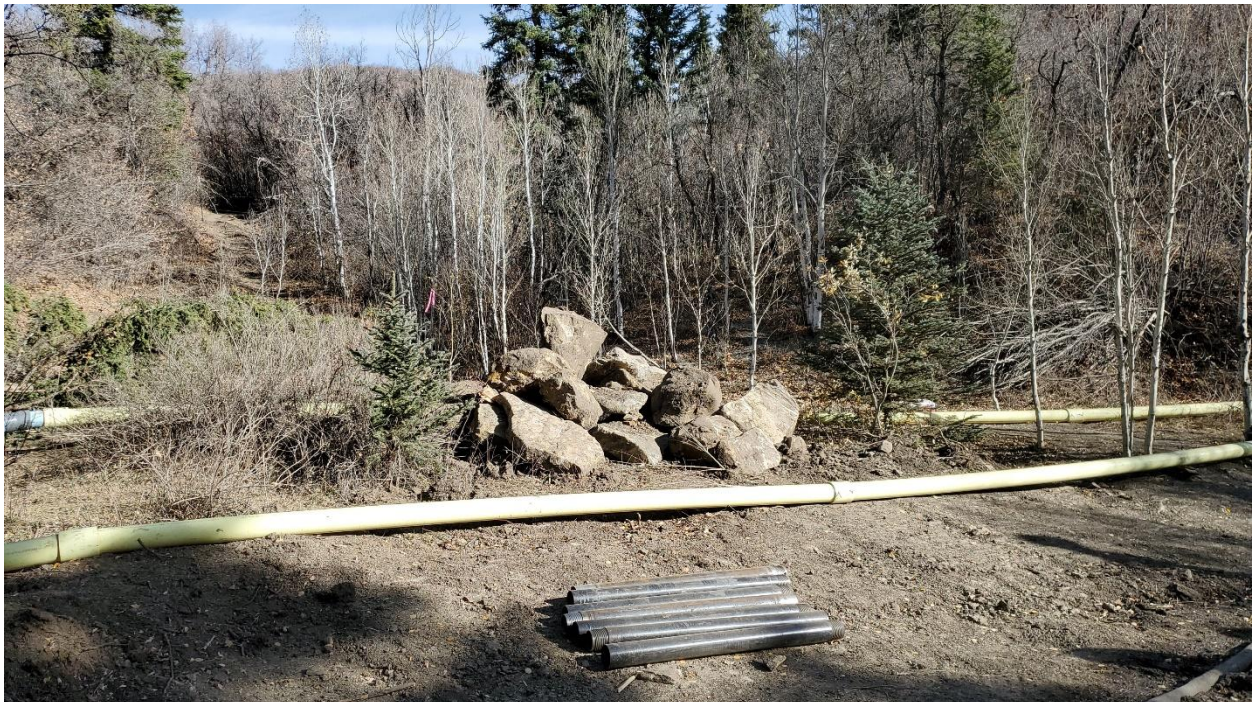
Figure 13: Stockpiled cobble and boulders, with 5' lengths of 5.5" drill casing in foreground

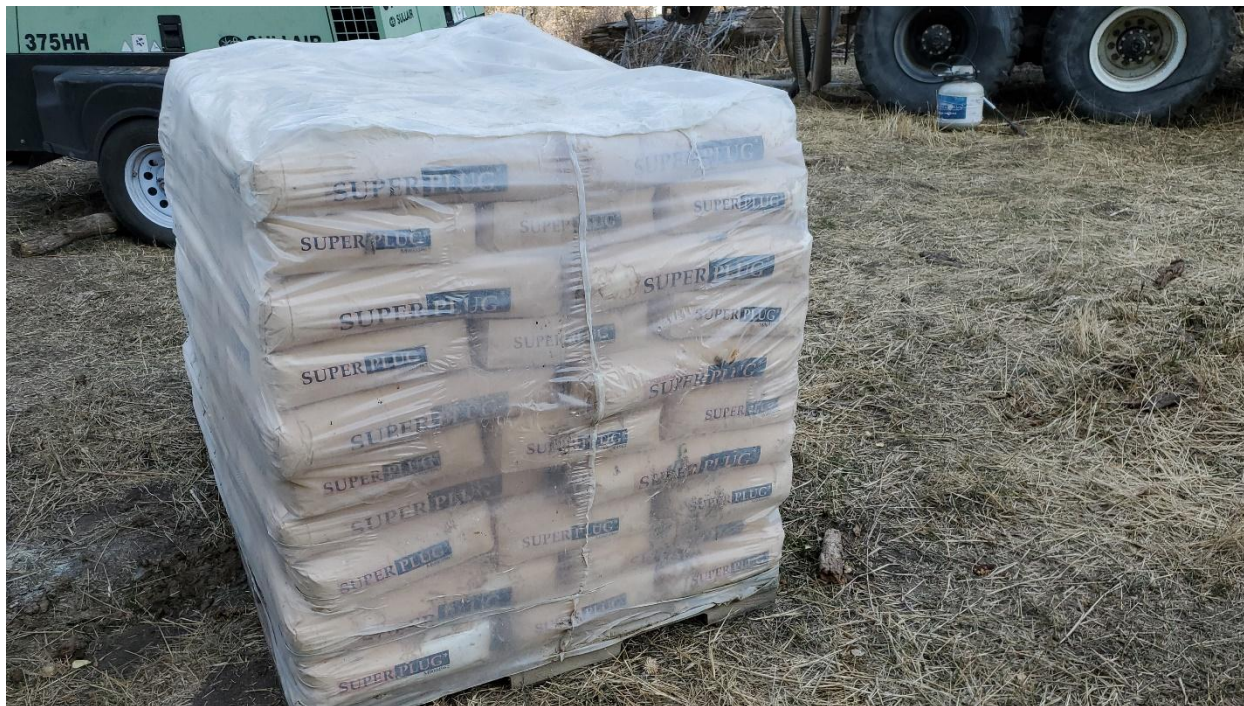
Topsoil had been salvaged from a borrow area adjacent to the subsidence and stockpiled. The perimeter of the disturbance had been protected with a silt fence. The topsoil stockpiles had been marked with sign posts, and protected with mulch and straw wattles. Cobbles and large boulders had been set aside. The subsided area had been filled with native material from the borrow area, compacted in 2' lifts. A 6-8" thick bentonite cap had then been made in place.

Figure 14: Bentonite left over after construction of cap

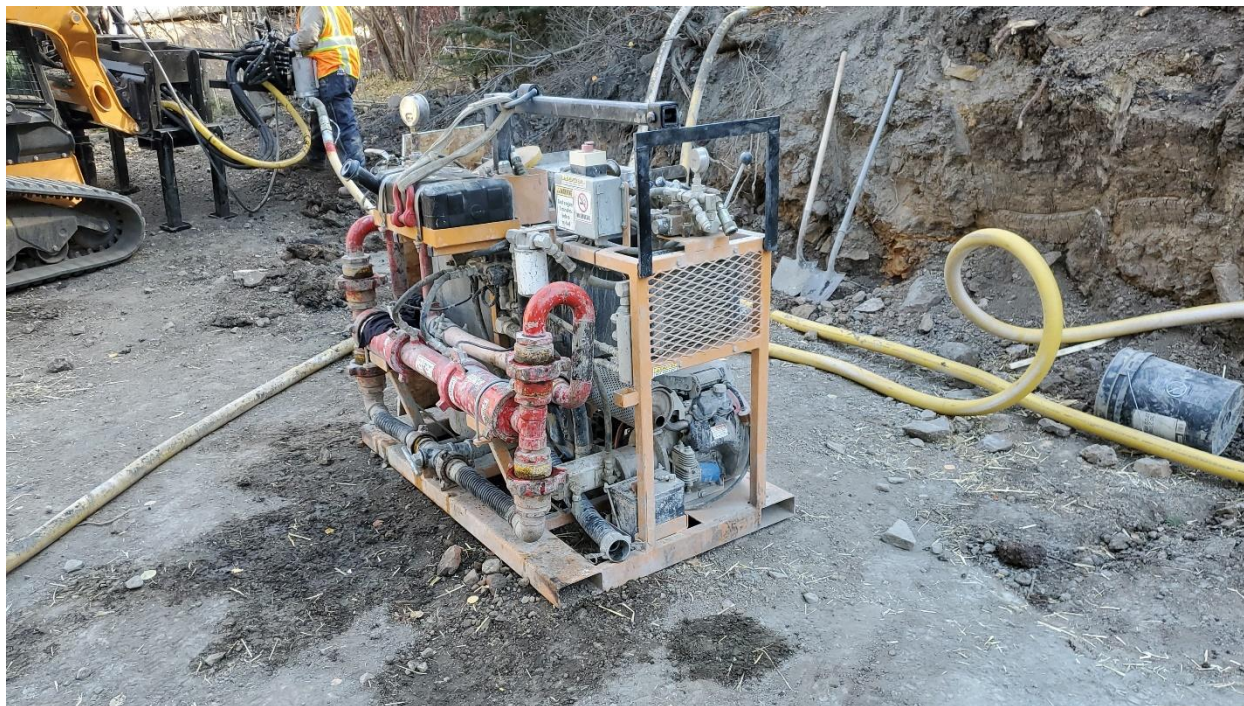
Figure 15: Grout pump

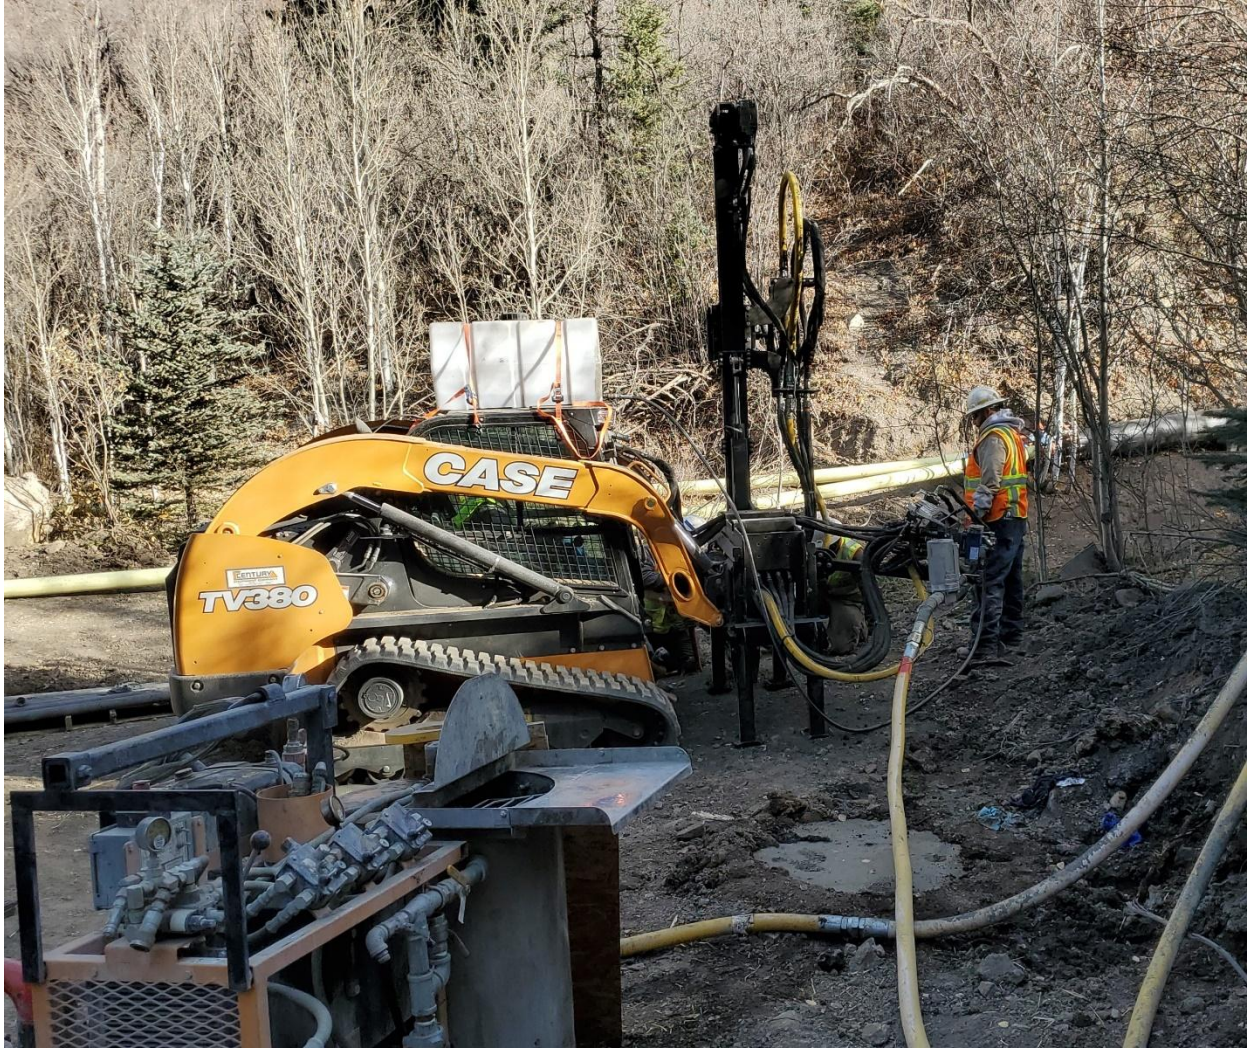
At the time of the inspection contractors with RACS, LLC. of Delta, CO were on site, with a small pneumatic drill rig mounted on a skid-steer. The drill rig was being used to construct holes to grout the backfilled material with the aim of reducing its permeability. The holes were being constructed using the "casing advance" technique, which is effective in unconsolidated material. A 5.5" casing is advanced in 5' lengths, with the drill stem inside of it. When the hole reaches consolidated material it is advanced a little further (8-12"), then the drill stem is withdrawn while the casing remains in place. The first section of casing is withdrawn and cement grout is poured into the hole with a bucket. This process is repeated until all of the casing has been removed and the hole is full of grout. At this point a steel plate with a pass-through port is placed over the hole and held down with the bucket of a back-hoe, the cement grout is then pressurized to approximately 150 psi using a grout pump, forcing it into the pore space of the fill material. The contractors were working on the second hole at the time of the inspection. Mr. Poulos expected that a total of 8-12 holes would be constructed in all and estimated that the total depth of the first hole was around 30' (thirty feet) and that it had been completed to the roof of the coal seam rather than the floor.

Figure 16: Skidsteer mounted drill rig, positioned over second hole. First hole visible in foreground.

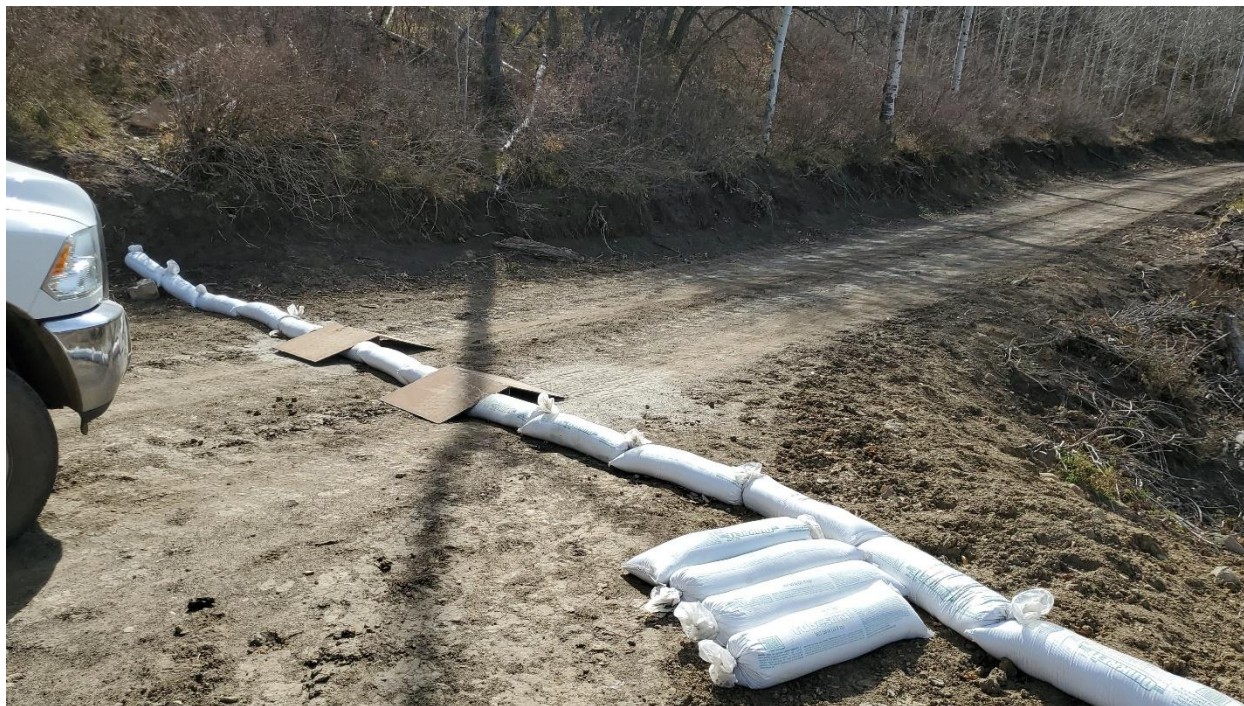
A row of sandbags had been placed for sediment control around the perimeters of the SS1 and SS2 pads. The use of sandbags to control runoff from the pads is not required by the mining permit (C1980007). Fresh straw bales for sediment control had been placed along the roads accessing the pads.

Figure 17: New sandbags for sediment control on SS1-1 pad (1)
