C1980007, West Elk Mine, October Inspection Report and NOV CV-2020-001

COLORADO
Division of Reclamation,
Mining and Safety
Department of Natural Resources

Permit Number: C-1980-007 Mine Name: West Elk Mine Operator: Mountain Coal Company, LLC Operator Address: Ms Kathleen G Welt 5174 Highway 133 Somerset, CO 81434	County: Delta, Gunnison Operation Type: Underground Permit Status: Active Ownership: Private
	Operator Representative Present: John Poulos, Kathy Welt
Operator Representative Signature: (Field Issuance Only)

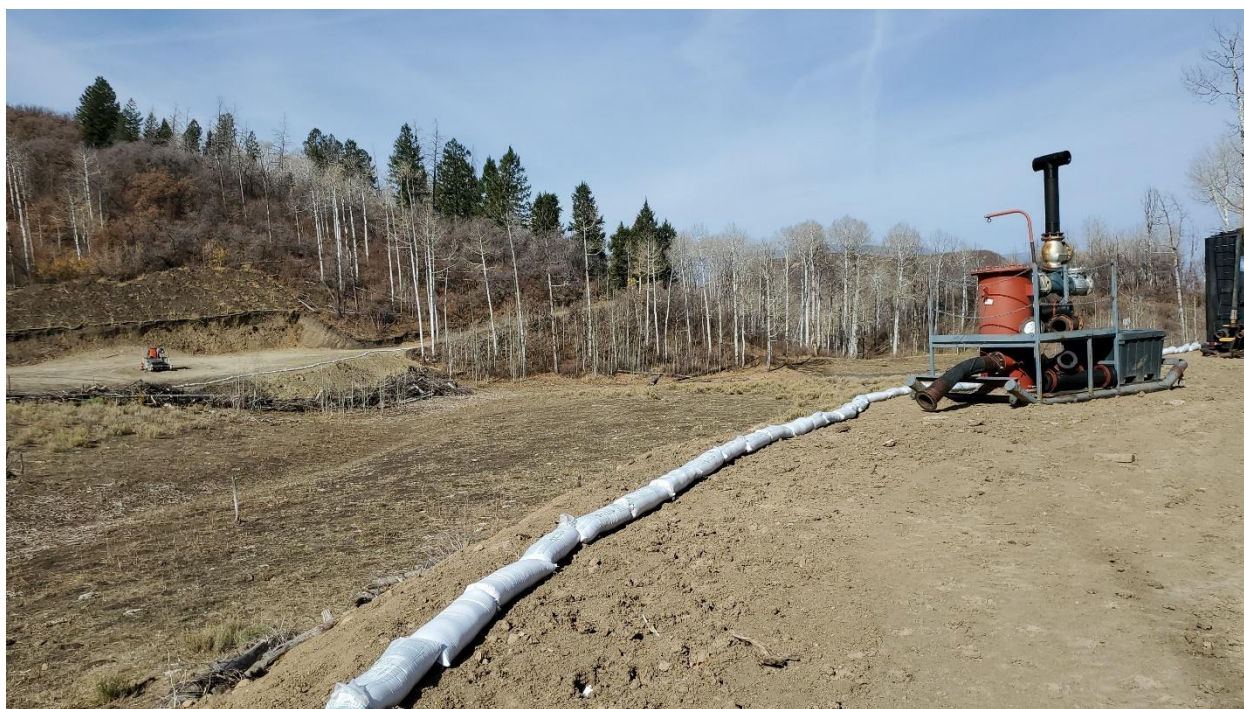
Figure 18: New sandbags for sediment control on SS1-1 pad (2)

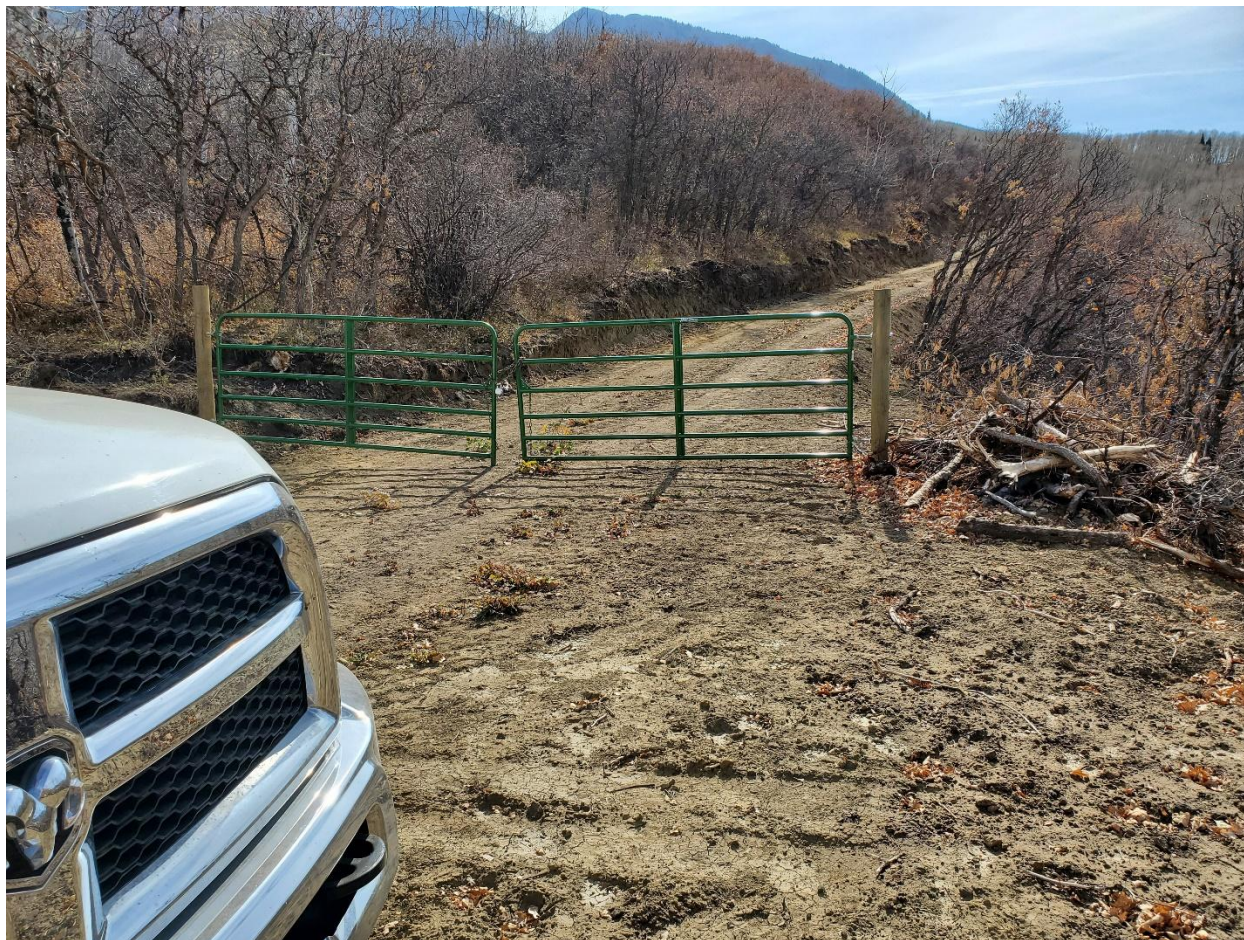
No recent work had taken place on the MVB pads, holes and roads for the SS2 panel and the gate remained locked.

Figure 19: Access to SS2 MVB pads still restricted by locked gate

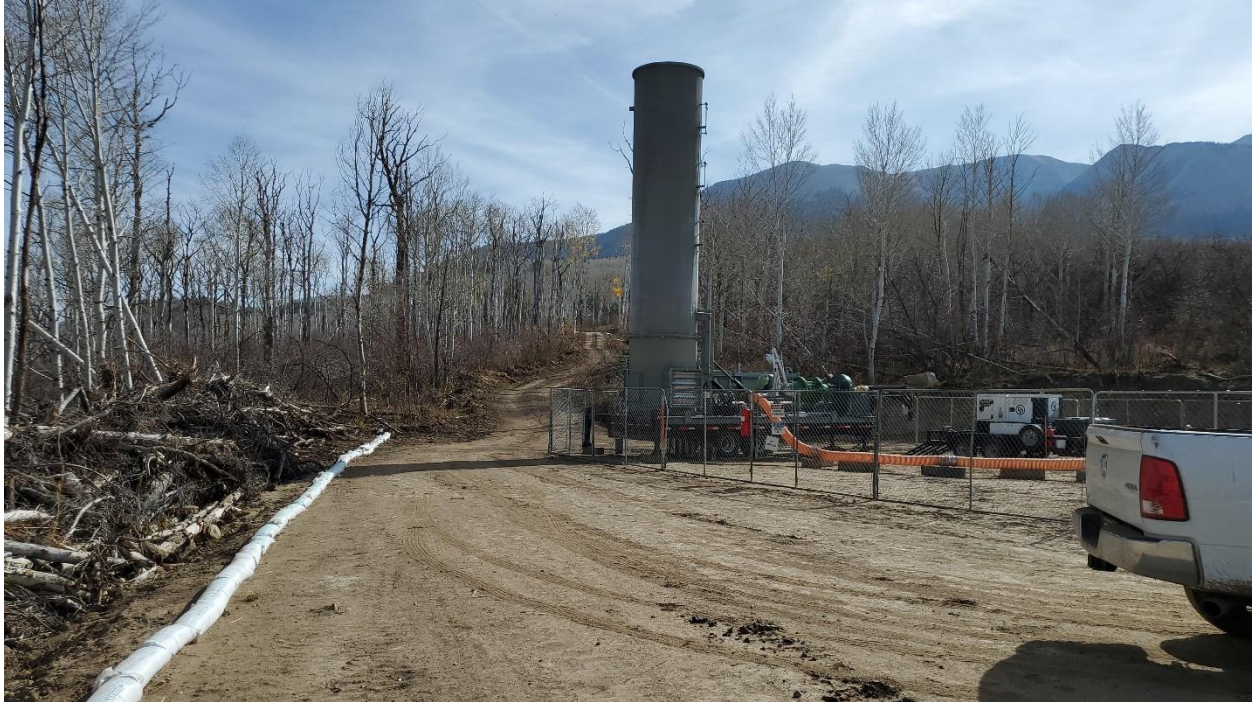
The mobile flare was in operation on the SS1-5 pad. Mr. Poulos was able to monitor the concentration of methane in the stream of gas coming from the borehole, its flow rate, and the temperature of the flame (to verify complete combustion), using his phone.

Figure 20: Mobile flare on SS1-5. Sandbags for sediment control shown

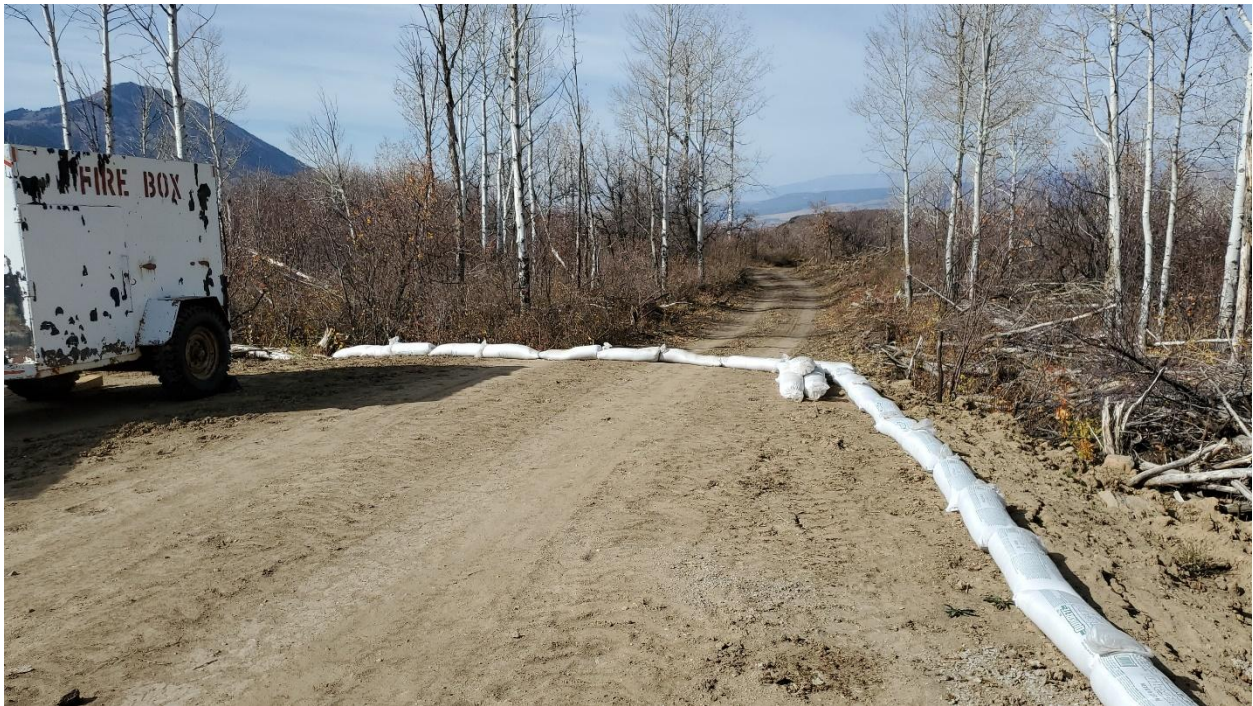
Figure 21: SS1-5 sediment control

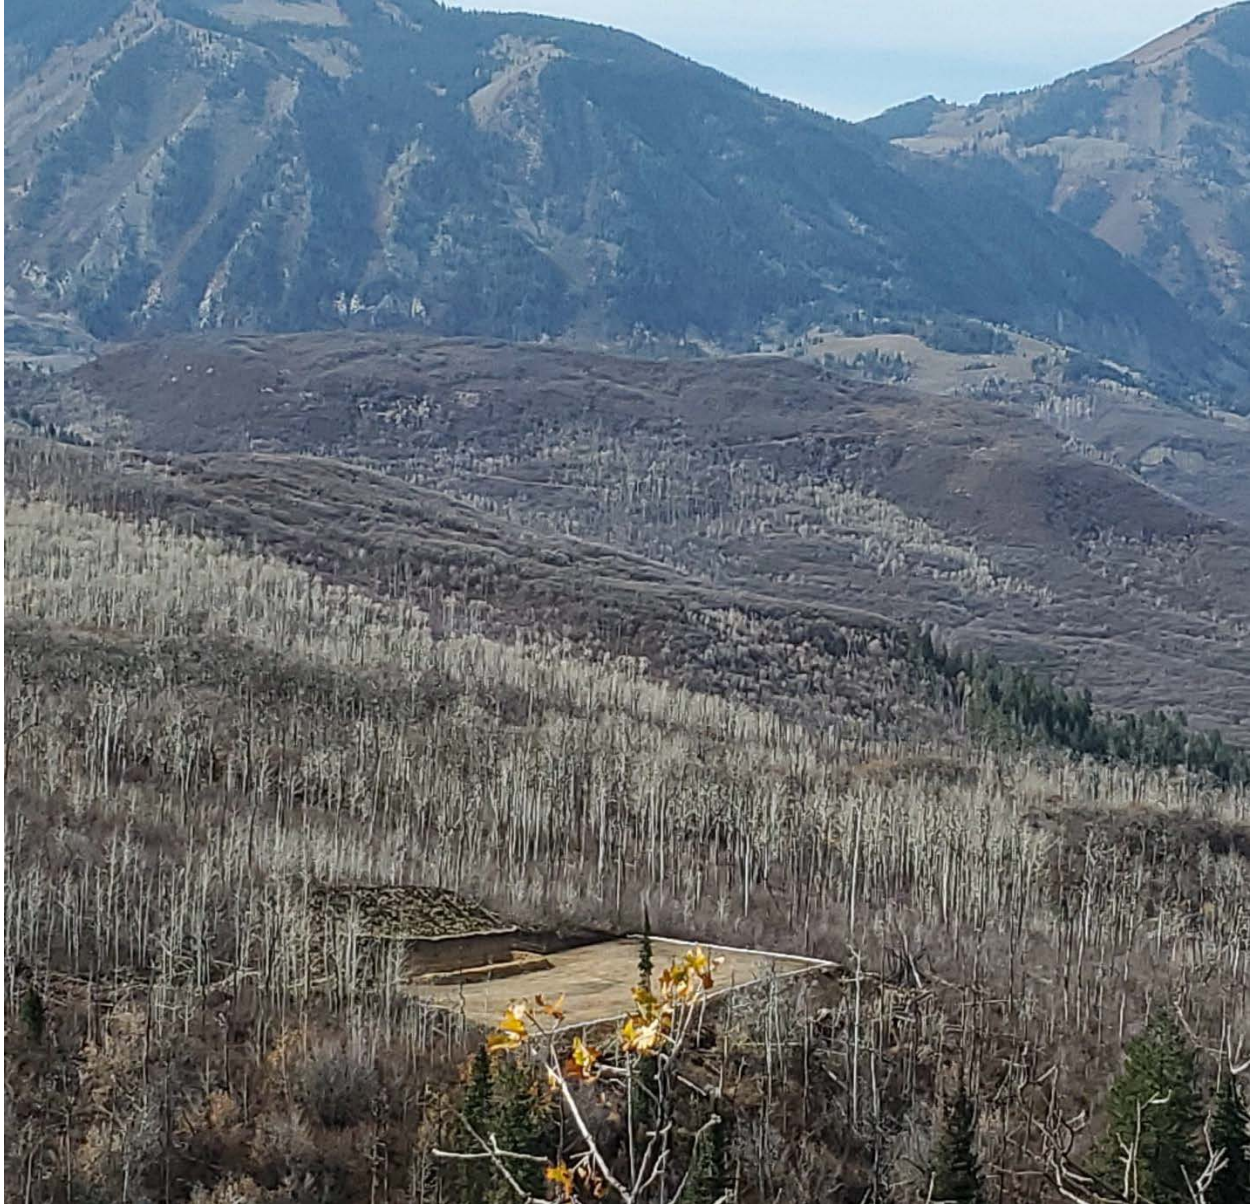
Figure 22: SS2-5 visible from SS1-5, sandbags for sediment control shown

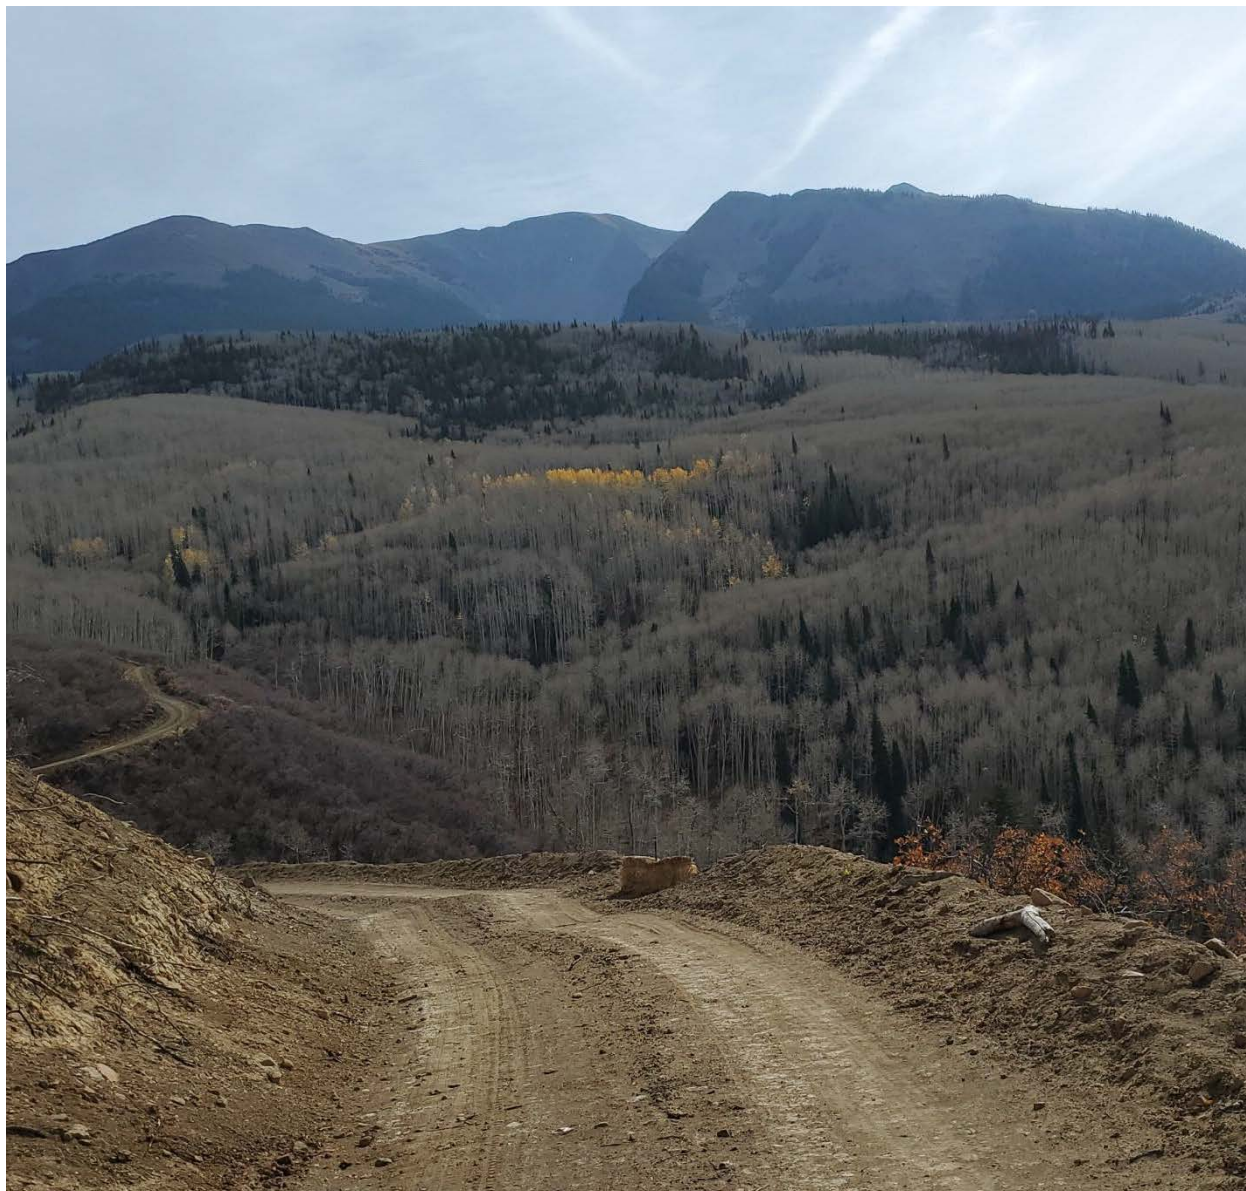
Figure 23: Refreshed straw bales for sediment control on SS1 road
