**MINERALS PROGRAM INSPECTION REPORT**  
**PHONE: (303) 866-3567**

<b>MINE NAME:</b> Sunnyside Gold Mine	<b>MINE/PROSPECTING ID#:</b> M-1977-378	<b>MINERAL:</b> Lead, zinc, copper, iron	<b>COUNTY:</b> San Juan
<b>INSPECTION TYPE:</b> Monitoring	<b>INSPECTOR(S):</b> Lucas West	<b>INSP. DATE:</b> October 6, 2020	<b>INSP. TIME:</b> 15:00
<b>OPERATOR:</b> Sunnyside Gold Corp	<b>OPERATOR REPRESENTATIVE:</b> Pat Maley, Terry Turner	<b>TYPE OF OPERATION:</b> 112 - Hard Rock Regular Operation	
<b>REASON FOR INSPECTION:</b> Normal I&E Program	<b>BOND CALCULATION TYPE:</b> None	<b>BOND AMOUNT:</b> \$60,534.00	
<b>DATE OF COMPLAINT:</b> NA	<b>POST INSP. CONTACTS:</b> None	<b>JOINT INSP. AGENCY:</b> None	
<b>WEATHER:</b> Clear	<b>INSPECTOR'S SIGNATURE:</b>

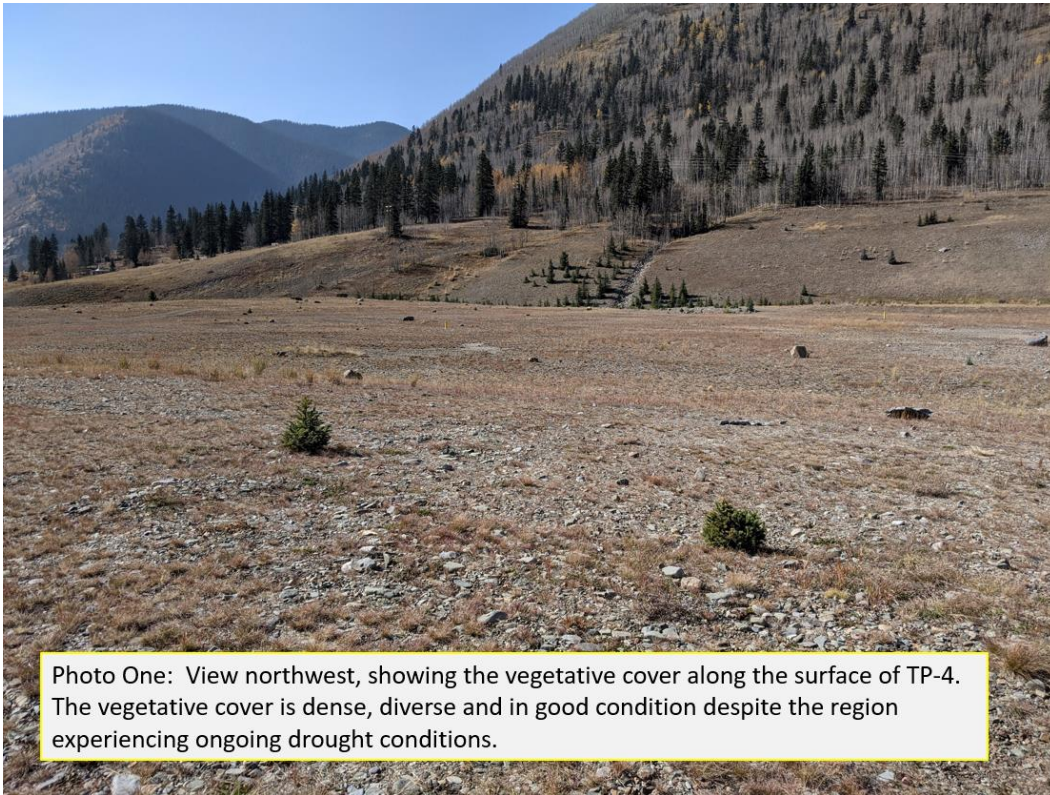
Photo One: View northwest, showing the vegetative cover along the surface of TP-4. The vegetative cover is dense, diverse and in good condition despite the region experiencing ongoing drought conditions.

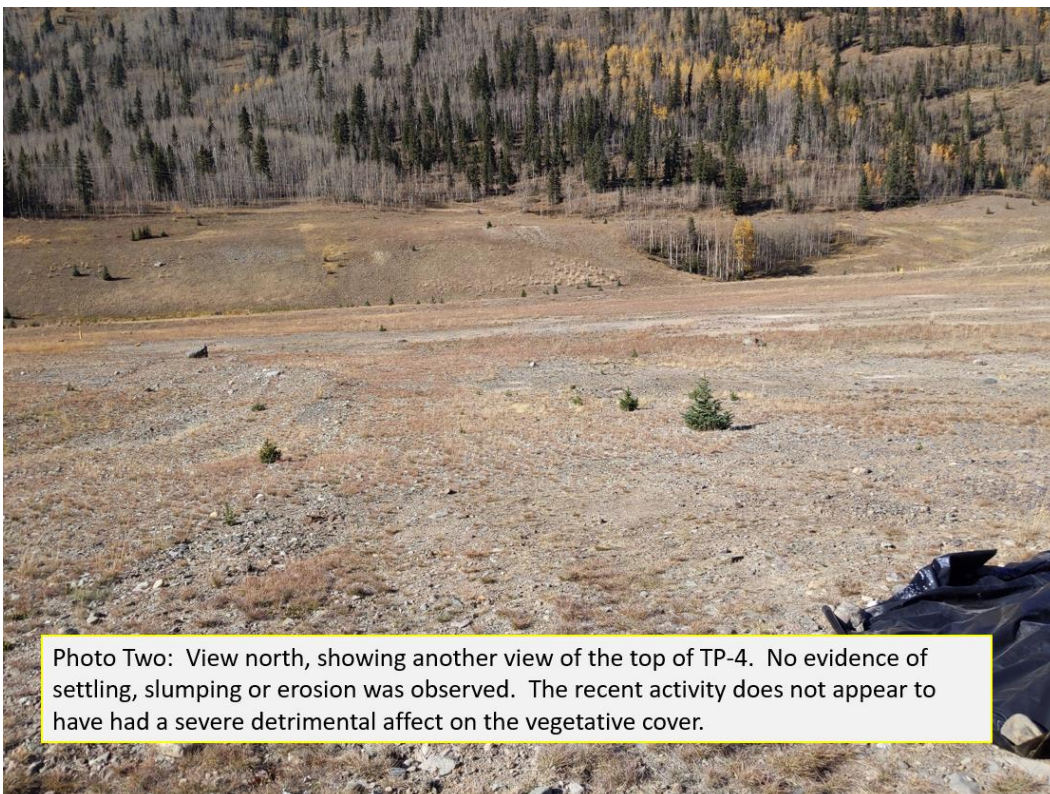
Proper mine identification signage was posted at the entrance to the site. Access to the site is controlled by a locked gate just off County Road 2. As a whole, the site is in similar condition to the previous inspections. The side slopes and top of the constructed repository were stable at the time of the inspection and are in good condition. Photos One and Two show the top of the repository which is well vegetated and showing signs of self-sustainment with previous years biomass observed. The vegetative cover on the top and side slopes of the facility is in excellent condition. The repository exhibits positive drainage and no impounded storm water or erosional issues were noted.

Photo Two: View north, showing another view of the top of TP-4. No evidence of settling, slumping or erosion was observed. The recent activity does not appear to have had a severe detrimental affect on the vegetative cover.

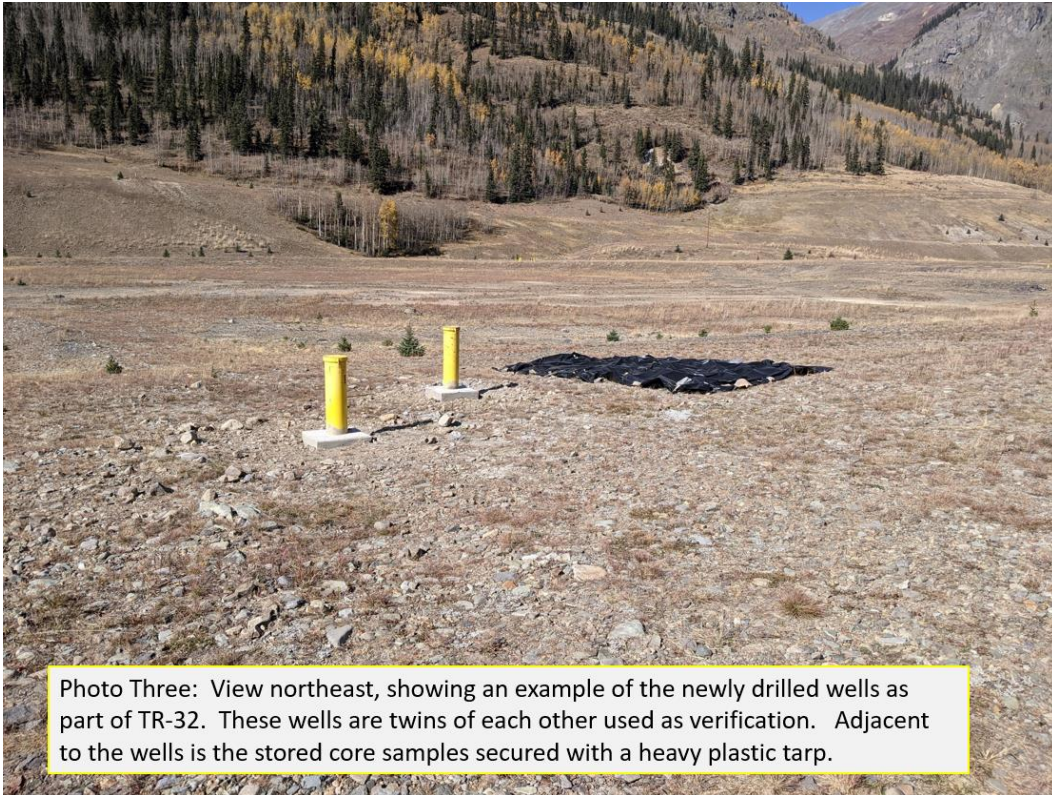
The recently approved TR-32 is for the installation of eight (8) monitoring wells around TP-4 to investigate groundwater quality, the potential for saturated basal tailings and act as continued groundwater monitoring wells. The eight wells consist of three new wells that will twin existing wells, two new wells to confirm existing data, two toe drain monitoring wells installed on the west and south sides of the facility and one completely new well located on the east end. Conversations with the Operator indicate that one more additional well may be required within the permit boundary. This may be submitted as an Addendum to TR-32 as the purpose and construction details are almost the exact same as the other wells completed under the Revision. An example of the twinned holes can be seen in Photo Three. All work that was conducted appears to be within the design specifications and locations described in TR-32. The core samples were still stored on the surface however were protected with a heavy plastic tarp.

Photo Three: View northeast, showing an example of the newly drilled wells as part of TR-32. These wells are twins of each other used as verification. Adjacent to the wells is the stored core samples secured with a heavy plastic tarp.
