MINERALS PROGRAM INSPECTION REPORT
PHONE: (303) 866-3567

MINE NAME: Cresson Project	MINE/PROSPECTING ID#: M-1980-244	MINERAL: Gold	COUNTY: Teller
INSPECTION TYPE: Monitoring	INSPECTOR(S): Patrick Lennberg	INSP. DATE: October 29, 2020	INSP. TIME: 08:30
OPERATOR: Cripple Creek & Victor Gold Mining Company	OPERATOR REPRESENTATIVE: Jeana Ratcliff	TYPE OF OPERATION: 112d-3 - Designated Mining Operation	
REASON FOR INSPECTION: Normal I&E Program	BOND CALCULATION TYPE: None	BOND AMOUNT: \$209,491,188.00	
DATE OF COMPLAINT: NA	POST INSP. CONTACTS: None	JOINT INSP. AGENCY: None	
WEATHER: Clear	INSPECTOR'S SIGNATURE:

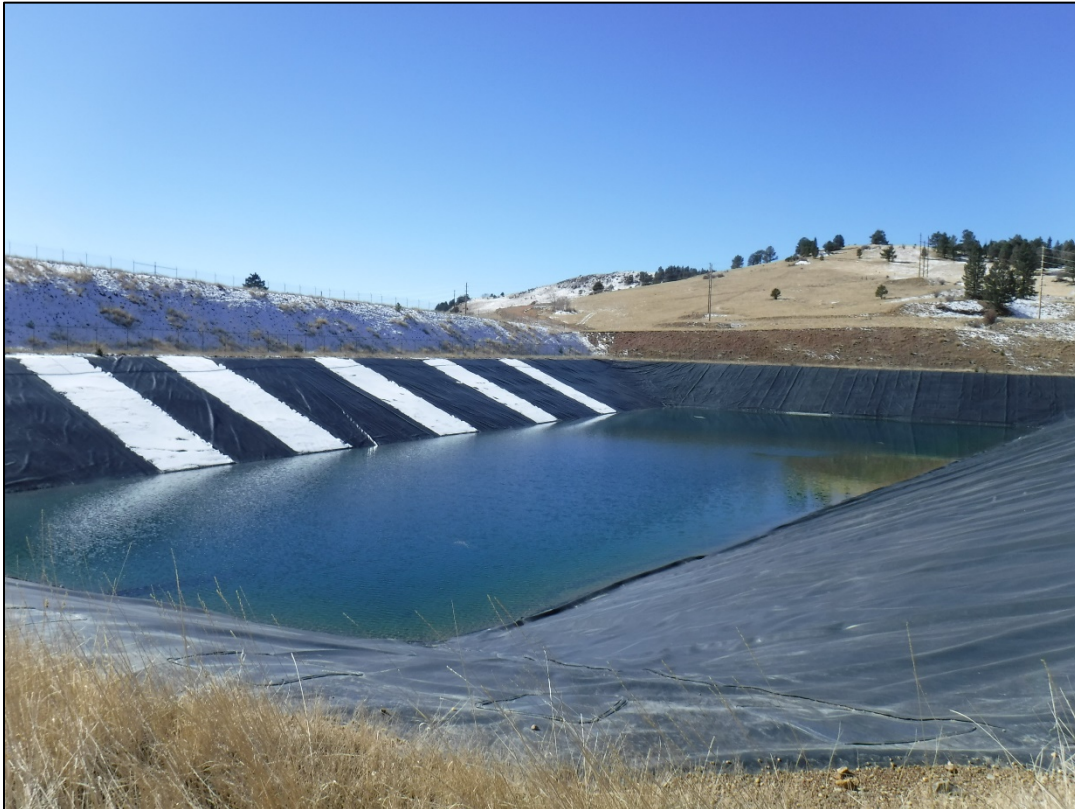
Photo 1: External Storage Pond area

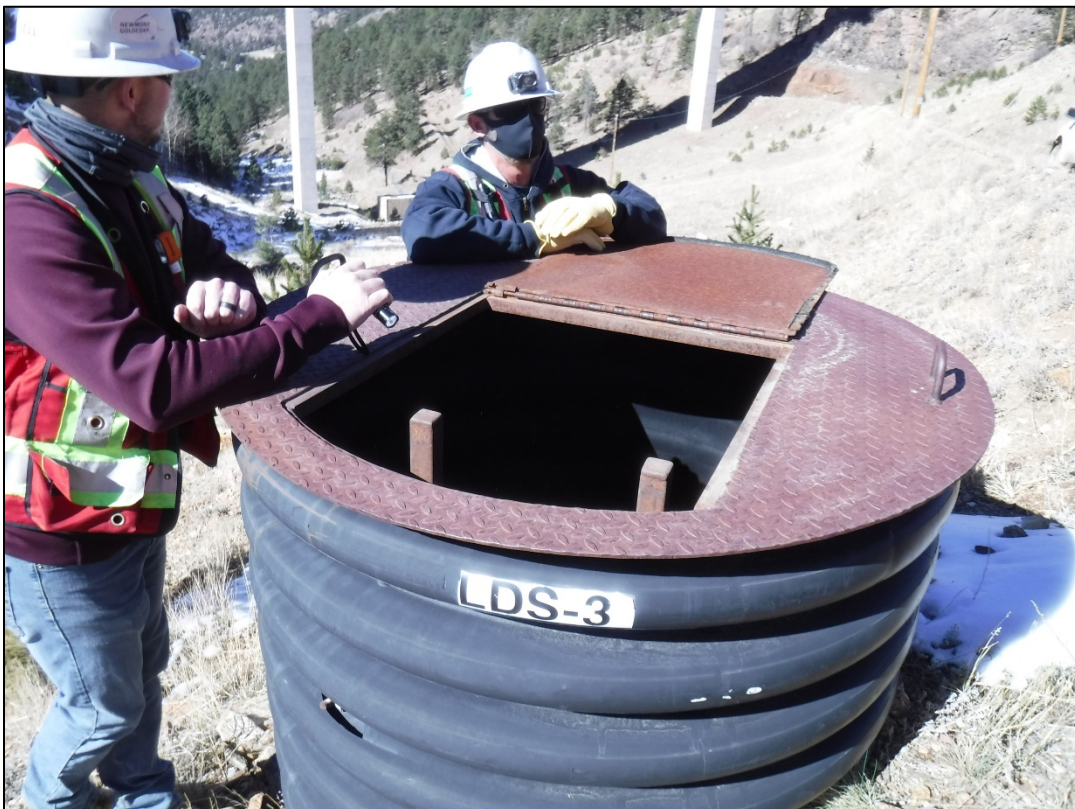
All 15 of the AGVLF Leak Detection System (LDS) sumps were inspected. All the sumps were found to be dry, except LDS-3 and 13. While the bottom of each sump did have water in it the buckets at the outfall of the leak detection piping were dry. Possible sources of the water in the bottom of the sumps are meteoric water entering the sump from poorly sealing lids and/or condensation resulting from the interaction of cold temperatures with humid ambient air. The operator must inspect all sumps weekly, and sample and characterize any water present. The operator is reminded any water in the sump should be removed after sampling so it can be determined if water continues to enter the sump.

Photo 2: Leak detection system (LDS) sump number 3

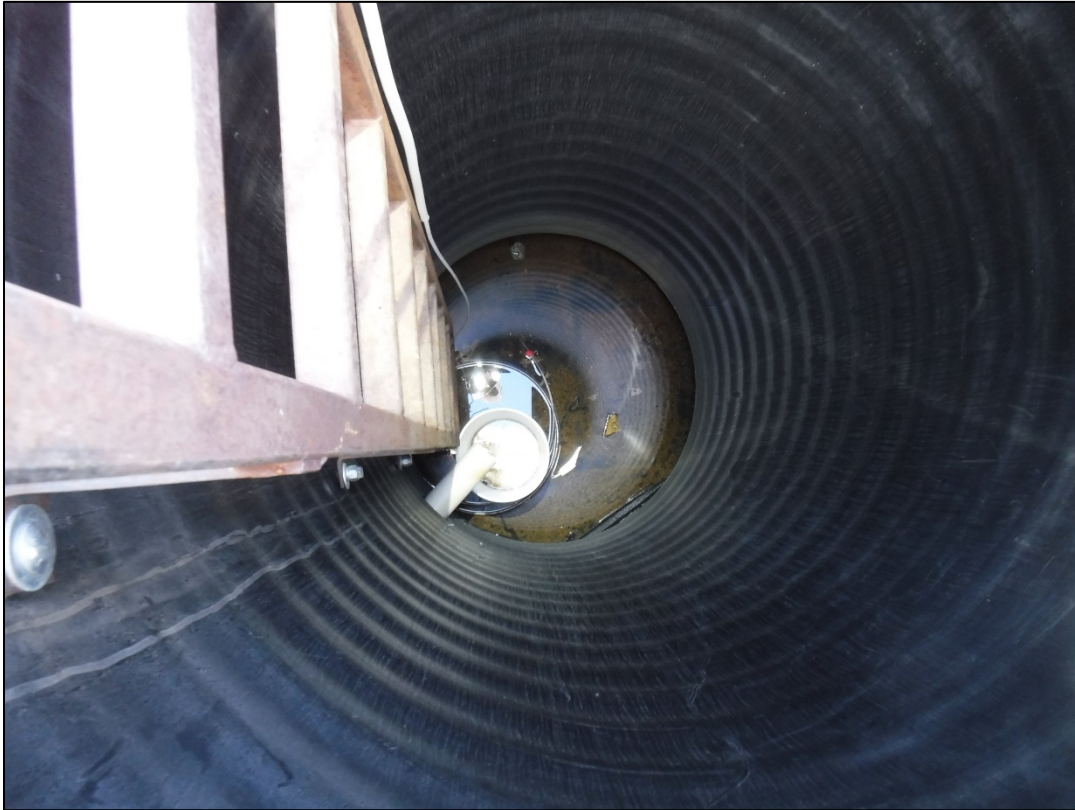
Photo 3: Inside LDS 3 note water in bottom of sump but bucket is dry

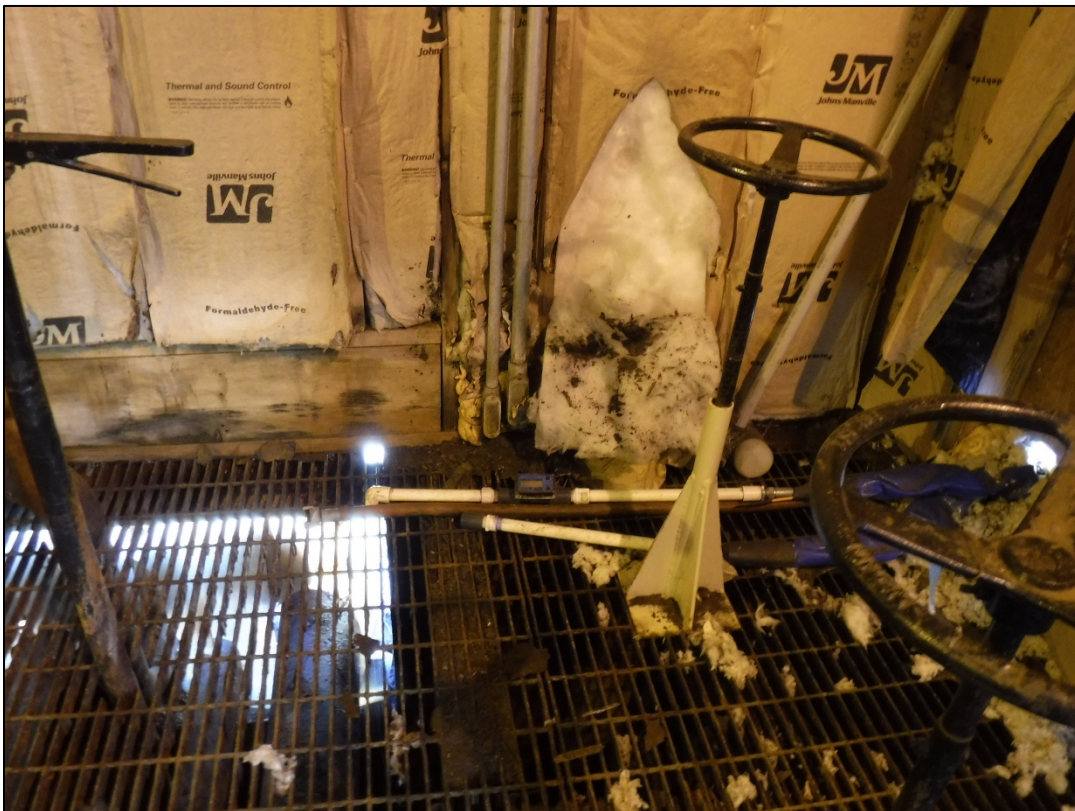
The pumpback system was observed. The ponds and basins associated the system were dry, a minor dusting of snow remained in the basins from a recent storm event. The structure over the pumpback system was being reinforced to protect from falling debris from the elevated highway overhead.

Photo 4: Inside of the pumpback shed

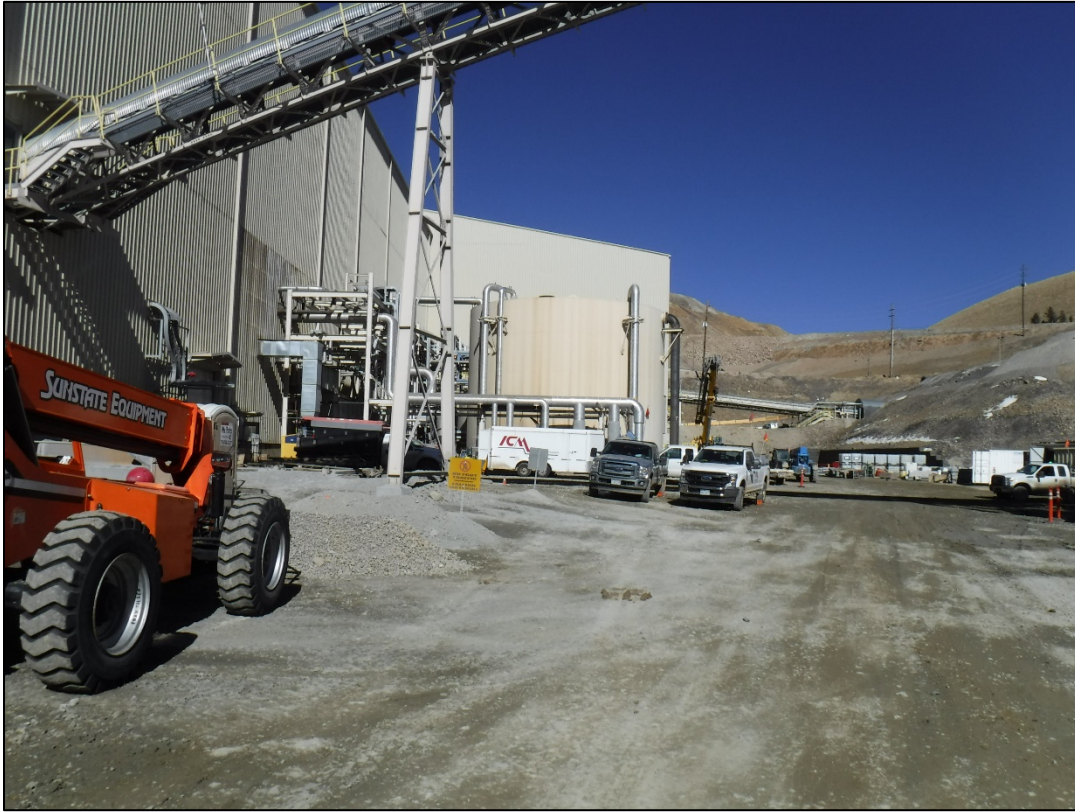
Photo 5: Crowded work area on the east side of the High Grade Mill

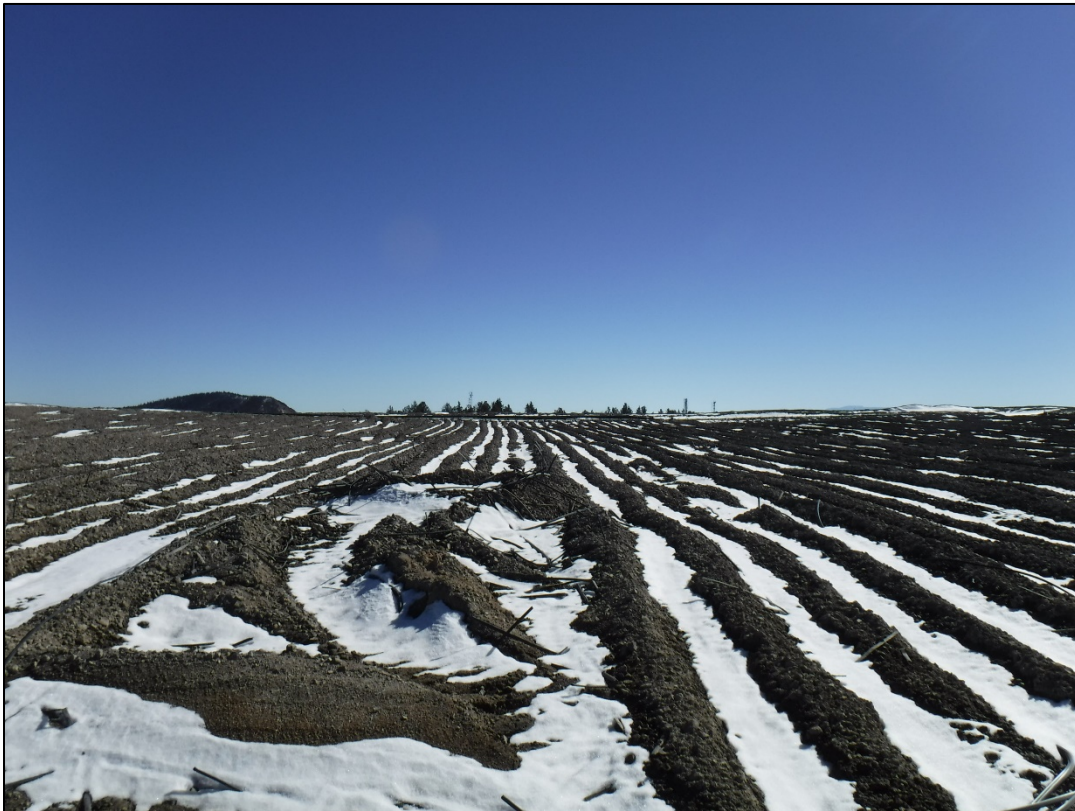
The current and maximum elevation of ore placement in the AGVLF is 10,400 feet (for Phase V). The Division inspected active leaching surfaces on the AGVLF. These surfaces were dry and no ponding of leachate, greater than 3 feet by 3 feet, was observed. The operator has moved away from surface leaching in favor of using injection wells as the weather has moved to winter conditions. There are a 143 injection wells at the site and at any given time there are three wells in operation. Similar conditions were observed on the 10,300 and 10,200 feet areas.

Photo 6: Top of the AGVLF 10,400 ft level, typical conditions, looking east

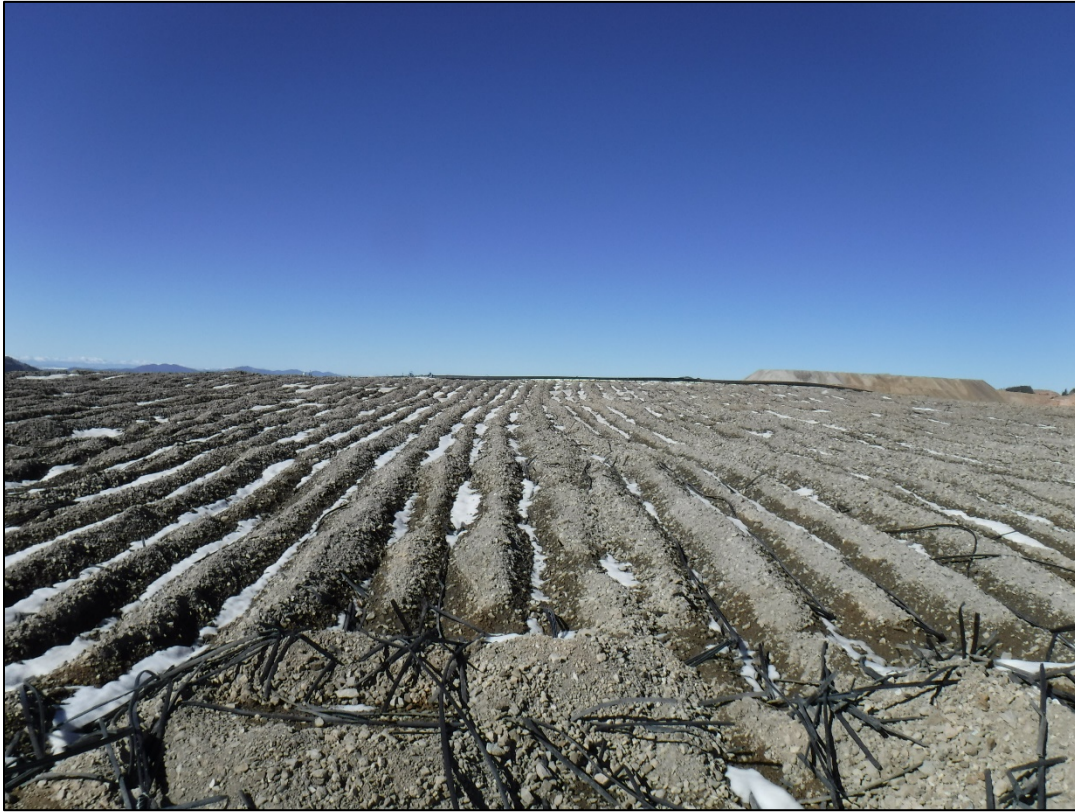
Photo 7: Top of the AGVLF 10,400 ft level, typical conditions, looking west

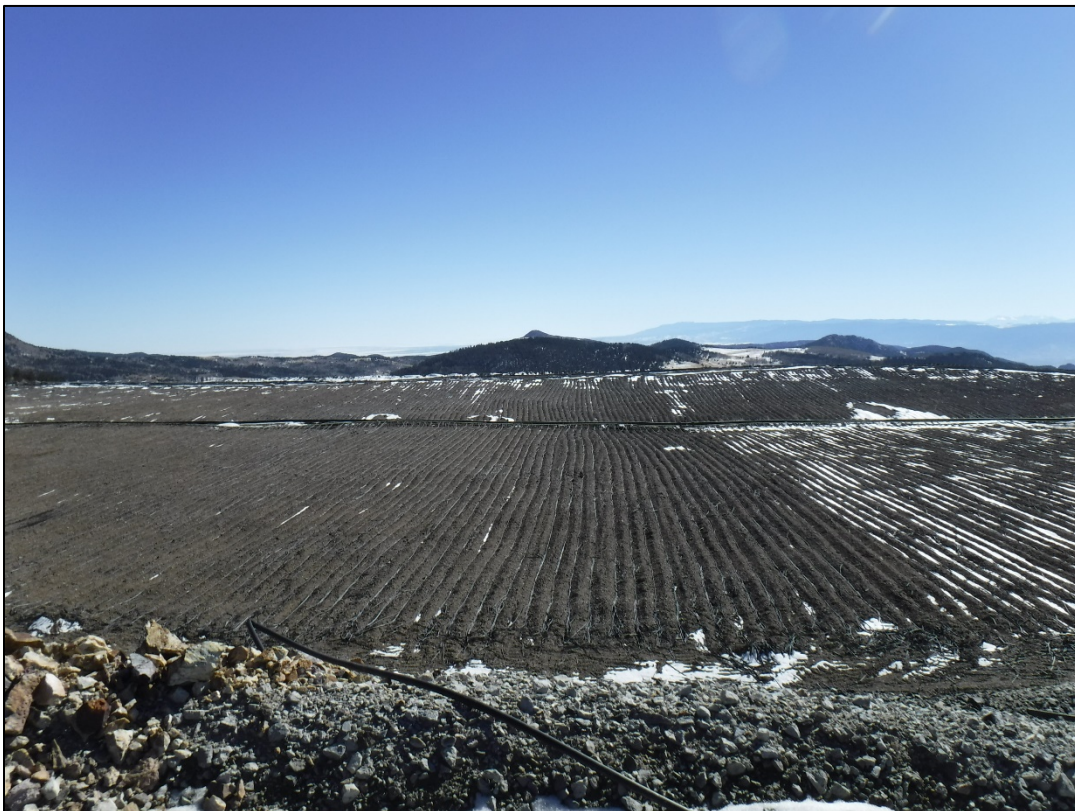
Photo 8: Top of the AGVLF 10,200 ft level, typical conditions, looking south

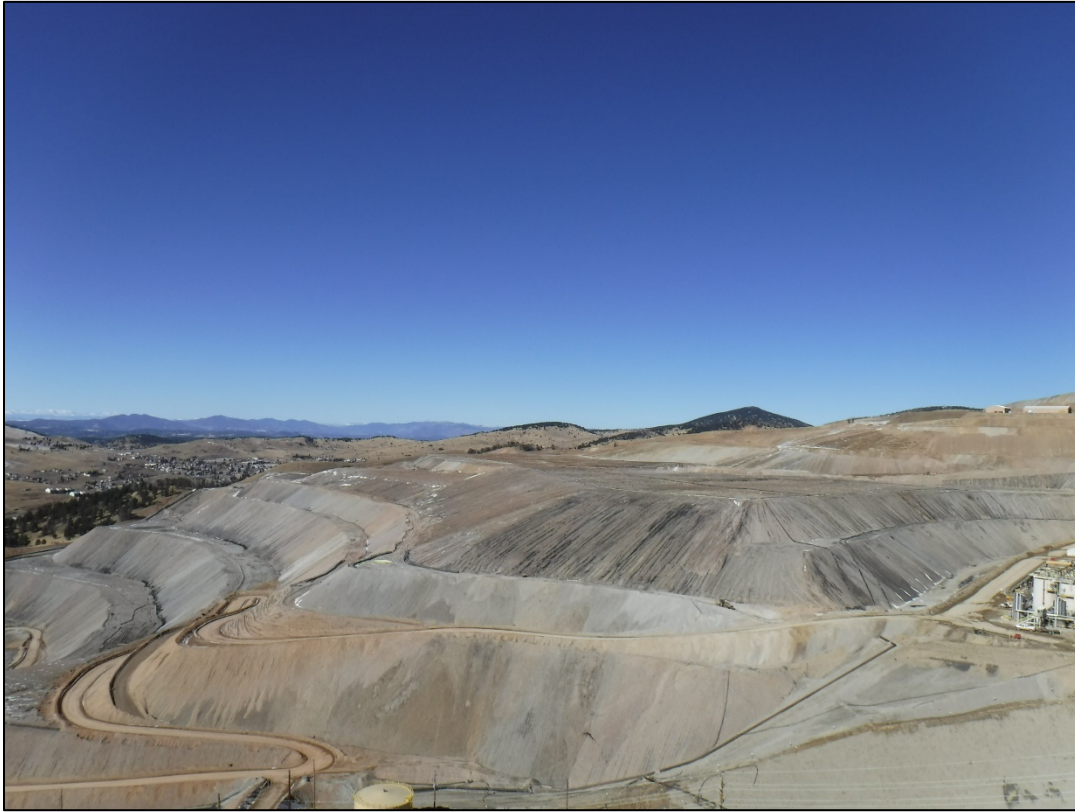
The operation is currently placing lifts with run of mine material mixed with cement material, which is dispensed directly into the truck beds from the relocated silo approved through TR-114. Run of mine material is ore material of sufficient quality that it can be leached without having to be crushed. Additionally, crushed material is also being placed in lifts. The Division inspected active leaching surfaces on the SGVLF. The operation is required to minimize ponding of leaching solution to less than 3 feet by 3 feet in area. This is to prevent the ponds from being a wildlife attractant. Active leaching areas appeared to be well-ripped to minimize ponding. No ponding was observed.

Photo 9: VLF 2 overlook area, no ponding visible at the time of inspection

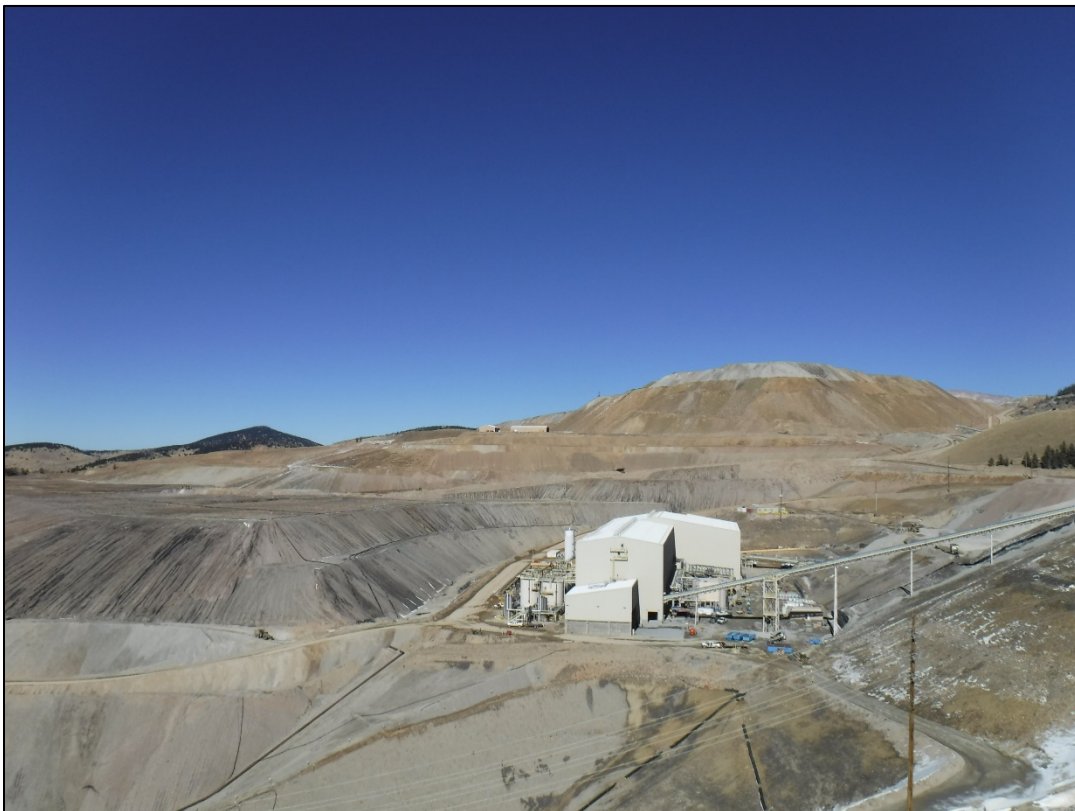
Photo 10: VLF 2 overlook area, overview of High Grade Mill and surrounding area

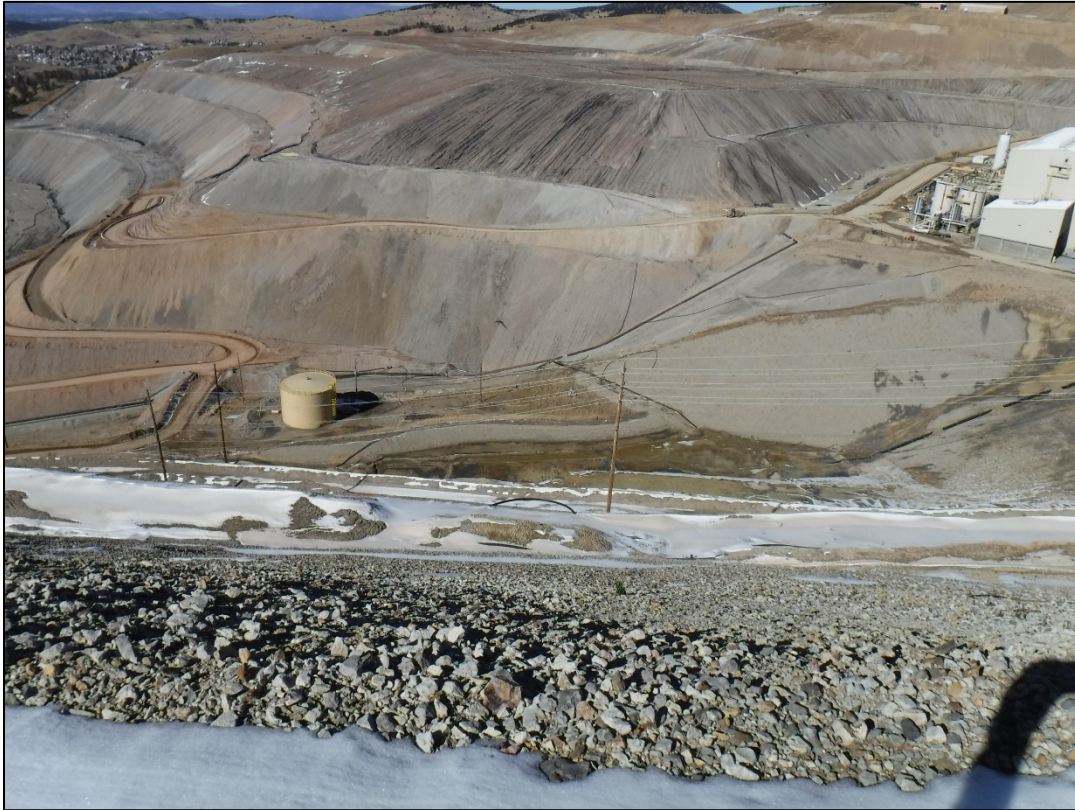
Photo 11: Water storage tank and elongated sump on VLF 1

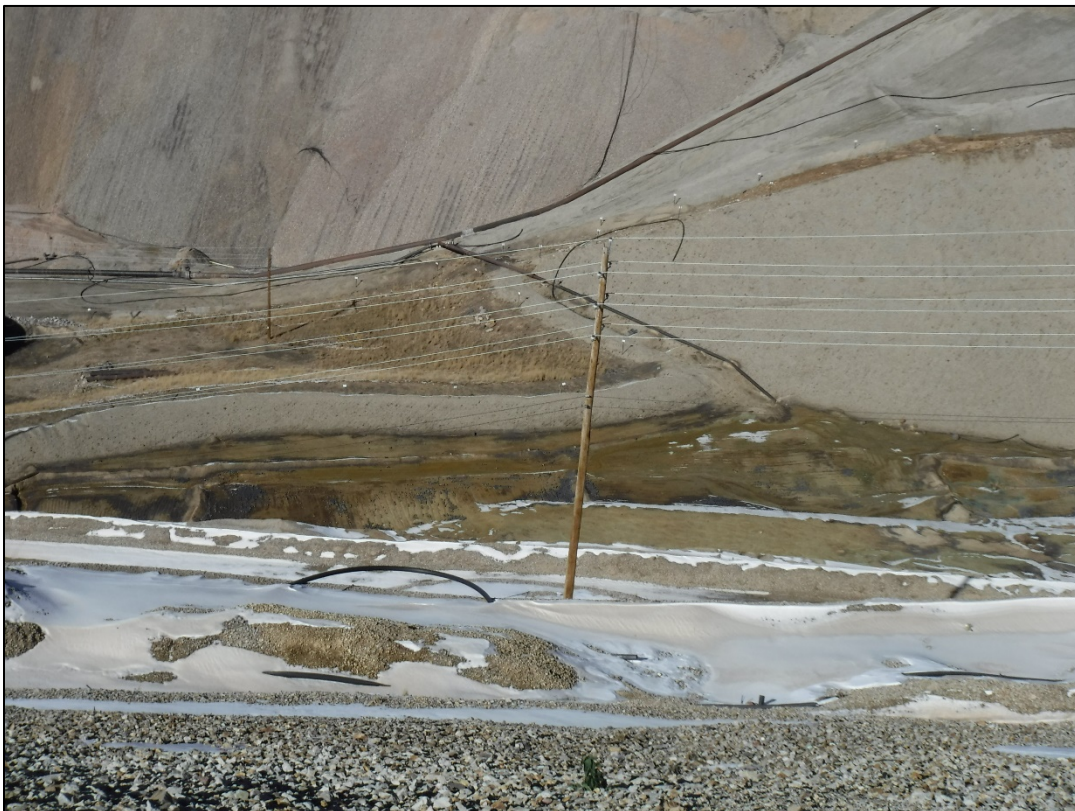
Photo 12: Close-up view of the dry sump.
