MINERALS PROGRAM INSPECTION REPORT
PHONE: (303) 866-3567

MINE NAME: Baseline Resource	MINE/PROSPECTING ID#: M-1997-058	MINERAL: Sand and gravel	COUNTY: Weld
INSPECTION TYPE: Monitoring	INSPECTOR(S): Eric Scott	INSP. DATE: November 16, 2020	INSP. TIME: 09:45
OPERATOR: Hall-Irwin Aggregates, LLC	OPERATOR REPRESENTATIVE: Ed Lafferty	TYPE OF OPERATION: 112c - Construction Regular Operation

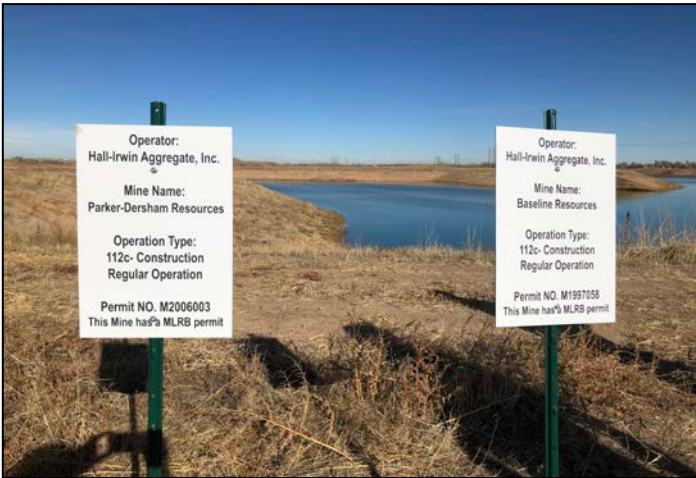
PROBLEM/POSSIBLE VIOLATION: Problem: Erosion gullies and ruts were observed on-site on the inner slopes of the lined reservoirs as shown in the attached photos. This is a problem at this time for failure to protect the affected land from erosion pursuant to C.R.S. 34-32.5-116 (4) (j).

- 1) Erosion gullies in the reclaimed slopes of the lined reservoirs will need to be repaired (photo 2)
- 2) Vegetation at the site at this time, although recently mowed, appears to be in generally poor condition and consists mainly of weeds and noxious species such as cheat-grass and Russian thistle. There are also several Russian olive trees that will need to be removed. The permittee will need to take aggressive action to eliminate noxious species and establish the approved reclamation vegetation.

CORRECTIVE ACTIONS: The operator shall provide photo documentation to the Division verifying erosion gullies and ruts have been repaired by the corrective action date.
