**MINERALS PROGRAM INSPECTION REPORT**  
**PHONE: (303) 866-3567**

<b>MINE NAME:</b> Cresson Project	<b>MINE/PROSPECTING ID#:</b> M-1980-244	<b>MINERAL:</b> Gold	<b>COUNTY:</b> Teller
<b>INSPECTION TYPE:</b> Monitoring	<b>INSPECTOR(S):</b> Timothy Cazier, P.E.	<b>INSP. DATE:</b> September 15, 2020	<b>INSP. TIME:</b> 09:30
<b>OPERATOR:</b> Cripple Creek & Victor Gold Mining Company	<b>OPERATOR REPRESENTATIVE:</b> Jeana Ratcliff	<b>TYPE OF OPERATION:</b> 112d-3 - Designated Mining Operation	
<b>REASON FOR INSPECTION:</b> Normal I&E Program	<b>BOND CALCULATION TYPE:</b> None	<b>BOND AMOUNT:</b> \$209,491,188.00	
<b>DATE OF COMPLAINT:</b> NA	<b>POST INSP. CONTACTS:</b> None	<b>JOINT INSP. AGENCY:</b> None	
<b>WEATHER:</b> Clear	<b>INSPECTOR'S SIGNATURE:</b>

<b>SIGNATURE DATE:</b> November 18, 2020

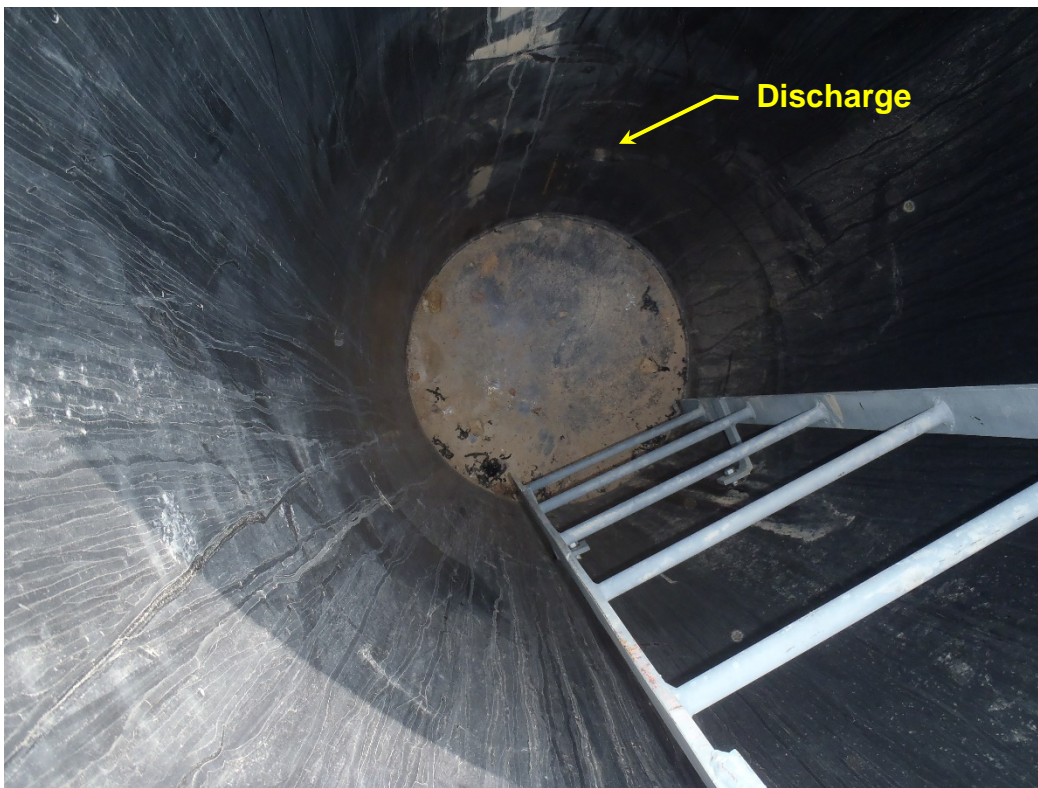
All three of the VLF2 Leak Detection System (LDS) sumps were inspected. All the sumps were found to be dry (see **Photo 1**). Subsequent to the DRMS' October inspection of the VLF 1 LDS sumps, this inspector was reminded of the buckets installed in those sumps to aid in collecting potential leak water. None of the three VLF 2 sumps had buckets suspended below the LDS pipe discharge points in their respective sumps. [The DRMS recommends buckets be installed in the VLF 2 sumps in a fashion similar to those associated with VLF 1 sumps.](#)

Photo 1. VLF 2, LDS-1 sump – dry (note lack of bucket below LDS pipe discharge).

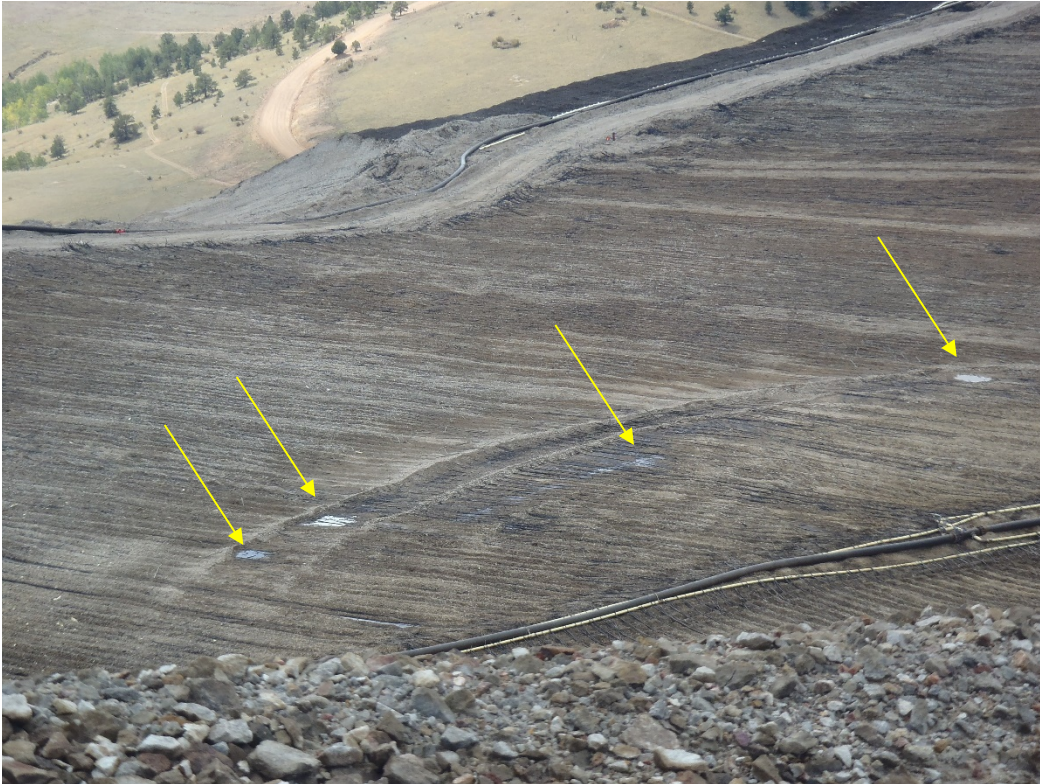
Aregua Gulch Valley Leach Facility (VLF 1): Messrs. Dylan Noble and Laurin Colby accompanied the DRMS to VLF 1. VLF 1 was checked for solution ponding limits based on the approved wildlife protection plan limiting ponding to areas less than 3 feet by 3 feet. Observations of the 10,200 level showed some areas that appeared to likely be exceeding the 3' x 3' limit (see **Photo 2**), but otherwise appeared to be well ripped to enhance infiltration and reduce ponding. Mr. Colby contacted CC&V Operations to coordinate mitigation. The 10,300 level also appeared well ripped. However, some maintenance was being performed at the time this level was observed. The maintenance required the distribution pipe be flushed, resulting in temporary ponding according to Mr. Colby (see **Photo 3**). The 10,400 level was observed to be well-ripped and no ponding was observed on this level (see **Photo 4**).

Photo 2. VLF 1, Level 10,200 ponding possibly > 3ft x 3ft.

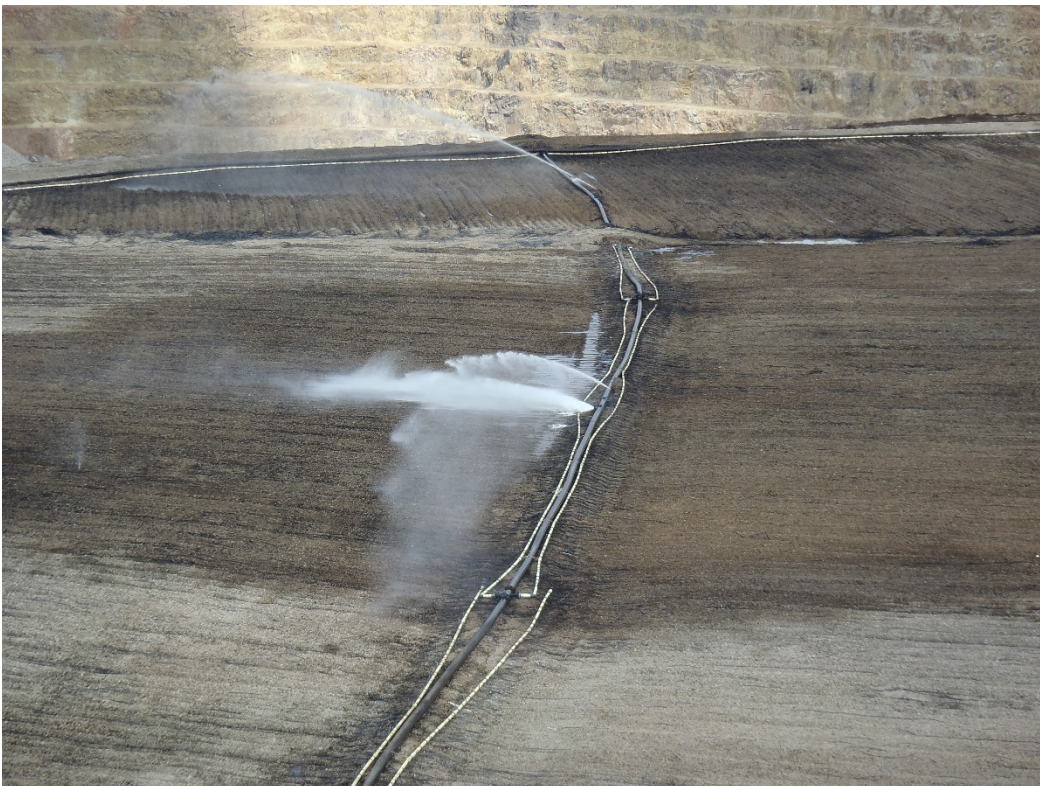
Photo 3. VLF 1, Level 10,300 ponding – temporary due to flushing required by maintenance.

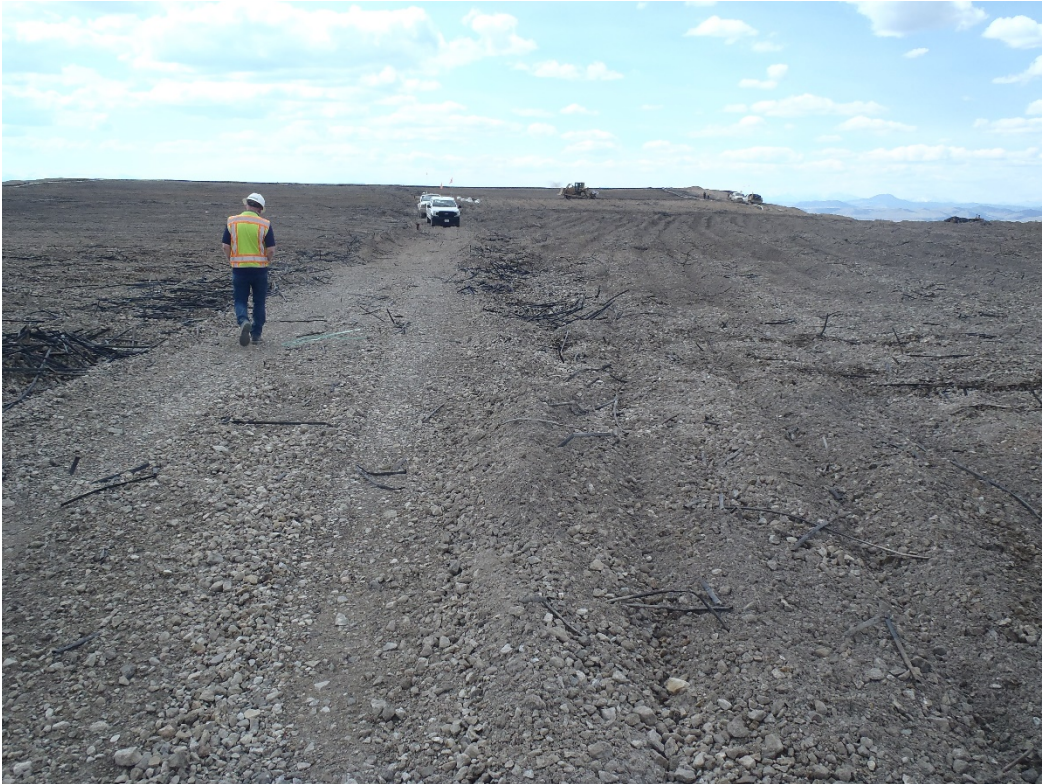
Photo 4. VLF 1, Level 10,400 – no ponding (looking west).

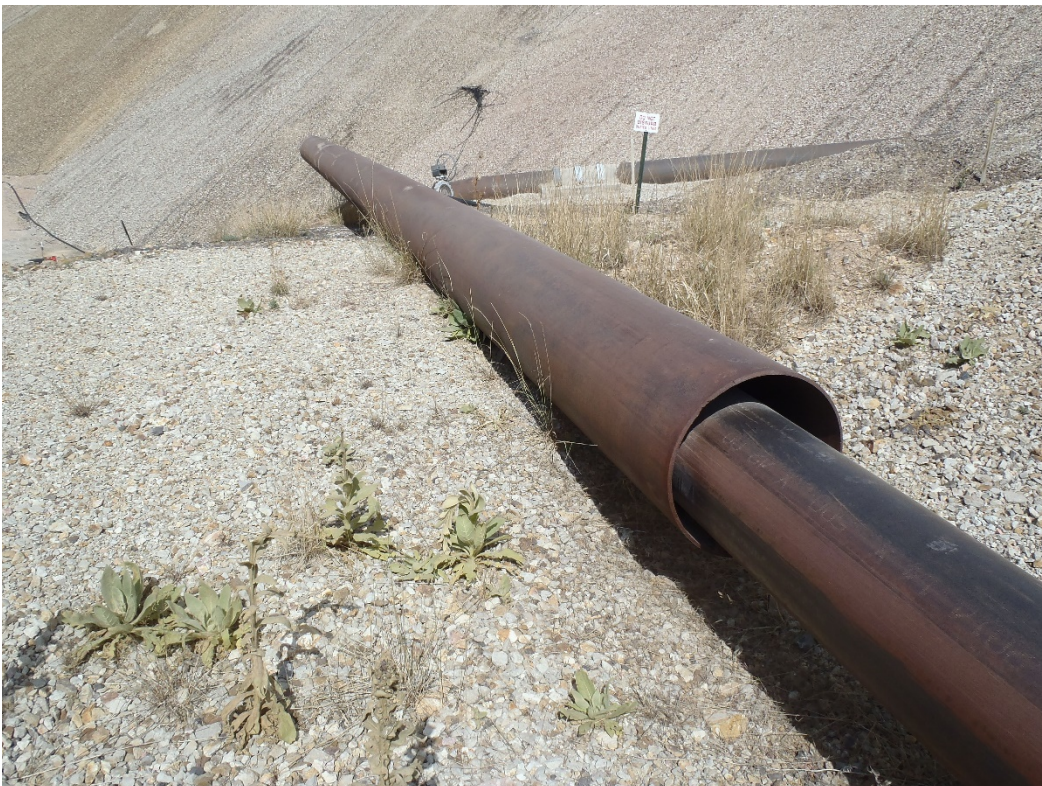
Off liner dual containment process solution pipe: The header pipe between VLF 1 and VLF 2 crosses a short unlined area (see **Photo 5**). This short segment has a dual pipe to capture and divert any leaking solution onto the lined area. No signs of leakage were observed in the dual pipe area.

Photo 5. Dual containment pipe between VLF 1 and VLF 2 lined areas (looking NW).

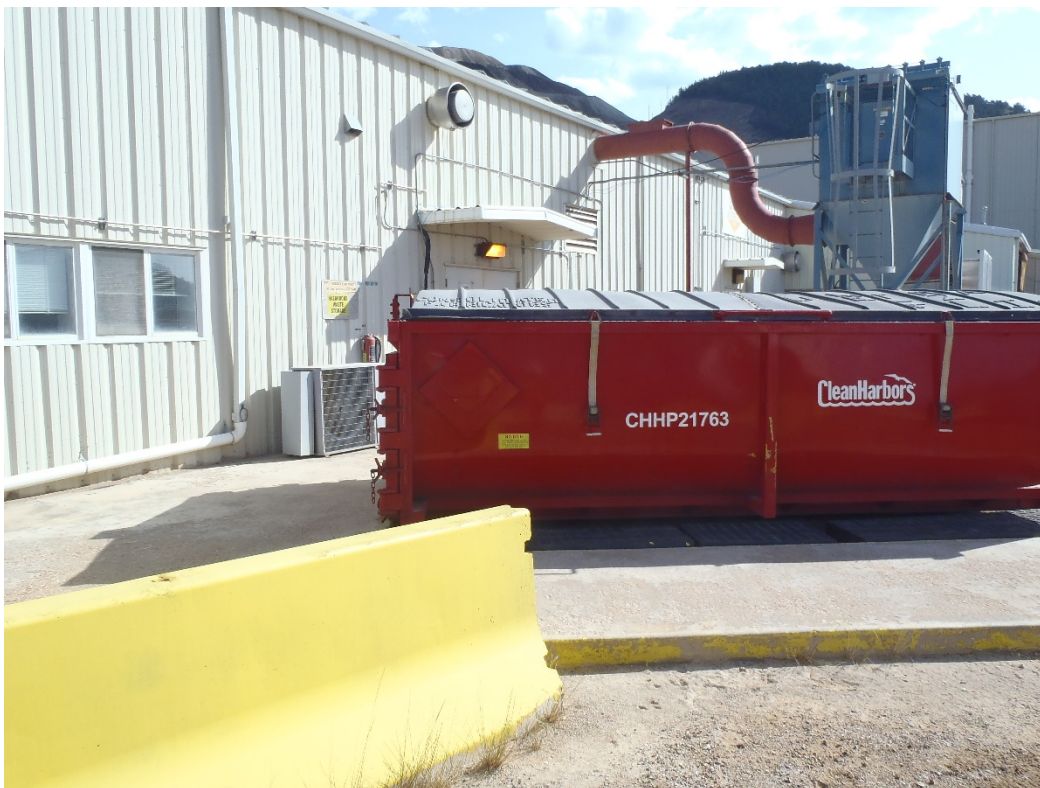
Assay/Process Lab: Messrs. Dylan Noble and Tim Lamere accompanied the DRMS on the Carlton Assay/Process Lab exterior walk-around inspection. The purpose was to perform a visual inspection for leaks, spills and secondary containment problems. CC&V is considered a large quantity generator of lead waste. A Clean Harbors roll-off container was observed on the south side of the building for temporary storage of this waste (see **Photo 6**). Site representatives stated Clean Harbors is on a 60-day cycle for transporting this material off-site. Multiple containers ranging from 5-gallon buckets to 55-gallon drums were observed (see **Photo 7**) outside the building. All appeared to be sealed and labeled. Super sacks containing spent carbon were observed on the northeast corner of the building (see **Photo 8**). Stormwater controls and piping were observed directing runoff towards the VLF 1 lined area north of the building (see **Photo 9**). No signs of spilled material were observed.

Photo 6. Clean Harbors roll off bin at Assay Lab for large quantity generators.

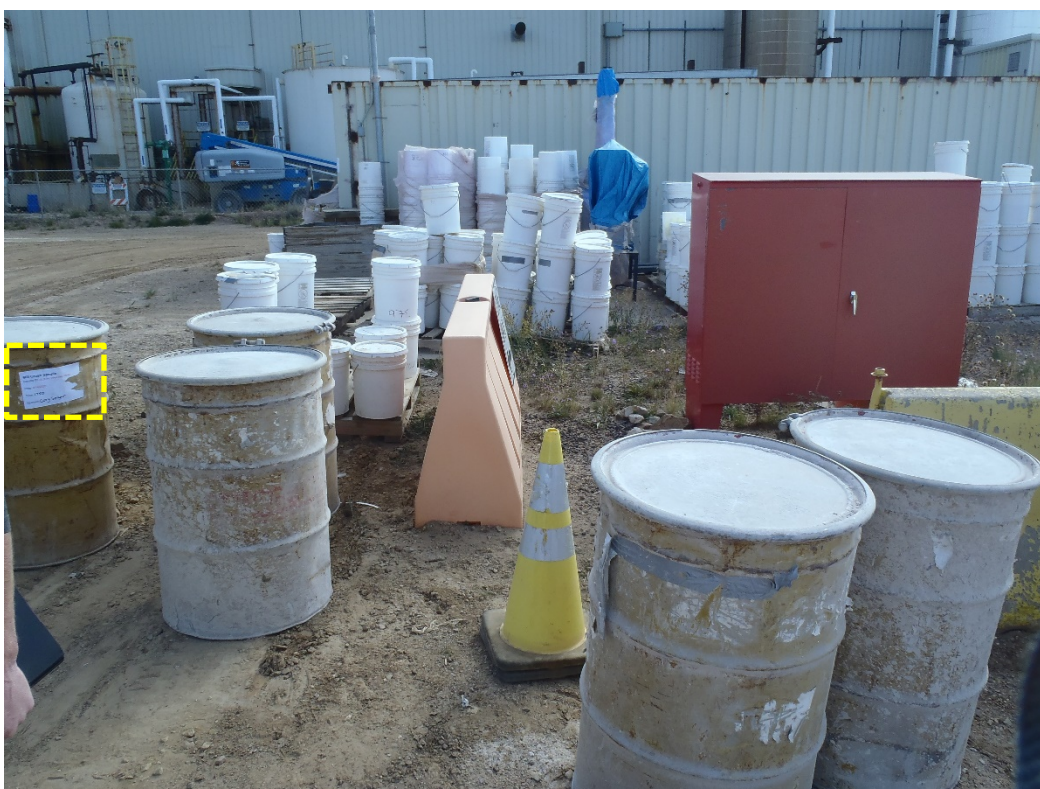
Photo 7. Sealed sample containers outside Assay Lab: 5-gallon buckets to 55-gallon drums (note typical label).

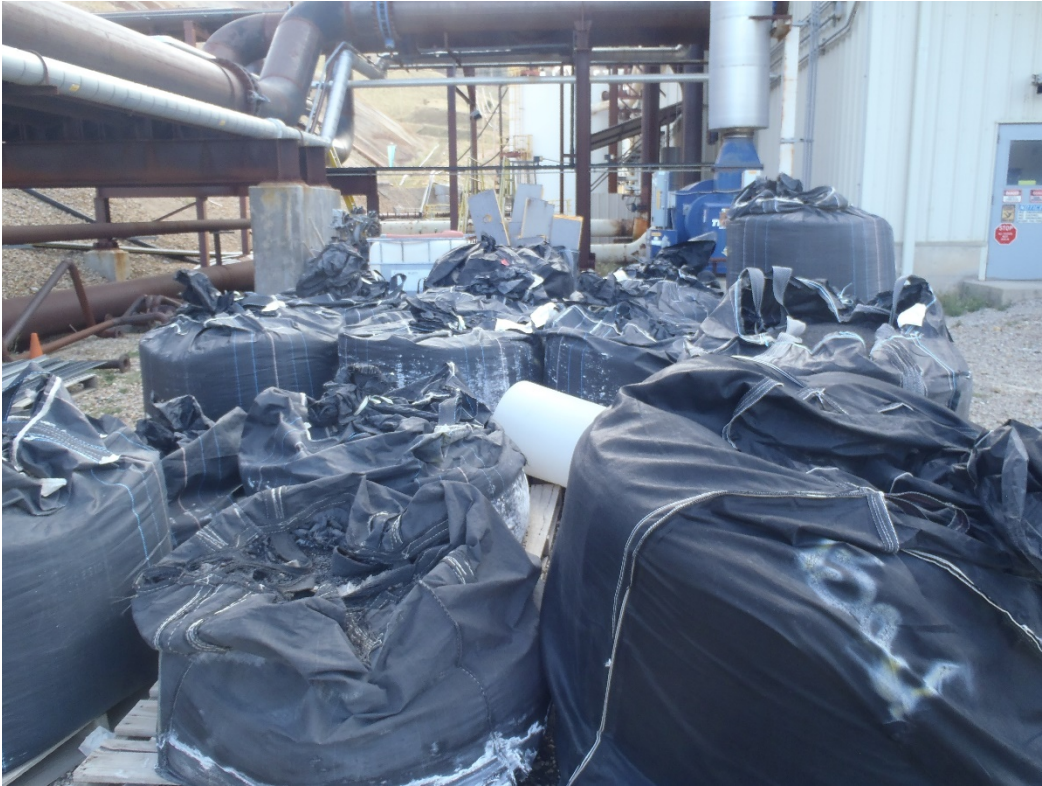
Photo 8. Super sacks containing spent carbon (NE corner of Assay Lab).

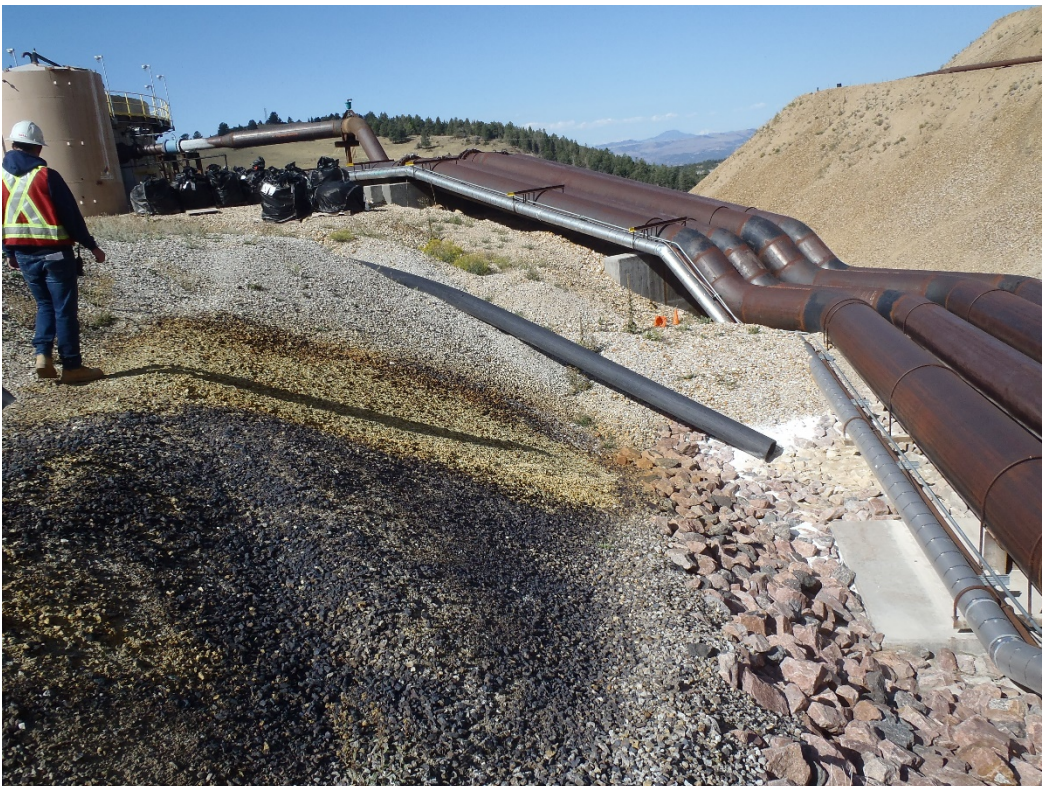
Photo 9. Stormwater discharge pipe to VLF 1 lined area (NW corner of Assay Lab).

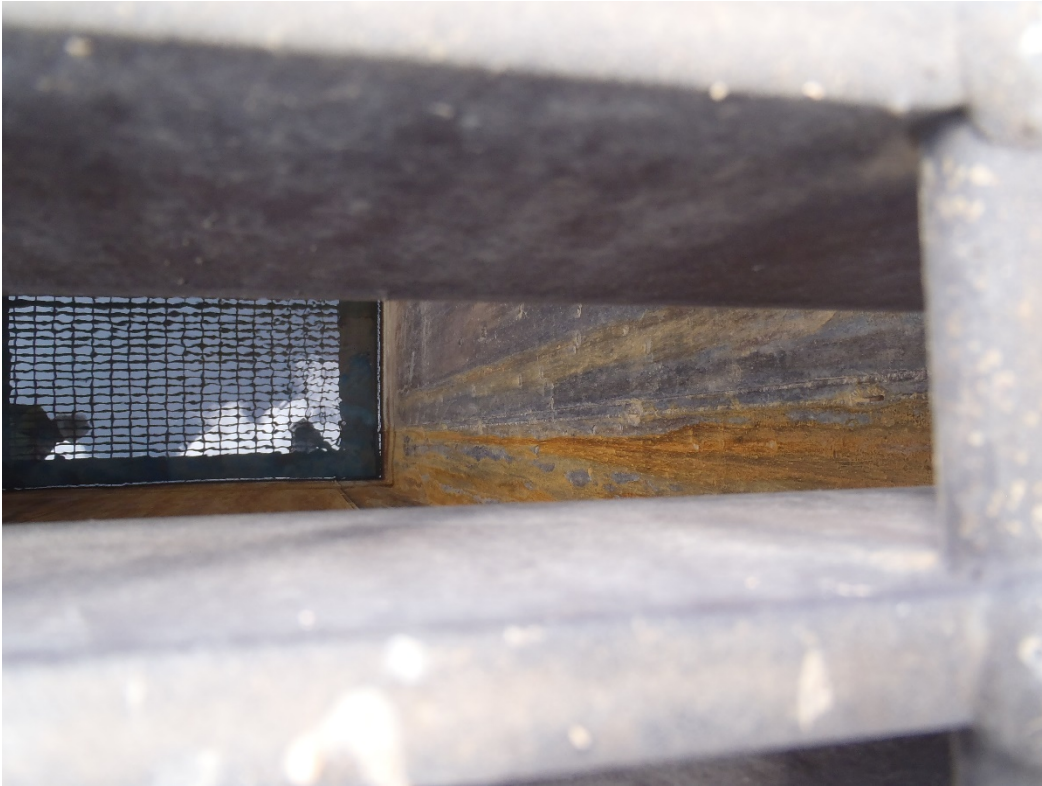
High Grade Mill: Mr. Andrew Orser accompanied the DRMS on the mill exterior walk-around inspection. The purpose was to perform a visual inspection for leaks, spills and secondary containment problems. Both the east and west sides of the mill exterior were inspected, as well as the area around the concentrate storage facility (Con Barn). Both sides appeared well maintained and no measurable secondary containment storage volume was observed. Water was observed in the mill sump on the southwest corner of the mill platform (see **Photo 10**). Mr. Orser stated the water quality has been tested and the pH is typically between 3 and 3.5. The characterization of the water in the sump and the liner below it are being considered as part of the amendment (AM-13) currently under review by the DRMS.

Photo 10. Water in High Grade Mill sump.

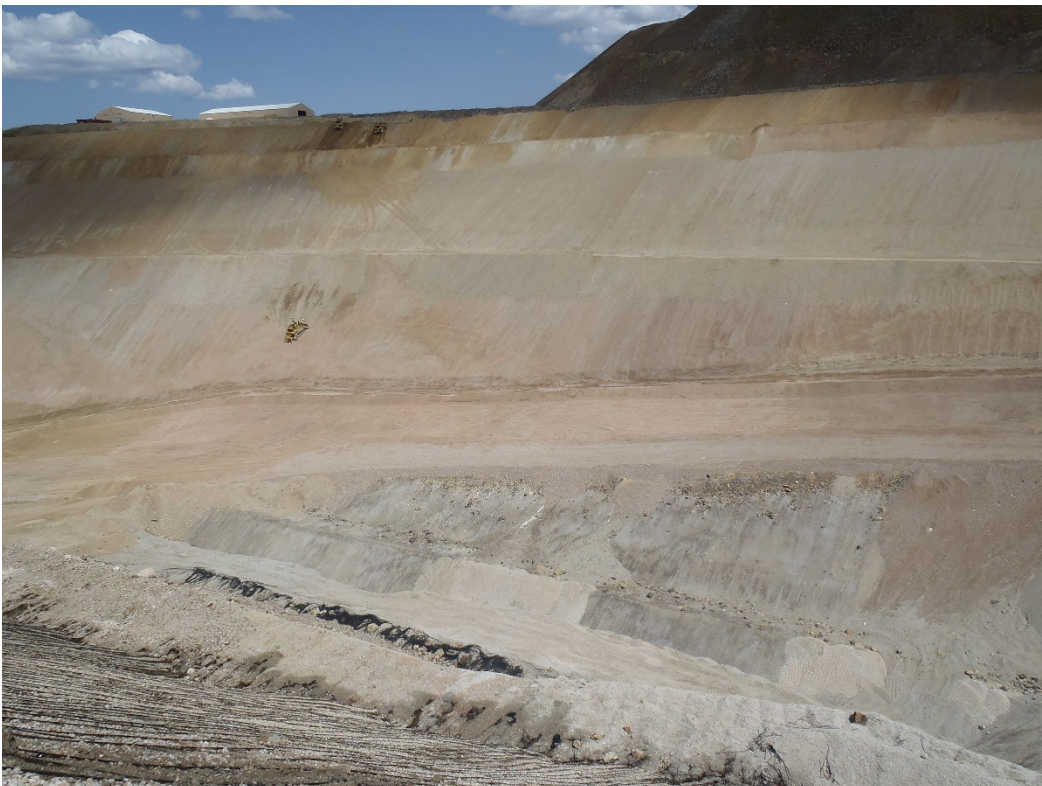
Squaw Gulch Valley Leach Facility (VLF 2) Construction: Mr. Steve Blaskovich accompanied the DRMS to the crest of the pad on the north side of VLF 2 to observe construction. Drain cover fill (DCF) was being graded to final thickness in the phase 2B1, 2B2 and 2B3 bench areas (see **Photo 11**), covered by the TR-123 CQA report received by the DRMS on 9/25/2020. Geomembrane had been deployed on the phase 2B4 area and soil liner fill (SLF) was observed being placed and conditioned in the phase 2B5 bench area (see **Photo 12**), covered by the TR-125 CQA report received by the DRMS on 11/17/2020. Mr. Blaskovich was asked about placing DCF on geomembrane with significant wrinkles. He said the cool overnight temperatures generally contract the geomembrane enough to take out wrinkles which result from geomembrane expansion caused by warm daytime temperatures and absorption of heat from the sun. He indicated the ideal ambient temperature for placing DCF is at or below 50°F. No problems were observed.

Photo 11. Drain cover fill being graded to 3ft thickness on VLF 2, phase 2B1, 2B2 and 2B3 bench areas.

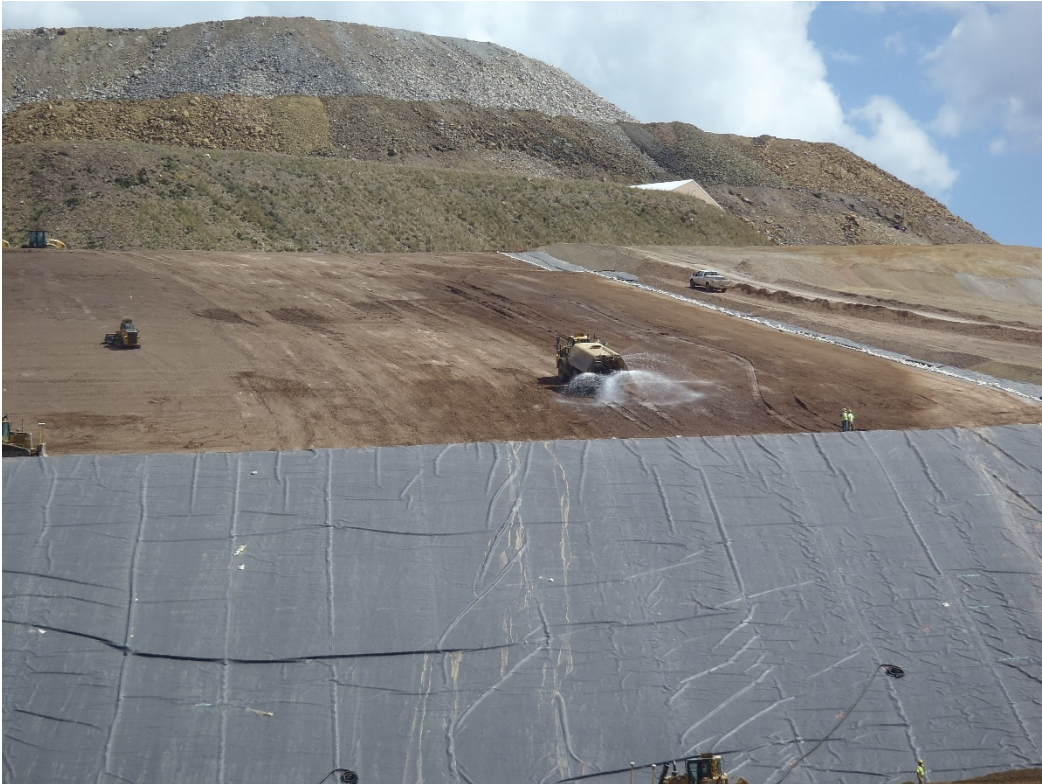
Photo 12. SLF being placed and conditioned in the phase 2B5 bench area.

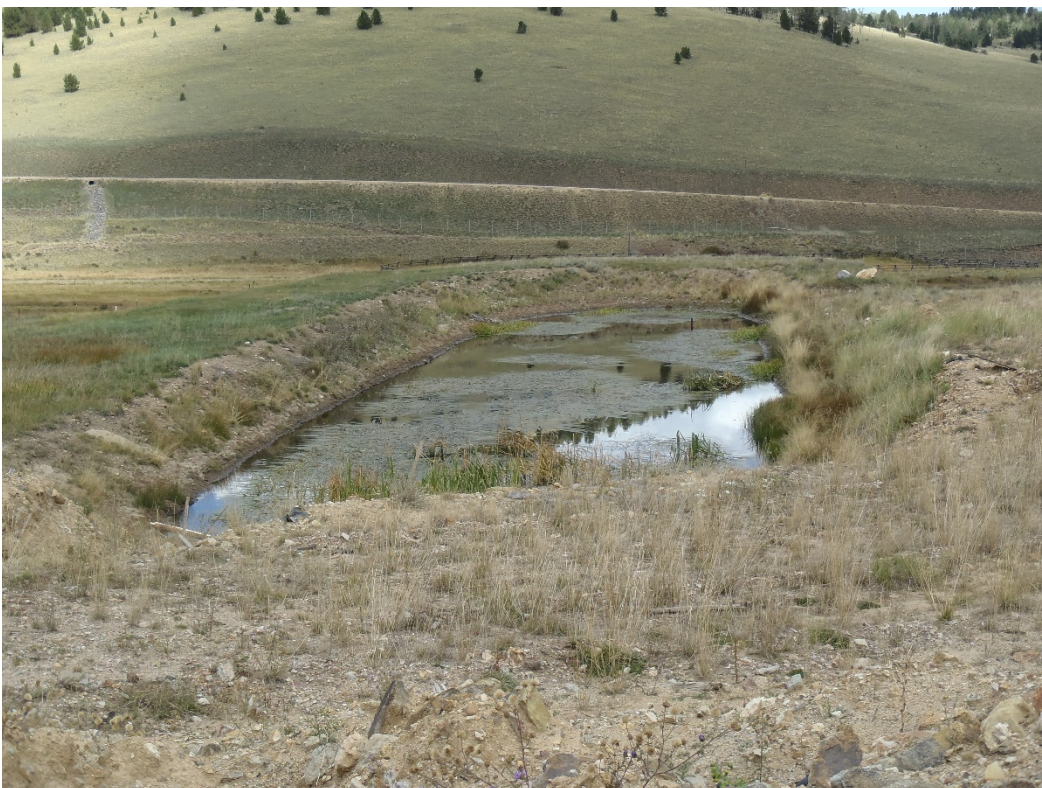
EMP 17A: Messrs. Tyler O'Donnell and Brian Crawford accompanied the DRMS to the pond area. Based on photos taken during the DRMS September 3, 2020 aerial inspection (report to be sent under separate cover), EMP ponds 17A (see **Photo 13**) and 17B (see **Photo 14**) appear to permanently retain stormwater. These two ponds were visited during the inspection for discussion and confirmation. Both ponds are thought to be lined facilities, explain the retention. CC&V representatives believed their water agreements accounted for this permanent storage, but agreed to research and confirm this assertion.

Photo 13. EMP 17A (note aquatic vegetation – looking NE).

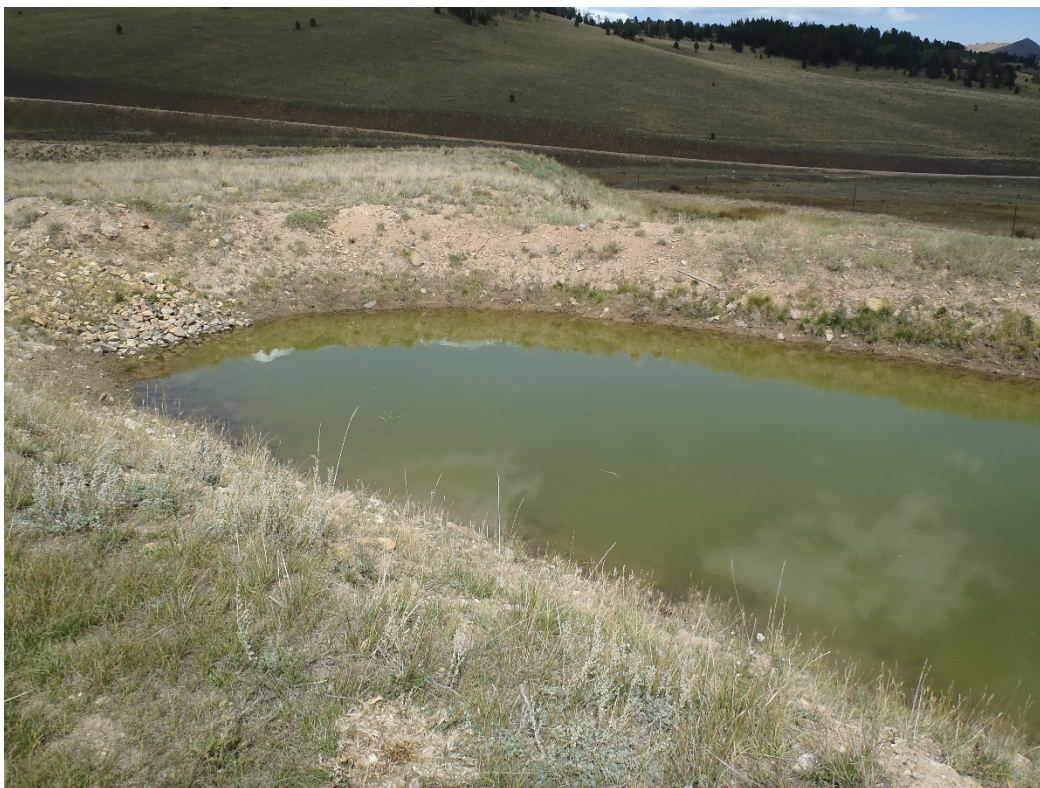
Photo 14. EMP 17B (no aquatic vegetation, but appears to be permanent storage – looking NE).
