MINERALS PROGRAM INSPECTION REPORT
PHONE: (303) 866-3567

MINE NAME: May Day Idaho Mine Complex	MINE/PROSPECTING ID#: M-1981-185	MINERAL: Gold and silver	COUNTY: La Plata
INSPECTION TYPE: Monitoring	INSPECTOR(S): Lucas West	INSP. DATE: November 5, 2020	INSP. TIME: 08:15
OPERATOR: Sunrise Mining LLC	OPERATOR REPRESENTATIVE: Jack and Barbara Nielson	TYPE OF OPERATION: 112d-2 - Designated Mining Operation	
REASON FOR INSPECTION: Normal I&E Program	BOND CALCULATION TYPE: None	BOND AMOUNT: \$137,448.00	
DATE OF COMPLAINT: NA	POST INSP. CONTACTS: None	JOINT INSP. AGENCY: None	
WEATHER: Clear	INSPECTOR'S SIGNATURE:

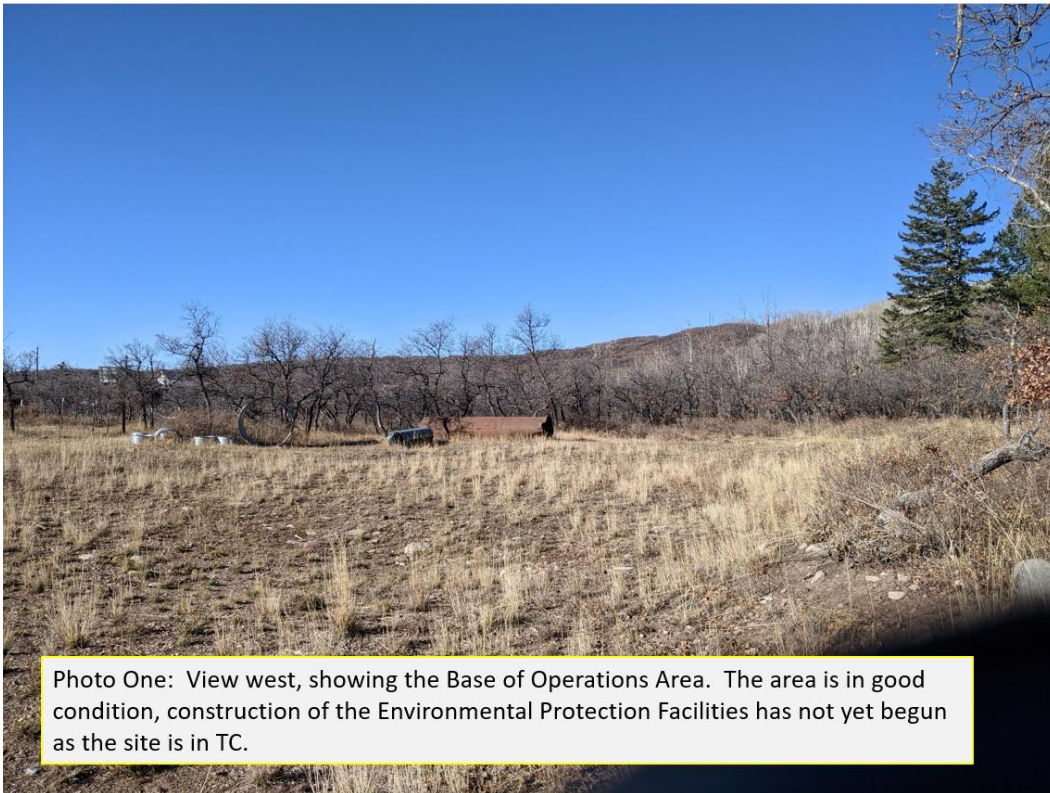
Base of Operations: The Base of Operations area will be the location of the mine offices as well as the lined ore storage pad used to stage ore prior to transport. Construction of these facilities has not begun yet and the area is in the same condition as it was during the previous inspection. A few pieces of leftover materials from construction activities including pieces of culvert and large boulders are located in the area. The area can be seen in Photo One.

Photo One: View west, showing the Base of Operations Area. The area is in good condition, construction of the Environmental Protection Facilities has not yet begun as the site is in TC.

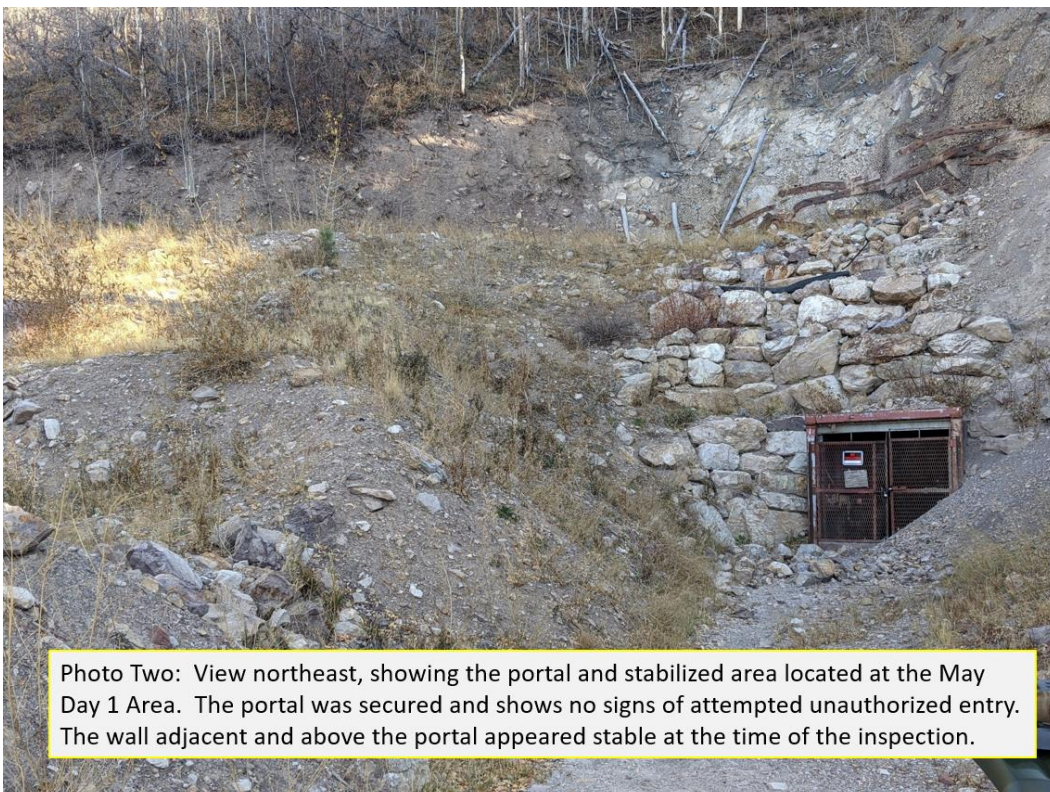
May Day 1 Area: The May Day area is in similar condition from the previous inspections and no significant changes have been made. The portal remains closed with a locked gate, and the surrounding slopes buttressed with the placement of large boulders. The area above the portal has been stabilized with wire mesh and rock bolts. The old mill building was not secure and was inspected at this time. Various equipment including an underground loader, several shipping containers and various other mining related debris are still on site. The surface conditions of the area are largely unchanged from the October 2016 Inspection. Photos Two and Three show the conditions of the May Day 1 Area.

Photo Two: View northeast, showing the portal and stabilized area located at the May Day 1 Area. The portal was secured and shows no signs of attempted unauthorized entry. The wall adjacent and above the portal appeared stable at the time of the inspection.

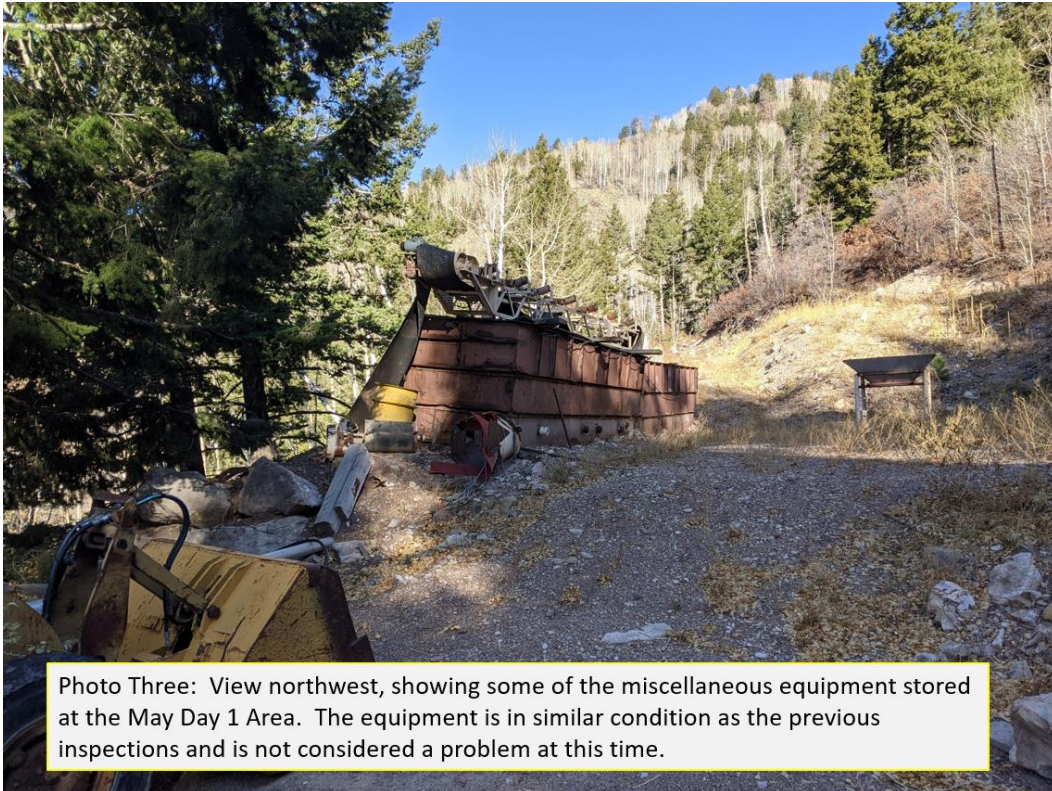
Photo Three: View northwest, showing some of the miscellaneous equipment stored at the May Day 1 Area. The equipment is in similar condition as the previous inspections and is not considered a problem at this time.

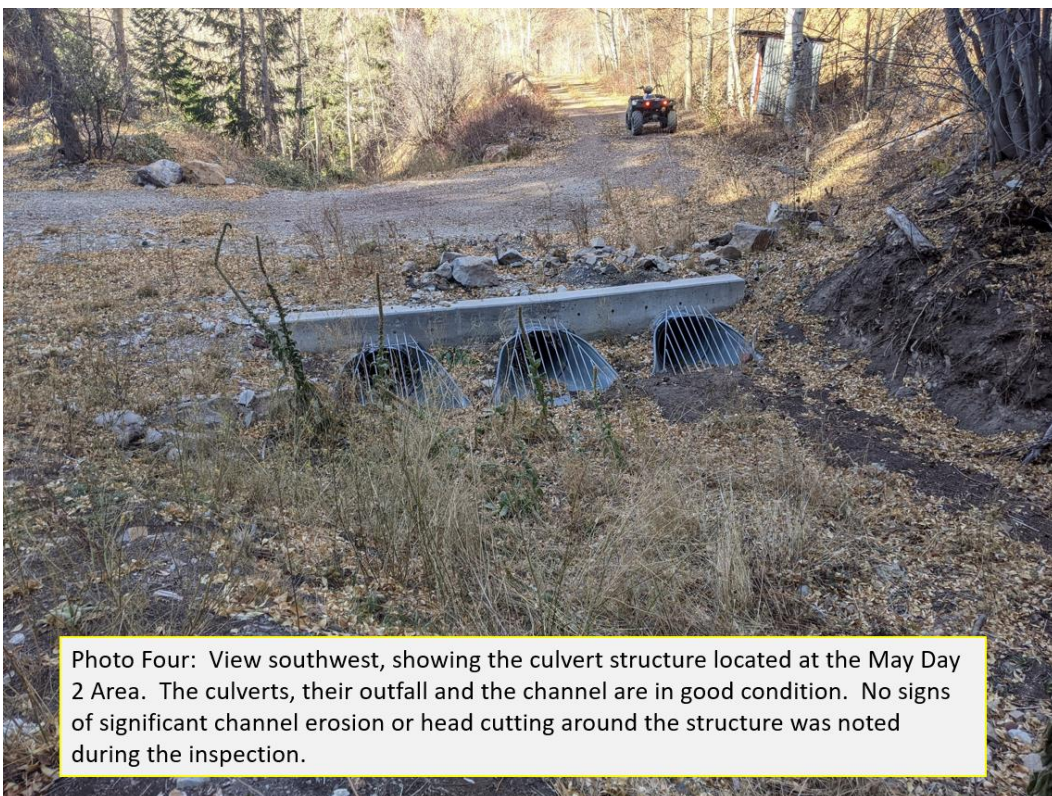
May Day 2 Area: The three culverts, and associated structures that were constructed as part of the restoration of Little Deadwood Gulch were functioning as designed at the time of the inspection and are in good condition as seen in Photo Four. The outfall of the culverts has been armored to prevent down cutting of the channel immediately downstream of the culverts. Within the channel immediately upstream of the culverts, two water bars have been installed to help dissipate the energy as the stream flow approaches the crossing. No significant signs of erosion in the channel or around the culvert structure was noted. The portal at the May Day 2 Area remains closed. A small waste rock pile was located adjacent to the closure, and was present during the previous inspection. This pile was previously thought to be a low grade ore stockpile, however on site discussions with the Operator indicate that it is not, nor has ever been low grade ore and the pile is in fact waste rock and benign in nature. No evidence of leaching or mineral staining was observed on or around the pile. The May Day 2 Area can be seen in Photo Five.

Photo Four: View southwest, showing the culvert structure located at the May Day 2 Area. The culverts, their outfall and the channel are in good condition. No signs of significant channel erosion or head cutting around the structure was noted during the inspection.
