## Bowie #2 inspection report

**PERMIT INFORMATION**

<b>Permit Number:</b> C-1996-083 <b>Mine Name:</b> Bowie No. 2 Mine <b>Operator:</b> Bowie Resources, LLC <b>Operator Address:</b> Mr. Basil Bear P.O. Box 1488 Paonia, CO 81428	<b>County:</b> Delta <b>Operation Type:</b> Underground <b>Permit Status:</b> Active <b>Ownership:</b> Private
	<b>Operator Representative Present:</b>  Basil Bear
<b>Operator Representative Signature:</b> (Field Issuance Only)

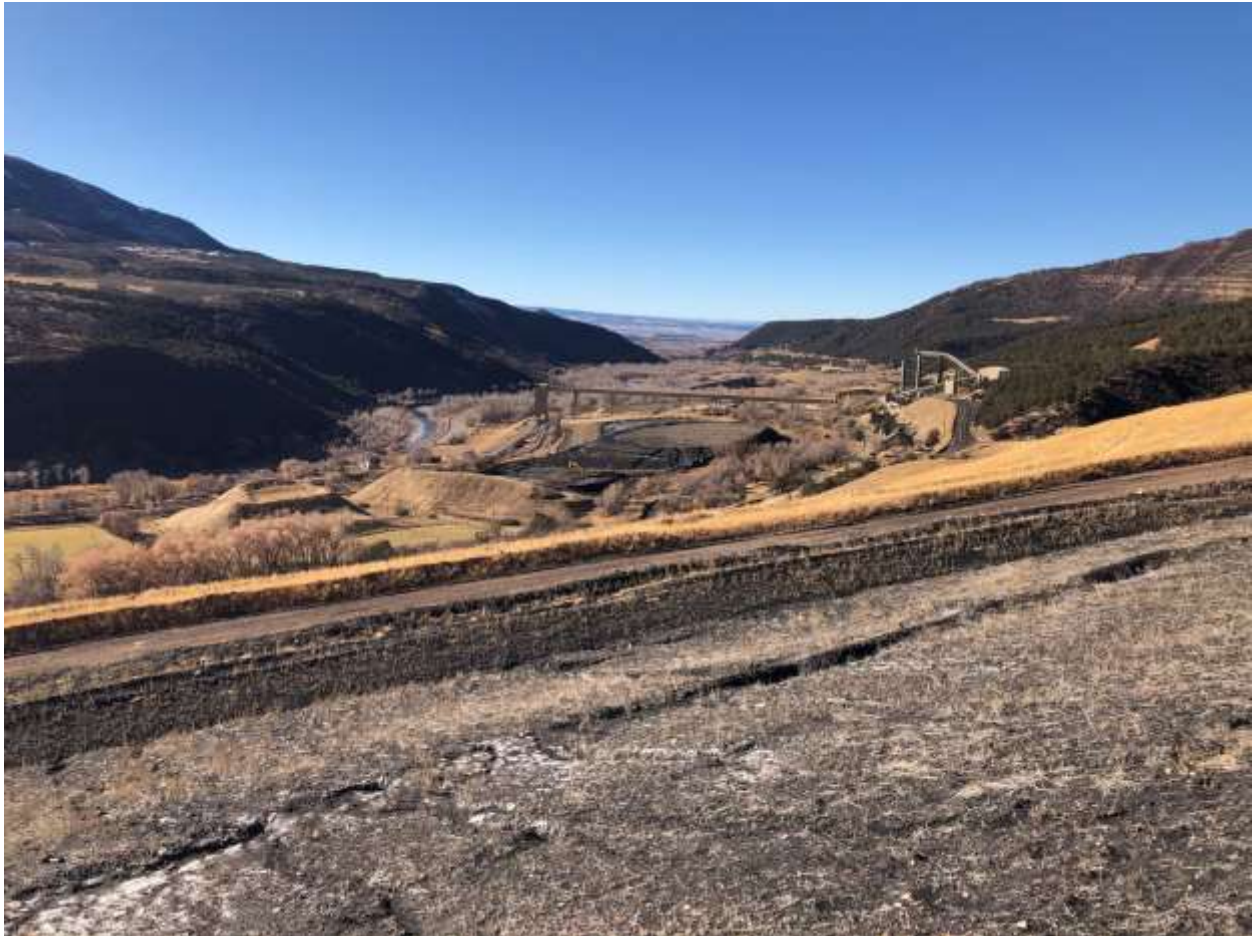
BRL continues to focus efforts on Gob Pile #3. Work on this pile was being performed during the inspection and entailed hauling soil from the eastern portion of the pile to the southwest corner.

**Gob Pile #3 and soil piles (taken from Gob Pile #2)**

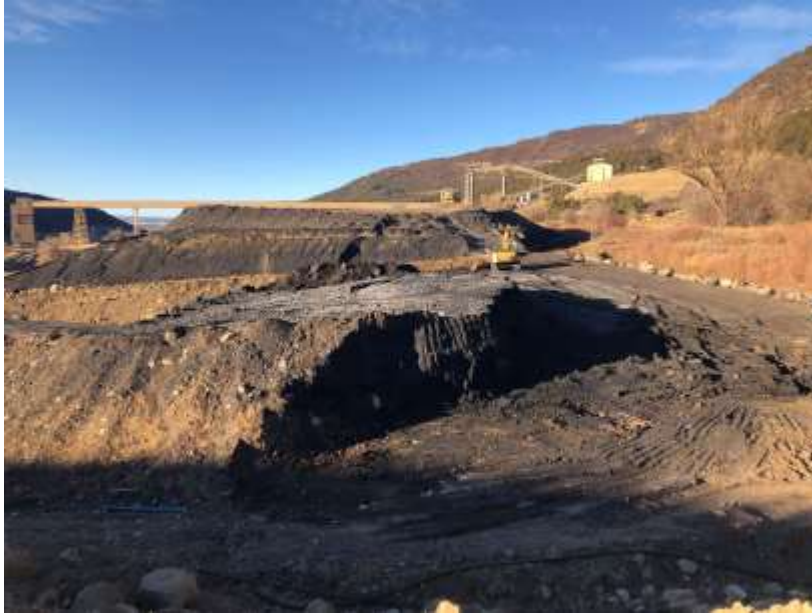
As noted above, BRL's work on Gob Pile #3 during the inspection entailed hauling coverfill material from the eastern portion of the pile to the southwest corner. Much of the waste material in the drying area has been moved to the west side of the pile.

**Gob Pile #3 – waste material on east side of pile (drying area)**

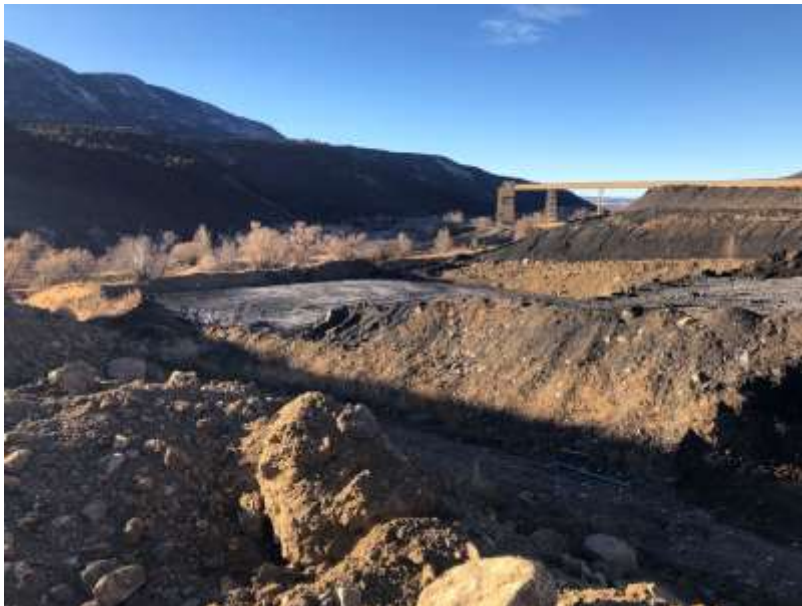
**Gob Pile #3 – south end of drying area**

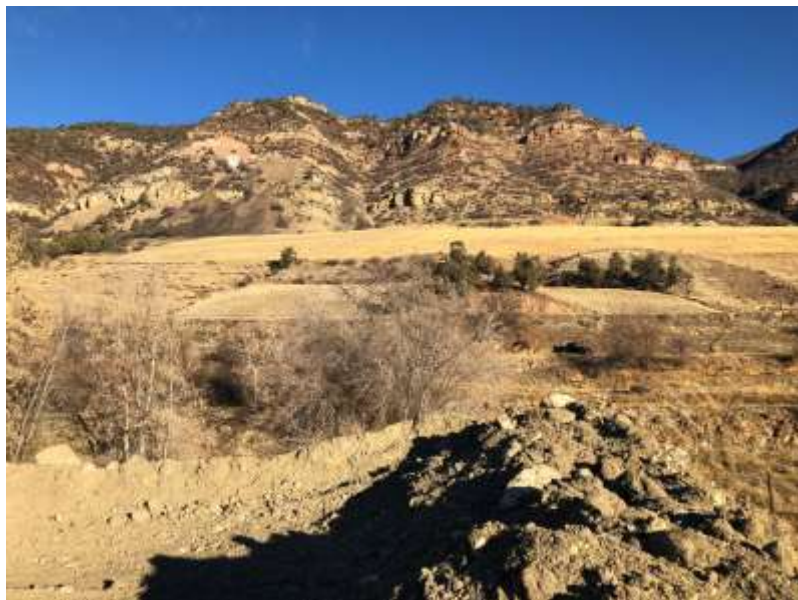
Gob Piles #1 and #4 were viewed from below and from the Haul Road. Gob Pile #4 was also viewed from Gob Pile #2. They both looked stable and well vegetated.

**Gob Piles #1 and #4**

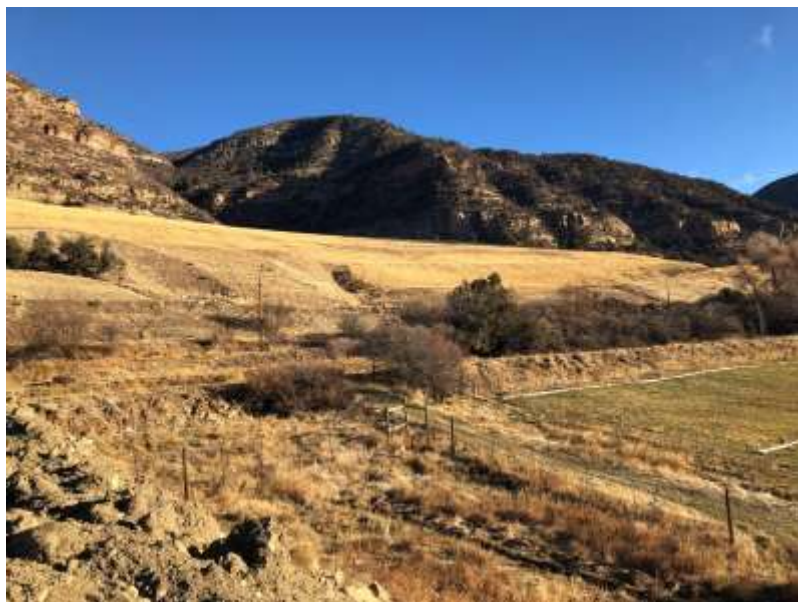
The lower portion of Gob Pile #2 appeared stable. The drainage control practices on the upper portion of this pile appear to be functioning well.

**Gob Pile #2**

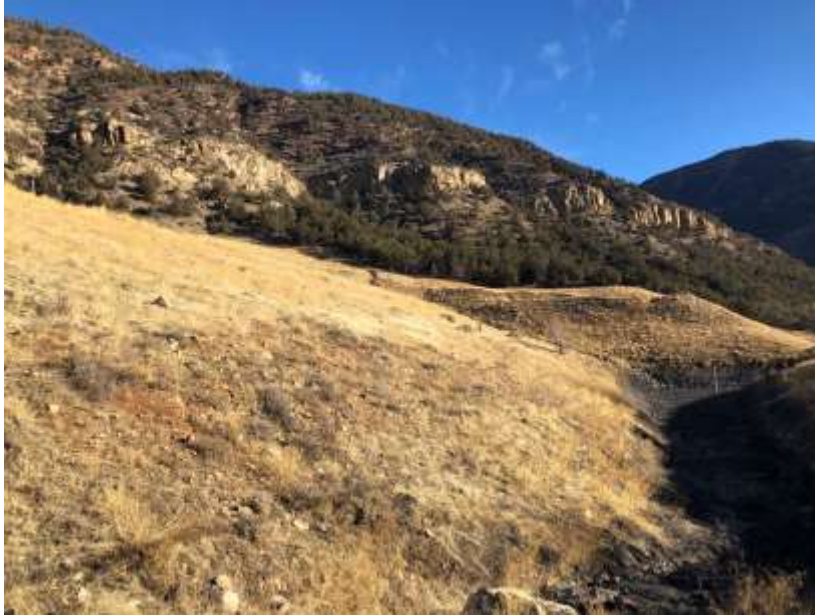
**Pond F, soil pile, and southeast corner of Gob Pile #2**

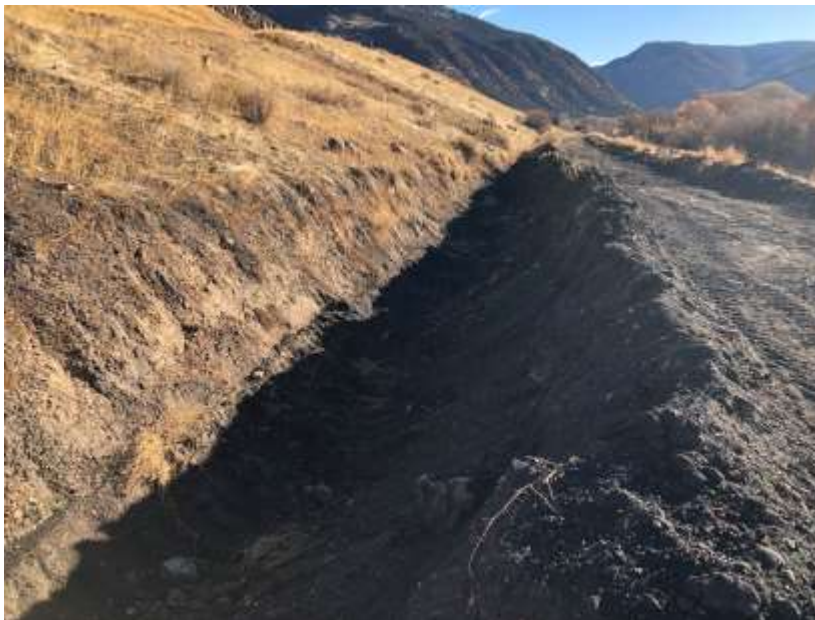
No problems were seen with ditches. Ditch D-F7 that drains to Pond F was dry; the low spot near the top of the ditch is approximately four inches deep and not considered a significant problem (but should be monitored to determine if it fills in next spring or if it gets worse). The ditch below the old power plant (improved by BRL staff in September) was functioning to divert runoff to the Deer Trail Ditch. The ditch below Curve 11 is functioning but needs continual monitoring; it is an odd mix of concrete, rock, wood, and corrugated plastic creating the channel.

**Ditch D-F7**

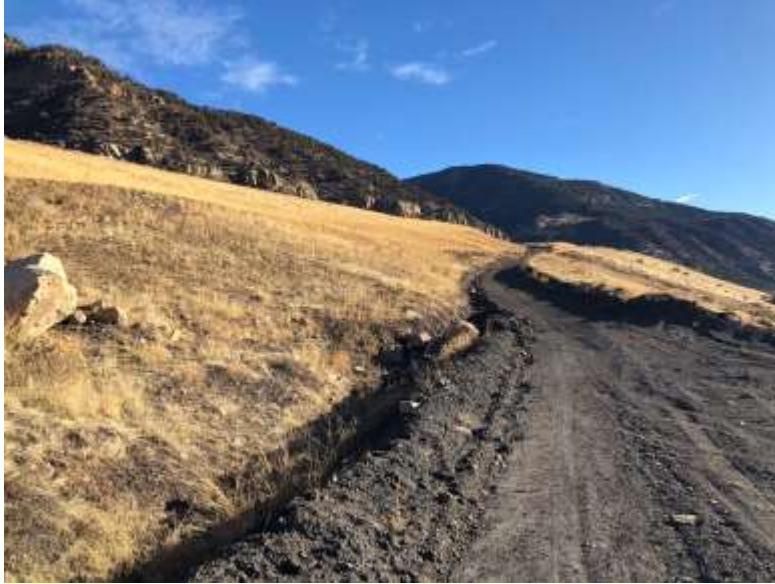
**Road to Gob Pile #2**

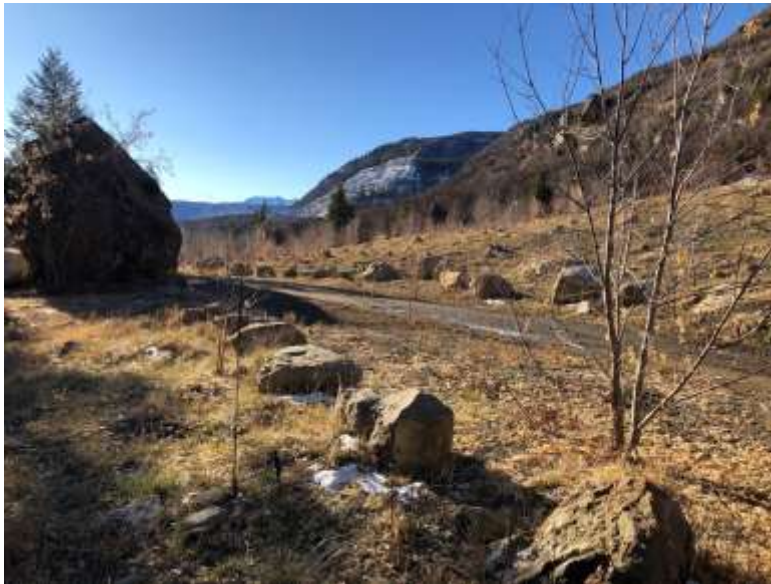
The reclaimed pad at the former Hubbard Creek Vent Shaft is in good shape (no erosion or weed patches were seen).

**Reclaimed pad for Hubbard Creek Vent Shaft**

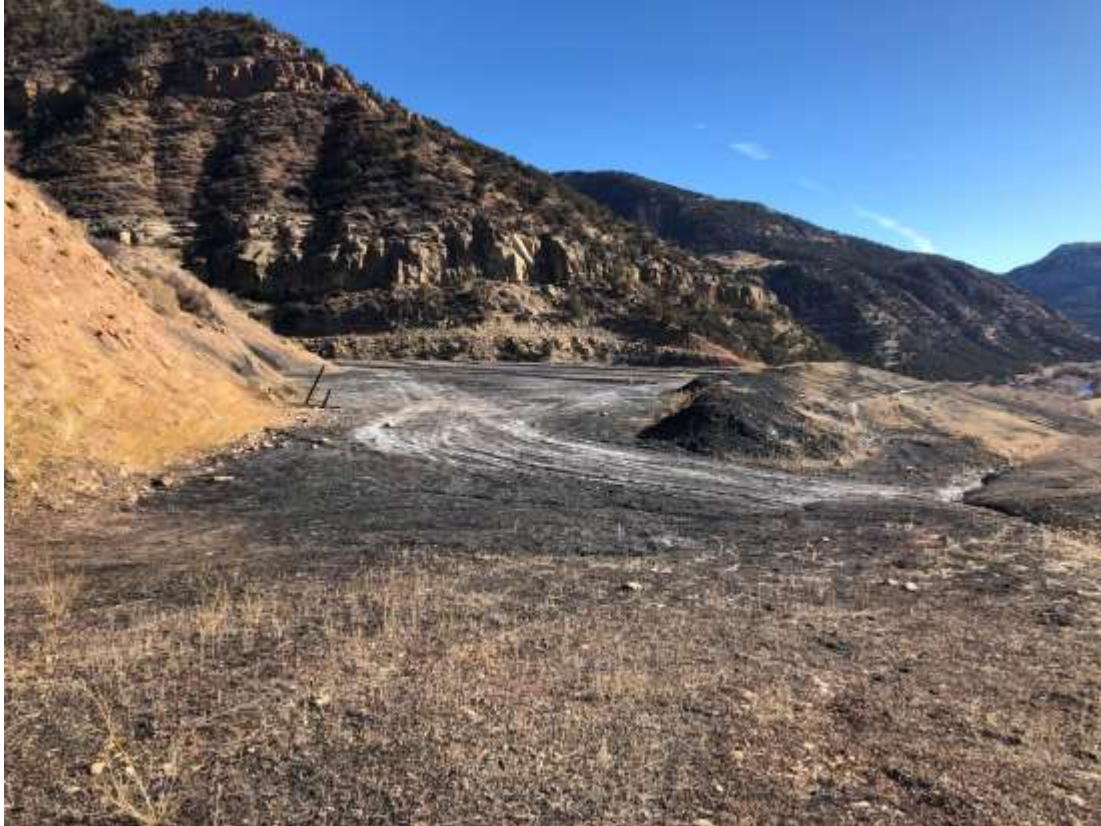
**Gob Pile #2 – well graded upper portion**

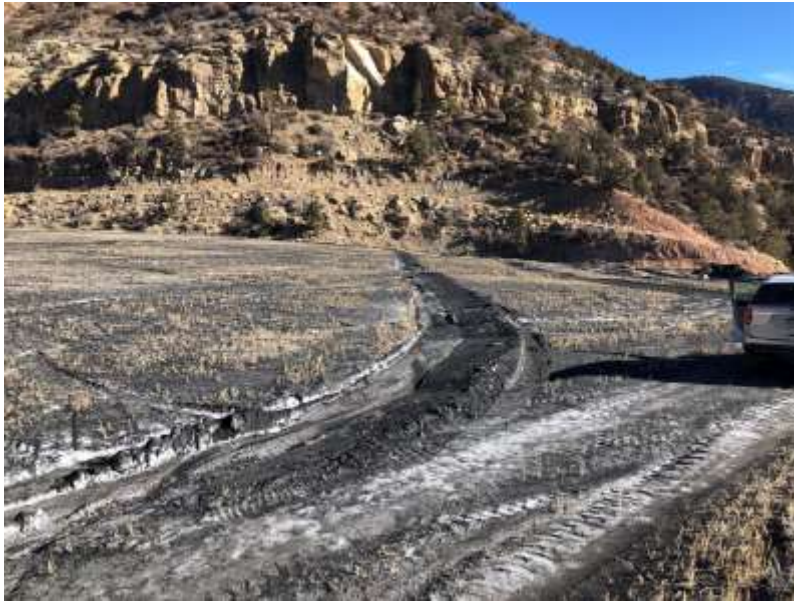
**Gob Pile #2 – temporary drainage ditches on upper portion**

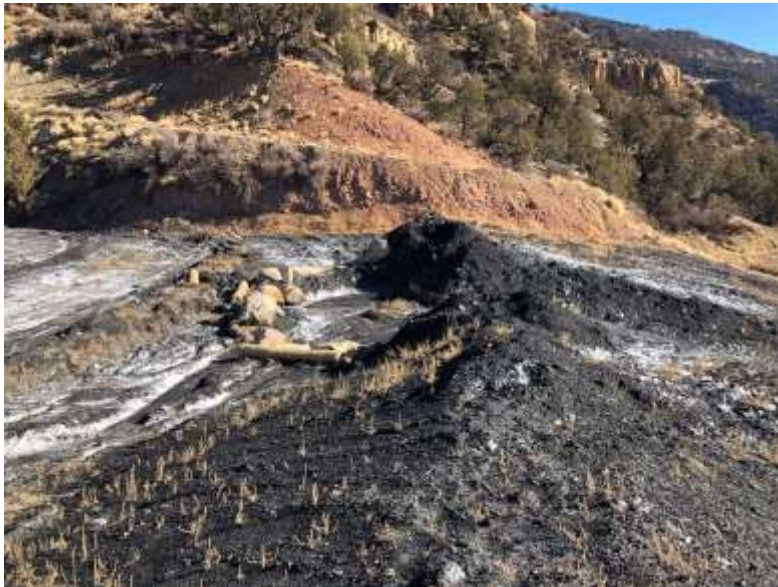
**Gob Pile #2 – sump and other sediment BMPs**

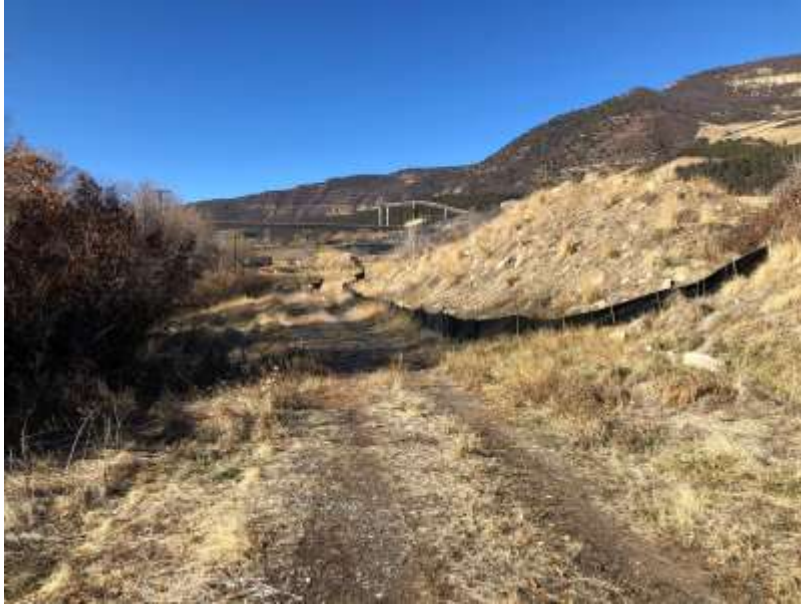
At topsoil stockpiles and coverfill piles, berms, vegetation, and silt fence are keeping these resources in place. The silt fence around the soil pile west of Pond J is an example of excellent installation.

**Soil stockpile west of Pond J – excellent installation of silt fence**

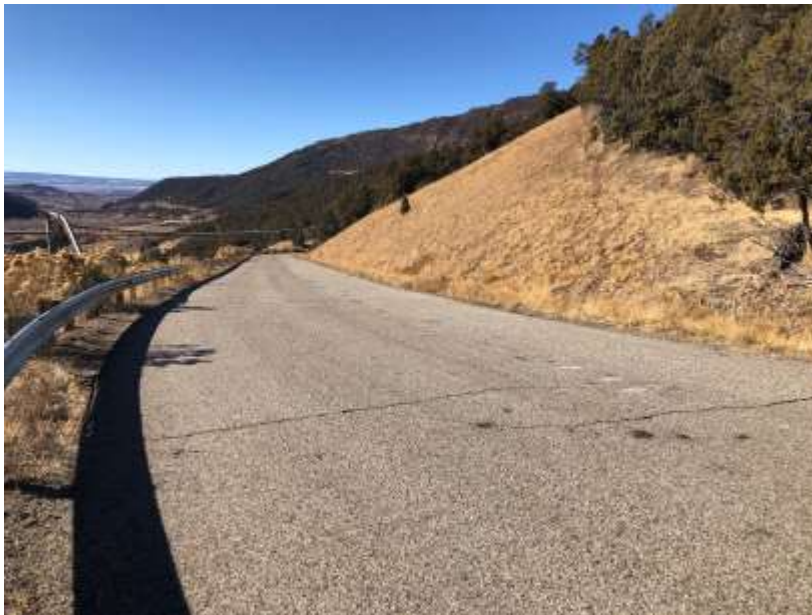
**Haul Road below Curve 3**

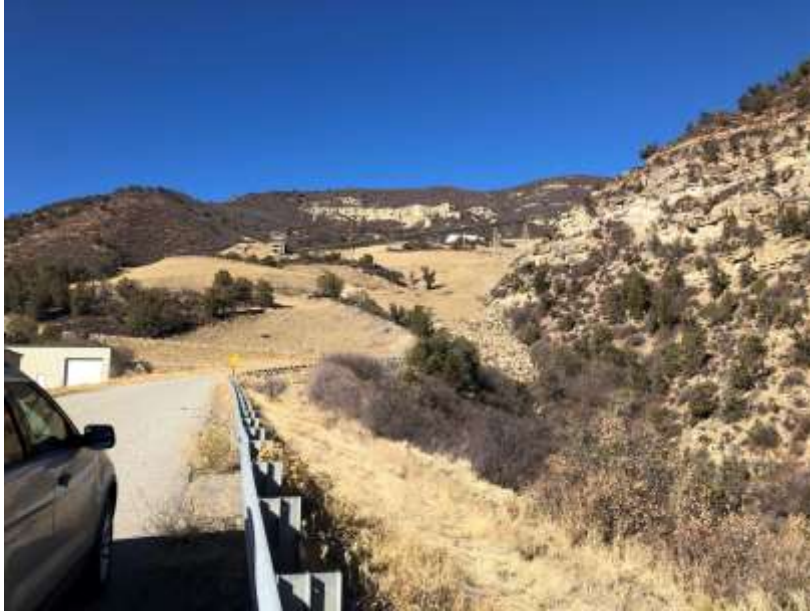
**Area above Topsoil Stockpile A**

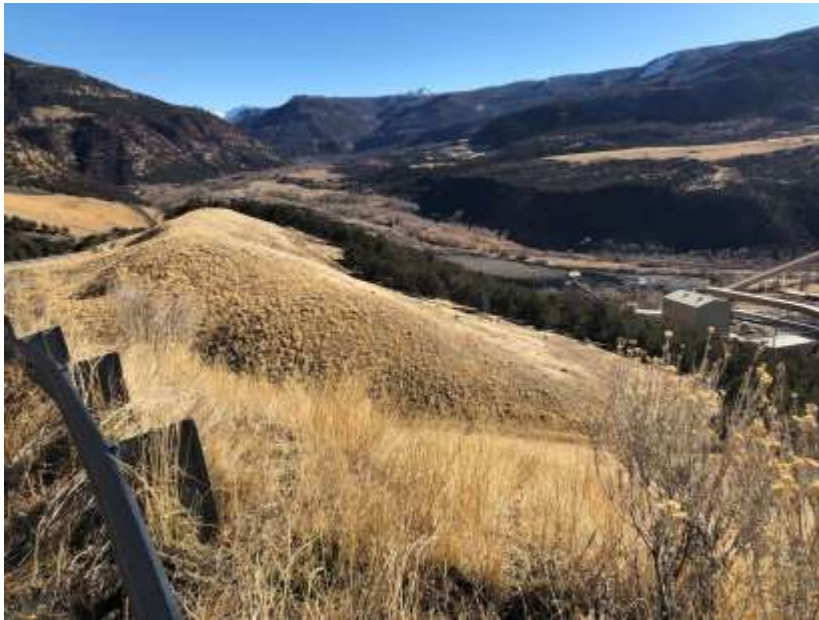
**Topsoil Stockpile A**

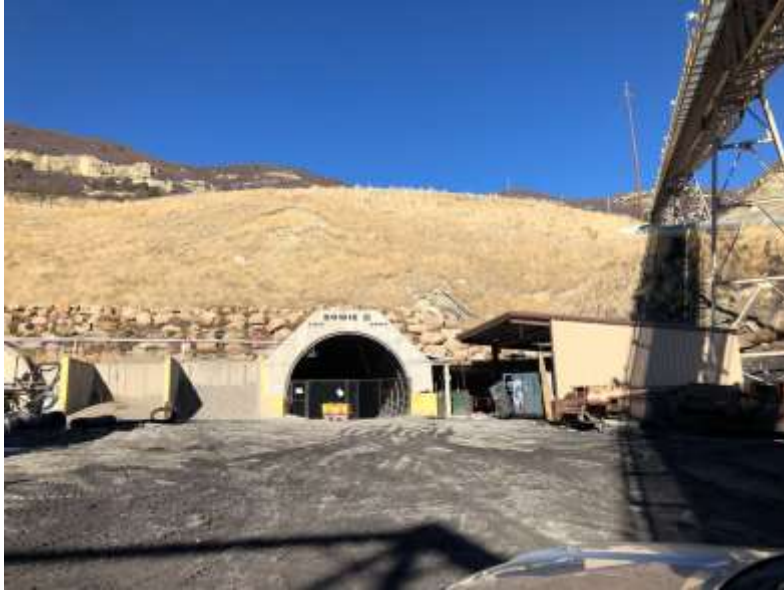
It appears that slumps have not moved significantly in the recent past. These include slumps by the B Portal and by Curve Number 11 along the Haul Road.

**B Portal - slump above portal is stable**

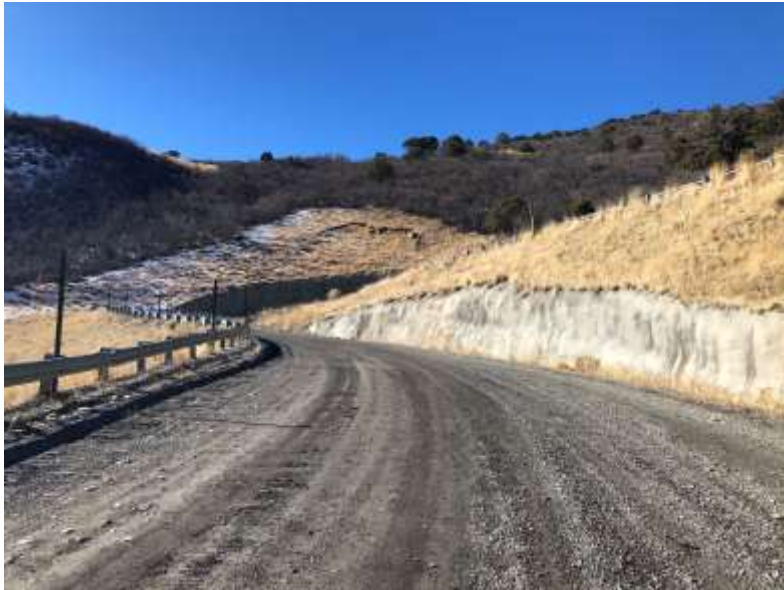
**Stable slump at Curve 11**

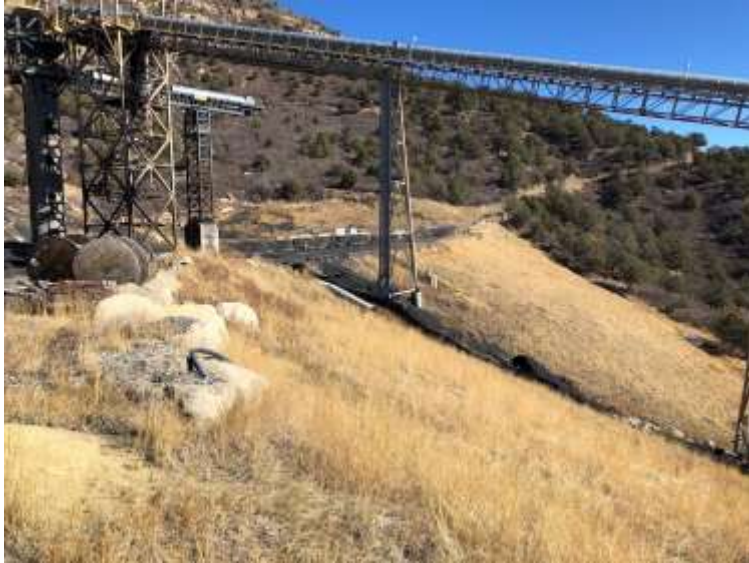
**Slope below D Portal bench**

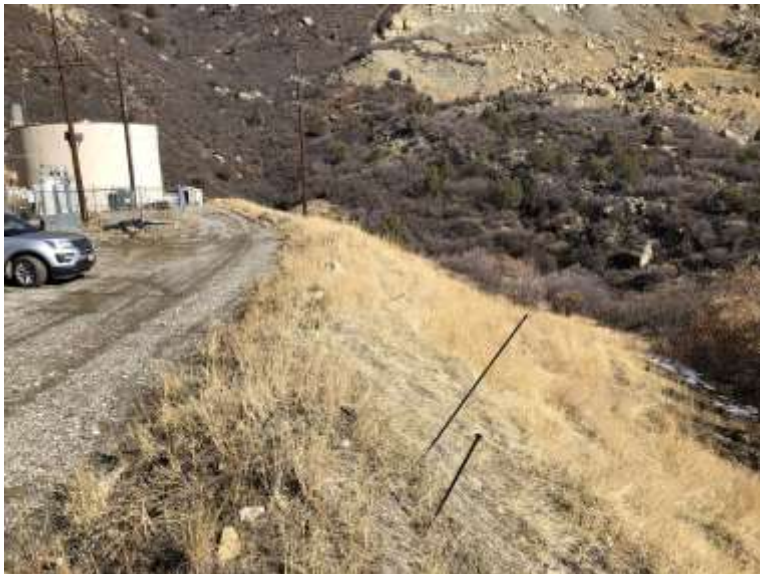
**Slope below Utility Bench**
