MINERALS PROGRAM INSPECTION REPORT
PHONE: (303) 866-3567

MINE NAME: Cresson Project	MINE/PROSPECTING ID#: M-1980-244	MINERAL: Gold	COUNTY: Teller
INSPECTION TYPE: Aerial Inspection	INSPECTOR(S): Timothy Cazier, P.E.	INSP. DATE: September 3, 2020	INSP. TIME: 11:31
OPERATOR: Cripple Creek & Victor Gold Mining Company	OPERATOR REPRESENTATIVE: None	TYPE OF OPERATION: 112d-3 - Designated Mining Operation	
REASON FOR INSPECTION: Normal I&E Program	BOND CALCULATION TYPE: None	BOND AMOUNT: \$209,491,188.00	
DATE OF COMPLAINT: NA	POST INSP. CONTACTS: None	JOINT INSP. AGENCY: DRMS	
WEATHER: Clear	INSPECTOR'S SIGNATURE:

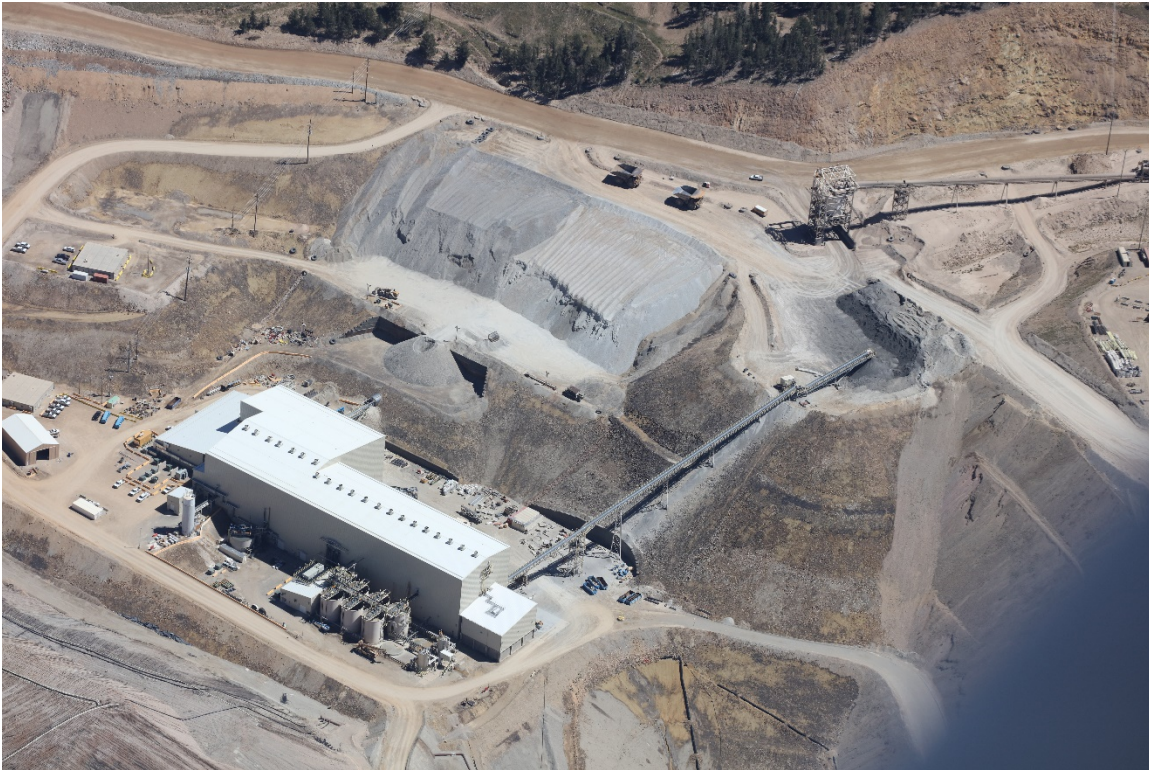
High Grade Mill: The purpose was to perform a visual inspection for leaks, spills and secondary containment problems. Only the west (see **Photo 1**) side of the mill exterior were inspected with no observable impact on the secondary containment.

Photo 1. West side of High Grade Mill (looking NE).

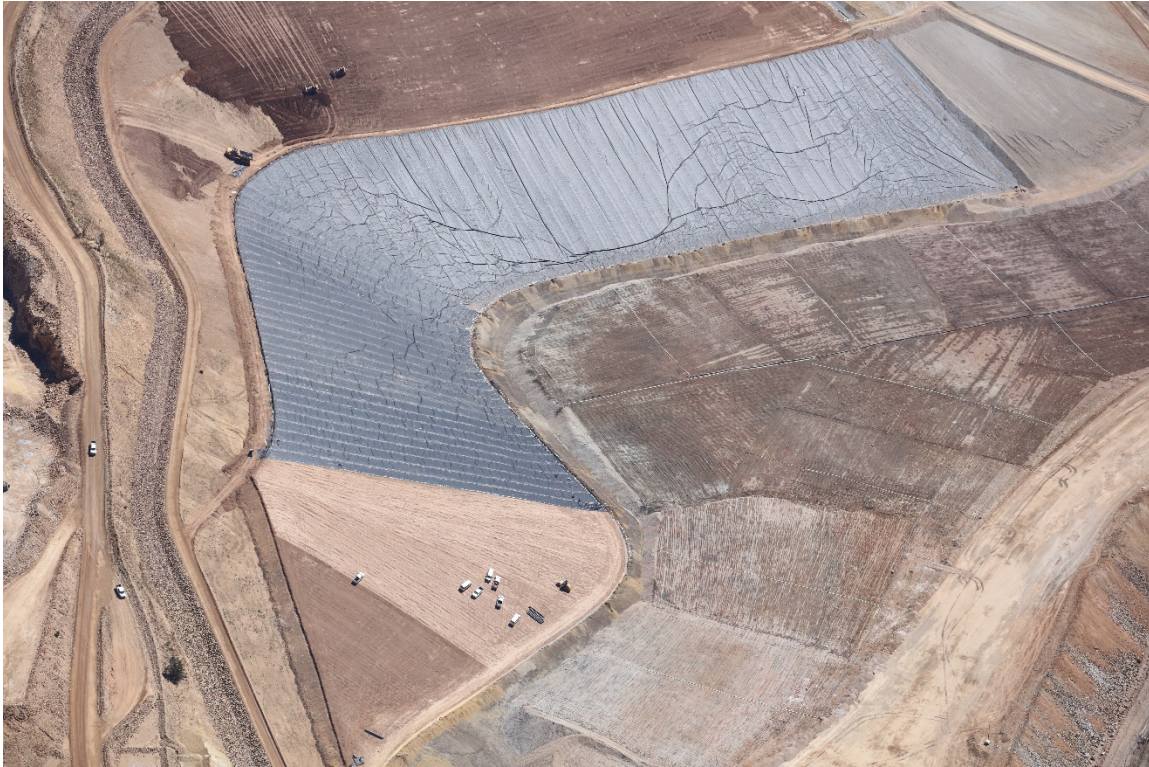
Squaw Gulch Valley Leach Facility (VLF 2): A focus of the aerial inspection for VLF 2 was the ongoing phase 2 construction. A large wrinkle was observed in the deployed geomembrane (see **Photo 2**). CC&V was contacted and assured the DRMS on September 10th that DCF will not be placed on wrinkled geomembrane. This was confirmed with the CC&V construction superintendent during the September 15, 2020 regular inspection (submitted under separate cover). No ponded process solution was observed in the active leach areas and ore stacking appeared to be in compliance with the stacking plan approved in TR-103 (see **Photos 3 and 4**).

Photo 2. VLF 2, Phase 2 construction – not large wrinkles in geomembrane (looking SE).

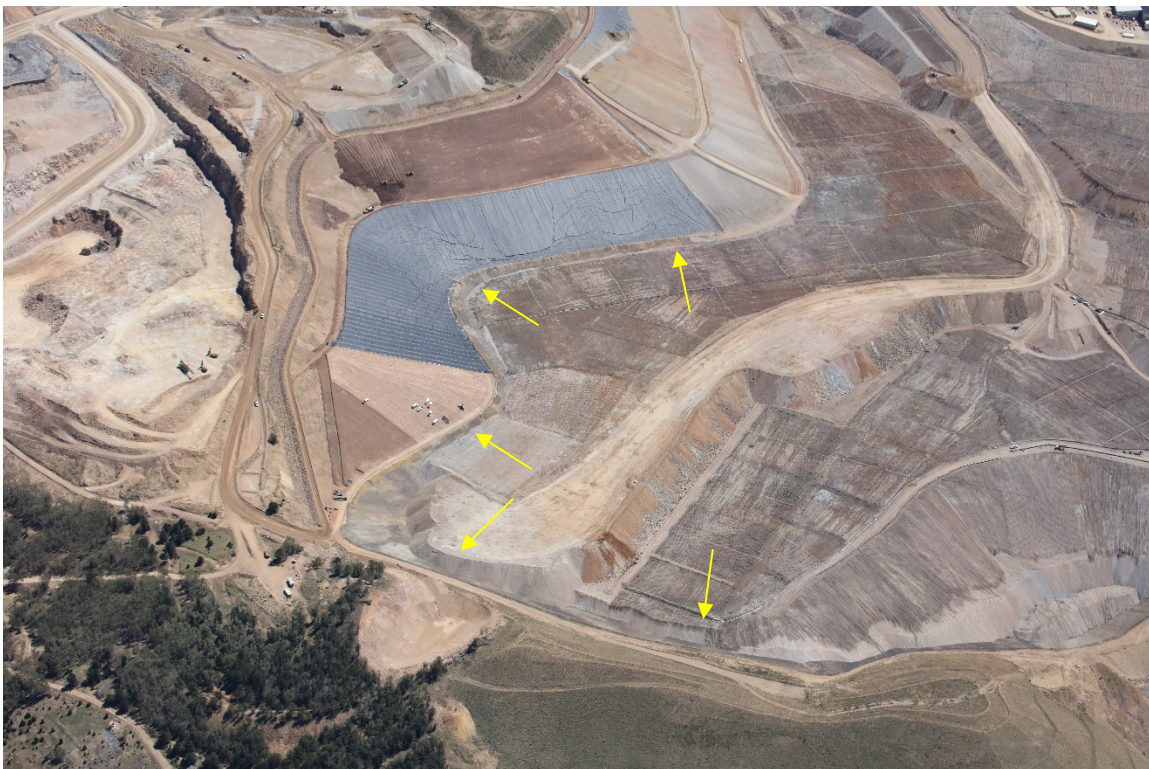
Photo 3. VLF 2 – ore stacking in compliance with TR-103 (looking SE).

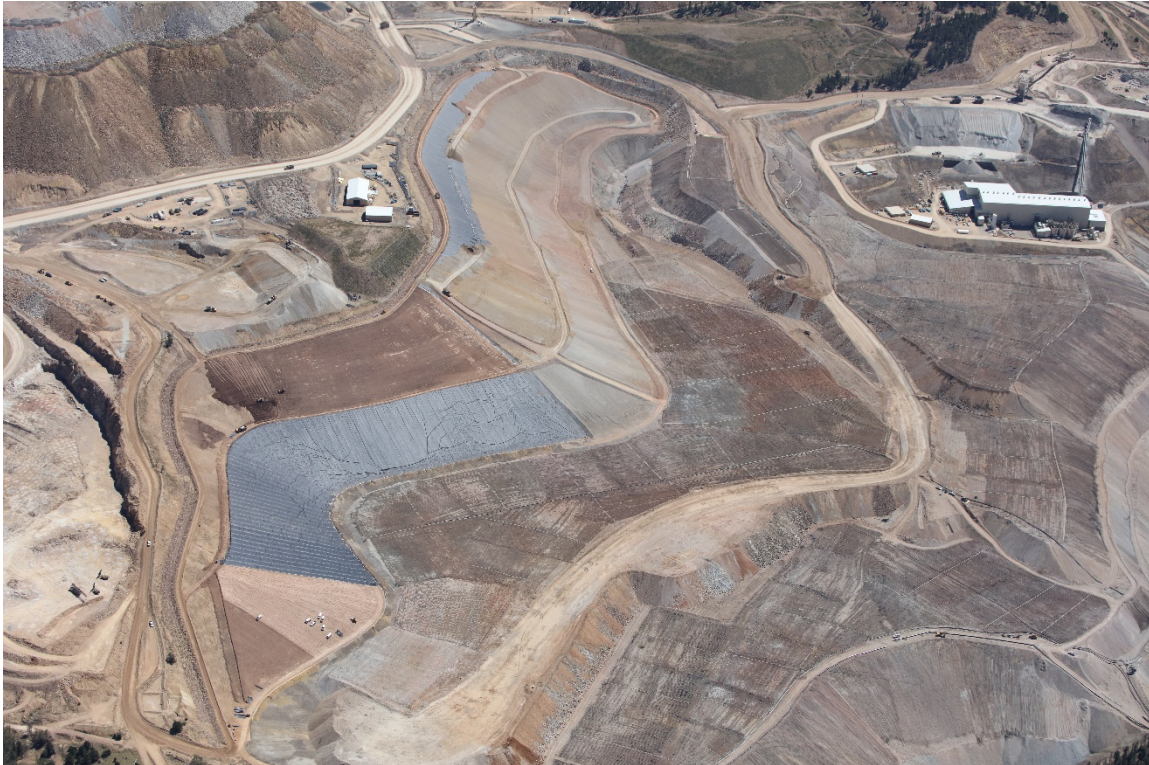
Photo 4. VLF 2 – overview of phase 2 construction and ore stacking (looking SE)

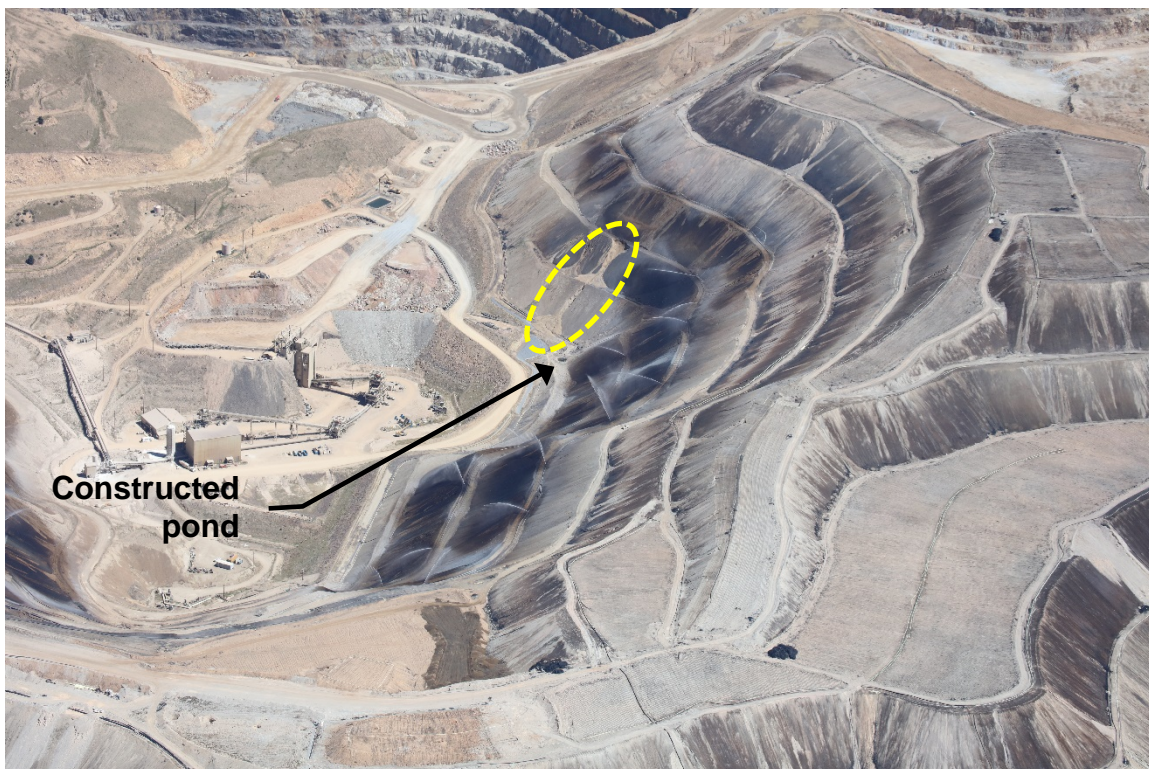
Arequa Gulch Valley Leach Facility (VLF 1): No solution ponding resulting from leaching operations was observed on VLF 1. However, a constructed pond was observed on the north end of the Phase V area (see **Photo 5**), as well as sluffing from two benches above the TR-65 liner extension and berm raise. The sluffed material appears to have remained on the liner. It should be noted this sluffing was not observed in the previous aerial inspection (flown May 18, 2020). High capacity pivoting sprinklers were observed applying process solution on the north side of VLF 1 (see **Photo 5**). The DRMS will follow-up with the Phase V constructed pond during a future regular inspection.

Photo 5. VLF 1 – side slope leaching, sluffing (circled) & constructed pond (north side, looking east).

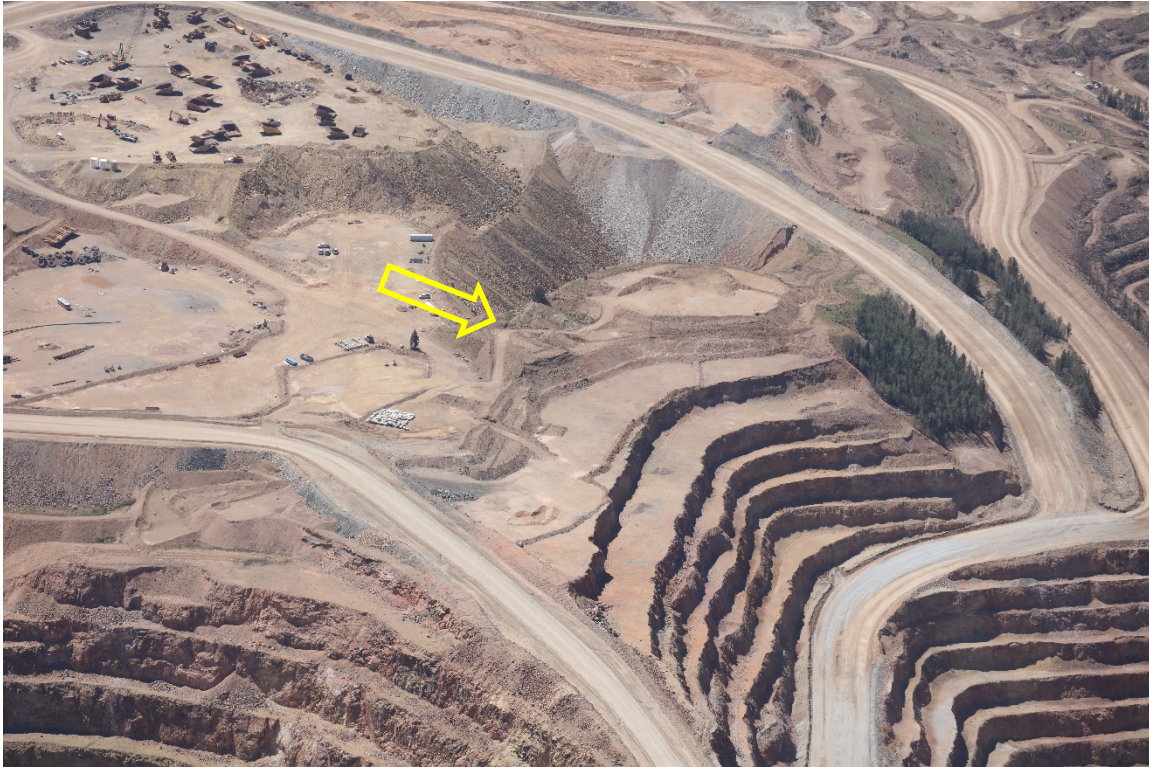
Topsoil Stockpiles: Topsoil stockpile (TS) #21 (south of the Globe Hill pit and west of the WHEx pit, see **Photo 6**) was observed to be unvegetated. A file review indicates TR-102 (approved 6/6/2018) allowed a relocation of this topsoil to TS #39 (see **Photo 7**). The unprotected TS #21 is subject to topsoil loss through erosion. [We recommend the remainder of TS #21 be moved to TS #39 as soon as practical and seeded to establish a protective vegetative cover.](#)

Photo 6. Topsoil stockpile #21 (looking SSW WHEX in left foreground, Globe Hill Pit in right foreground).

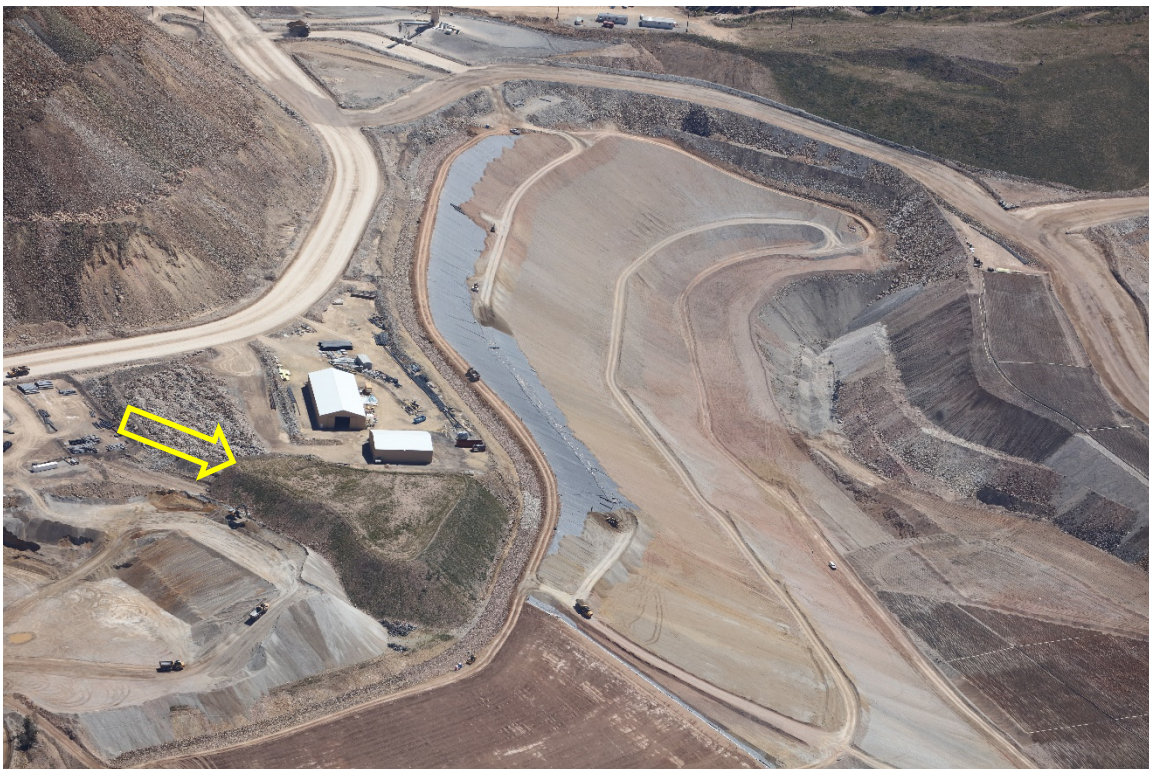
Photo 7. Topsoil stockpile #39 (looking SE, VLF 2 construction on right).

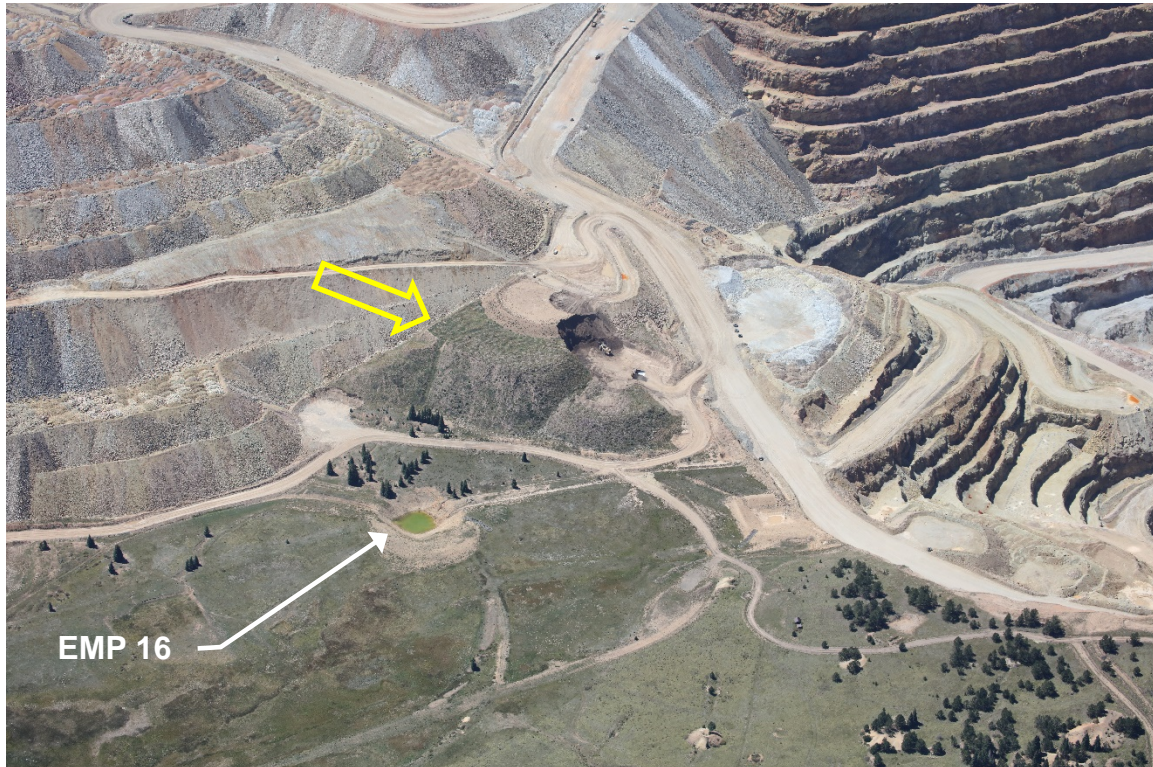
Topsoil from TS #6 (see **Photo 8**) is being excavated and used for reclamation on the south end of the ECOSA.

Photo 8. Topsoil stockpile #6 being excavated (looking SW, WHEX on right).

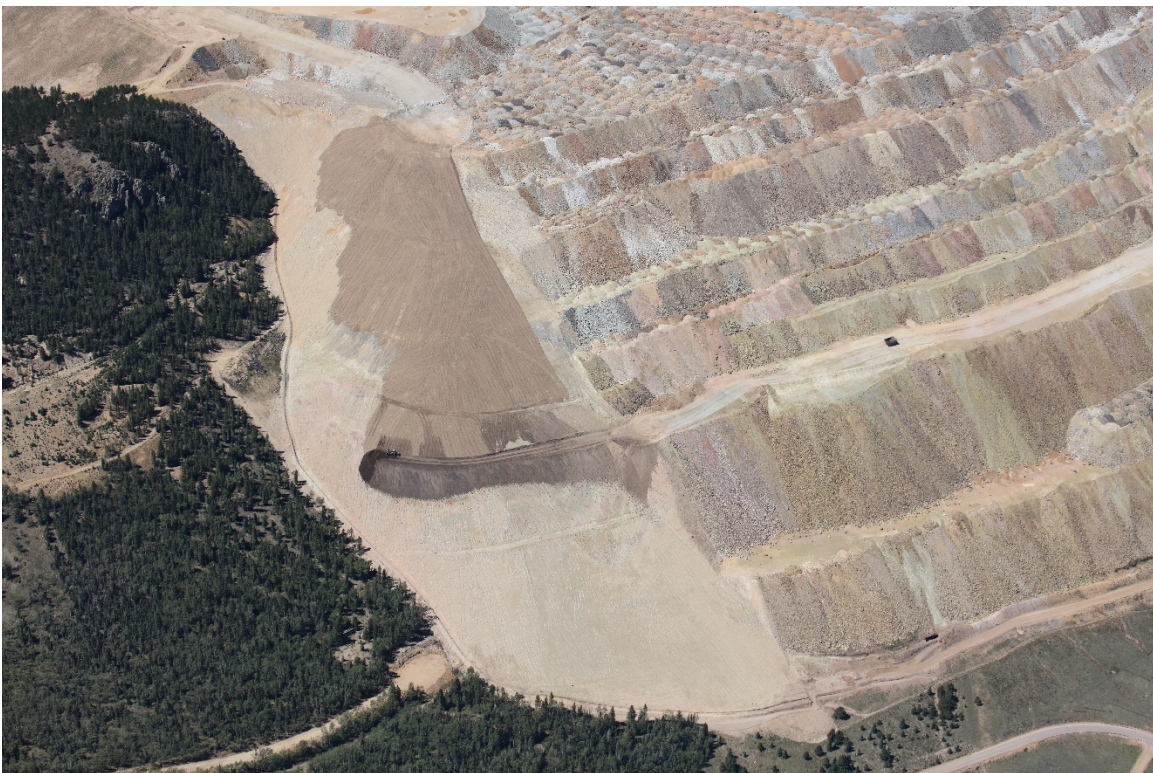
Photo 9. Reclamation grading & topsoil placement on the south end of ECOSA (looking west).

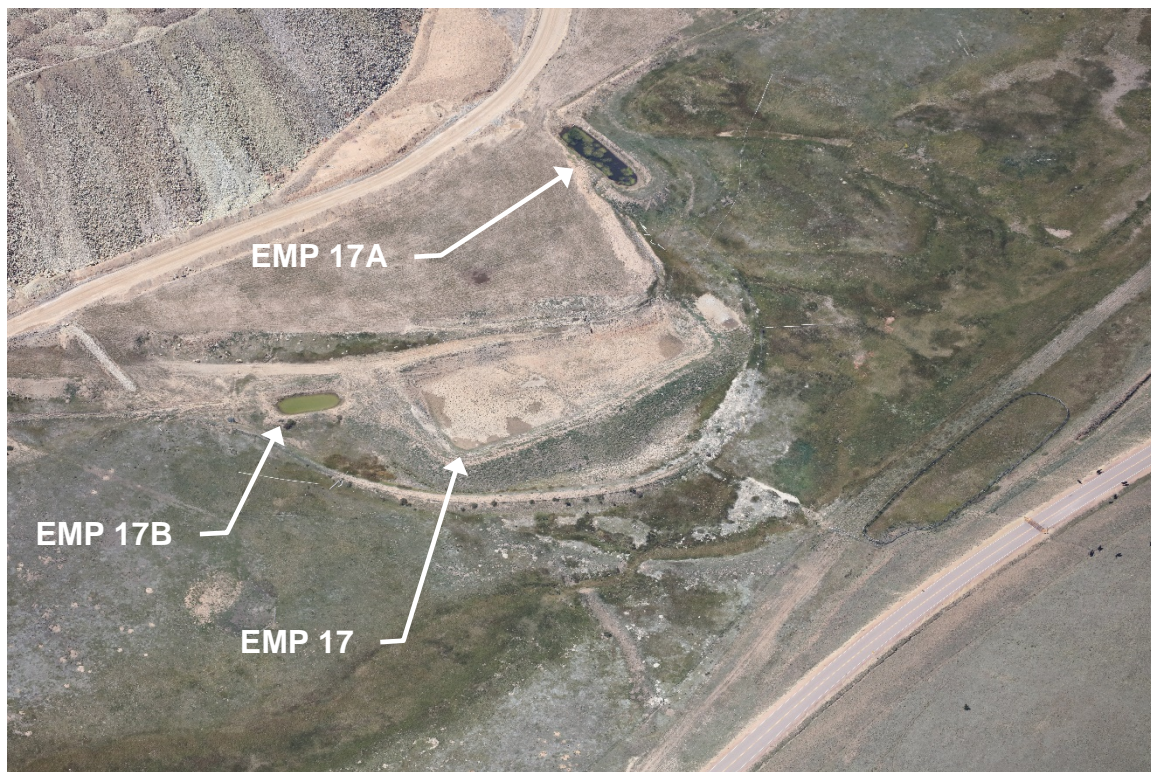
East Cresson Overburden Storage Area (ECOSA) / Altman Backfill Reclamation: Reclamation grading and topsoil placement was observed on the south end of the ECOSA (see **Photo 9**). Photos of EMP 17A and 17B (see **Photo 10**) showed what appeared to be permanently stored water. Measurements using Google Earth indicate EMP 17A has a surface area of about 5,300 sq. ft and EMP 17B has a surface area of ~2,350 sq.ft. The DRMs followed

Photo 10. EMP 17 ponds – A & B with permanent water storage (looking west).

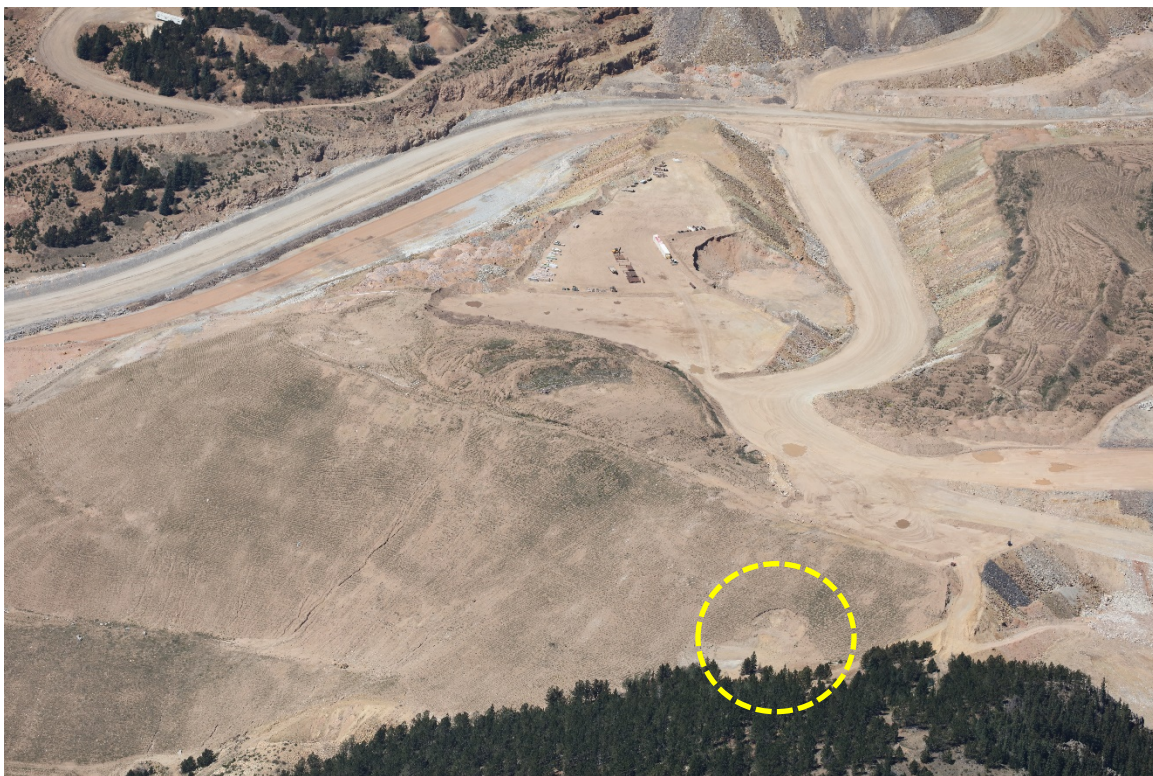
up on this observation during the September 15, 2020 regular inspection (submitted under separate cover). What appeared to be an excavation or sluffing in the reclaimed area of the Altman backfill was observed (see **Photo 11**). A follow-up with CC&V personnel indicates this is an exploration drill pad.

Photo 11. Altman backfill reclamation area exploration drill pad disturbance (looking west).

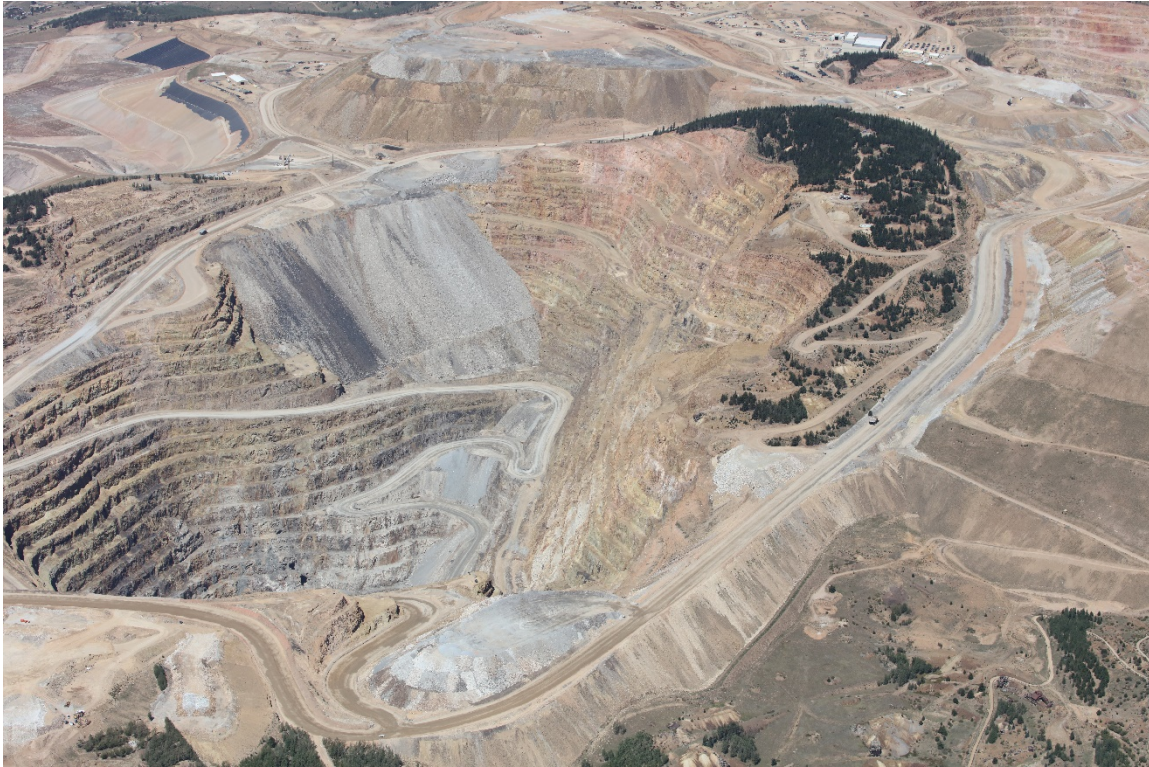
Photo 12. Main Cresson Pit (looking NW, Altman backfill on right).

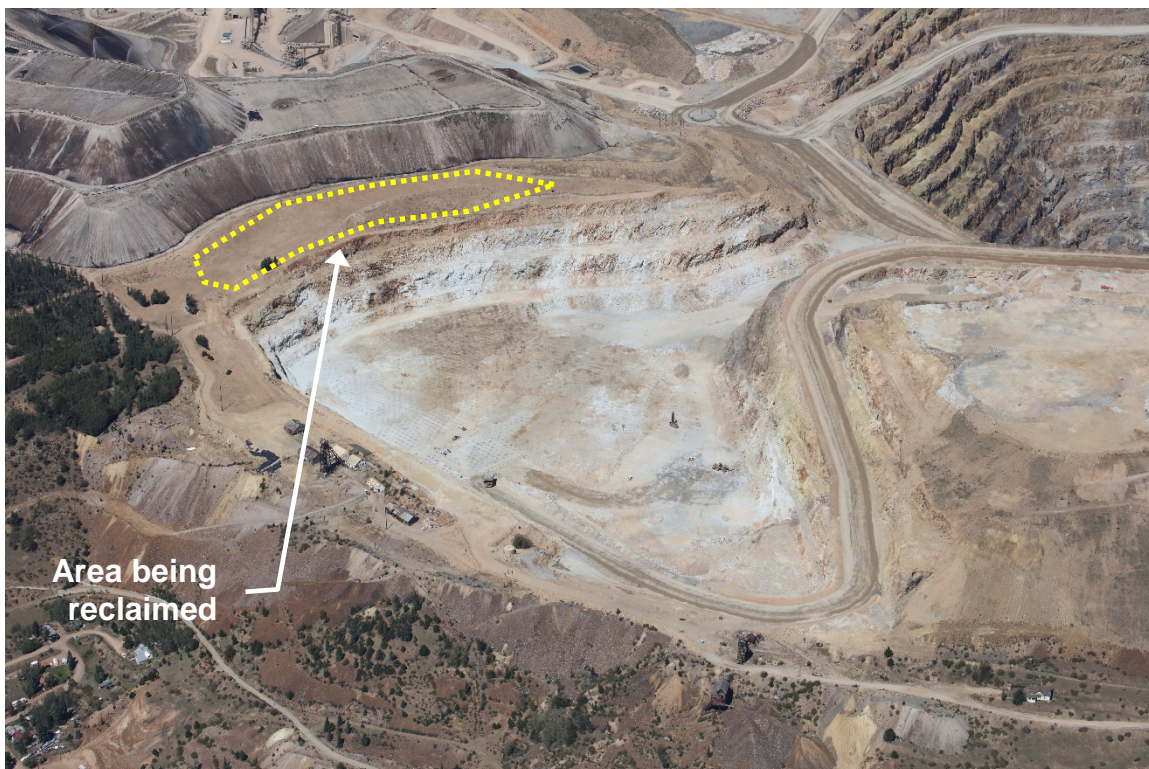
Photo 13. South Cresson Pit (looking NW, Main Cresson upper right).

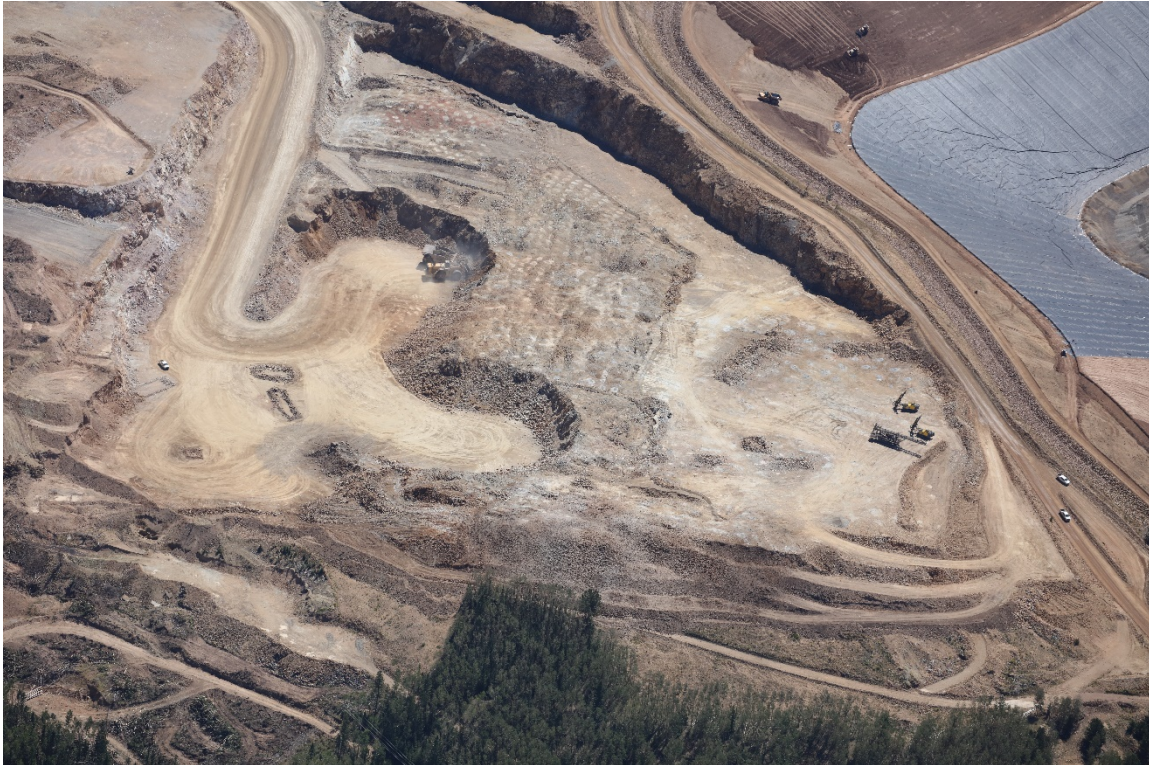
Photo 14. Schist Island Pit – active mining (looking south, VLF 2 construction on left).

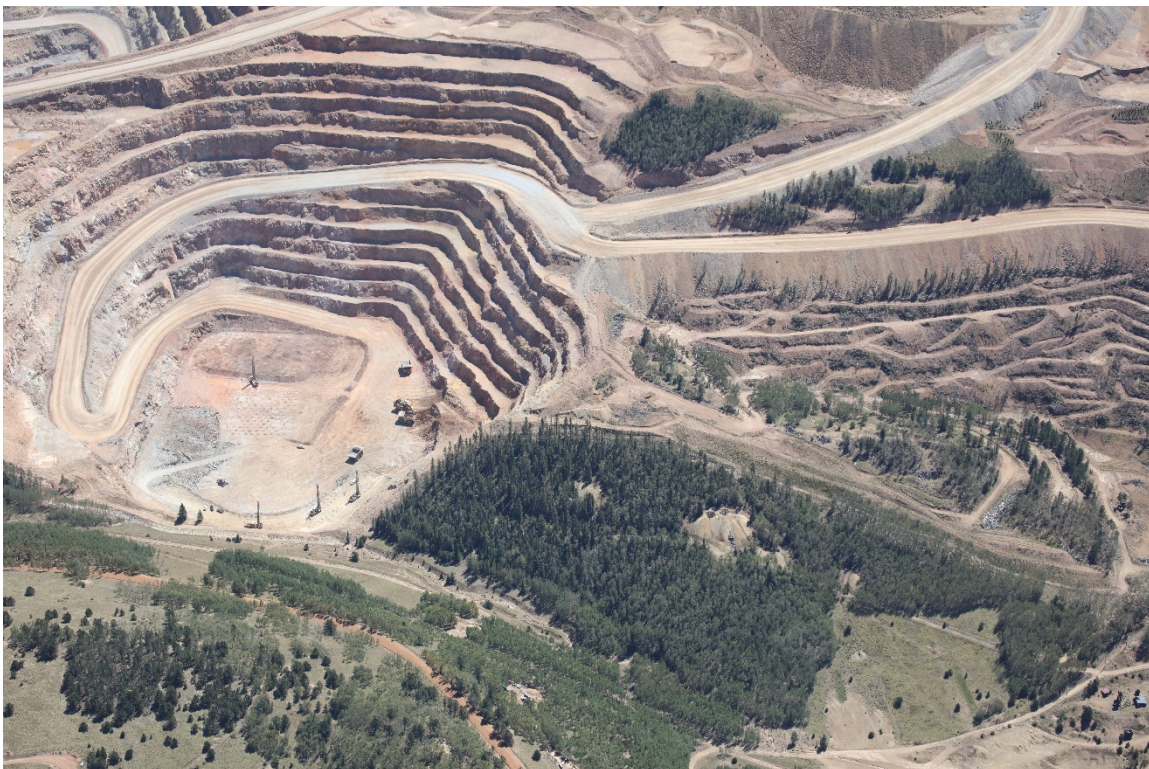
Photo 15. Globe Hill Pit (looking SE, WHEX pit upper left).

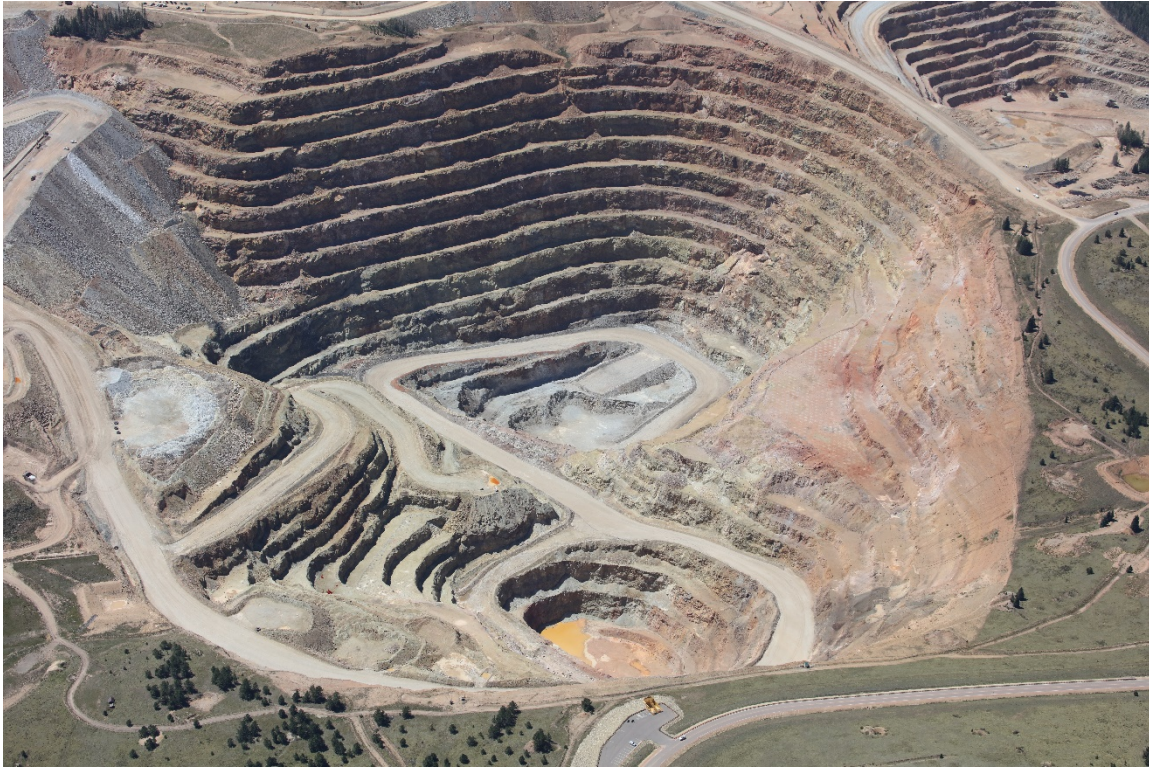
Photo 16. WHEX Pit – water in eastern pit bottom (looking WSW, Globe Hill pit in upper right).

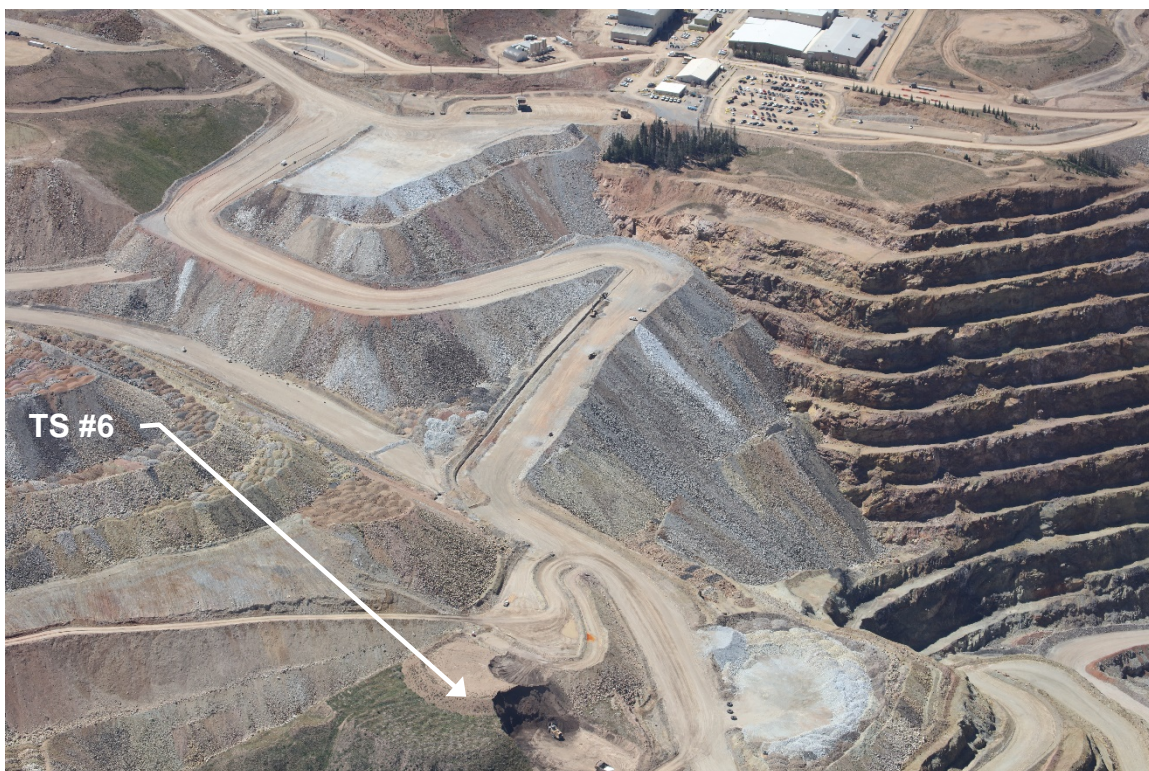
Photo 17. WHEX Pit backfill progression (looking SW, Ironclad facilities in background).
