Bowie #1 report

PERMIT INFORMATION

Permit Number: C-1981-038 Mine Name: Bowie No. 1 Mine Operator: Bowie Resources, LLC Operator Address: Mr. Basil R Bear P.O. Box 1488 Paonia, CO 81428	County: Delta Operation Type: Underground Permit Status: Active Ownership: Private
	Operator Representative Present: None
Operator Representative Signature: (Field Issuance Only)

Inspection Start Date: November 17, 2020 Inspection Start Time: 12:30 Inspection End Date: November 17, 2020 Inspection End Time: 15:00		Inspection Type: Coal Complete Inspection Inspection Reason: Normal I&E Program Weather: Clear	
Joint Inspection Agency: None		Joint Inspection Contacts: 	
Post Inspection Agency: None		Post Inspection Contacts: 	
Inspector(s): Robert Zuber, P.E.	Inspector's Signature:

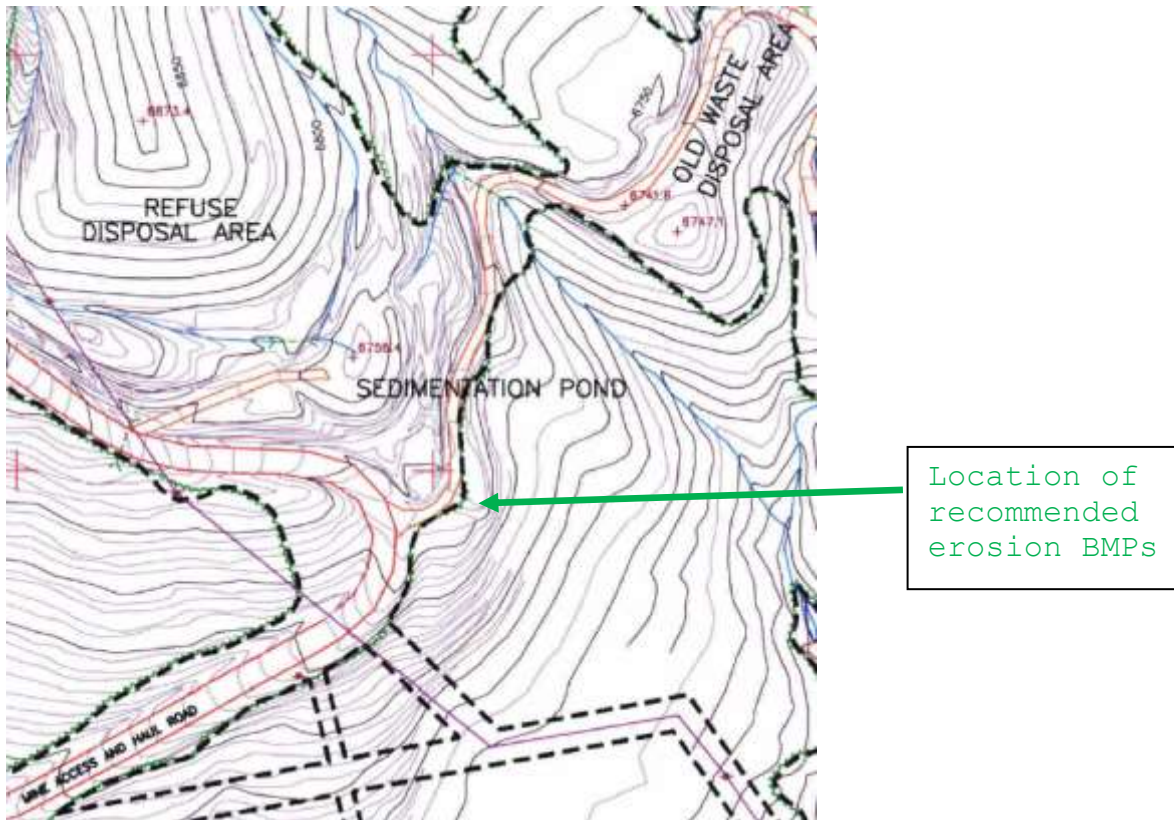
Below the RDA (see the map for location) straw bales are functioning, but additional BMPs are recommended to prevent erosion at the interface with undisturbed land.

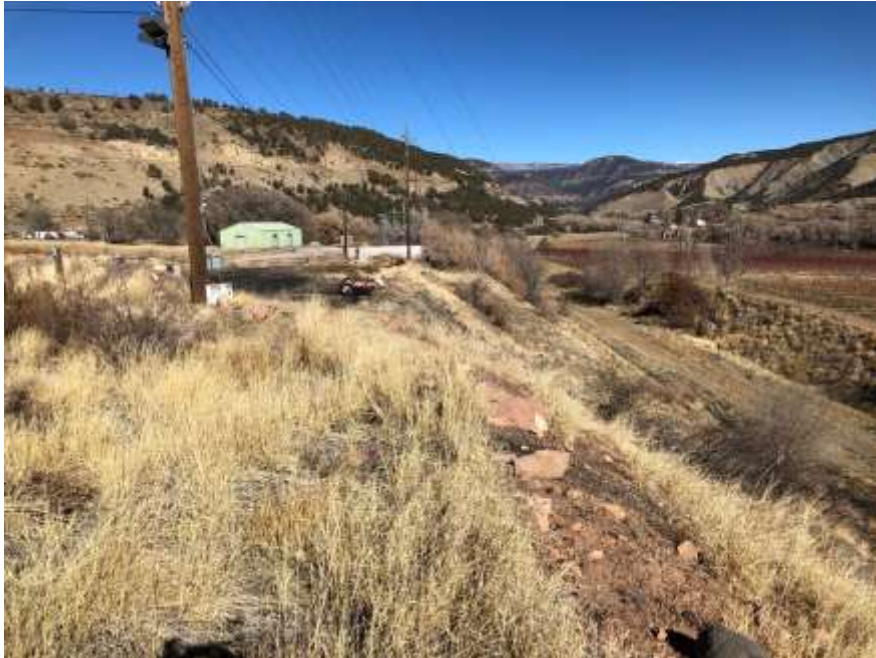
No problems were seen with the Coal Storage Area by the highway or with the loadout. The slope below the substation and the rest of the main yard at the loadout is stable.

Slope below yard at the loadout – west side

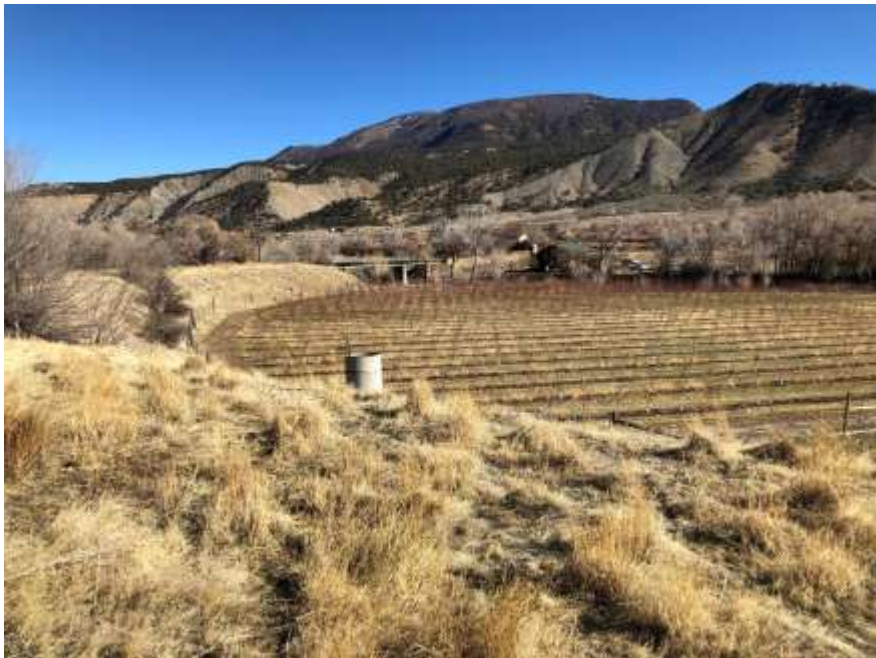
Slope below east side of the loadout

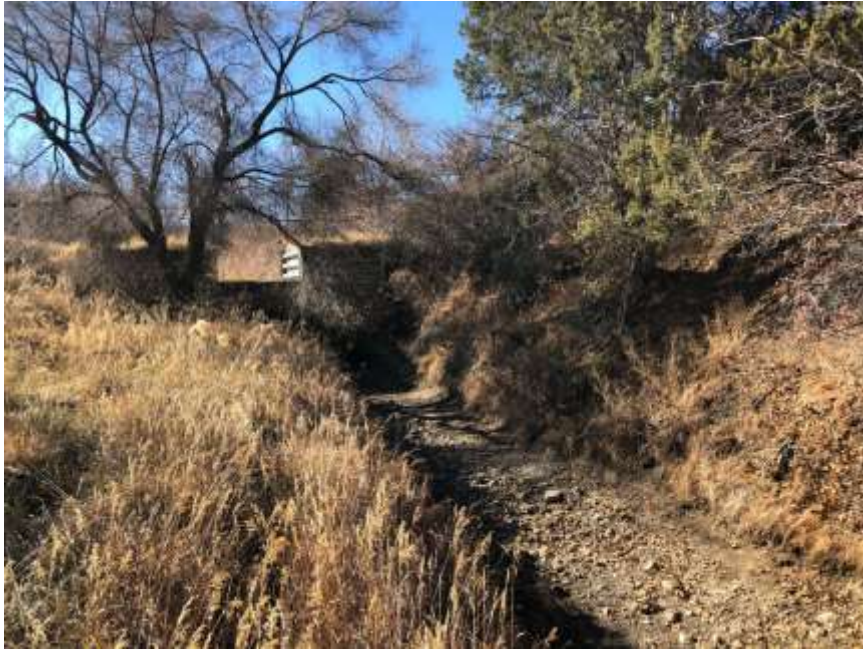
The ponds at the loadout, the Coal Storage Area (near loadout), and at the West Mine were dry, and no problems were identified with these ponds. The primary spillway at the loadout pond appears to be functioning, although it is difficult to see in the pipe. The emergency spillway has been cleared of branches.

The irrigation canal that flows through the loadout (including a 600-foot culvert) was dry.

Loadout spillway and dry irrigation ditch

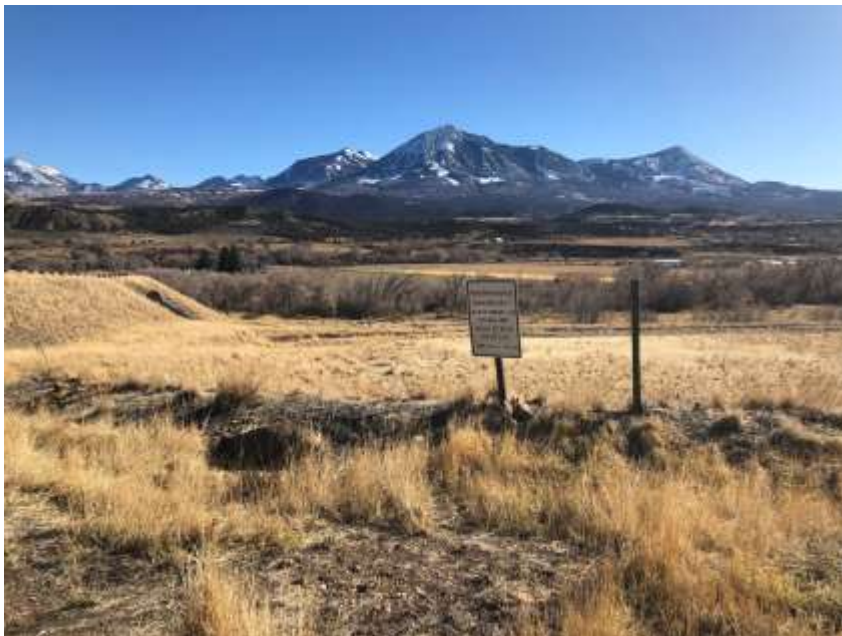
Good stands of vegetation were seen at the reclaimed area of the East Mine (including the RDA, reclaimed ponds, and the Old Waste Disposal Area), the ROM and Timber Storage areas, and the West Mine. The vegetation is not as good at the coal storage area by Black Bridge Road, but there is no erosion there.

Coal storage area at Black Bridge Road

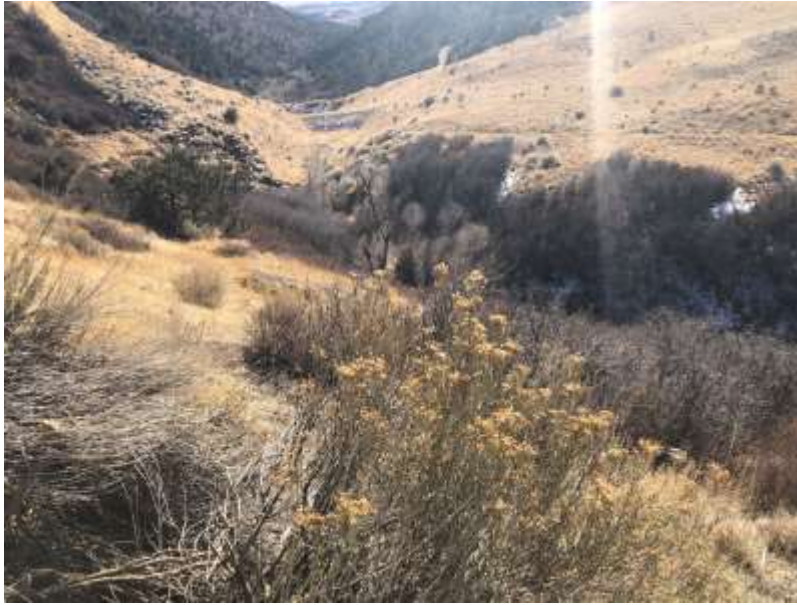
West Mine ponds

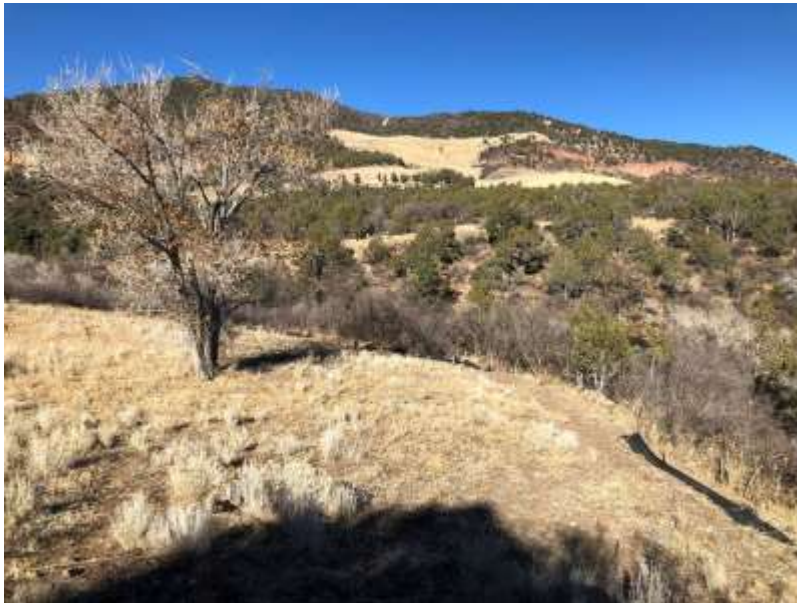
The sediment control BMPs below the Refuse Disposal Area are functioning. The BMPs at the R.O.M. Storage Area pond are functioning but should be inspected often as the silt fence is sagging and the berm is not very high.

R.O.M. Storage – reclaimed pond

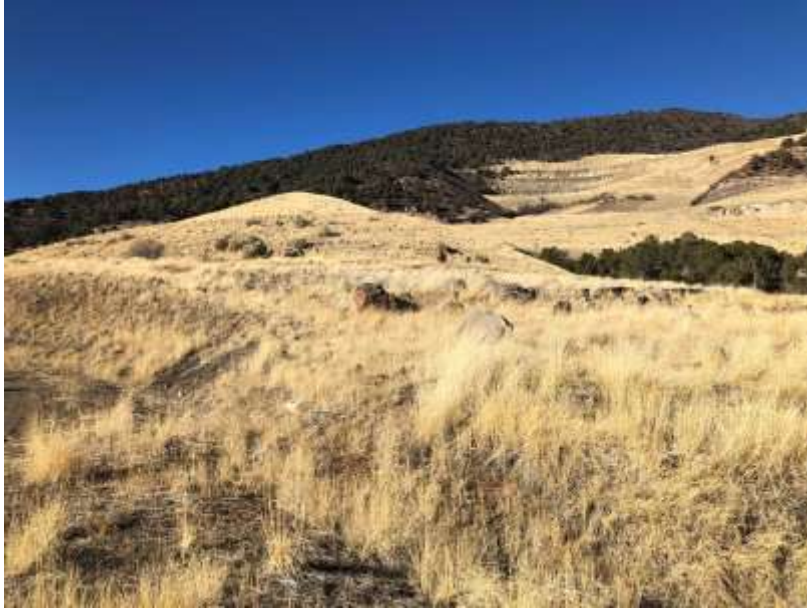
Lower portion of East Mine, including RDA (taken below reclaimed pond)

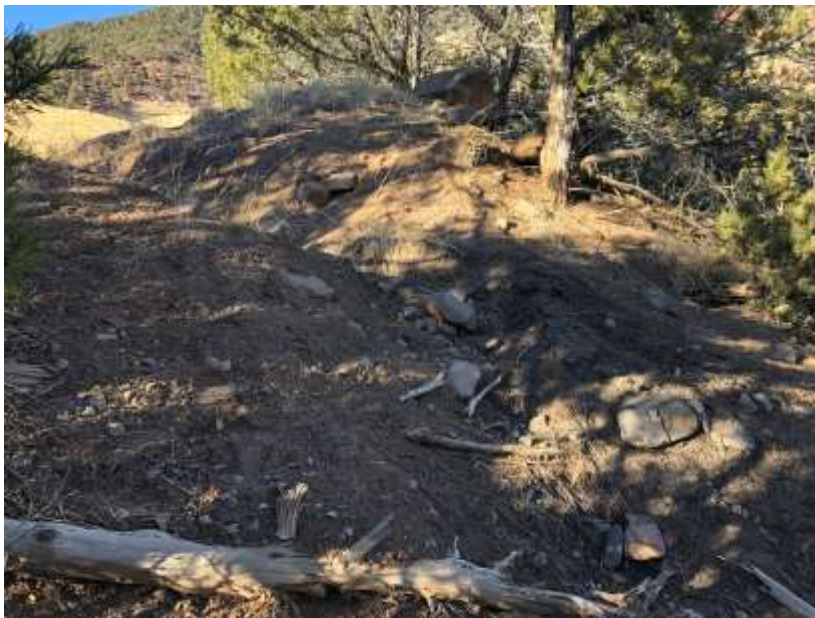
Area below RDA where erosion control BMPs are recommended

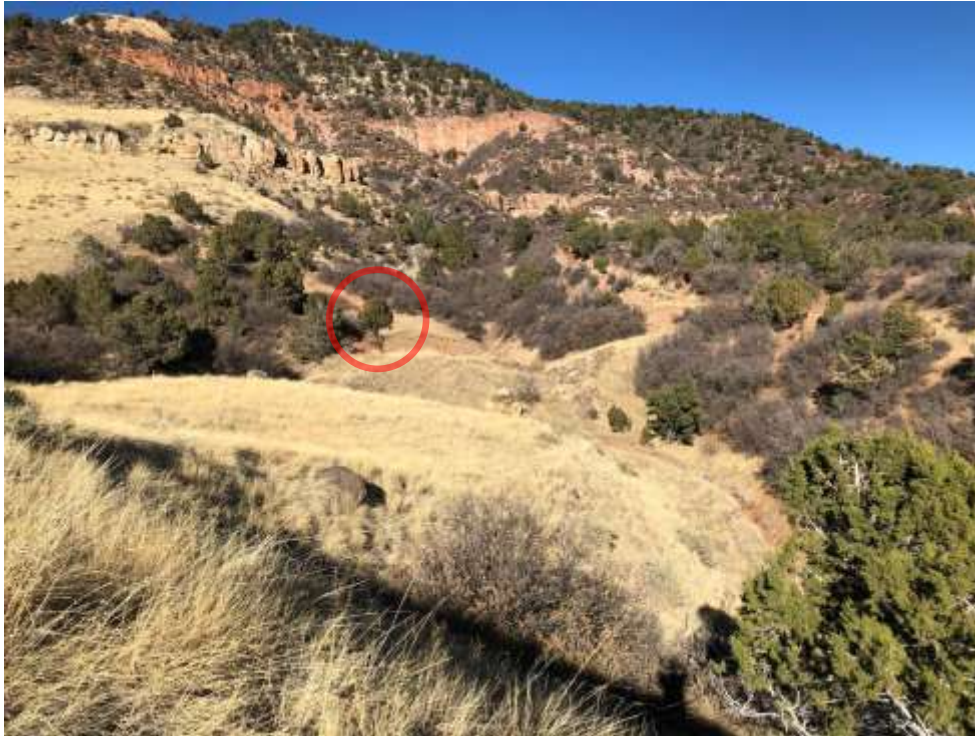
Area of reclaimed Ponds 1 and 2 (circled tree should be monitored for erosion)

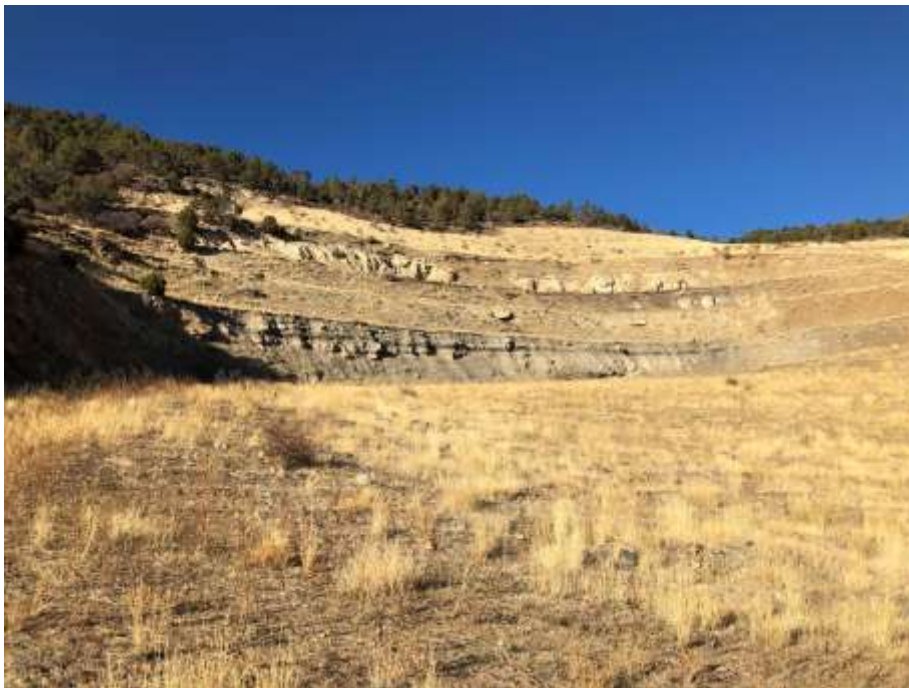
Cliff above reclaimed portal bench
