Inspection report for North Thompson Creek Mine

PERMIT INFORMATION

Permit Number: C-1981-025	County: Garfield		
Mine Name: North Thompson Creek Mine	Operation Type: Underground		
Operator: MINREC, Inc.	Permit Status: Inactive		
Operator Address:	Ownership: Private		
Mr. Stan Muhr	-		
627 241/2 Road, Unit H	Operator Representative Present:		
Grand Junction, CO 81505			
,	None		
Operator Representative Signature: (Field Issuance Only)

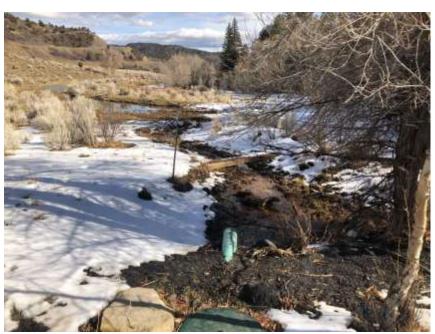
No problems were identified with ditches between the ponds or the aeration ditch above the Long Pond. At the outlet to Pond P-9, the diversion of discharge to the Refuse Pond is functioning well, and there was no discharge to the creek (Outfall 01). The old ditch out of Pond T-2 (with a pipe spillway) was dry; discharge from Pond T-2 flows directly to Pond P-9.

Flow into aeration ditch at top of treatment system

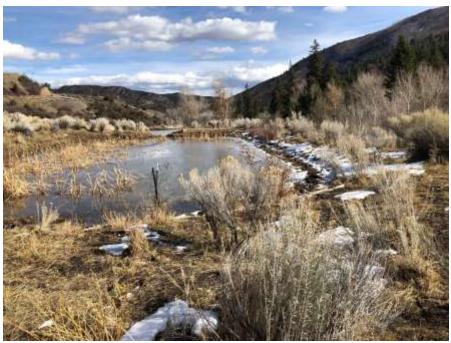
Treatment Pond T-1, with Treatment Pond T-2 in the background

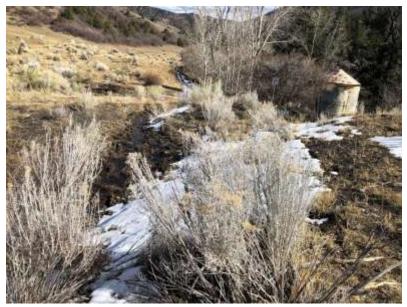
Flow out of the Polishing Pond (Pond P-9)

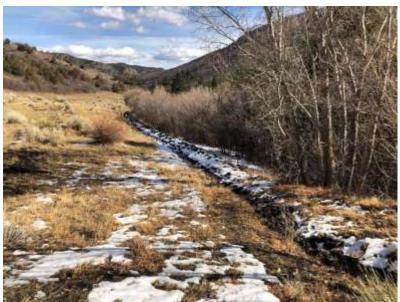
The ditch into the Refuse Pond (which was breeched in September) was functioning. Along its entire length from Pond P-9, it has been cleared of sediment and vegetation to insure that this ditch continues to function.

Ditch between Pond P-9 and the Refuse Pond

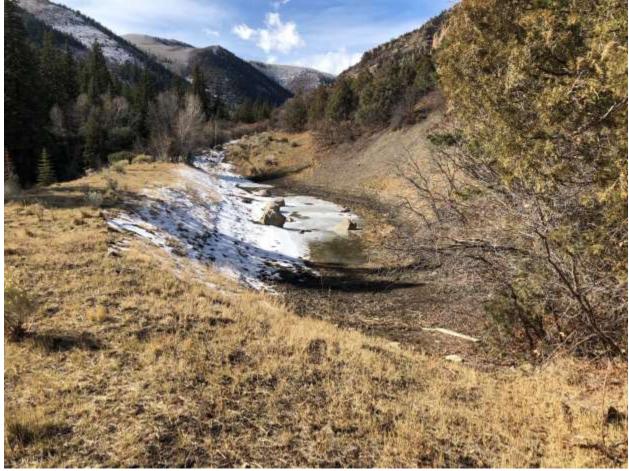
Refuse Pond
